# PRELIMINARY BAT ROOST ASSESSMENT

NHDC Decarbonisation Project: Hitchin Swimming Pool

794-ENV-ECO-21554  
B  
November 2024

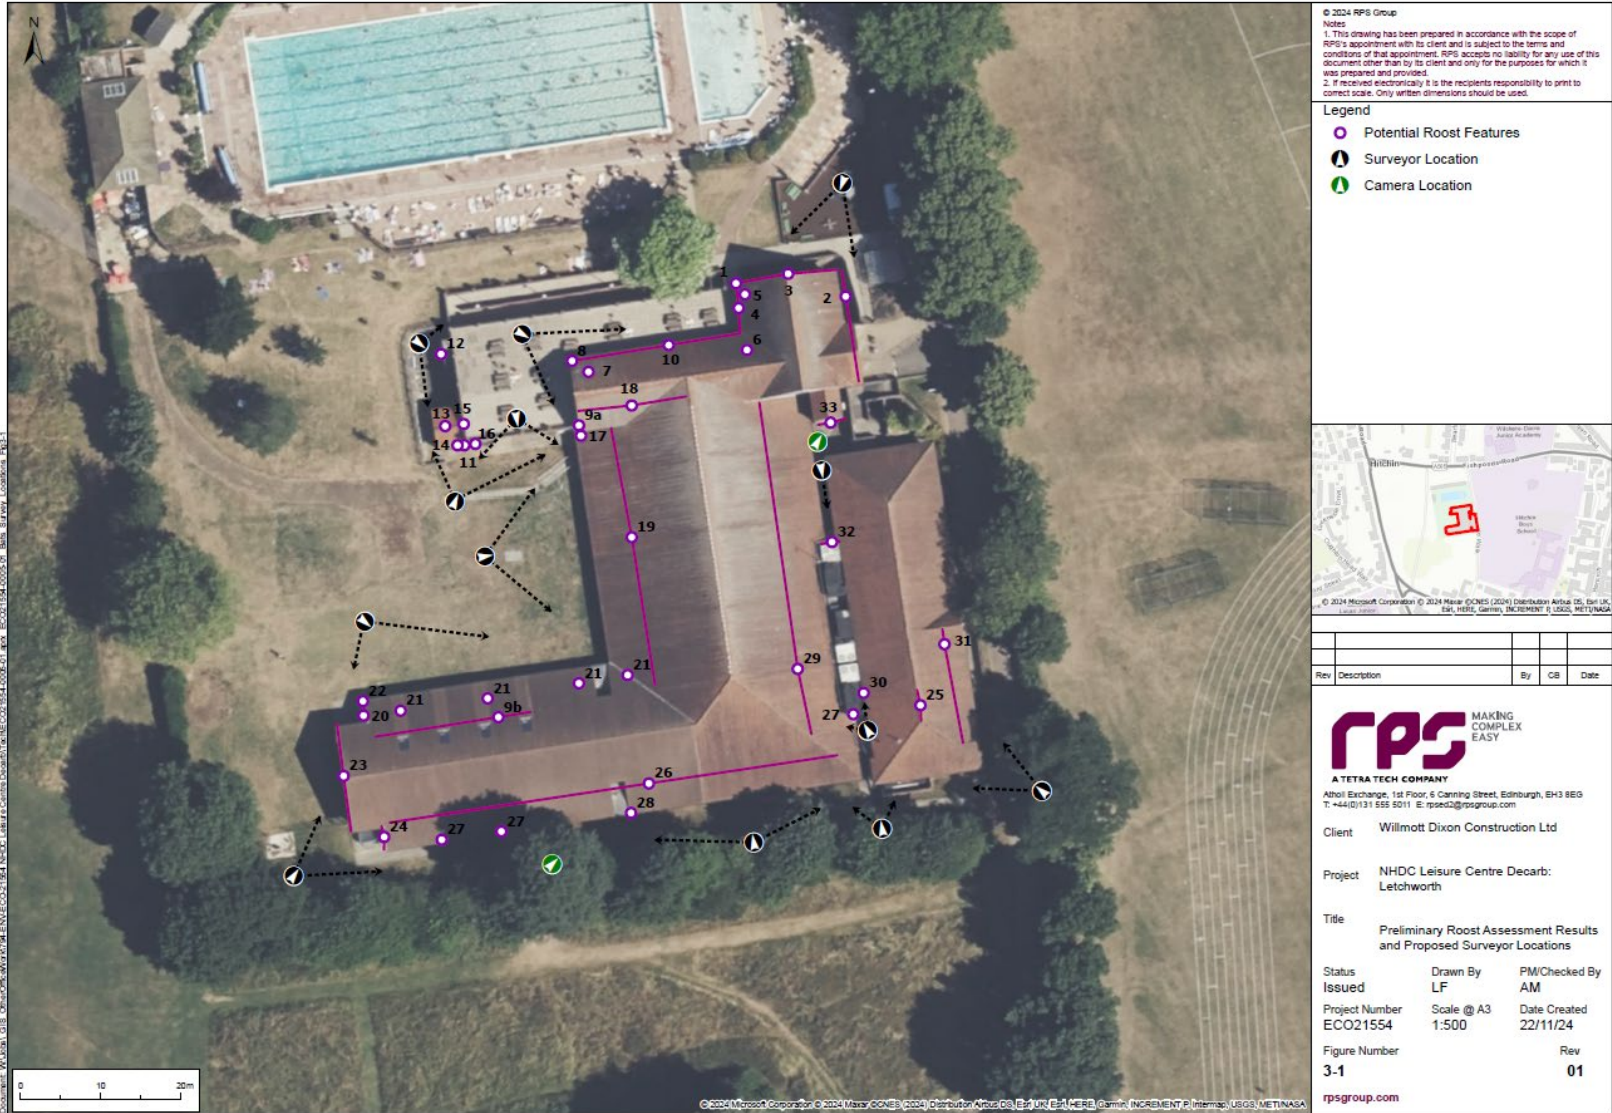
Figure 3.1: Preliminary Roost Assessment Results and Proposed Surveyor Locations.

- 3.1.3 A map of the PRFs on the structure is presented in **Figure 3.1**. Description and photographs of identified potential roosting features are presented in **Appendix A**.

- 4.3.4 **Figure 3.1** shows proposed locations of surveyors expected to be required to sufficiently cover all features identified on the building during each survey.

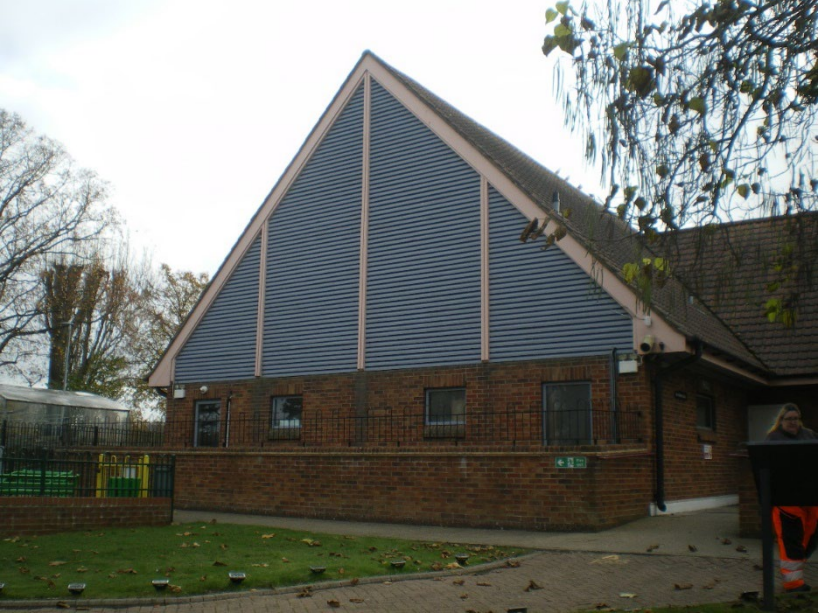
| Feature | Description | Photo |
|---|---|---|
| 1 | Hole in mesh behind shuttering allowing egress. North-west corner, north elevation | A photograph showing the north-west corner of a building. The building has a steep gable roof covered in blue corrugated metal. The lower portion of the building is constructed of red brick. There are several windows visible on the brick section. The building is surrounded by a green lawn and some trees in the background. |

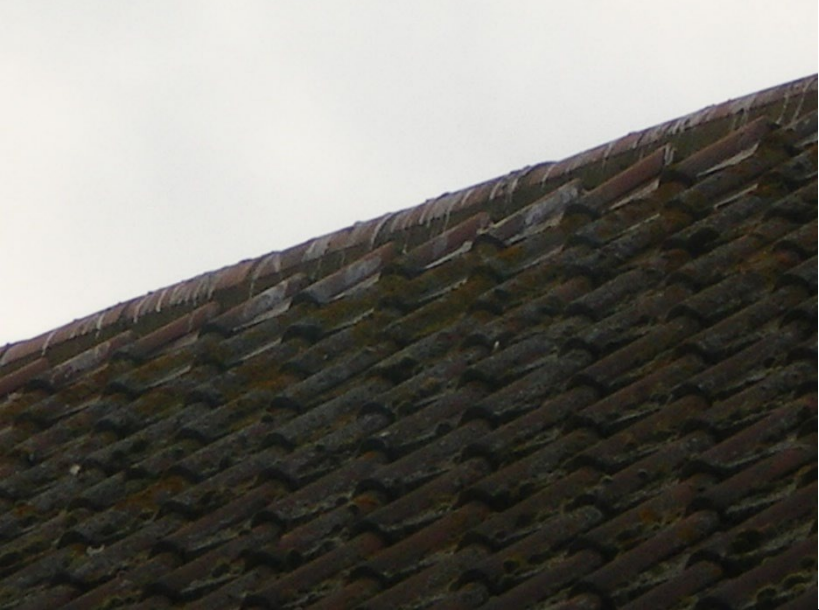
| Feature | Description | Photo |
|---|---|---|
| 2 | Gaps along the first row of tiles. North end of the building, east elevation | A close-up photograph of a roof surface. The roof is covered with dark, weathered tiles. The focus is on the first row of tiles, where there are visible gaps and some debris. The sky in the background is overcast. |

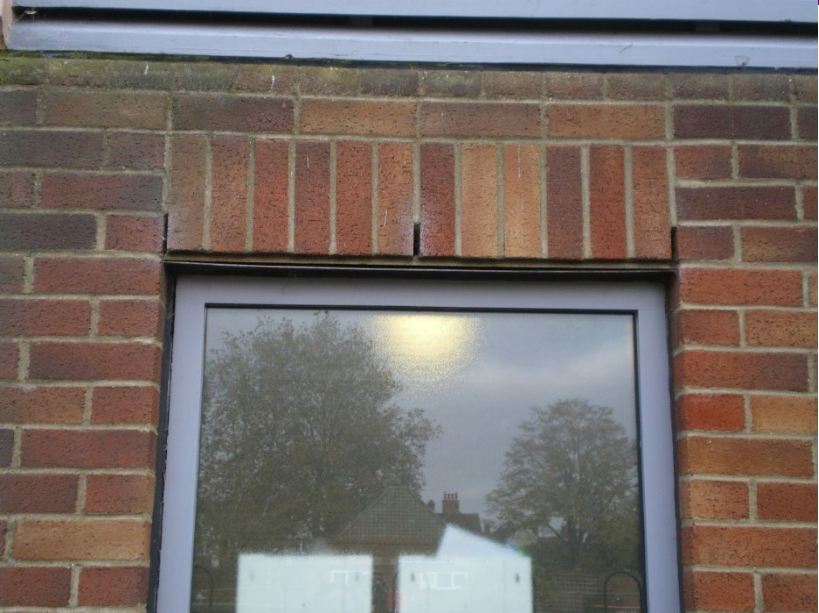
| Feature | Description | Photo |
|---|---|---|
| 3 | Weepholes above the windows, North end of the building, west elevation | |

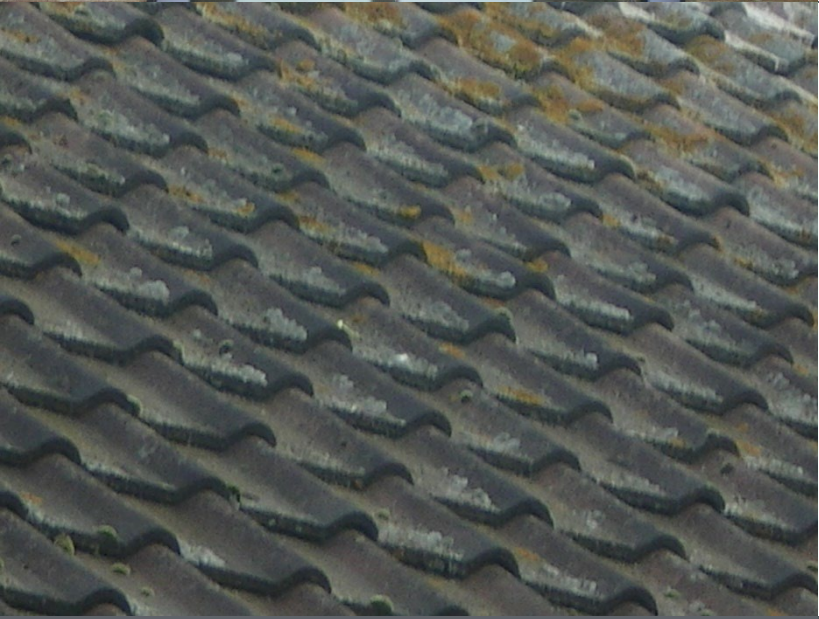
| Feature | Description | Photo |
|---|---|---|
| 4 | Occasional gaps between tiles over the roof. North end of the building, west elevation | |

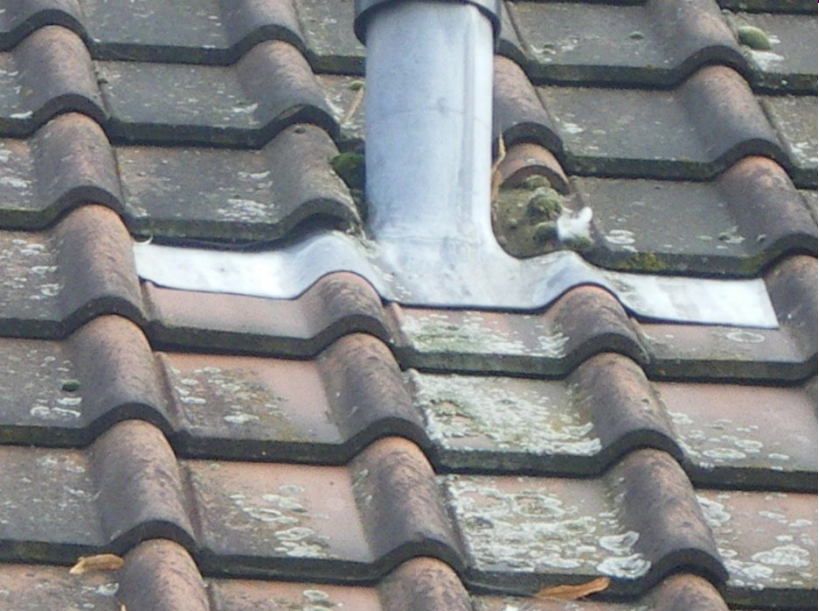
| Feature | Description | Photo |
|---|---|---|
| 5 | Gap on lead flashing on the vent. North end of the building, west elevation | |

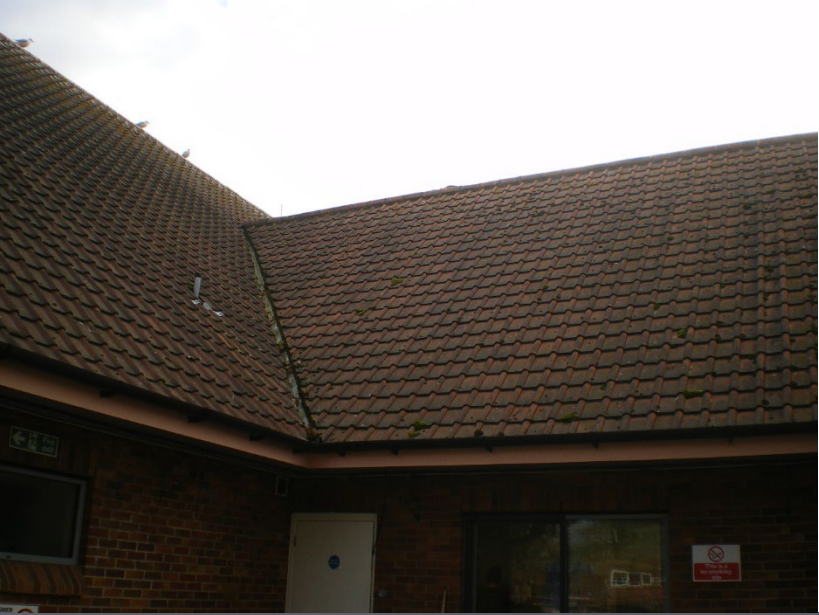
| Feature | Description | Photo |
|---|---|---|
| 6 | Gaps in the tiles.<br>North elevation, east side of the roof | |

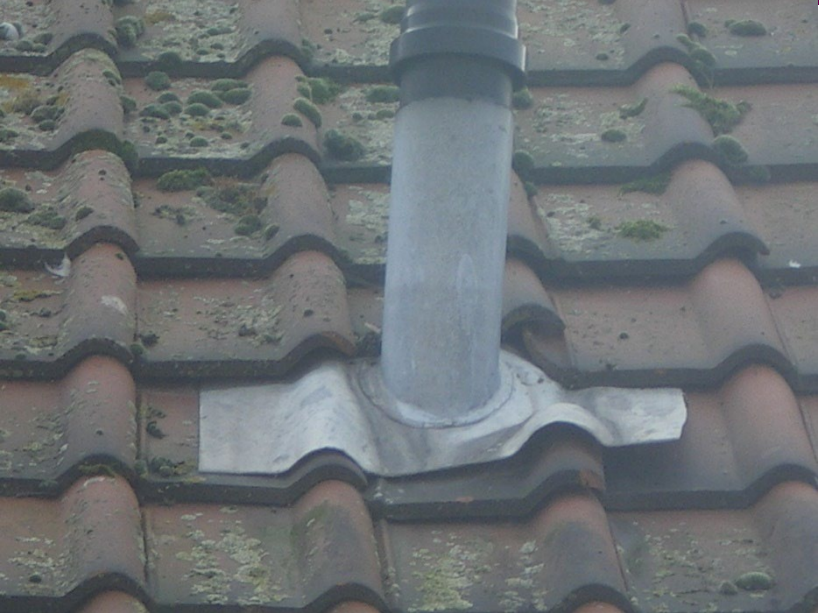
| Feature | Description | Photo |
|---|---|---|
| 7 | Lead lifted around vent in the roof. North elevation | |

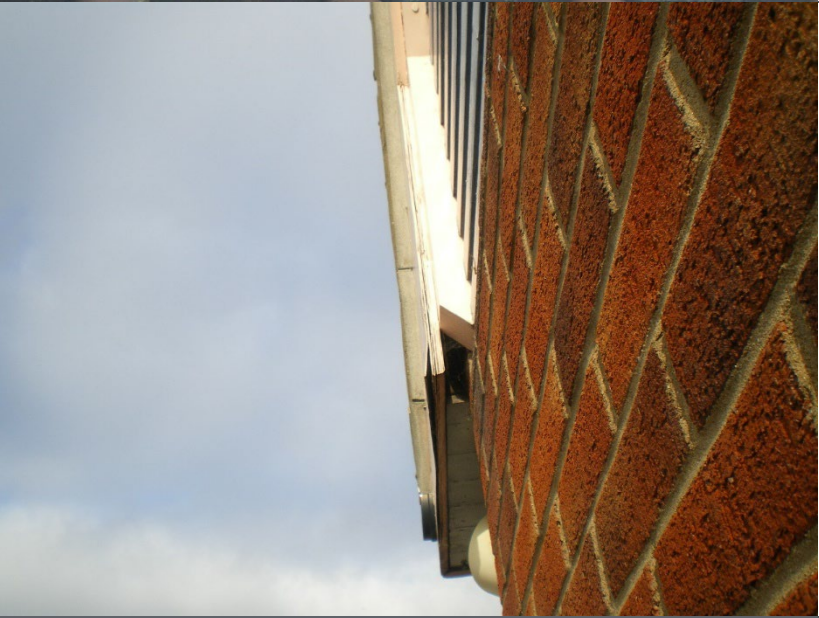
| Feature | Description | Photo |
|---|---|---|
| 8 | Gap in wooden soffit / roof edging. West elevation, north side of the large wooden venting | |

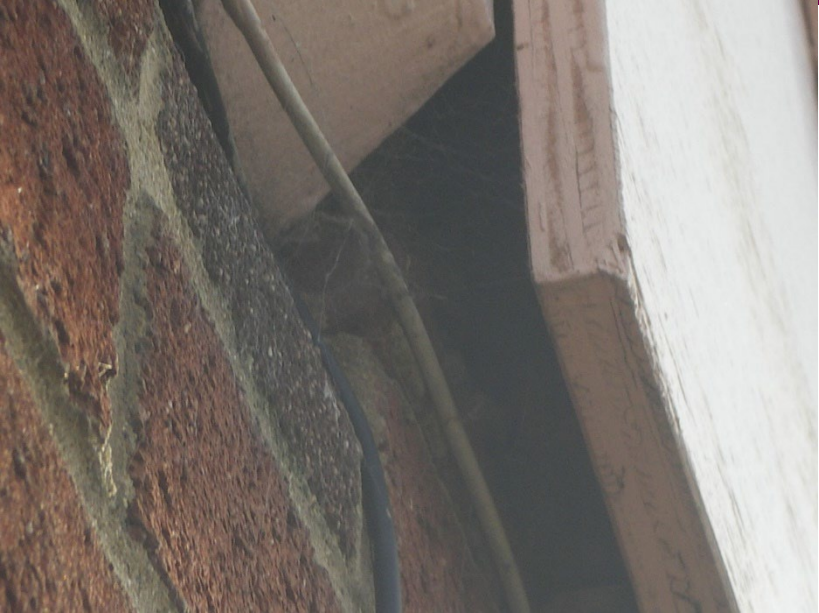
| Feature | Description | Photo |
|---|---|---|
| 9a | Gap in wooden soffit / roof edging. West elevation, south side of the large wooden venting | |

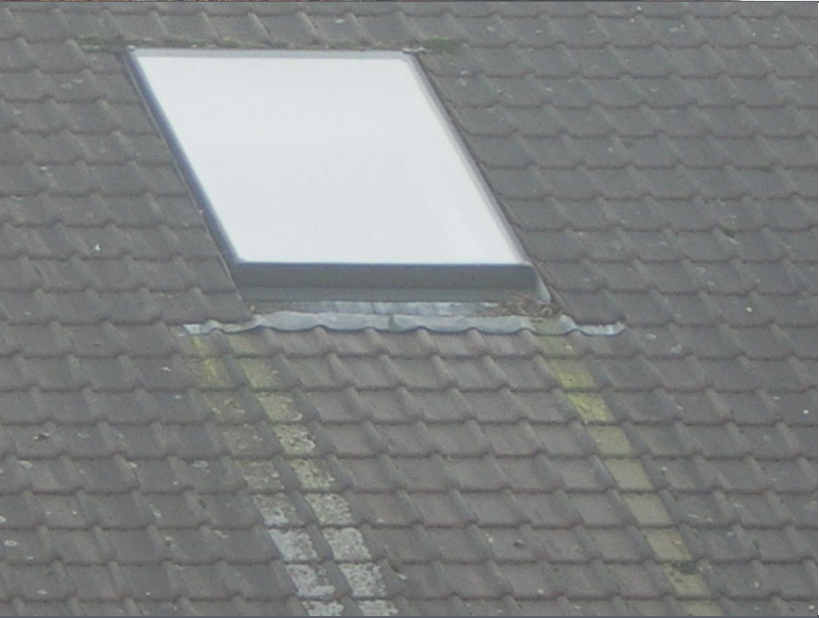
| Feature | Description | Photo |
|---|---|---|
| 9b | Lead under the roof windows. Above the indoor swimming pool, north elevation | |

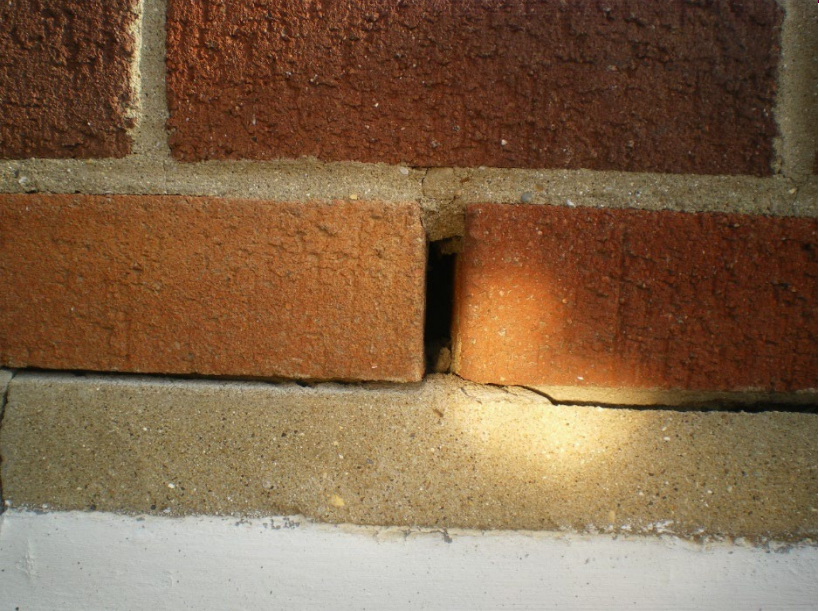
| Feature | Description | Photo |
|---|---|---|
| 10 | All aspects of the building – weepholes low on the walls | |

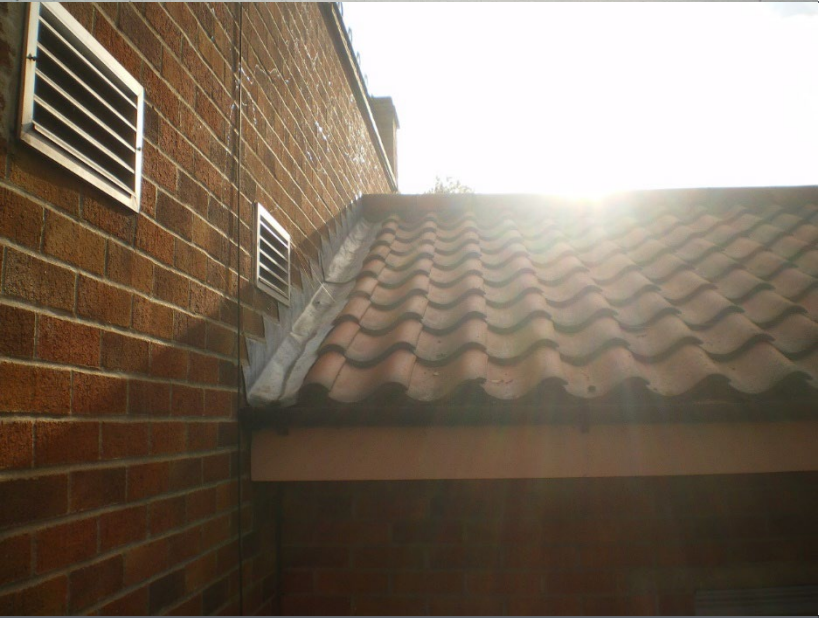
| Feature | Description | Photo |
|---|---|---|
| 11 | Lead flashing has gaps. North elevation | |

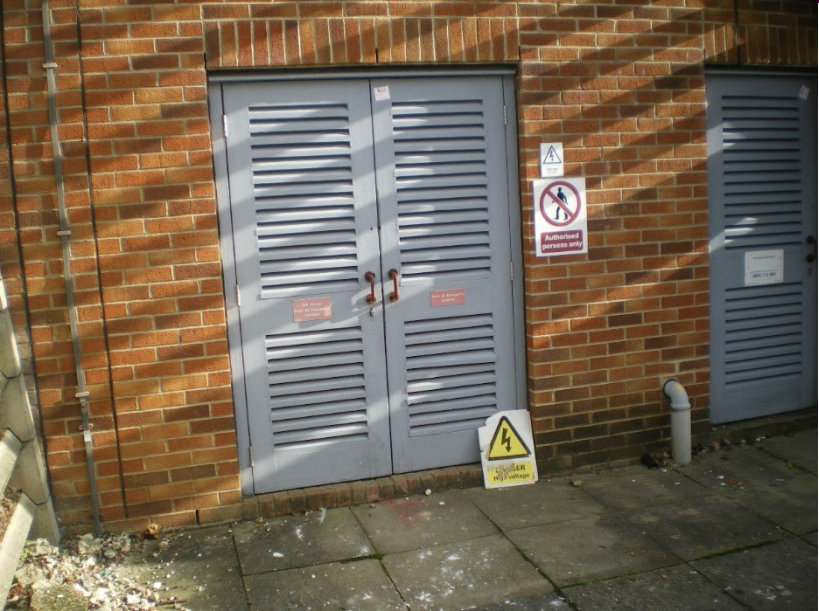
| Feature | Description | Photo |
|---|---|---|
| 12 | Small plant rooms with vented doors | |

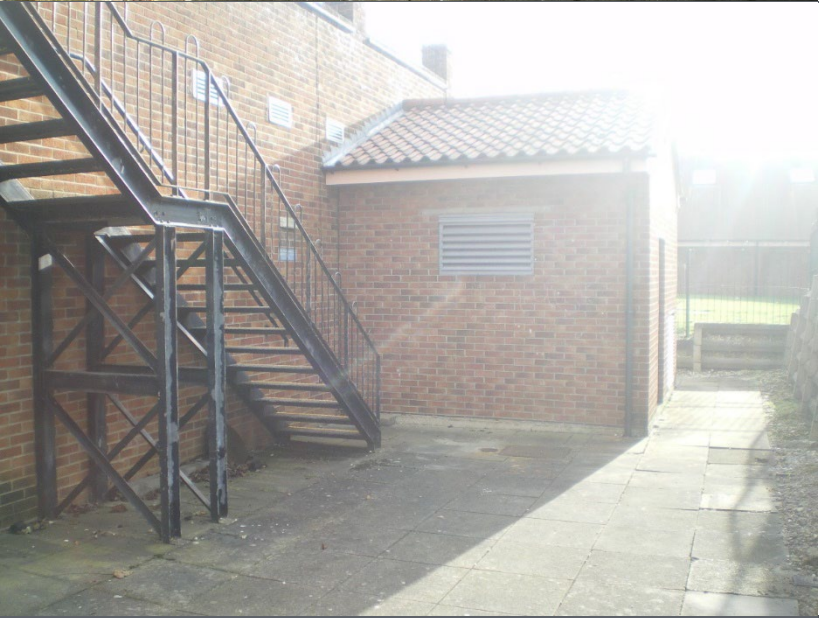
| Feature | Description | Photo |
|---|---|---|
| 13 | Small plant room with vented doors | |

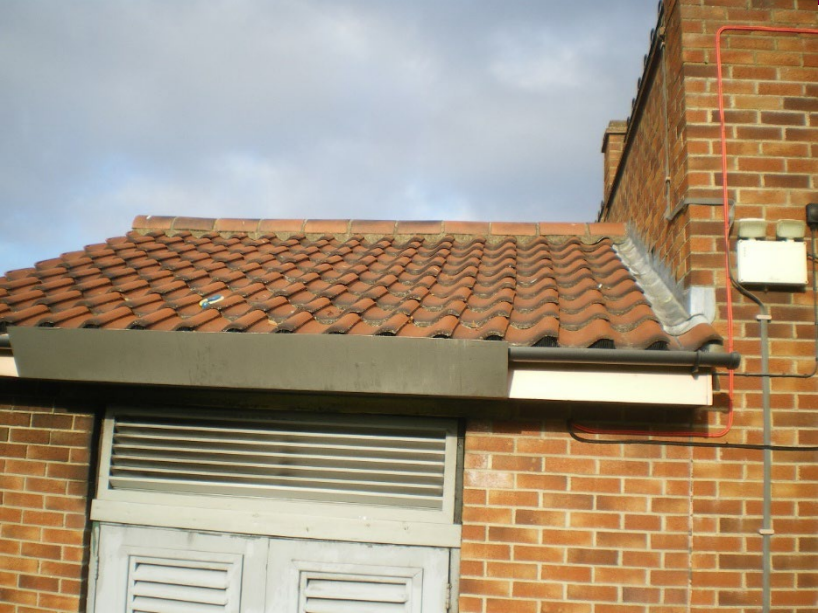
| Feature | Description | Photo |
|---|---|---|
| 14 | Lead flashing gap along the roof edge. South elevation | A photograph showing the south elevation of a building's roof edge. The roof is covered with reddish-brown tiles. A grey lead flashing strip runs along the edge of the roof, but there is a visible gap between the flashing and the roof tiles. Below the roofline, there is a white louvered door or window. To the right, a brick wall is visible with a red cable running vertically and a white rectangular object, possibly a light fixture or sensor, mounted on it. |

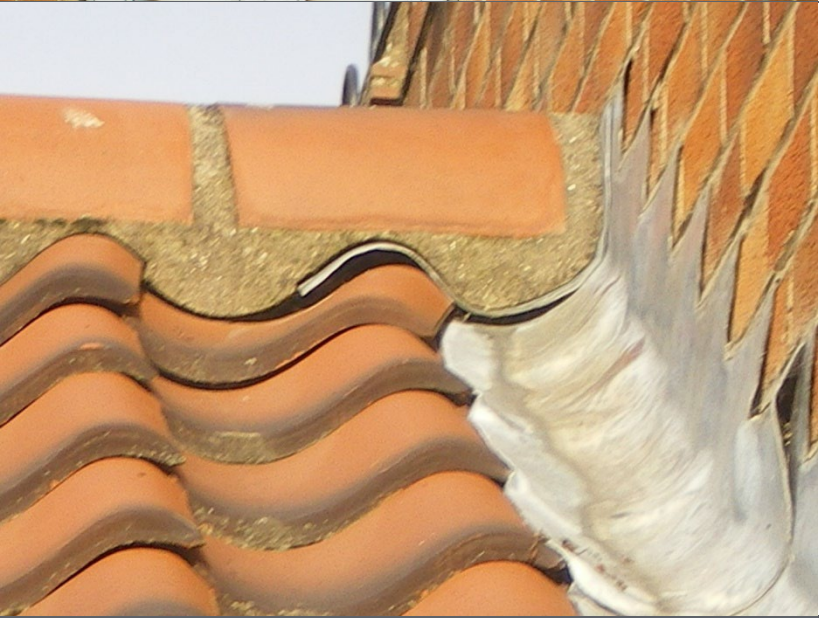
| Feature | Description | Photo |
|---|---|---|
| 15 | Gap at apex near wall. South elevation | A close-up photograph of the roof apex near a brick wall. The roof is covered with reddish-brown tiles. A white, curved object, possibly a downspout or a pipe, is visible on the right side of the image. There is a noticeable gap between the roof tiles and the wall, which is the focus of the assessment. |

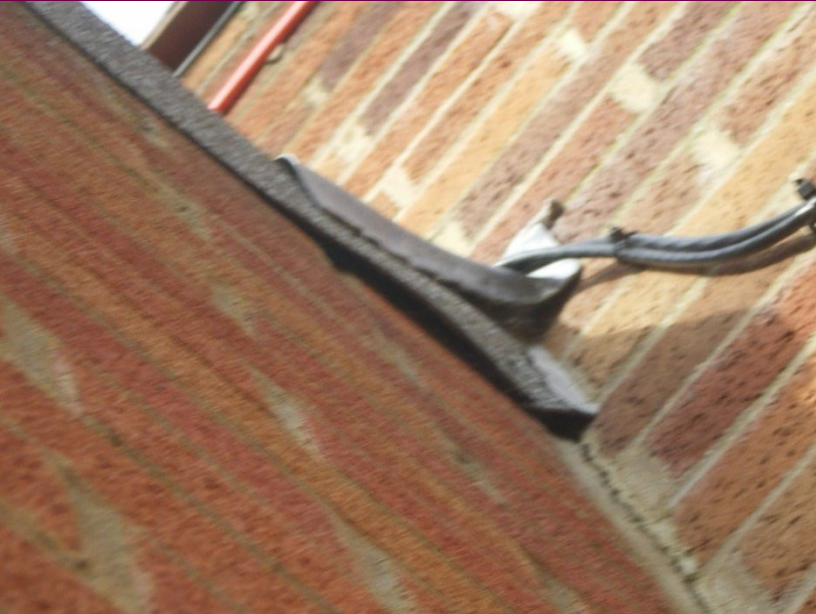
| Feature | Description | Photo |
|---|---|---|
| 16 | Bitumen and lead flashing gap. South elevation | A close-up photograph showing a gap in the bitumen and lead flashing on a brick wall. The flashing is dark and appears to be made of lead, with a visible gap between it and the brickwork. A red pipe is visible in the upper left corner of the frame. |

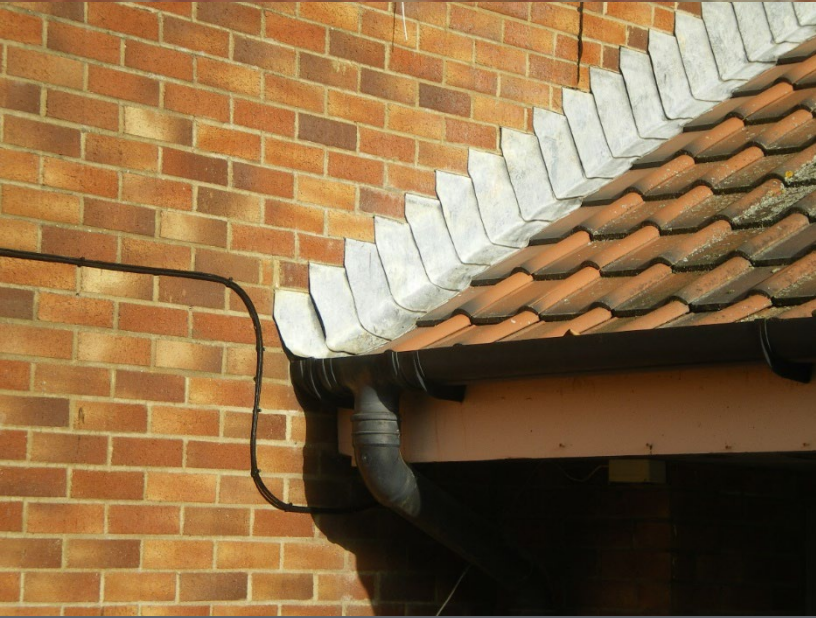
| Feature | Description | Photo |
|---|---|---|
| 17 | Gaps in lead flashing between roof and wall. West elevation | A close-up photograph showing gaps in the lead flashing between a roof and a brick wall. The flashing is made of lead and is visible as a series of overlapping, angled pieces. The roof is covered with orange tiles, and a black downspout is visible on the right side of the frame. |

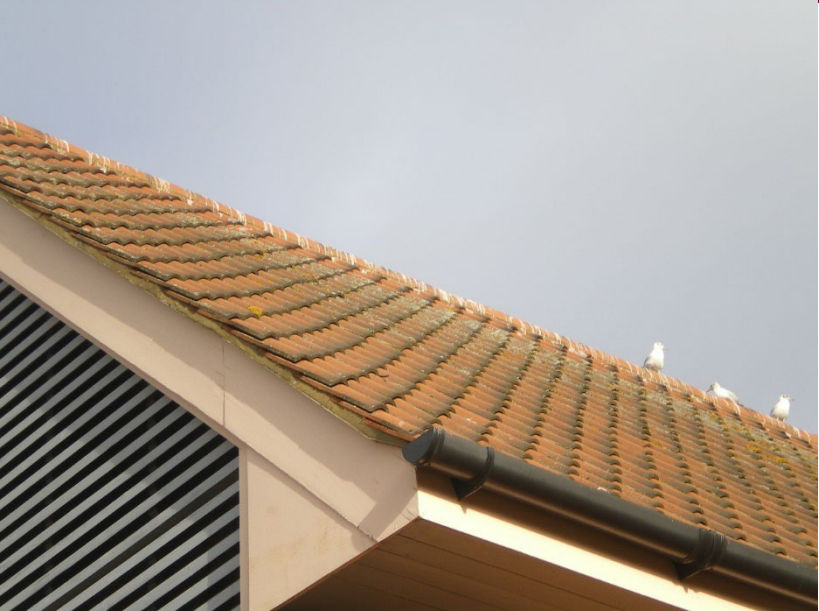
| Feature | Description | Photo |
|---|---|---|
| 18 | Gaps under tiles across this section of roof. South elevation | A close-up photograph of a roof section with reddish-brown tiles. The tiles are laid in a standard pattern, but there are visible gaps between them, particularly along the ridge and in some of the lower rows. The sky is overcast and grey. |

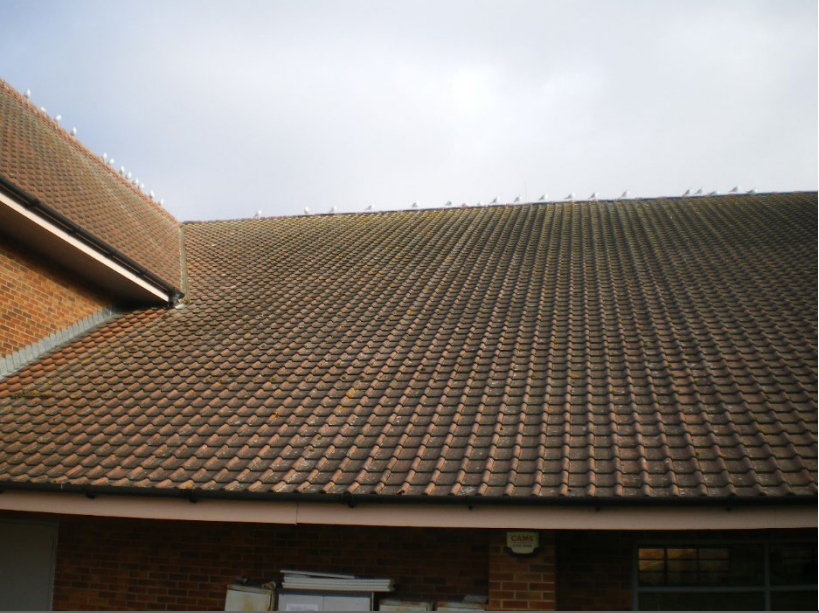
| Feature | Description | Photo |
|---|---|---|
| 19 | Occasional gaps between tiles over the roof. West elevation | A wide-angle photograph of a large roof covered in reddish-brown tiles. The tiles are laid in a standard pattern, but there are occasional gaps between them, particularly along the ridge and in some of the lower rows. The sky is overcast and grey. |

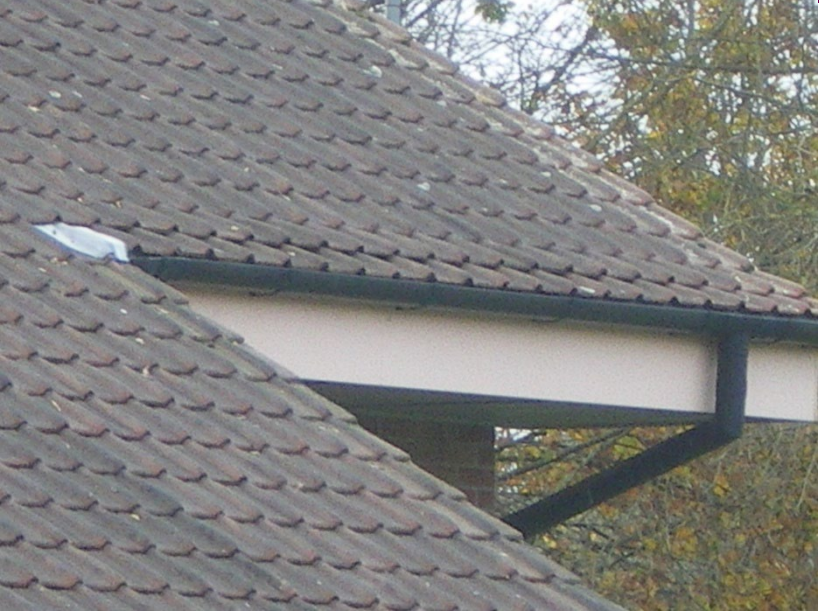
| Feature | Description | Photo |
|---|---|---|
| 20 | Row of lifted tiles along the short roof at the end of the indoor swimming pool building. North elevation | |

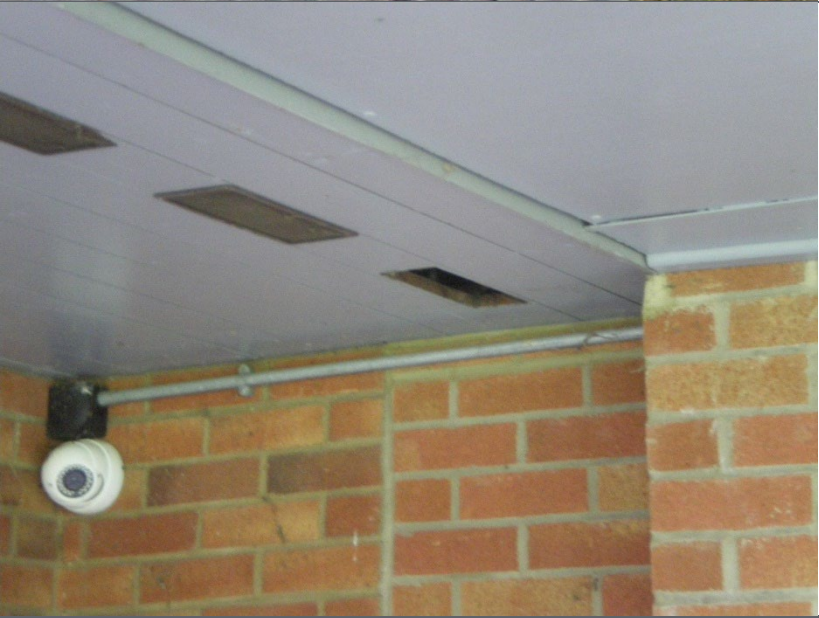
| Feature | Description | Photo |
|---|---|---|
| 21 | Missing vents in the wooden soffit / roof edging. North elevation | |

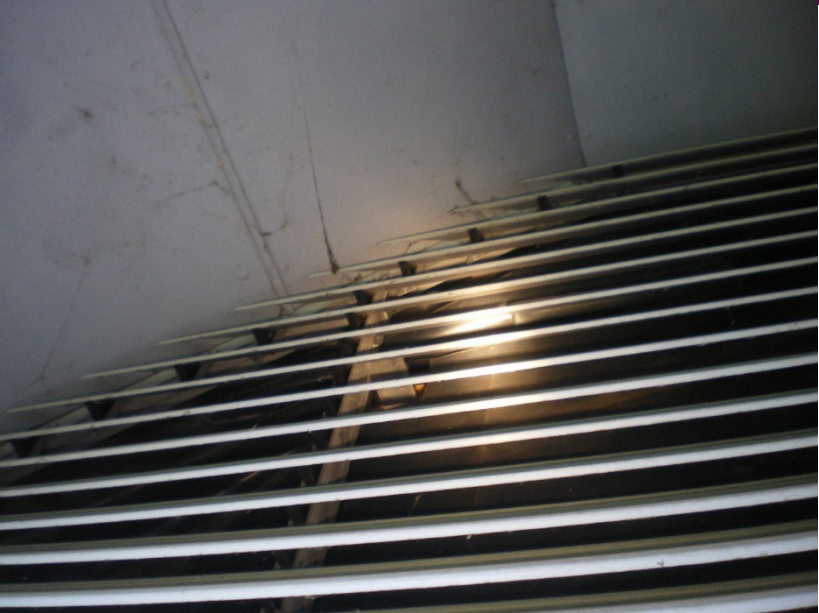
| Feature | Description | Photo |
|---|---|---|
| 22 | Wooden vent with no mesh, west end of indoor swimming pool room.<br>West elevation | |

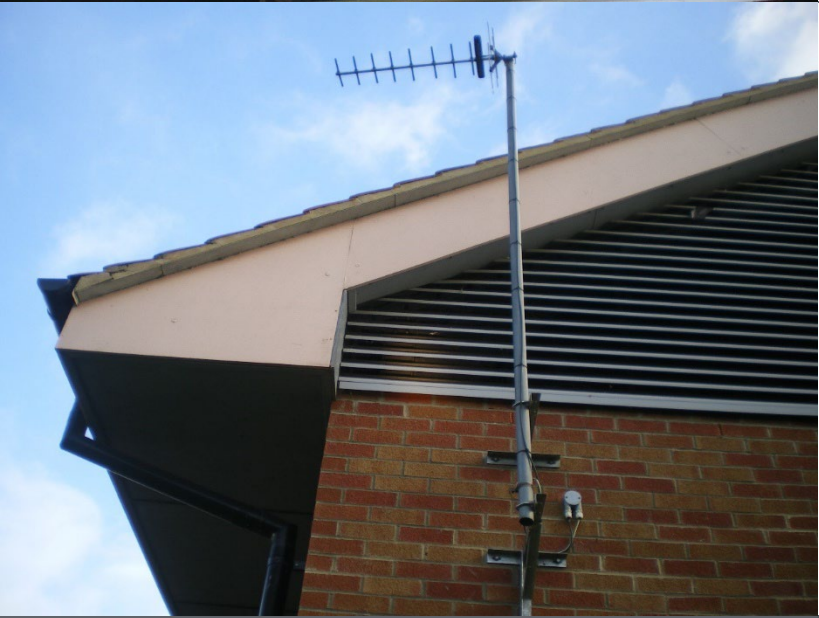
| Feature | Description | Photo |
|---|---|---|
| 23 | Large wooden venting. West elevation | |

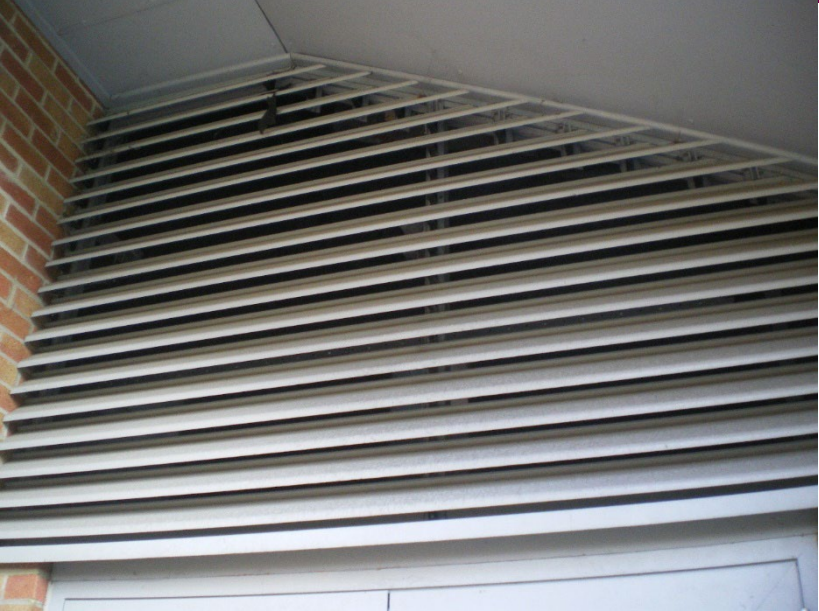
| Feature | Description | Photo |
|---|---|---|
| 24 | Small wooden venting. West elevation | |

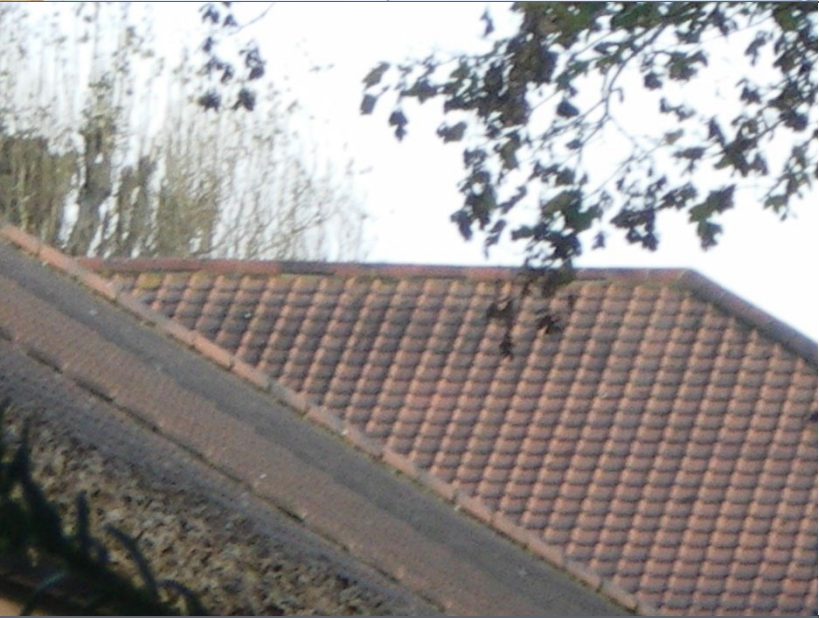
| Feature | Description | Photo |
|---|---|---|
| 25 | Gaps under ridge tiles. South end of front building | |

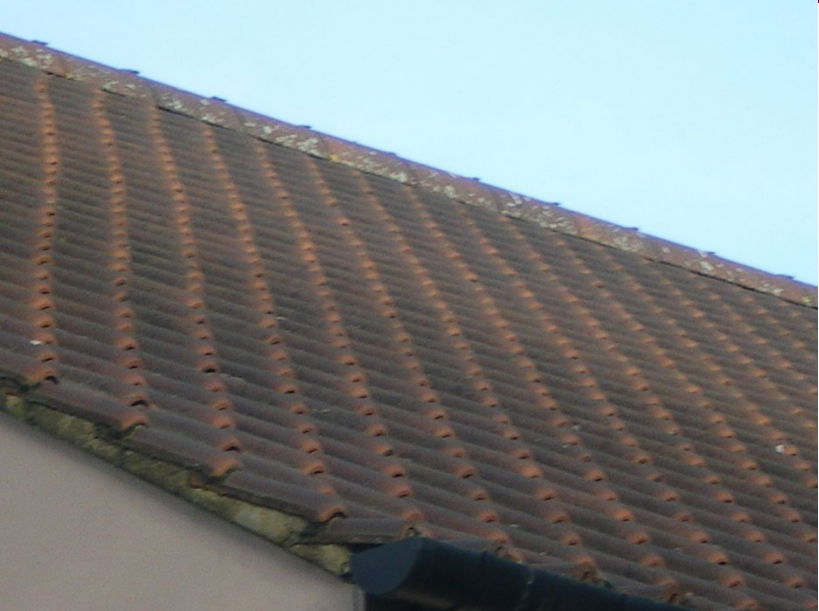
| Feature | Description | Photo |
|---|---|---|
| 26 | Gaps between tiles all along the roof. South elevation | |

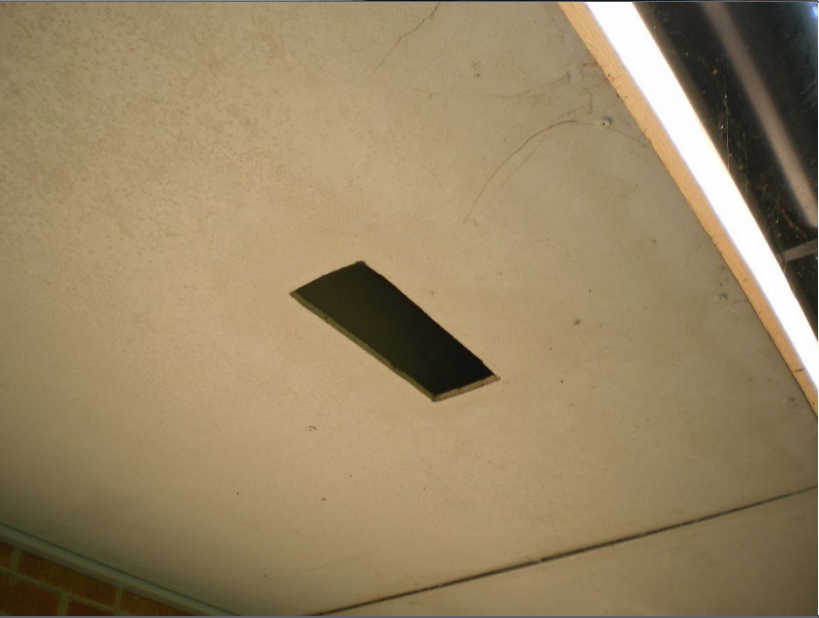
| Feature | Description | Photo |
|---|---|---|
| 27 | Missing vents in the wooden soffit / roof edging. South elevation | |

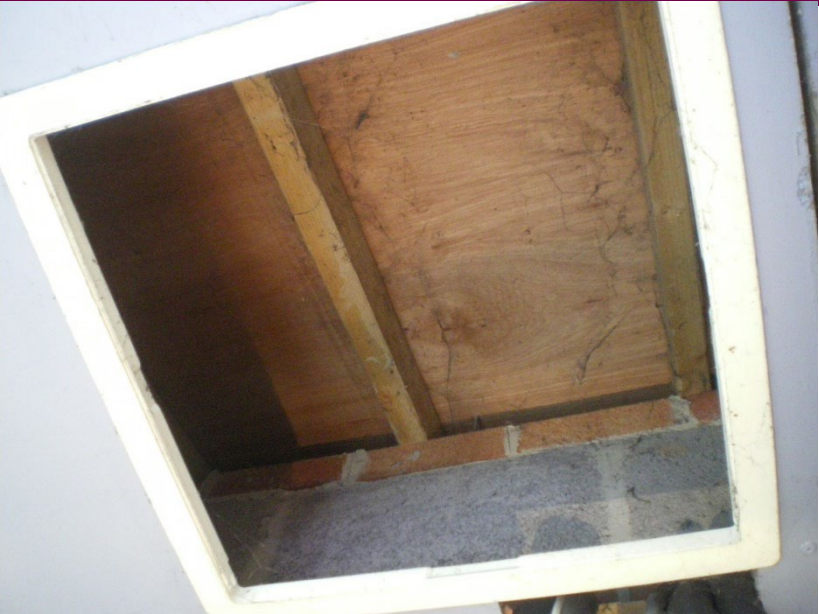
| Feature | Description | Photo |
|---|---|---|
| 28 | Hole without a cover in the wooden soffit / roof edging. South elevation | |

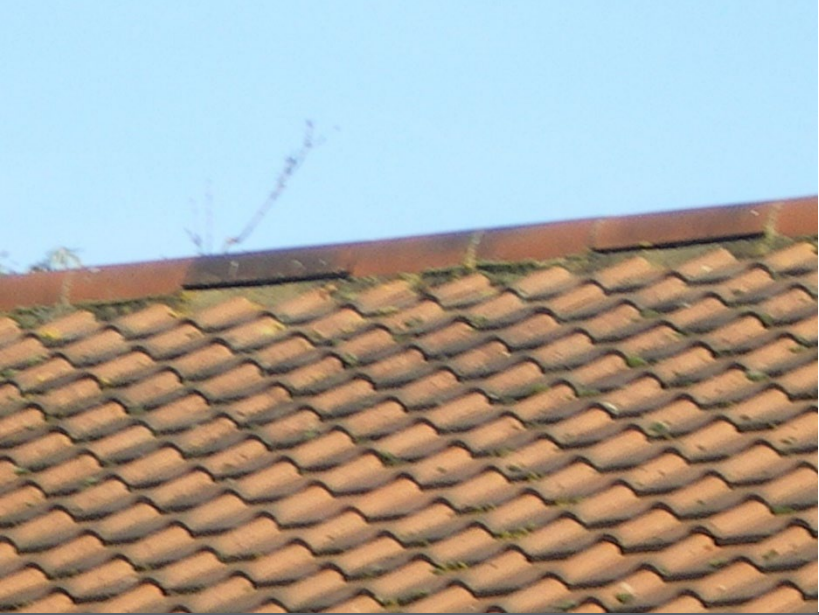
| Feature | Description | Photo |
|---|---|---|
| 29 | Gaps under edge tiles. East elevation | |

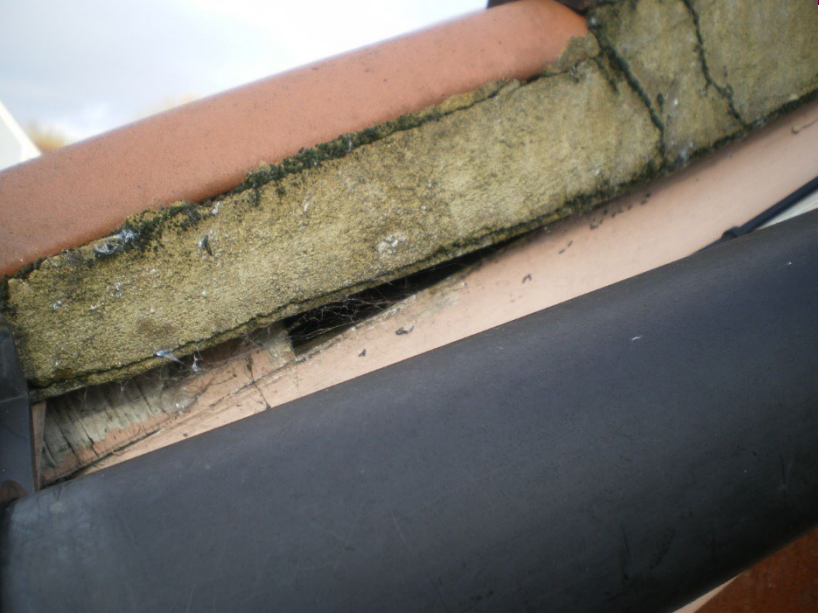
| Feature | Description | Photo |
|---|---|---|
| 30 | Gap between the edge of the wood and roof. South elevation | |

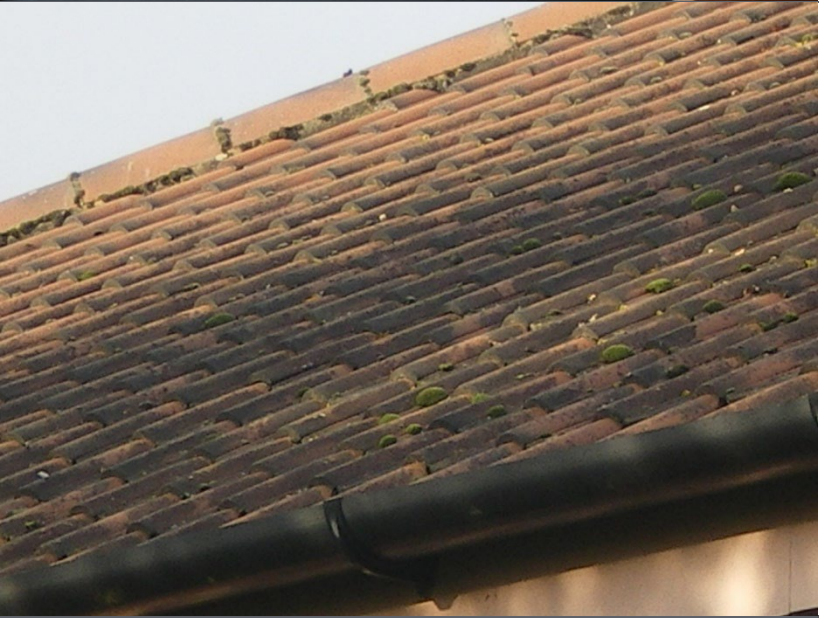
| Feature | Description | Photo |
|---|---|---|
| 31 | General gaps in tiles scattered along roof along the ridge. East elevation, south end of front building | |

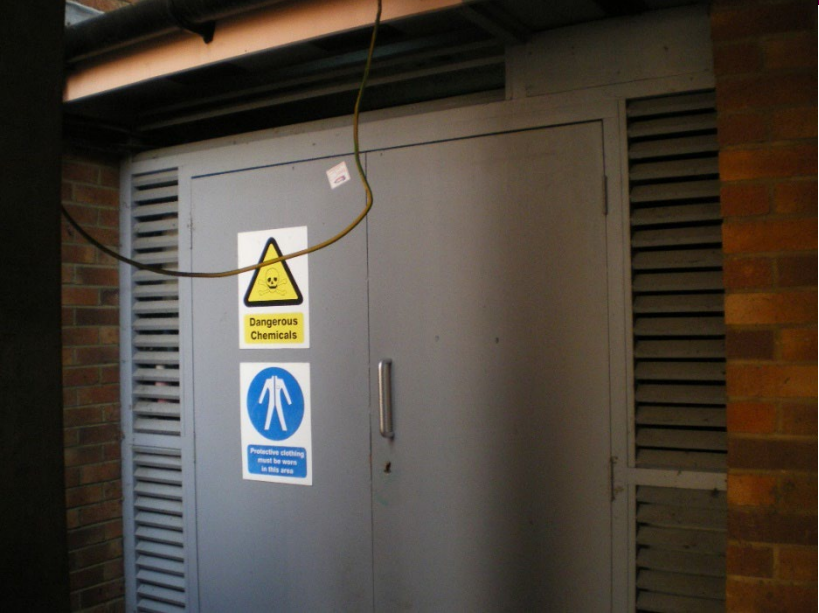
| Feature | Description | Photo |
|---|---|---|
| 32 | Small plant room with wooden vented access. Between indoor swimming pool and east facing building. | |

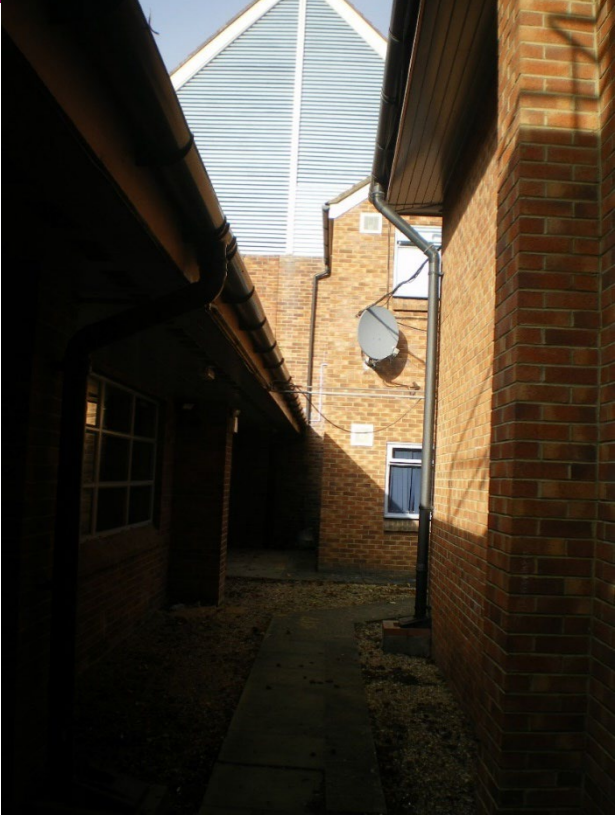
| Feature | Description | Photo |
|---|---|---|
| 33 | Weepholes above the windows of offices. South elevation | |
