# Arboricultural Impact Assessment Regarding Safety Liabilities and Potential Insurance Issues

## No. 5 Pirton Close, Hitchin, Herts SG5 2BU

**Mr Richard Mills**  
**RM/PCHH**  
**SAL/KMA/12158**  
**Shane A Lanigan**  
**16<sup>th</sup> September 2024**

Arboricultural Impact Assessment in respect of potential insurance issues and safety liabilities at:

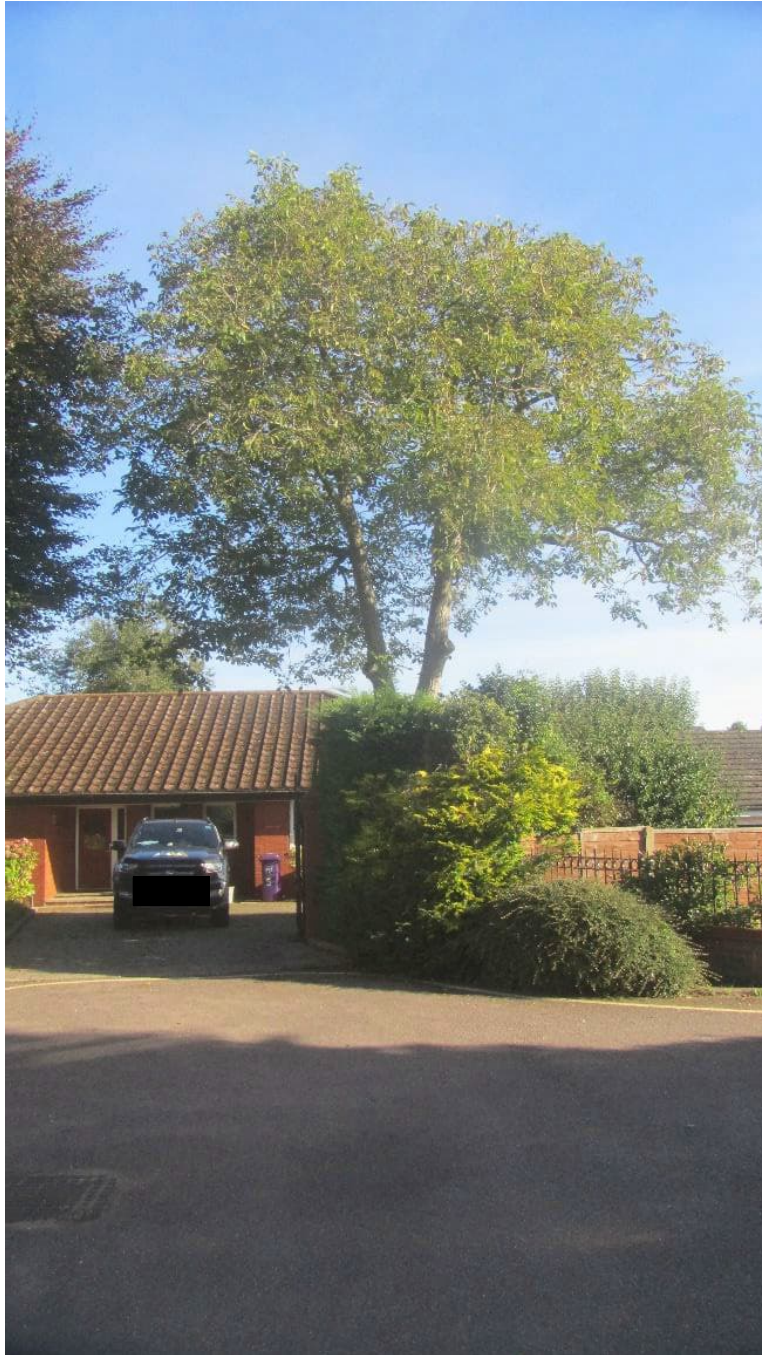
**5.2 The trees:** Tree 1 (walnut – see Photographs 1 & 2, Appendix 1) and Tree 2 (beech – see Photographs 5 & 6, Appendix 1) pre-date the building by many years as do the two third-party apple trees (T3 & T4, see Photograph 9, Appendix 1). The cypress hedge (G1 – see Photograph 10, Appendix 1) and T5, the third-party Lawson cypress (T5 – see Photograph 11, Appendix 1) are more recent introductions.

5.2.1 Tree 1, the common walnut is a tree of moderate-water-demand. It is located within its TZI of the bungalow front elevation but is currently only around half its likely ultimate size. Therefore, any contemporary adverse tree root/building interaction is improbable. This tree presents as being in somewhat poor condition but this is the way with walnut. It is minorly structurally compromised by two decaying branch removal wounds on the lower trunk but is not likely to fail due to this effect.

**PHOTOGRAPH NO. 1 – T1 – Common walnut viewed from the south**

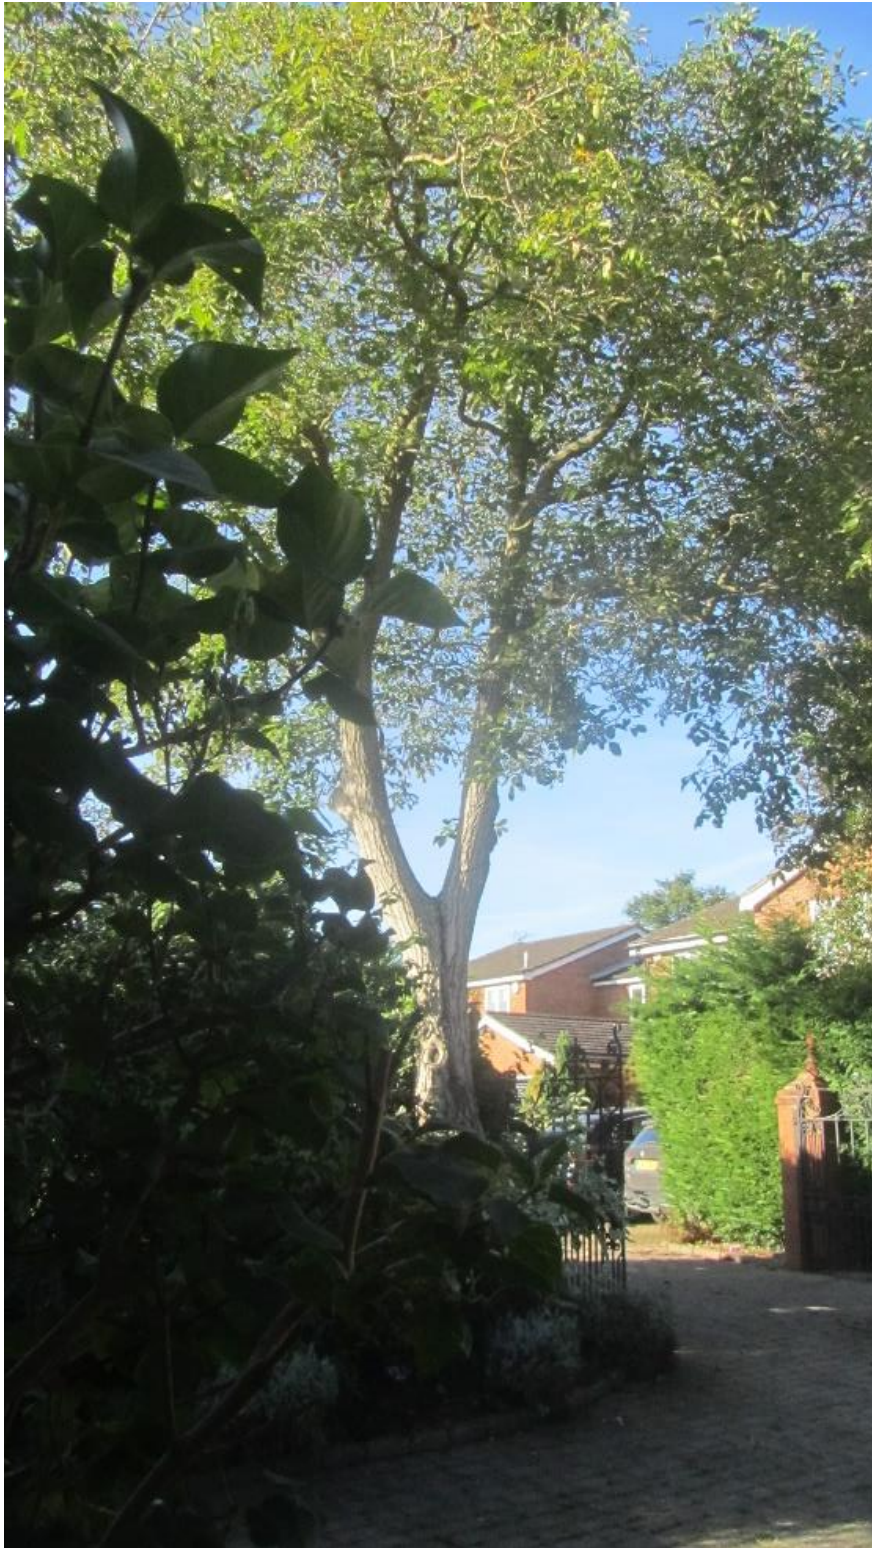
**PHOTOGRAPH NO. 2 – T1 – Common walnut viewed from the northeast**

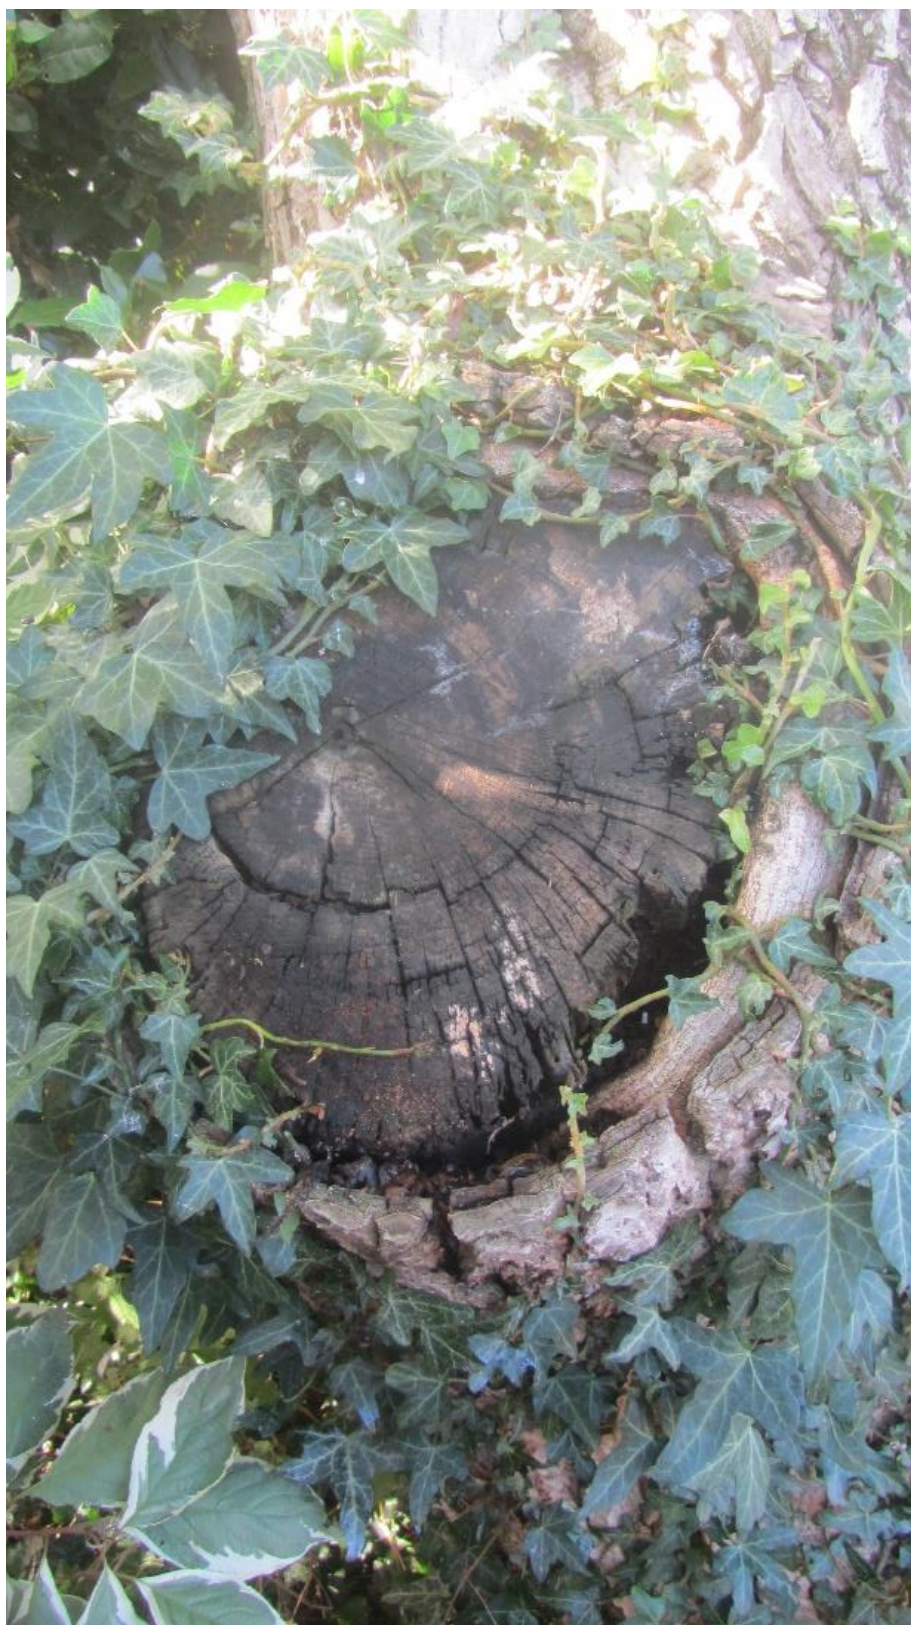
**PHOTOGRAPH NO. 3 – Decaying branch removal wound on the north side of  
T1**

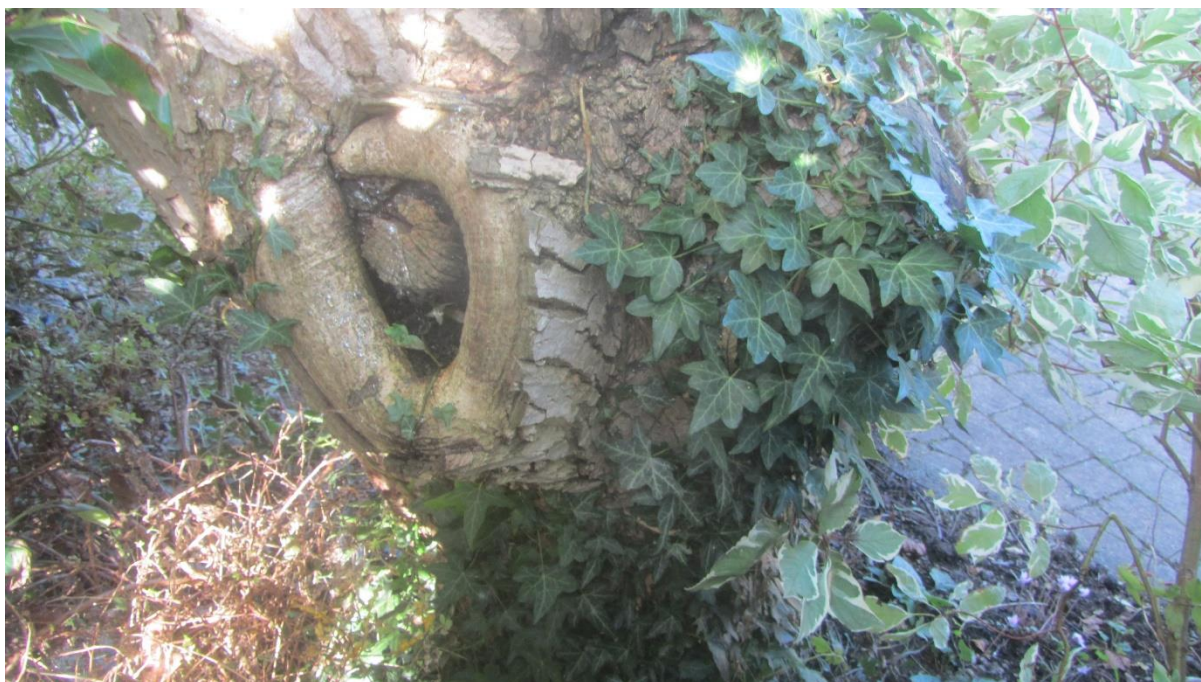
**PHOTOGRAPH NO. 4 – Decaying branch removal wood on the eastern side of  
T1**

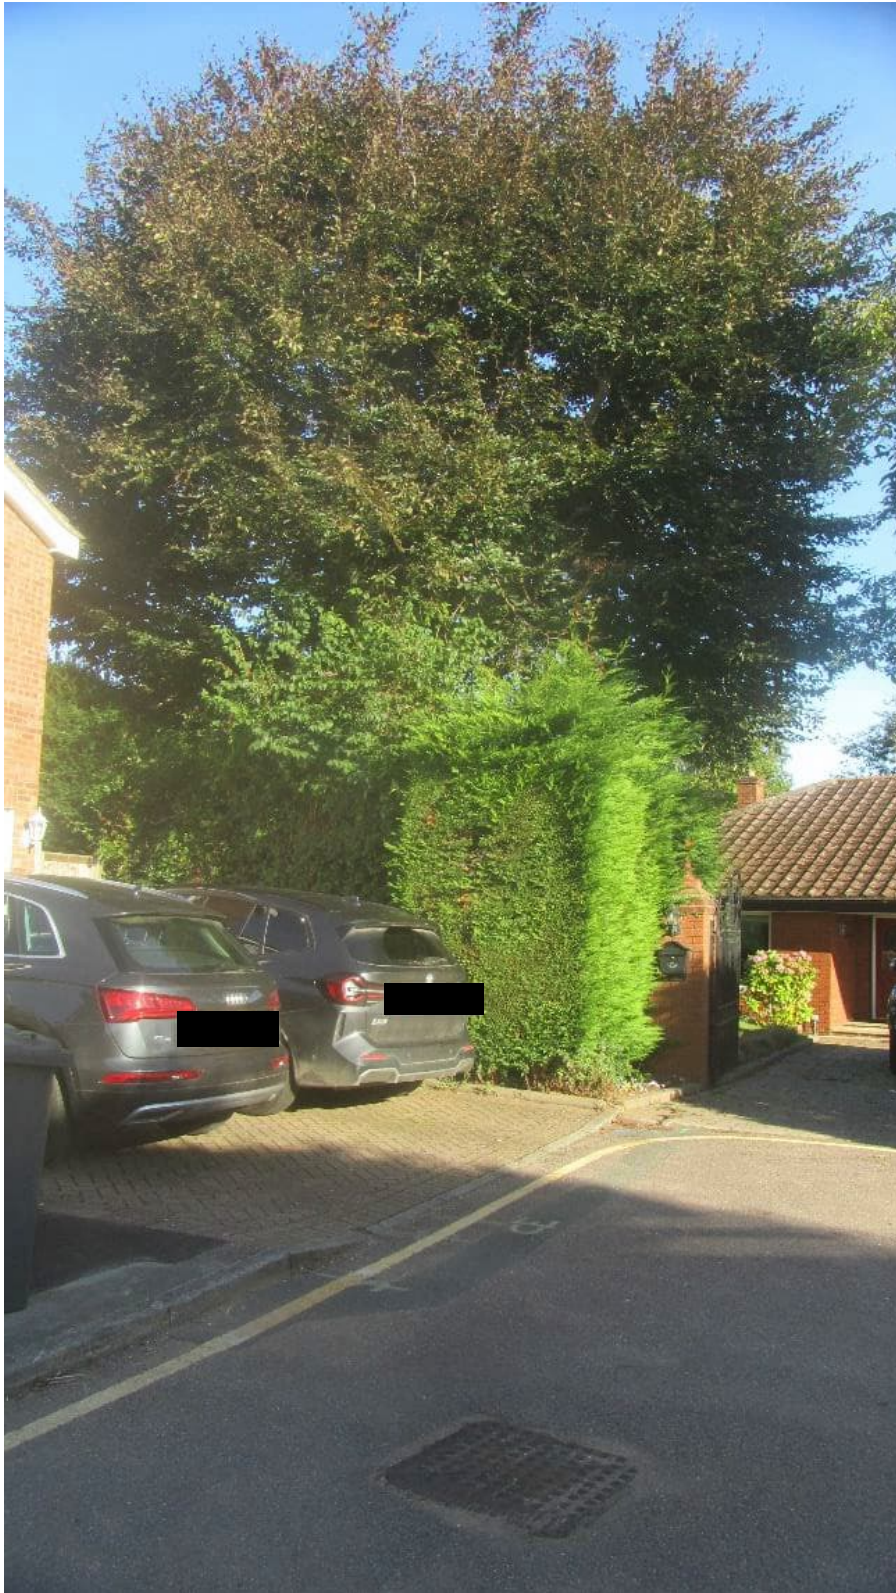
5.2.2 The second tree inspected, T2 – beech is the most significant on this site. It is of mature age class and likely around 100 years of age. The trunk and scaffold branch structure are sound with no real external signs of decay – other than some squirrel gnawing damage around the outer edge of a northern-side scaffold branch removal wound. Tree vigour and vitality are high, this being primarily evidenced by the foliar condition and density (see Photographs 5 & 6, Appendix 1) and secondarily by the rate and completeness of wound-wood growth which has, in most cases, completely occluded the wounds where branches have been pruned-off to ‘lift’ the canopy.

**PHOTOGRAPH NO. 5 – T2 – Common (European) beech viewed from the south**

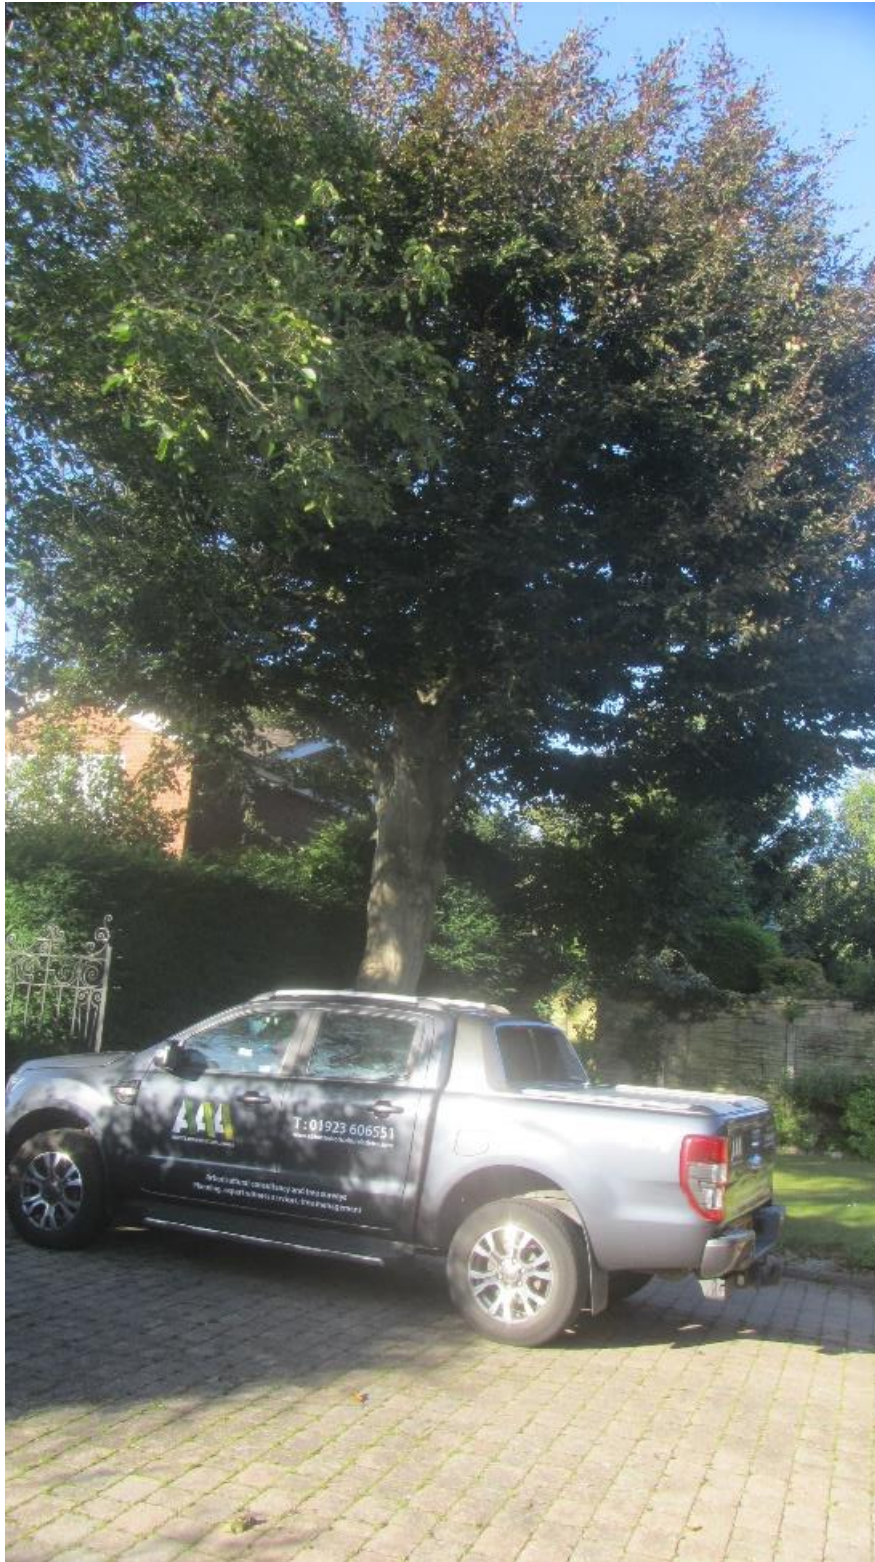
**PHOTOGRAPH NO. 6 – T2 – Beech viewed from the northeast**

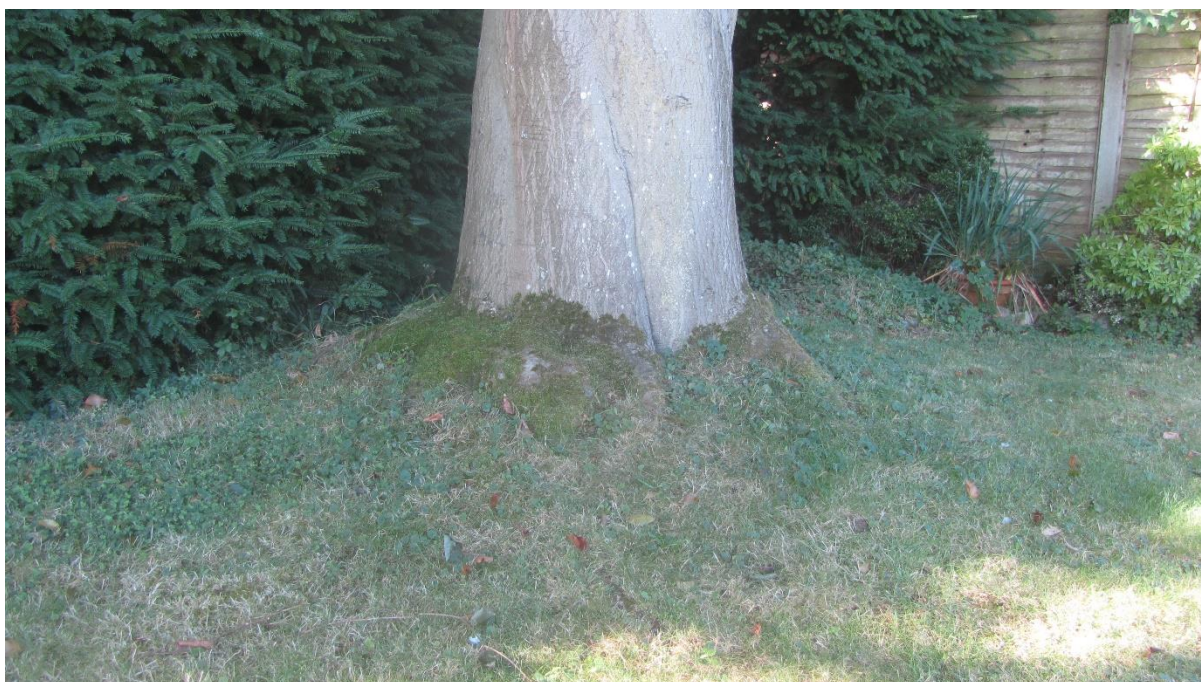
**PHOTOGRAPH NO. 7 – North side of the base of T2**

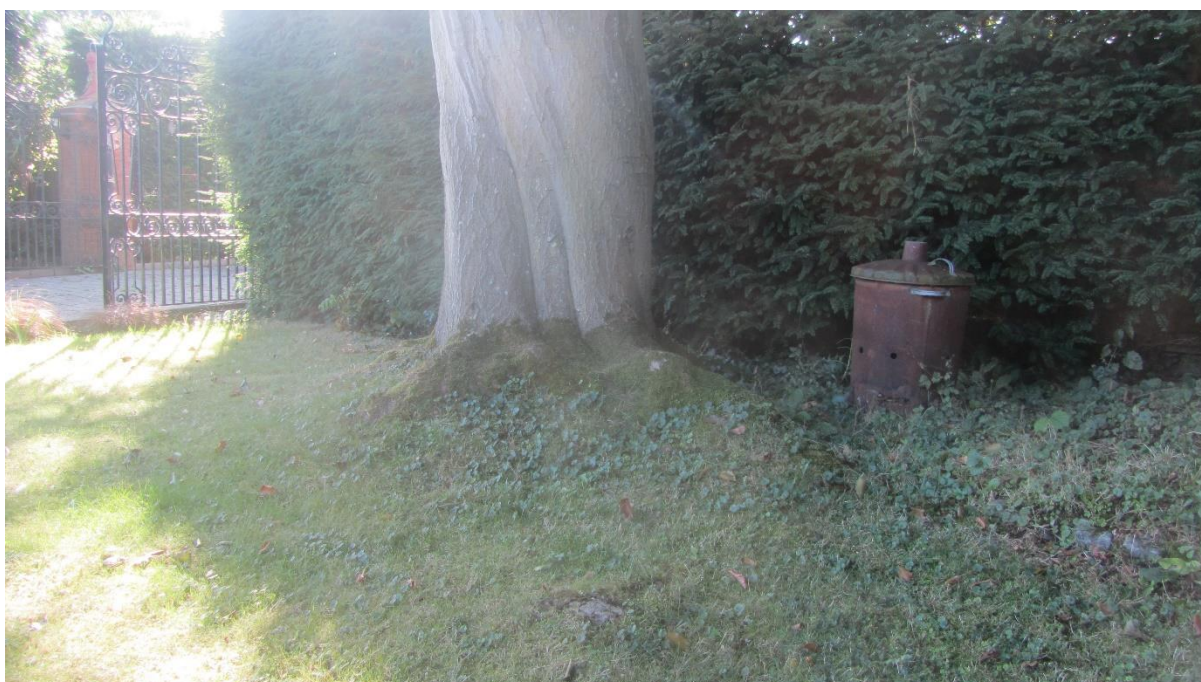
**PHOTOGRAPH NO. 8 – Northwest side of the base of T2**

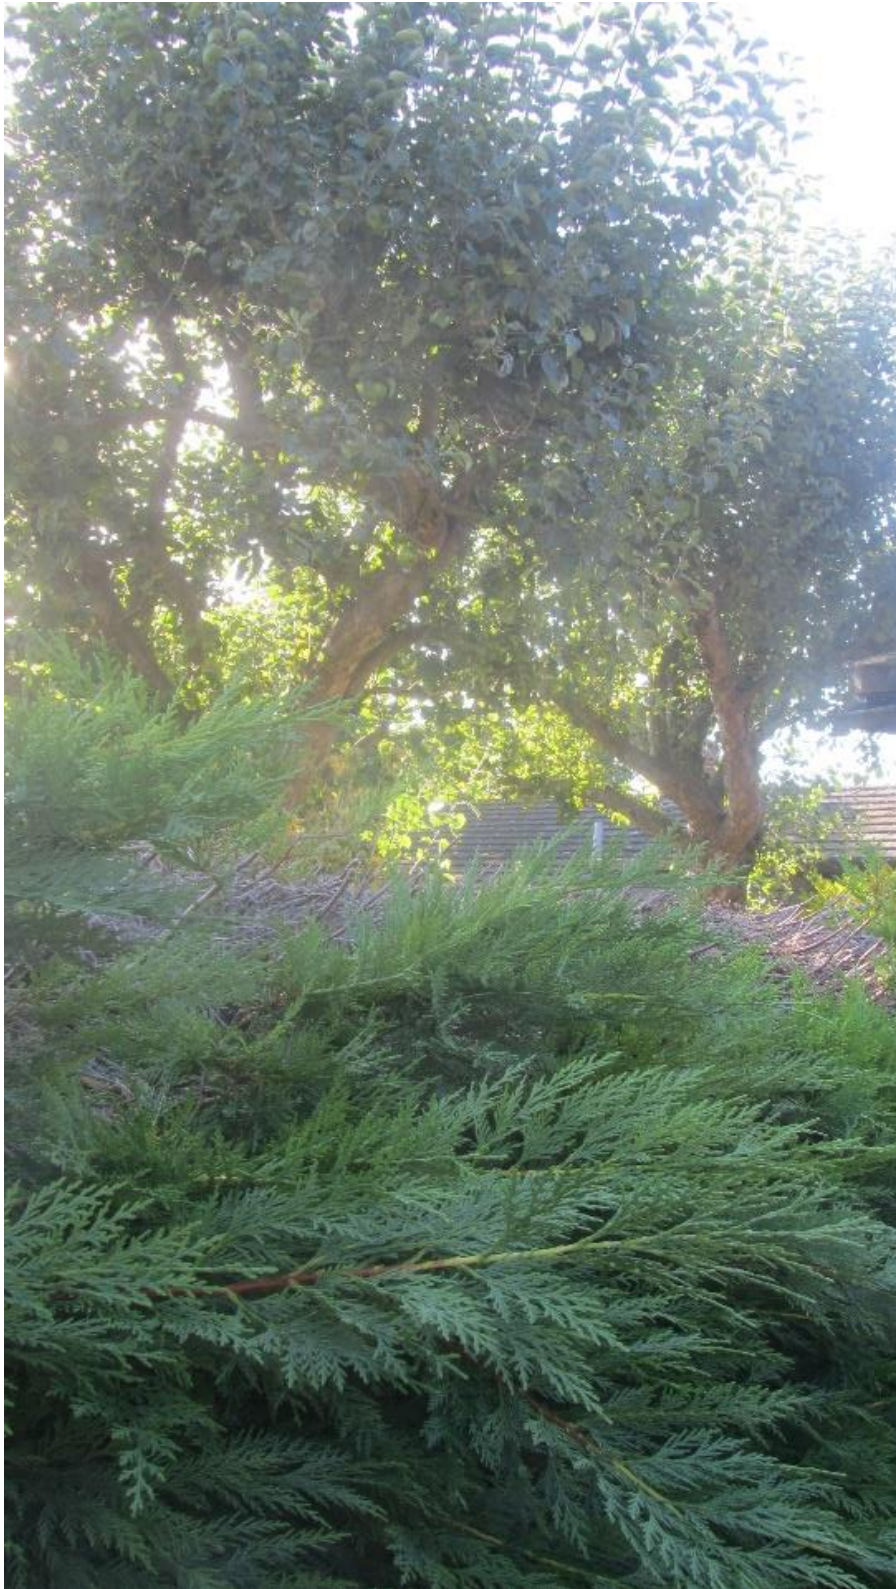
**PHOTOGRAPH NO. 9 – T3 & T4 # – third-party owned apple trees**

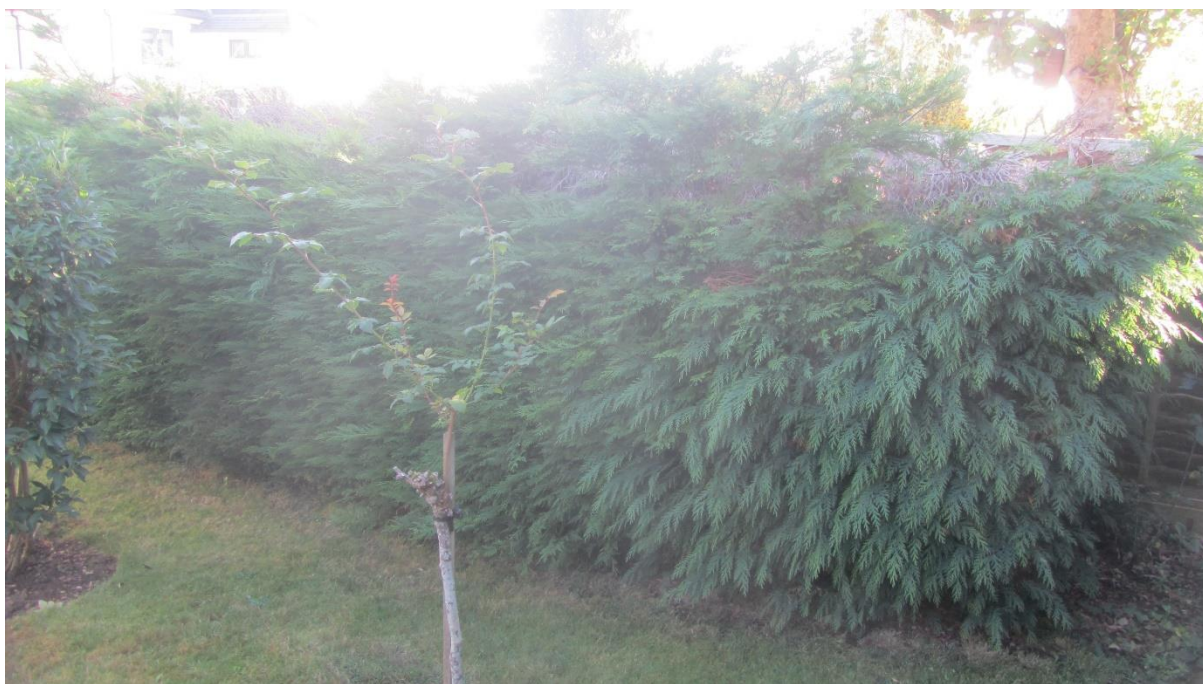
**PHOTOGRAPH NO. 10 – G1 – Leyland cypress hedge**

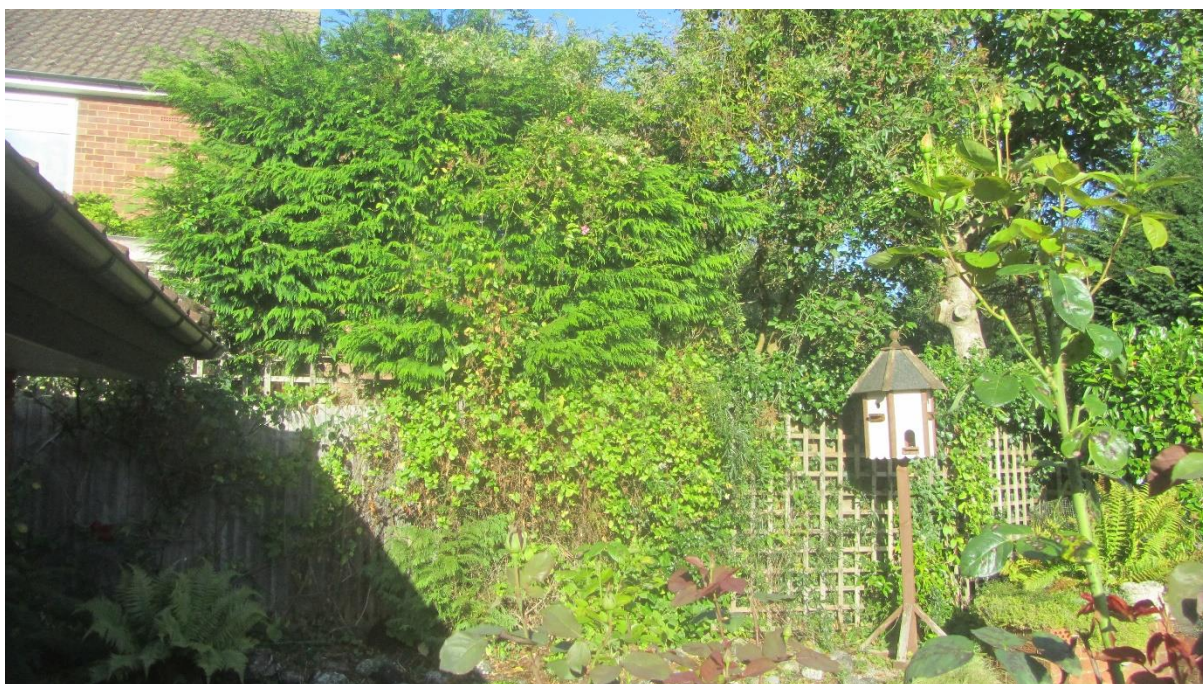
**PHOTOGRAPH NO. 11 – T5 # – third-party owned Lawson cypress**
