**HERITAGE ASSESMENT, SCHEDULE OF WORKS, PHOTOGRAPHIC  
SCHEDULE AND ROOM IDENTIFICATION PLANS**

February 2025 **(REV A)**

FOR ASSOCIATED REMEDIAL AND REPAIR WORKS  
AT  
OLD SEXTONS, RUSHDEN ROAD  
SANDON, NR. BUNTINGFORD  
HERTFORDSHIRE SG9 0QY

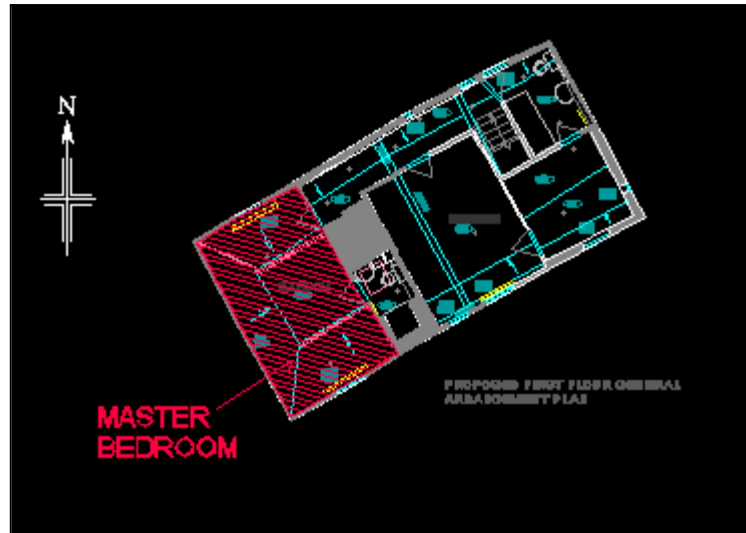
### **MASTER BEDROOM (FIRST FLOOR)**

Patch repairs to the ceiling to the south-east end of the room to remedy the damp/mould patches caused by water ingress and poor ventilation in the likely location of the roof hips.

Small areas of patch repairs to the walls where the current surface is loose or unstable.

Both windows to the north and south are to be retained and refurbished (as agreed by separate permission) due to their poor condition and inability to easily open, which are contributing to the lack of ventilation and damp/mould patches.

A small area of floor repair is required close to the north Master Bedroom window where there currently appears to be a hole in the floor. The carpet is to be lifted to expose and diagnose the area requiring repair. Any lifted or broken floorboards should be replaced on a like-for-like basis. The timber floor joists should be carefully inspected for any structural instability, damp, decay and insect attack. If

required, a specialist report should be carried out and backed with an insurance guarantee prior to repair works being undertaken.

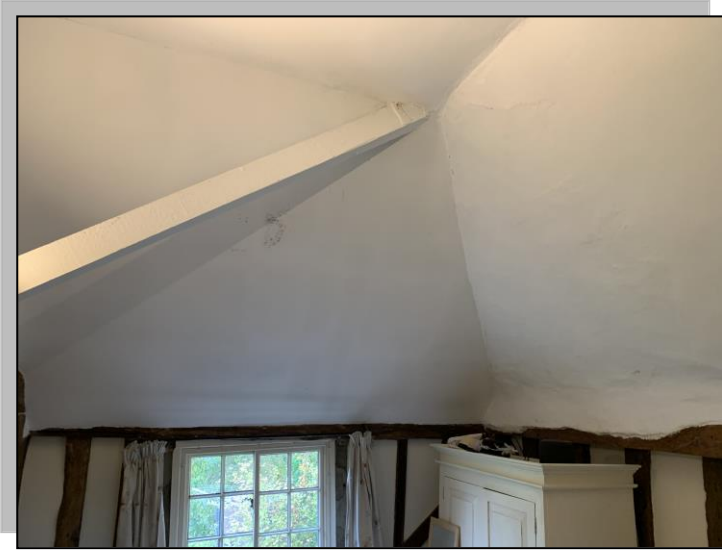
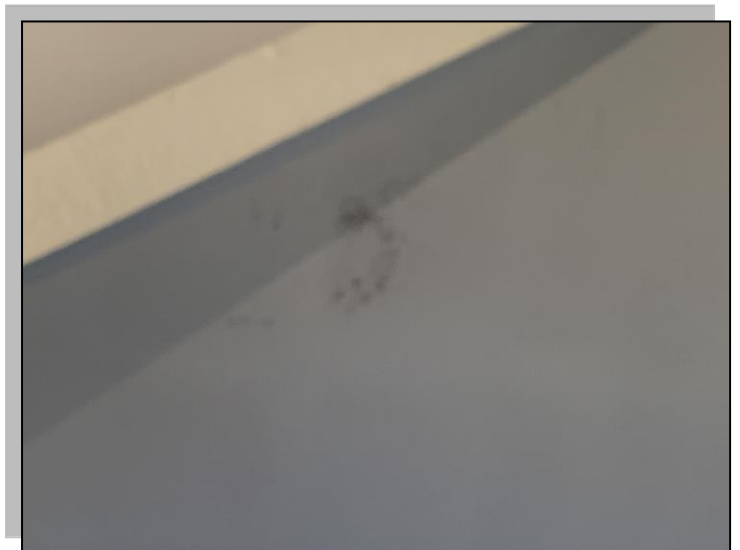
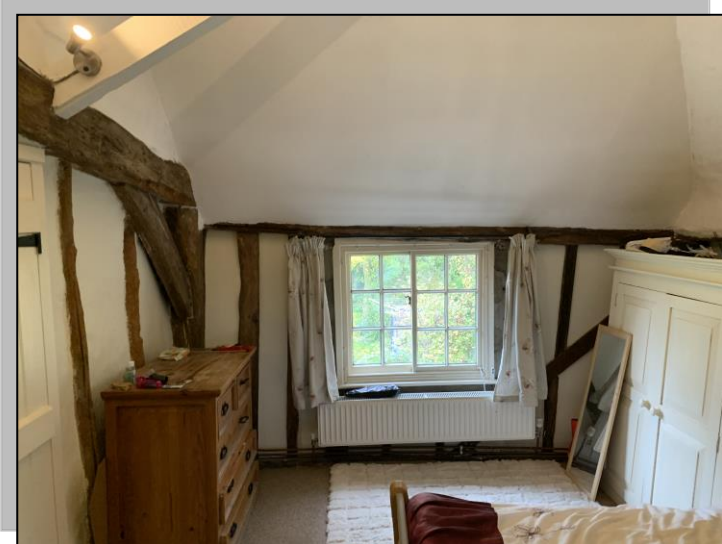
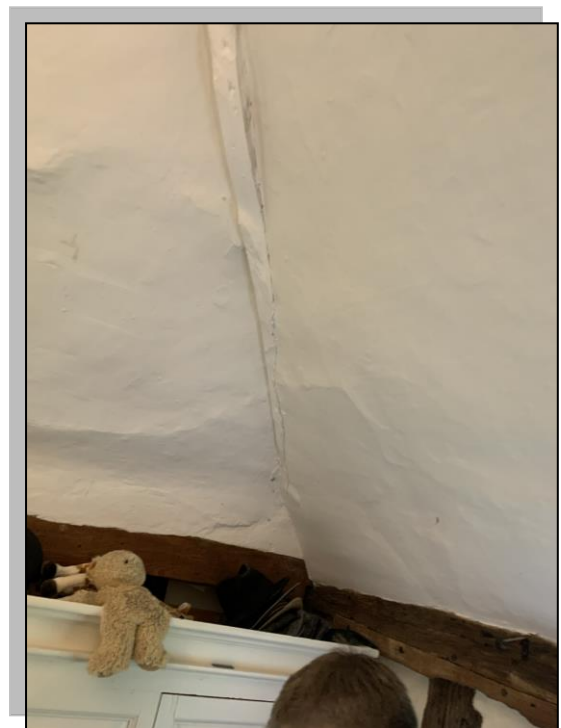
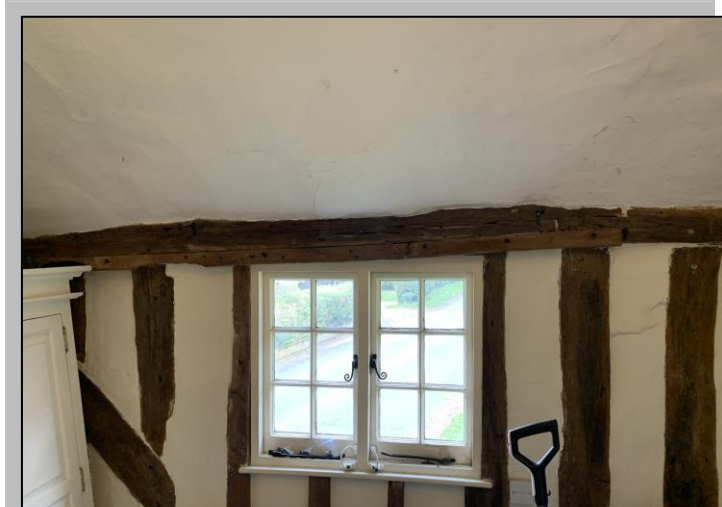
The photographs below provide an indication of the dampness and mould that has occurred to the ceiling over an extensive period of time.

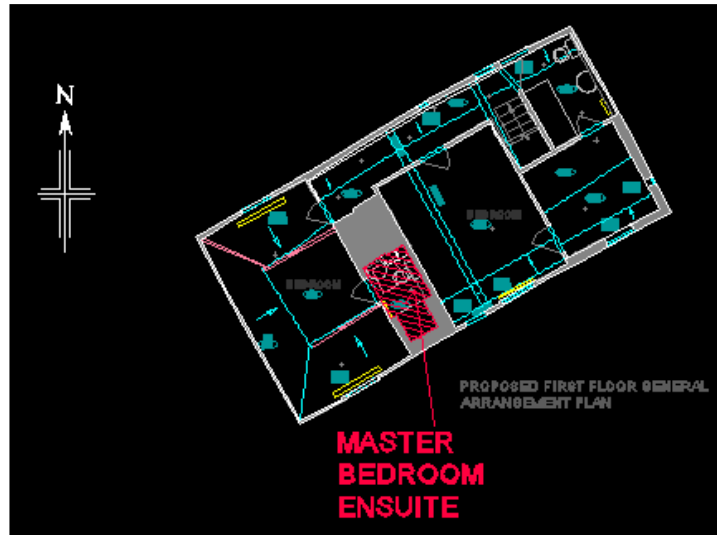
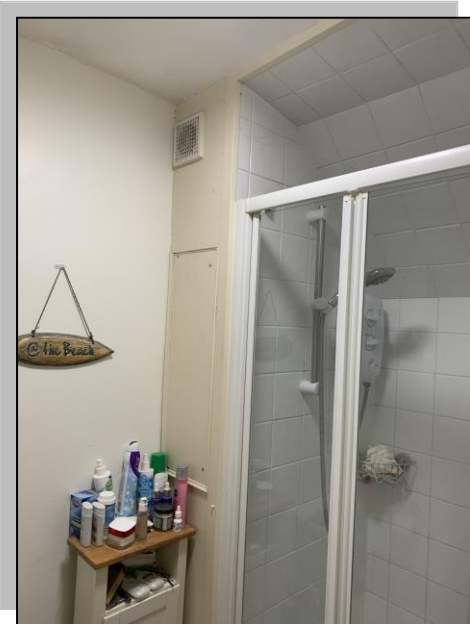
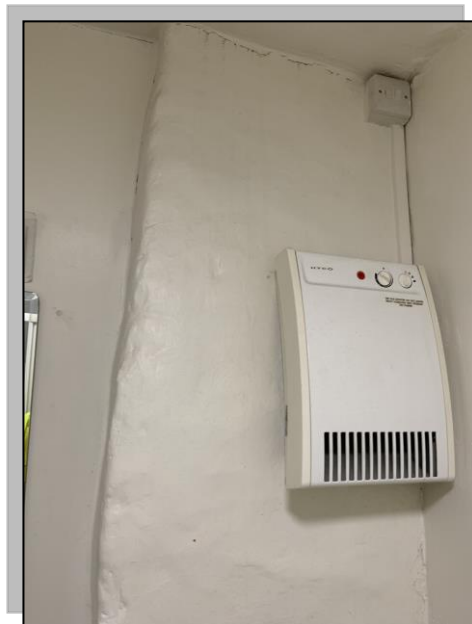
### **MASTER BEDROOM ENSUITE (FIRST FLOOR)**

Patch repairs to the ceiling where required to remedy the damage caused by and poor ventilation and dampness.

Small areas of patch repairs to the walls where the current surface is loose or unstable.

The current extractor fan is to be replaced with a modern equivalent to cope with the minimum extract rates as described within the Building Regulations.

The heater is to be replaced with a suitable modern equivalent suitable for high humidity and potential dampness.

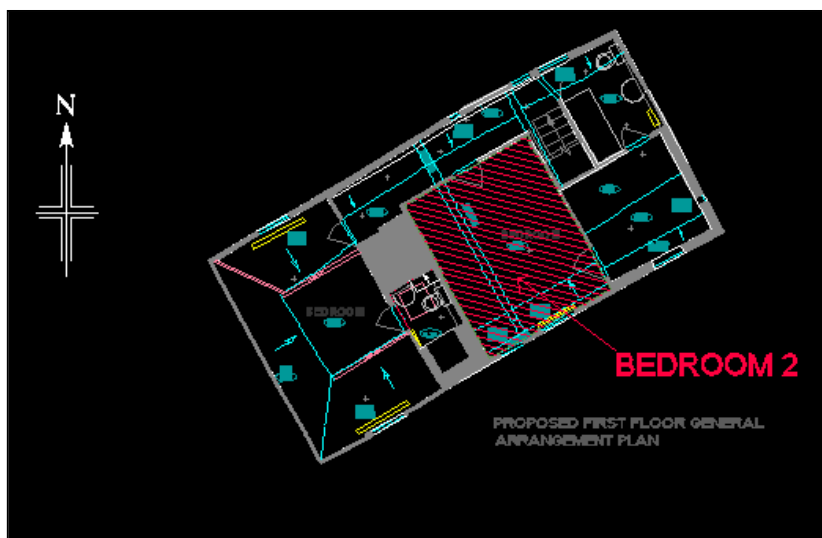
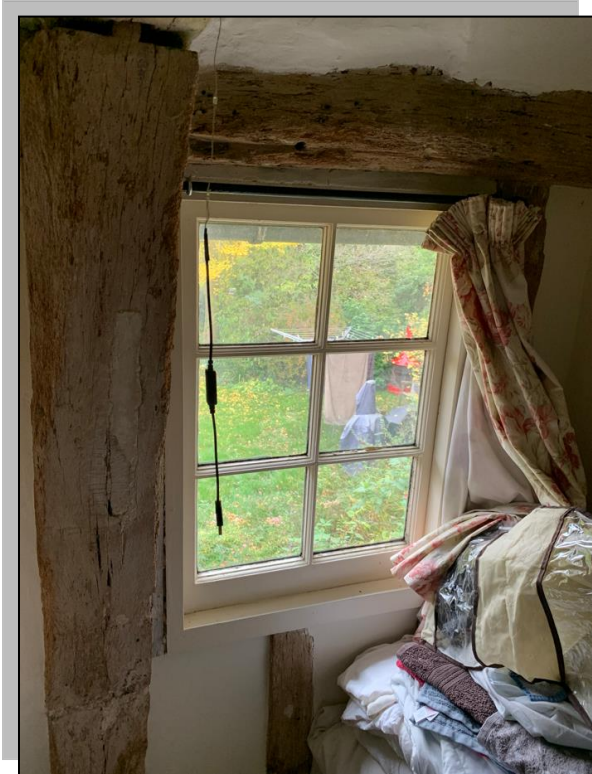
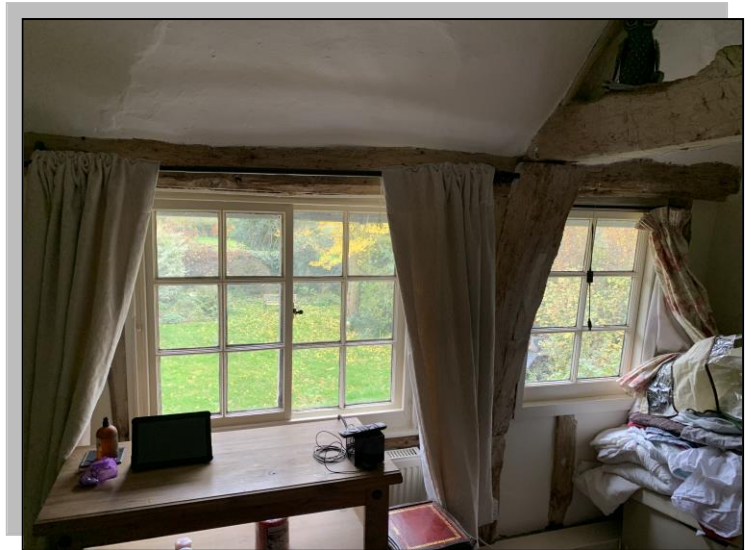
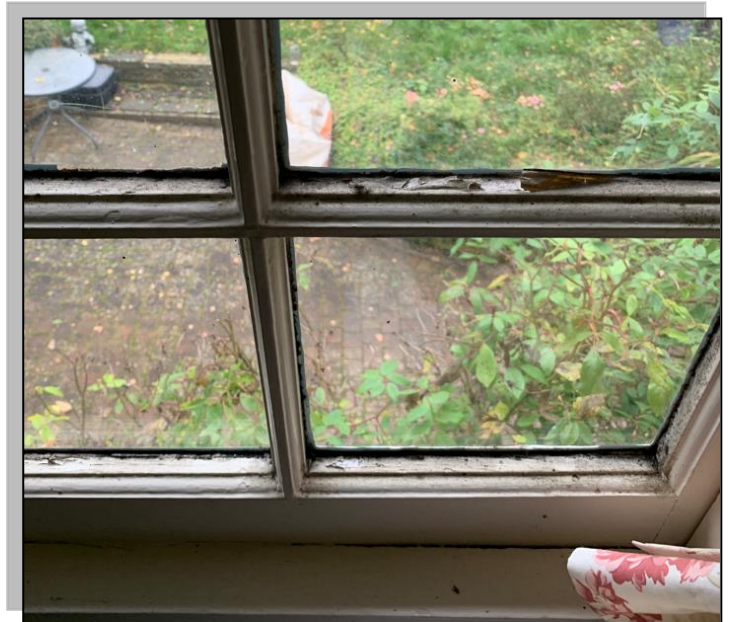
### **BEDROOM 2 (FIRST FLOOR)**

Patch repairs to the ceiling and walls to remedy where it is either loose or unstable. Window to be replaced due to its poor condition and inability to easily open, which is contributing to the lack of ventilation.

*(Photographs above indicate window W12 to be replaced with a 'Slimlite' alternative, and window W13 to be retained and refurbished under a separate permission)*

Patching work will incorporate a mixture of lime putty and gypsum (3:1) to a minimum of half part water. The skim coat will utilise a pre-mixed lime topcoat superfine plaster such as 'Ty-Mawr' with water mixed on site. A breathable emulsion finish suitable for lime-based plaster is to be used. (See photographs below)

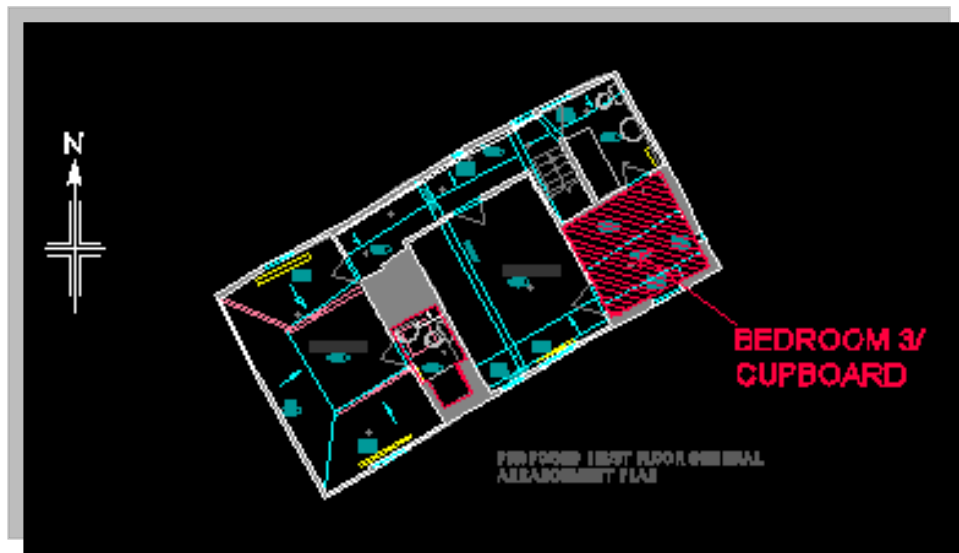
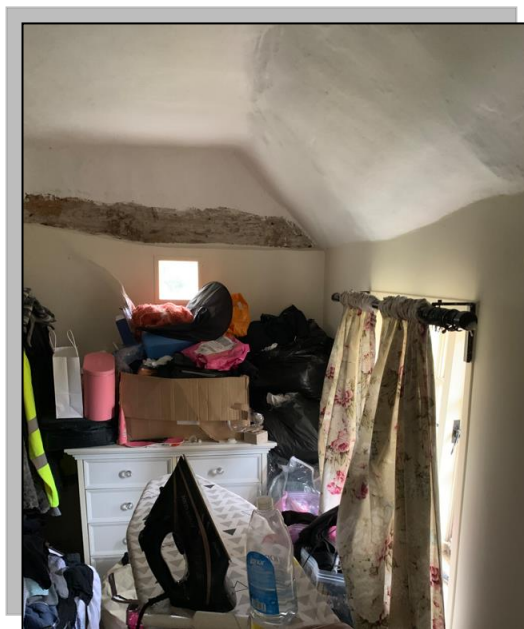
### **BEDROOM 3/CUPBOARD (FIRST FLOOR)**

Patch repairs to the ceiling and walls as previously described. Window W14 is to be refurbished under a separate permission.

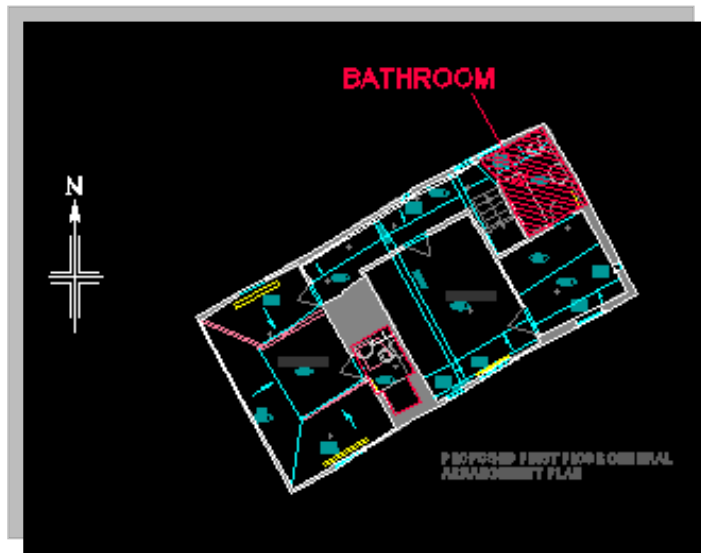
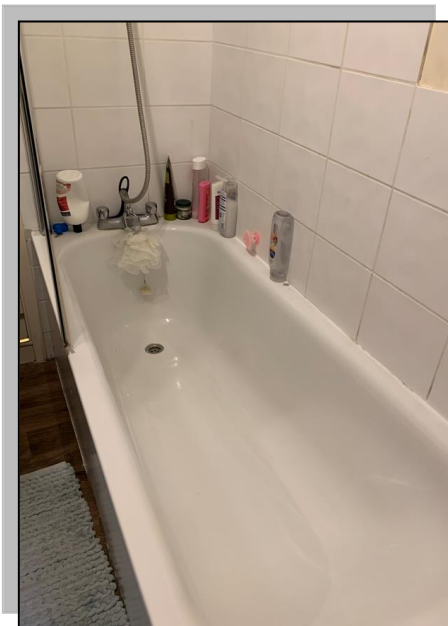
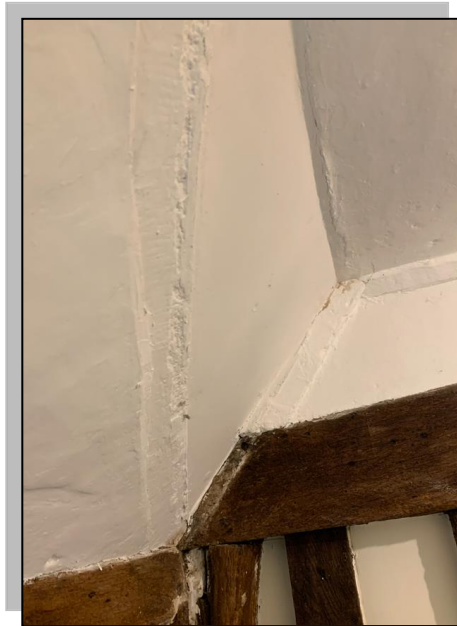
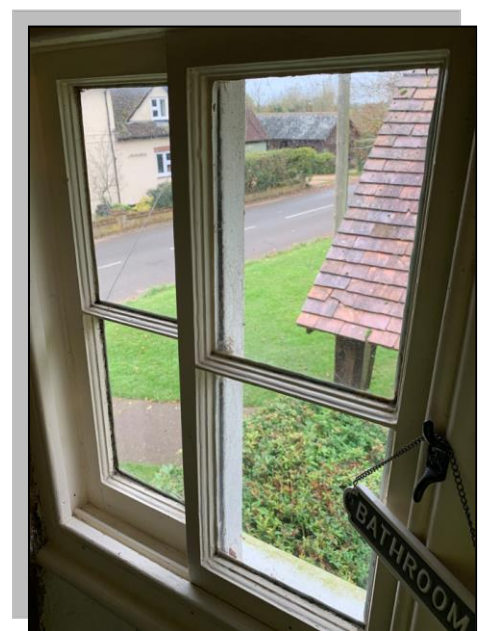
### **BATHROOM (FIRST FLOOR)**

Patch repairs to the ceiling and walls as previously described, and replacement window W15 to match the existing timber Yorkshire Slider.

Replacement sanitaryware and wall tiling on a like-for-like basis. All fittings to be installed in current locations and connected to existing waste pipes.

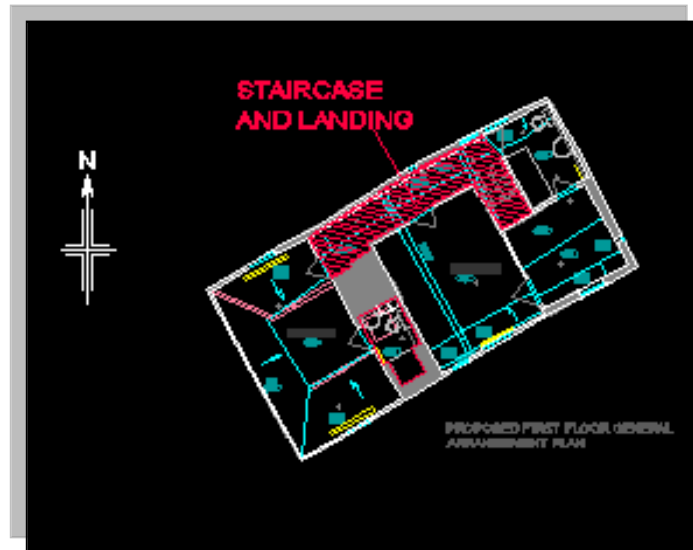
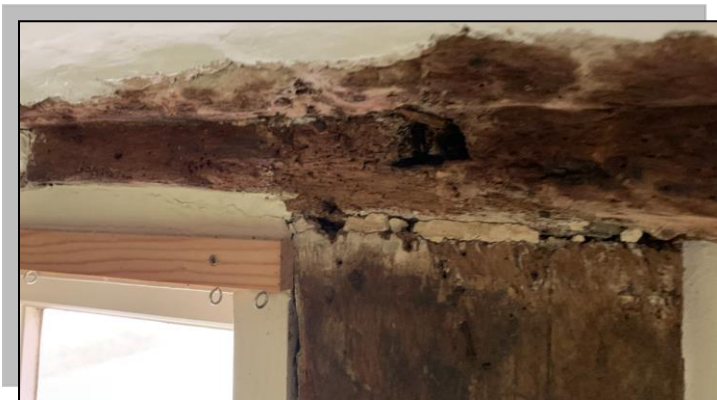
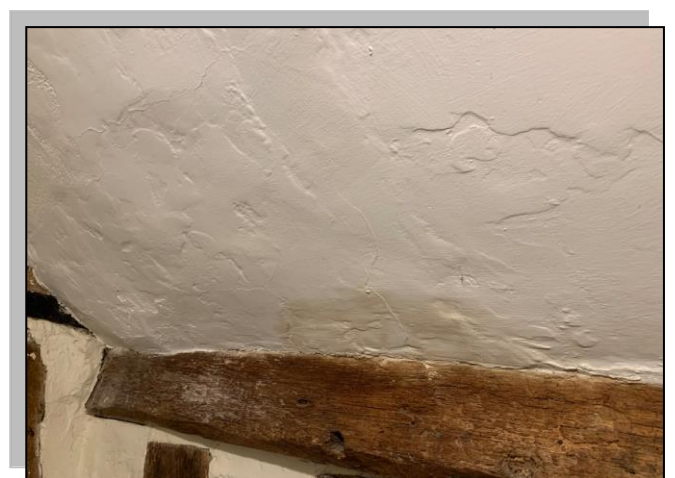
## **STAIRS AND LANDING**

Patch repairs to the ceiling and walls as previously described. Window W16 is to be retained and repaired as agreed by separate permission. Window W17 is to be replaced with a Slimlite equivalent. Damage to the timber wall plate over the landing area to be locally repaired as can be seen in the photograph below.

Installation of interlinked smoke detectors at ground and first floor level.

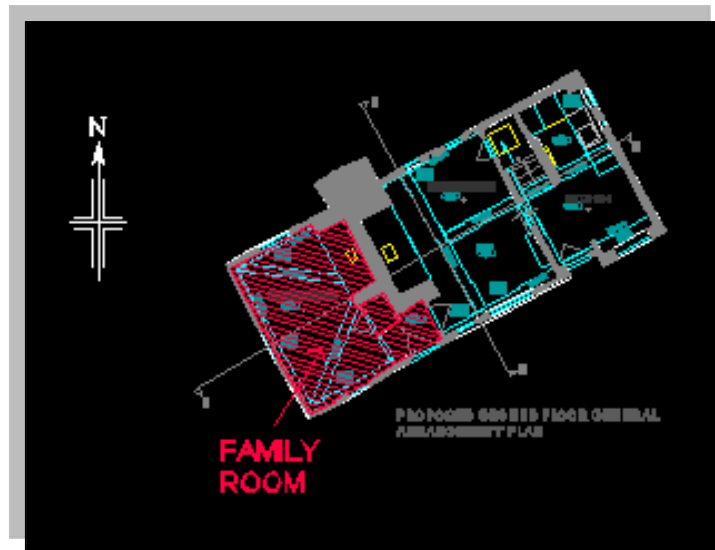
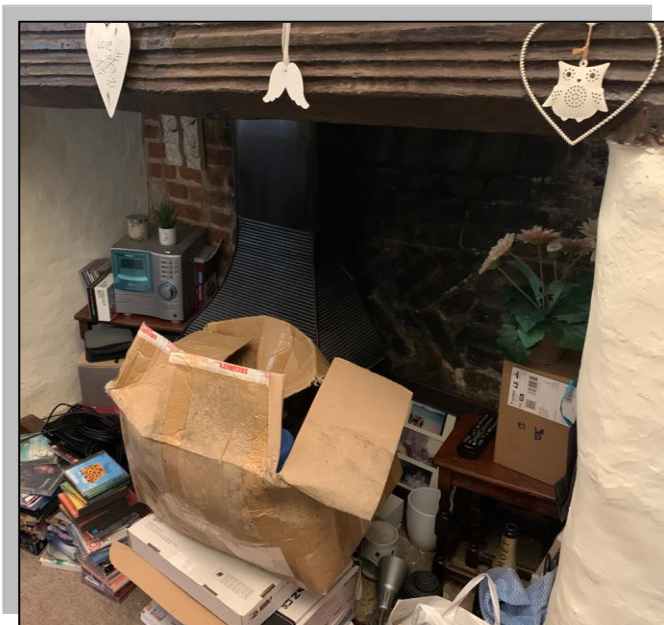
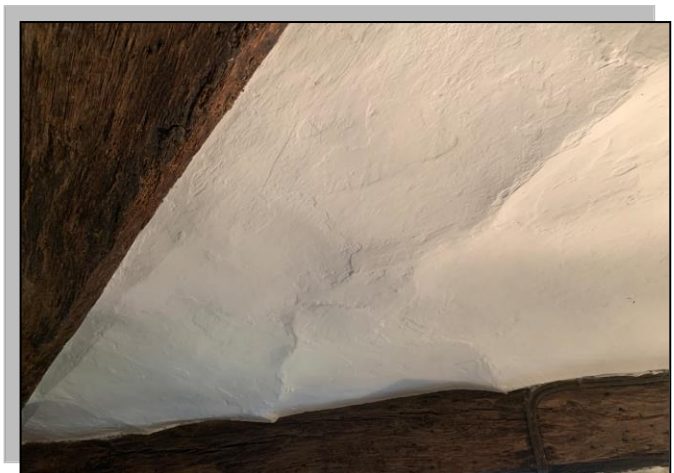
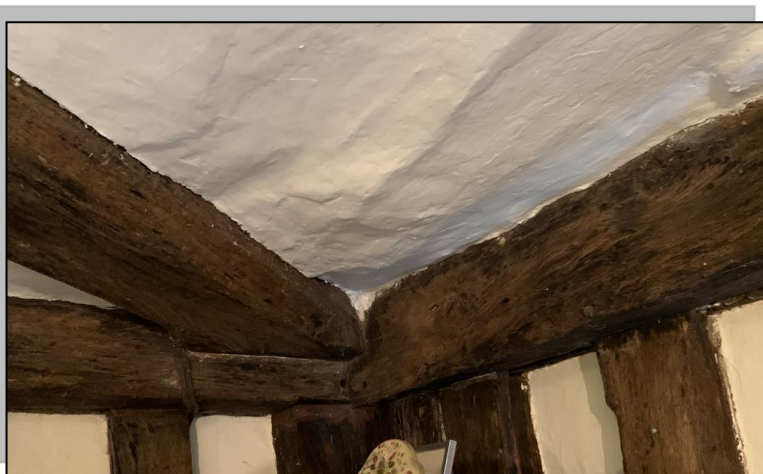
## **FAMILY ROOM (GROUND FLOOR)**

Patch repairs to the ceiling and walls as previously described. Windows W1 and W10 (currently Crittal) are to be replaced with a timber alternative to match the current appearance. Window W9 is to be retained and repaired as agreed by separate permission.

Replacement log burner to be installed. Existing flue to be checked for adequacy by specialist installer prior to installation.

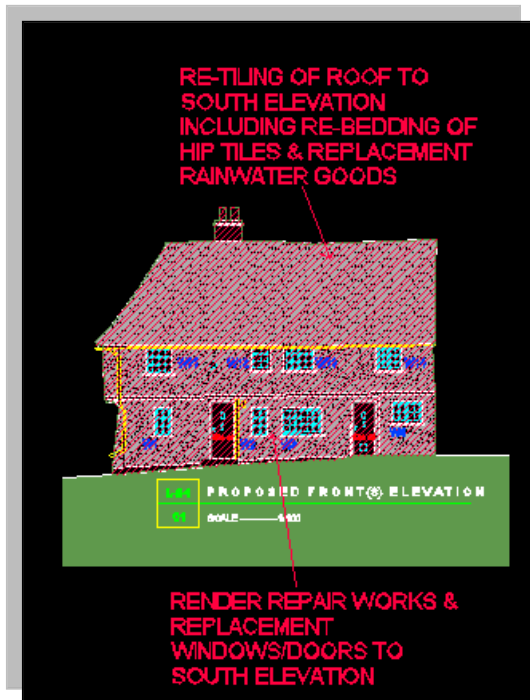
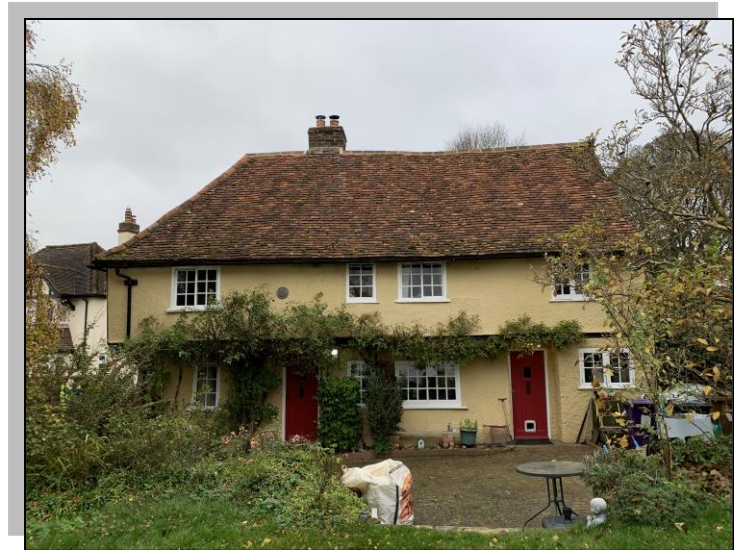
### **FRONT (SOUTH) ELEVATION**

- The existing render to all elevations should be carefully removed as the current finish, including previous repairs is cementitious and thus, does not allow the building to breathe sufficiently. In addition, the render is either live, loose or has fallen off.

- Erect scaffolding to remove existing roof tiles to this elevation only and set aside for re-use. Existing timber battens to be removed and replaced. The existing rafters and other timber members should be carefully inspected for any structural instability, damp, decay and insect attack, and any essential remedial repairs carried out. If required, a specialist report should be carried out and backed with an insurance guarantee prior to repair works being undertaken. The existing roof tiles will be re-fixed to new 25x38mm SW treated battens over 25x38mm counter battens on a vapour permeable sarking membrane. Any additional handmade tiles required will be supplemented with Sahtas Brookhurst handmade clay roof tiles (as recently approved on The Dovecote roof (Listed Building Ref: 18/00585/LBC Condition 4), and to match the north roof slope (which has previously been re-tiled). Existing ridge and hip tiles to be re-bedded and supplemented if necessary. Insulation installed above ceiling level within the loft space such as Knauf Earthwool Loft Roll 44 laid in 2 layers, 100mm thick between and 200mm at right angles across the ceiling joists

- Replace all rainwater goods (gutter and rainwater pipe). All proposed replacement rainwater goods are to be Brett Martin plastic heritage iron effect

- It is proposed to replace both timber doors to the south elevation with new timber doors as illustrated and specified on the proposed drawings.  
Windows W1, W2, W4 and W12 are to be replaced and Windows W3, W11, W13 and W14 retained as previously described.

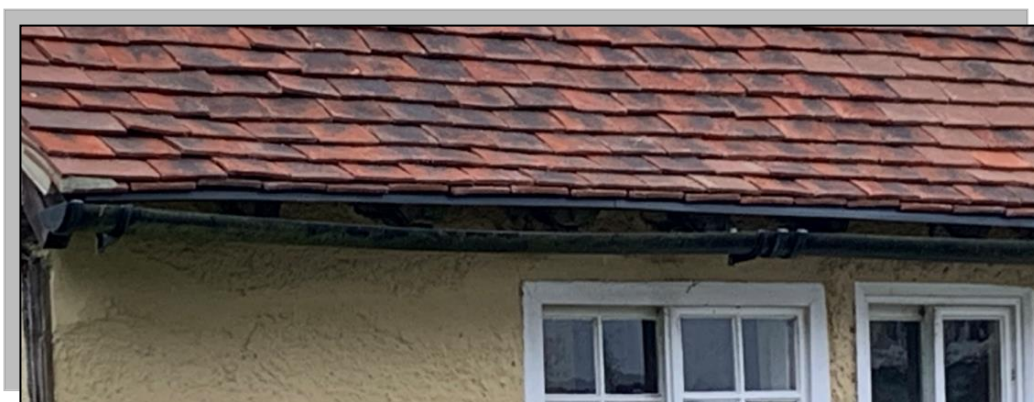
- Replace all gutters as these are not fitted correctly due to large gaps between the underside of the bottom row of tiles and the gutter itself, allowing rainwater to pass through.

*Poorly fitted gutter on north elevation*

All proposed replacement rainwater goods are to be Brett Martin plastic heritage iron effect roundstyle, with a 112mm dia. gutter, fixed back to each rafter end with matching gutter clips and galvanised steel top rafter brackets, and 68mm dia. downpipes. All fittings to be in black from the same range. Include for all running outlets, junctions, stop ends, corners, swan necks etc. This specification has recently been approved at the nearby Dovecote (Listed Building Ref: 18/00585/LBC) and other barn nearby refurbishments.

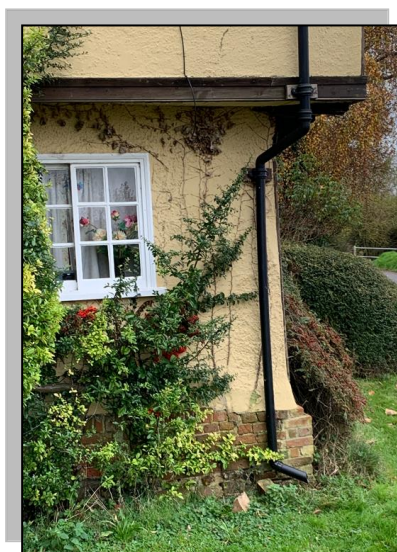
- Only one rainwater pipe discharges rainwater from this roof slope, located on the north-west corner of the building as indicated on the photograph below. It is therefore proposed to fit a new rainwater pipe to the opposite corner, discharging into a new perforated drain as described on Drawing No. L-03 Rev A running to the external perimeter at this end of the building.

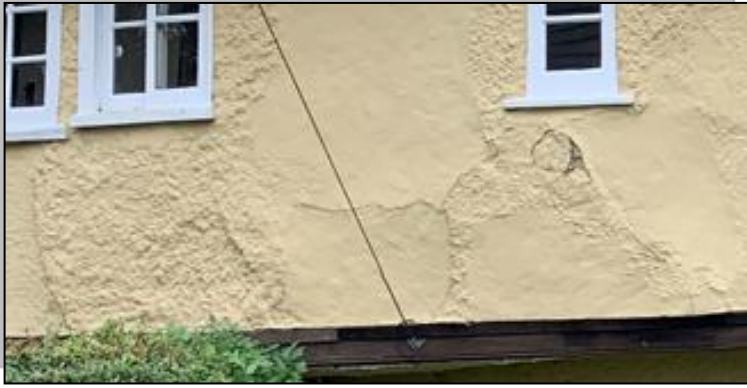
*Example of current loose and unstable cementitious render to North, East and West elevations*

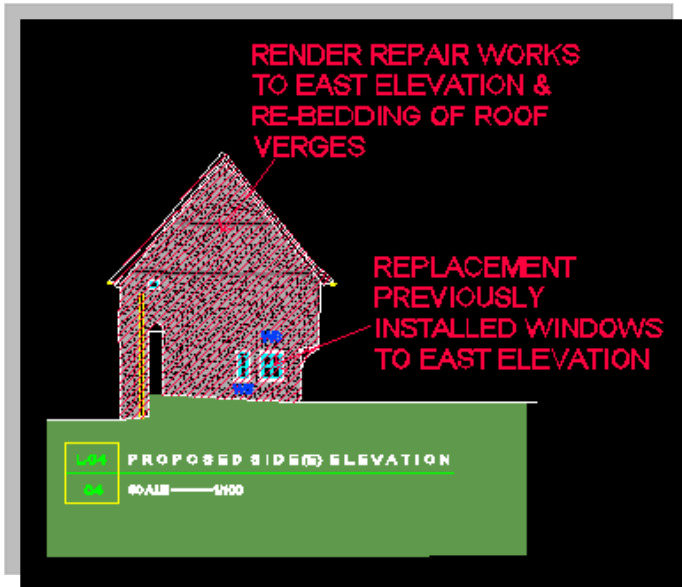
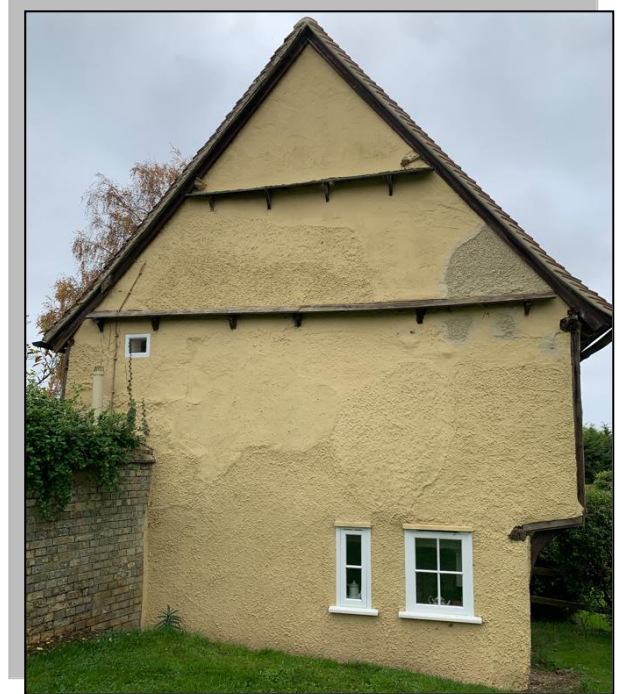
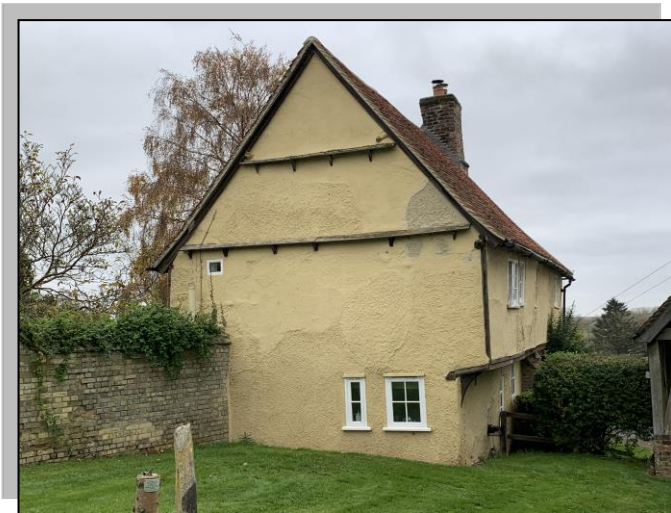
## **SIDE (EAST) ELEVATION**

- Carefully remove all existing render to the ground and first floor as previously described as the existing is loose and mostly live (refer to photograph below and elsewhere within this document). Immediate attention is required to prevent damp to the timber frame which should be carefully checked upon exposure and repaired/treated as necessary. In addition, the existing

render does not allow the building to breathe as it includes cementitious products for previous repairs to all elevations.

- Ground to be cut back and graded away from the house after all agreements have been secured with the land owners. New perforated pipe to be installed around the perimeter at this side of the building including connection of both new downpipes as indicated on the submitted drawings.
- Windows W5 and W6 are to be replaced as previously described.
- Repairs to roof verges after the south elevation has been re-tiled and all wall insulation installed.

- It is proposed to install Warmshell External Woodfibre boards (100mm thick) to all elevations after the careful removal of the existing loose and unstable render. This will be installed in full accordance with the manufacturer's recommendations. See literature below.
