## **Replacement of PVC Rainwater System to the FRONT of Property with a Traditional Cast Iron System**

**Points in Support of Application 24/02181/LBC - 4 Church Lane Kimpton SG4 8RP**

**Listed Buildings Register - Grade II, List entry no: 1102782**

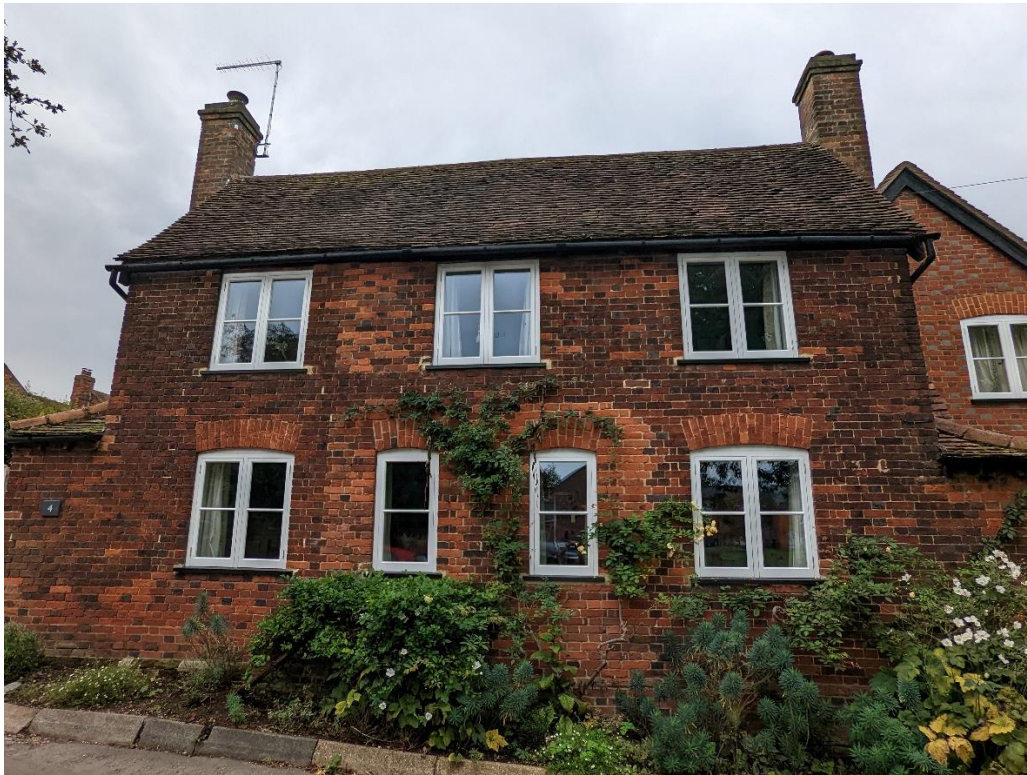
**Fig 1 – Current Front Aspect**

The existing gutters, rainwater pipes and brackets are plastic which we believe were fitted in approximately 1966 when the two cottages were converted into a single dwelling. The system is at the end of its useful life.

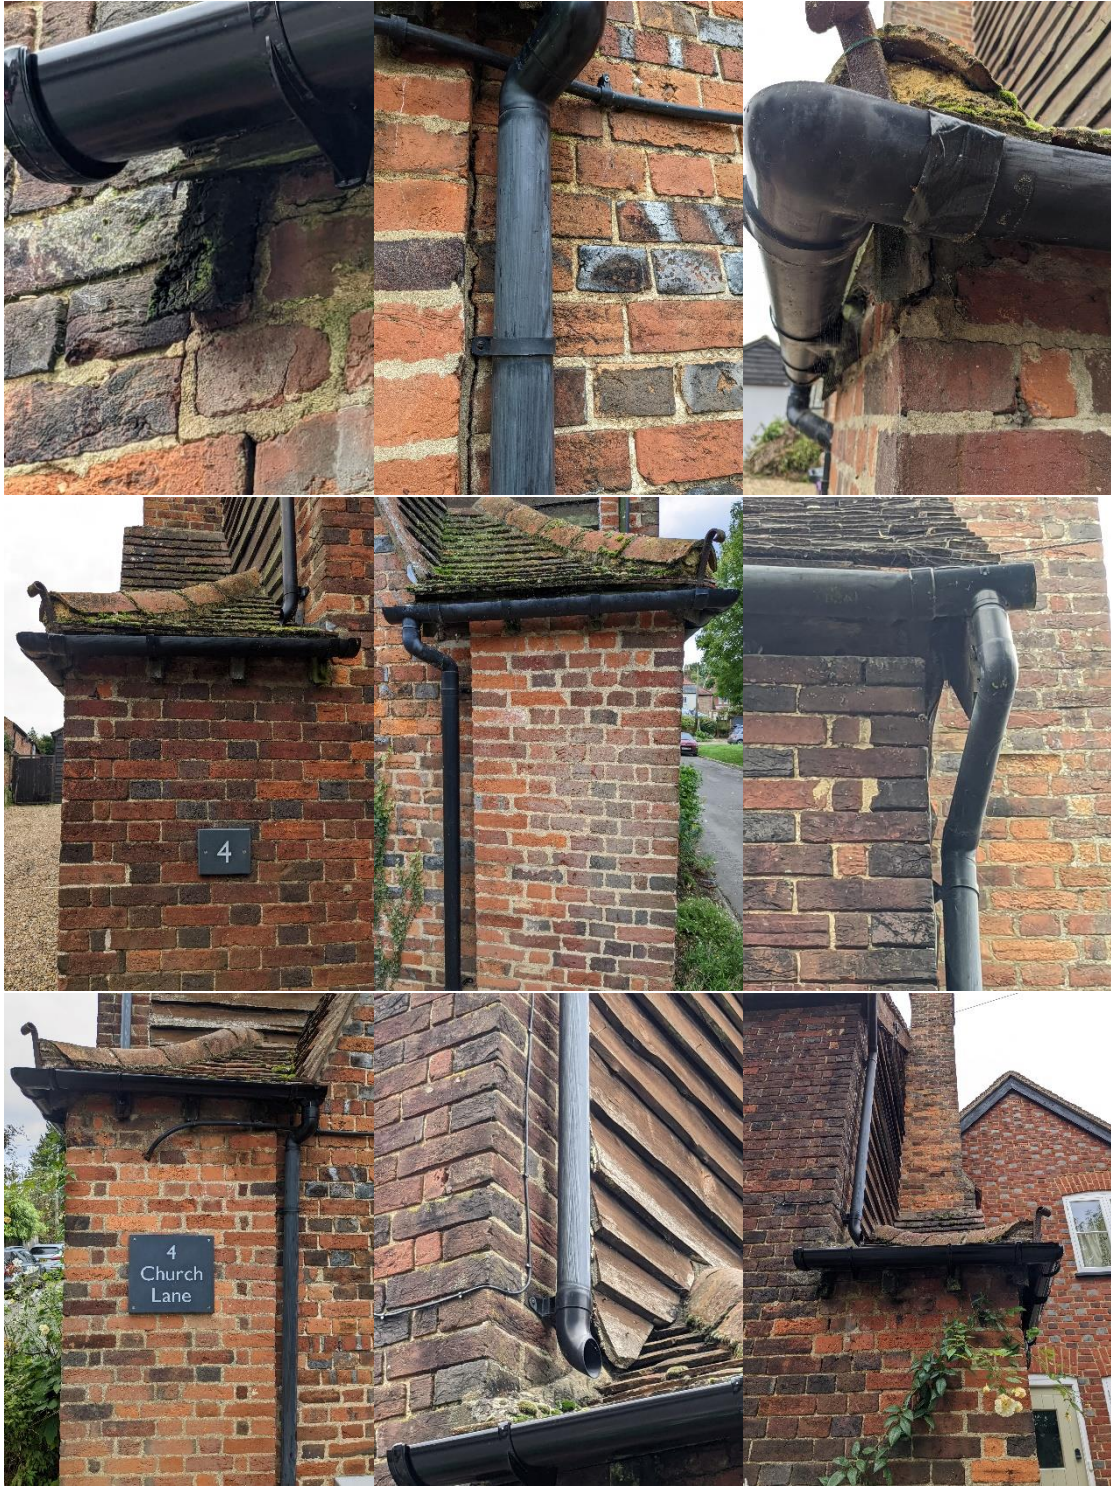
Fig 2 – Showing Defects in Current System

### **2) Shortcomings of the Present System – there are numerous defects in the current system. These are listed below and illustrated in fig 2.**

- (a) Some components are leaking and this is starting to damage the fabric of the building.
- (b) The RWP 1 & 2 have been moved from their original locations at the front of the building and discharge onto the low-level roofs to the North & South ends of the building. This has caused some overflowing and consequent damage to the ends of some of the rafters of the low-level roof. It has been necessary to temporarily fit new PVC components here to prevent further damage.

- (c) The fall is such that the flow of rainwater is not shared equally between the two RWP's. This compounds the overflow problem highlighted above.
- (d) The gutter & RWP'S are brittle in places due to their age and prolonged exposure to sunlight. This may become a safety issue and needs rectifying as a priority.

- (e) The PVC gutter is not in keeping with the style and character of the building. The PVC is blotchy and faded which detracts further from the appearance and period character of the rest of the building.

With the passage of time, these defects are likely to worsen if remedial action is not taken.

- (a) Remove & replace PVC gutter, RWP's and brackets with a new cast iron system.  
Cast iron is in keeping with the character of the building and is a much more durable solution than replacing with a new PVC system.
- (b) Repair as necessary and treat the ends of all rafters. To protect the fabric of the roof.
- (c) Repair any movement cracks as necessary using a lime mortar to match the original. To prevent further damage & water ingress.
- (d) Locate the RWP 1 & 2 on the front corners of the building where they would have been originally (see accompanying plan). This will enable them to discharge directly into the gutters attached to the rafters of the low level roofs and solve the current problem of overflow.
- (e) Fit cast iron gutter with appropriate fall. This will distribute the flow in the gutter equally between the two RWP's and reduce the likelihood of overflow still further.
