Ms Kim Fowler  
Great Barn  
Rabley Heath Road  
Welwyn  
Hertfordshire  
AL6 9UA

2<sup>nd</sup> June 2023  
Ref: 111651/CA

## Visual Structural Assessment Report for Proposed Conversion of Outbuilding

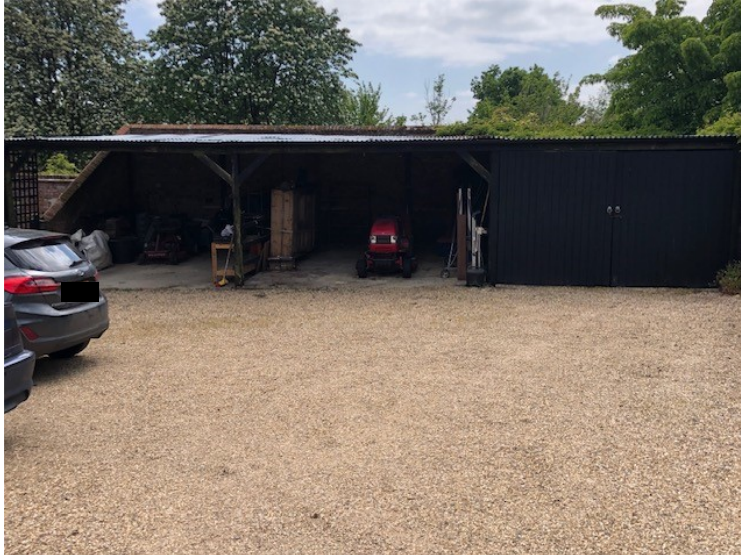
**Photo – 1: Front Elevation**

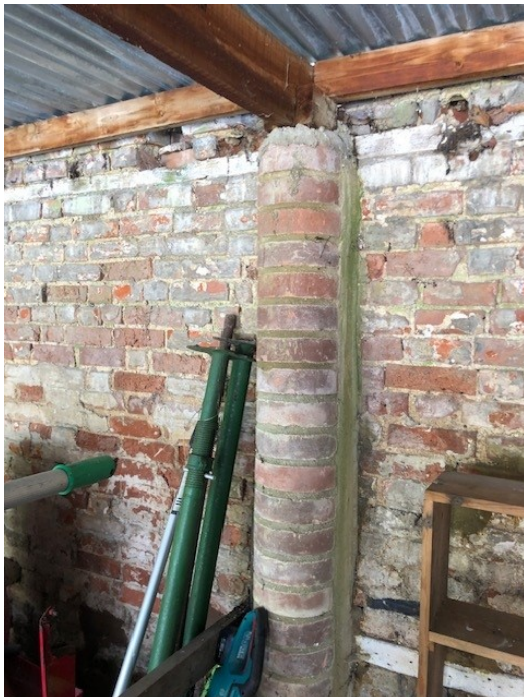
- The back elevation wall is approximately 12000mm in length and has a small brick pier on the inside at approximately 4250mm from the left hand elevation

- The rear wall has a slight out of vertical alignment towards the top section in places and a slight bow in the horizontal plane between the small central pier and left hand return wall

**Photo – 2: Rear Wall Internally with Small Pier**

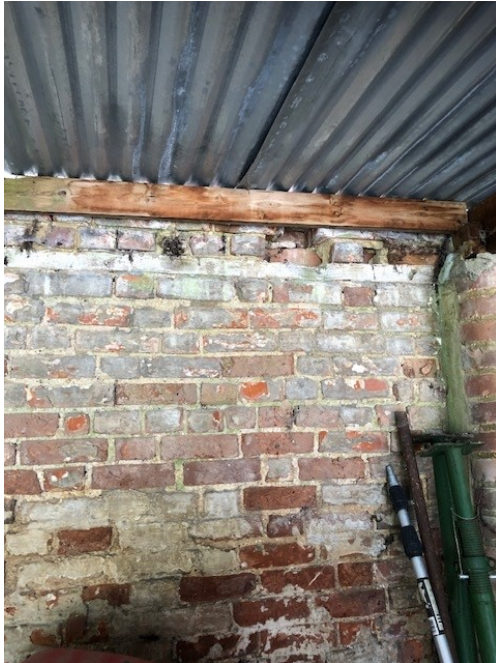
- The rear brickwall does not benefit from lateral restraint from the existing roof structure or indeed the small internal pier, albeit however the internal block partition wall does offer an element of restraint

**Photo – 3: Rear Wall Internally with Existing Corrugated Roof**

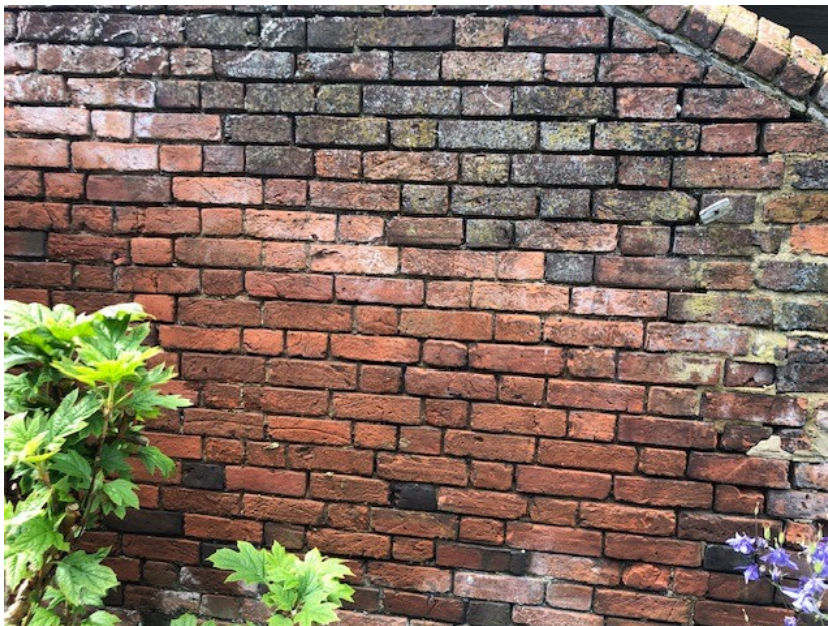
**Photo – 4: Side Wall**

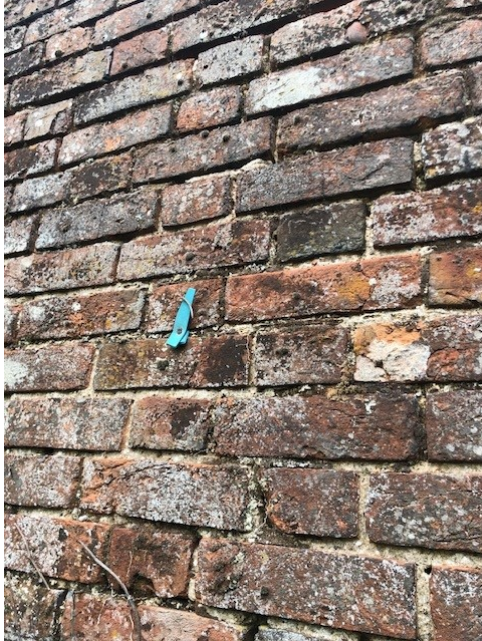
- The pointing between bricks to the “c – shape” wall is worn and erroded
- The back elevation wall in particular exhibits signs of mould and algea from water penetration

- The brick wall has no evidence of a damp proof course hence the presence of algea and mould

Photo – 5: Rear Wall Externally

- Cosmetically, the three brick walls are in need of the following:
  - Repointing most likely with lime mortar
  - Repair and replacement of brickwork where required

- Cleaning of brickwork to repair algae and mould
  - Consideration to the installation of a damp proof course
- From a structural perspective the lateral stability of the rear wall needs addressing as is evidenced by the the out of vertical alignment and horizontal bowing. Neither are significant to warrant concern in the short term

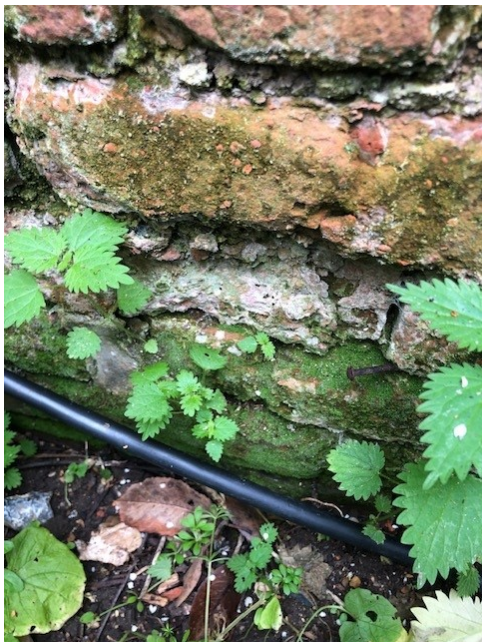
Photo – 5: Rear Wall Externally – Near Ground Level

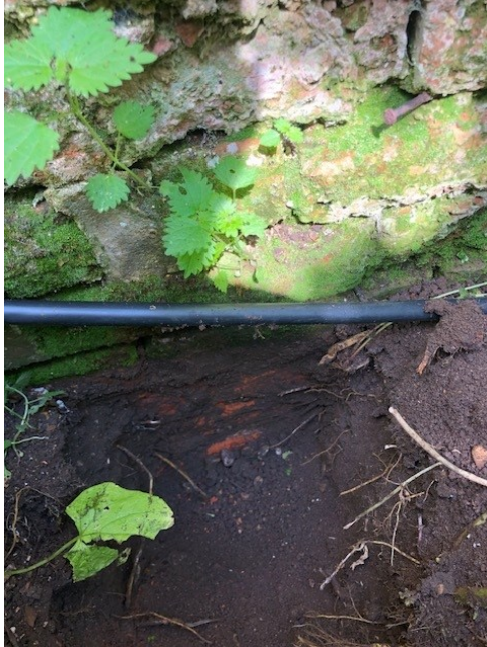
- There is no sign of crack patterns to the either of the walls
- The back wall abuts a dense area of vegetation on the adjoining neighbour’s land
- We took the liberty to excavate a little trial hole adjacent to the rear wall on the neighbour’s land with a spade. Due to the restriction in using a spade, we were only able to dig down approximately 300mm, however, there was a continuation of the wall, however, we were unable to prove the bottom level of the wall and hence its foundation

**Photo – 6: Rear Wall Externally – Below Ground Level**

- We would recommend further investigations post the planning stage at the outset of detailed design stage. These investigations would comprise:
  - Trial holes to confirm the depth and profile of the brick wall foundations

- Depending on the findings of the trial holes it may be that the existing wall may need to be underpinned either in part or its entirety or indeed the trees/vegetation behind the wall removed in order not to influence the existing and proposed foundations significantly in terms of founding depth

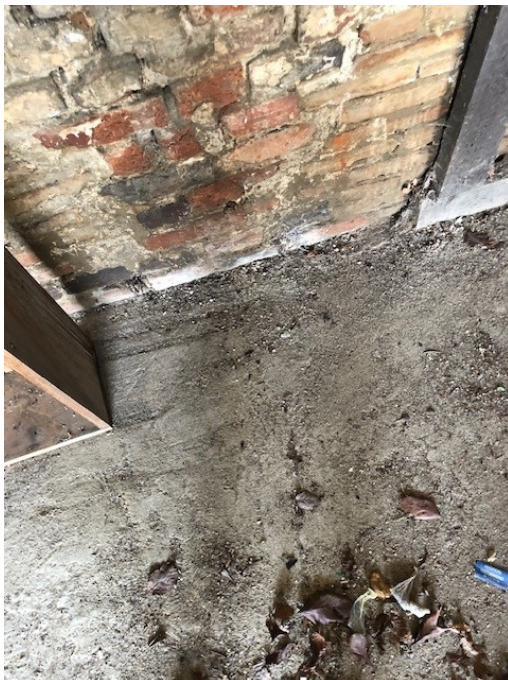
- The concrete slab in the main outbuilding area is uneven and exhibits signs of cracking
- The concrete slab in the garage area appears to be a more recent addition as it appears to be more even and does not exhibit and signs of distress in the form of cracking

**Photo – 7: Internal Concrete Slab**

- Core holes through the existing slab to confirm its thickness and if a damp proof membrane exists
- “The British Geological Maps” of the immediate area indiacte that the ground conditions to be expected are Chalk, which is the bedrock soil. There is no reference to the the superficial ground conditions, which is the layer of soil above the Chalk. Our knowledge of Welwyn informs us that there are out crops of Clay above the Chalk.

- The existing concrete floor slab based on the observations of our site visit, we would recommend is replaced with a slab laid flat and with the appropriate damp proof membrane and insulation to comply with the Building Regulations in force at the time
- The timber frame structure forming the roof ie purlins and posts are not fit for purpose as they exhibit signs of twisting/warping and therefore as part of the proposals should be demolished and replaced with a new structure.

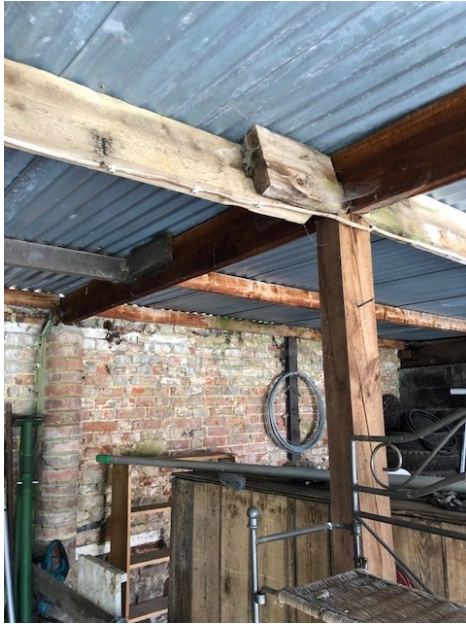
- The timber purlins appear to typically be 50 x 100 sections, which exhibit signs of warping and twisting
- The timber purlins are in turn supported by timber beams and posts

**Photo – 8: Twisted & Warped Timber Roof Purlins**

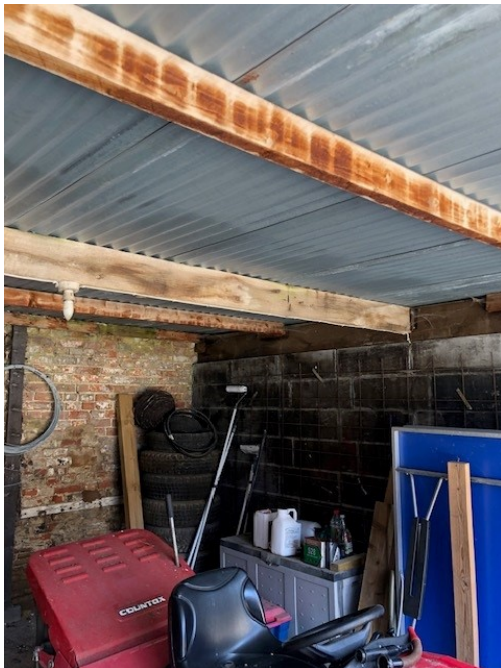
- There is a blockwork wall partition approximately 3850mm from the small brick pier that separates the main outbuilding from the garage area
- Either side of the small brick pier at half distance between the left hand elevation and blockwork wall partition there is a timber post tight to the back wall that is supporting the timber roof structure

**Photo – 8: Internal Blockwork Partition Wall**
