# **CAMBRIDGE ASBESTOS REMOVAL LTD**

**R & D for Asbestos containing materials at**

**Piggery  
Temple Dinsley  
School Lane  
Preston, Hitchin  
Hertfordshire, SG4 7RT**

REFERENCE; ECB/5342

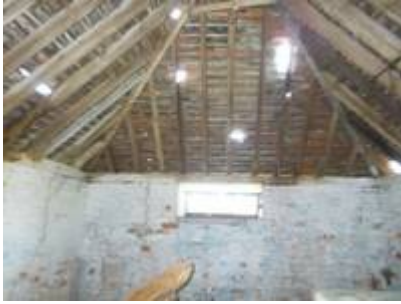
29433

No Action Required

No asbestos was detected and no  
samples taken.
