**HERITAGE ASSESMENT, SCHEDULE OF WORKS, PHOTOGRAPHIC  
SCHEDULE AND ROOM IDENTIFICATION PLANS**

February 2025

FOR ASSOCIATED REMEDIAL AND REPAIR WORKS  
AT  
OLD SEXTONS, RUSHDEN ROAD  
SANDON, NR. BUNTINGFORD  
HERTFORDSHIRE SG9 0QY

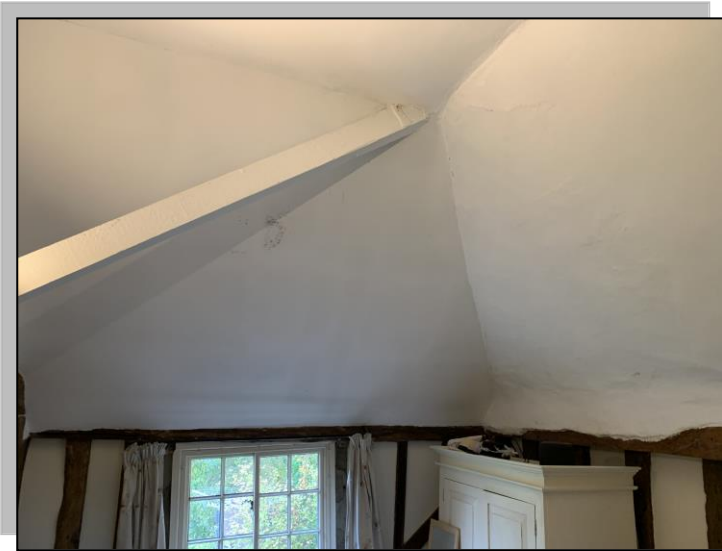
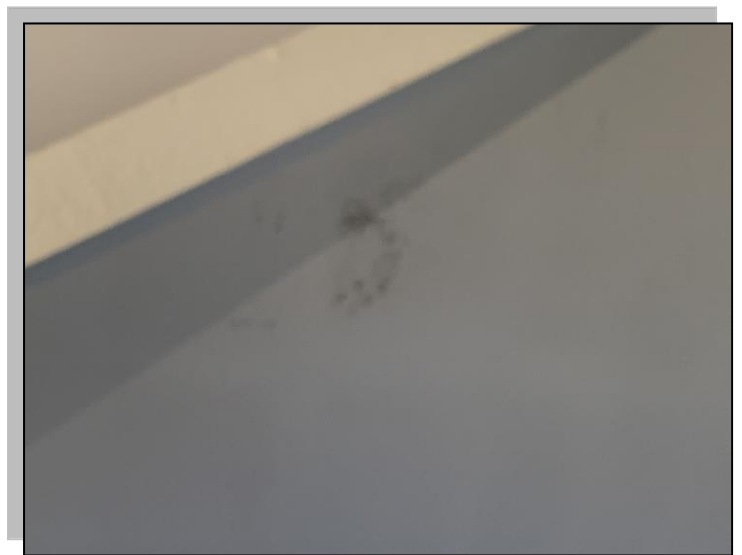
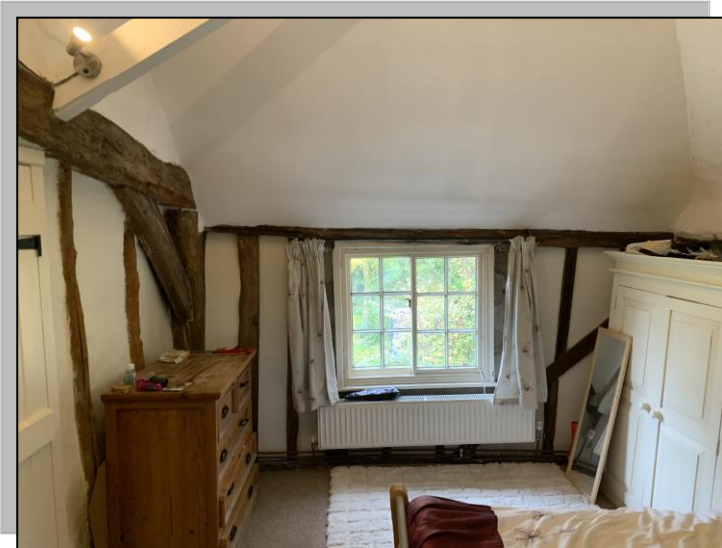
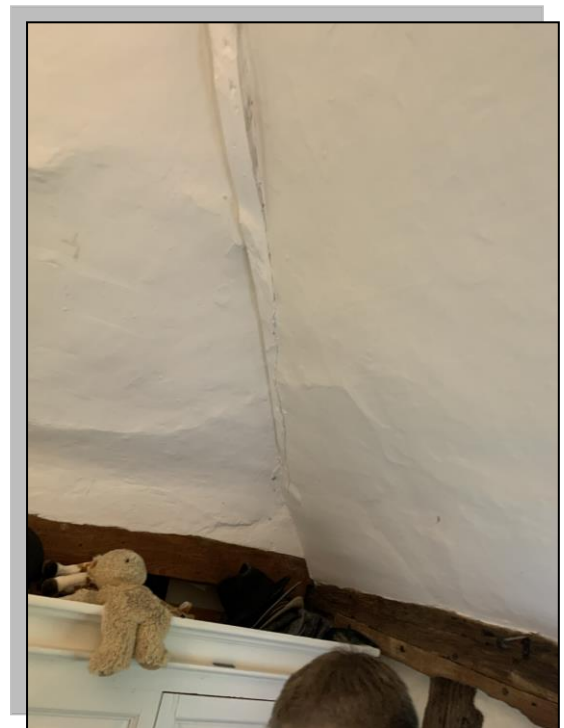
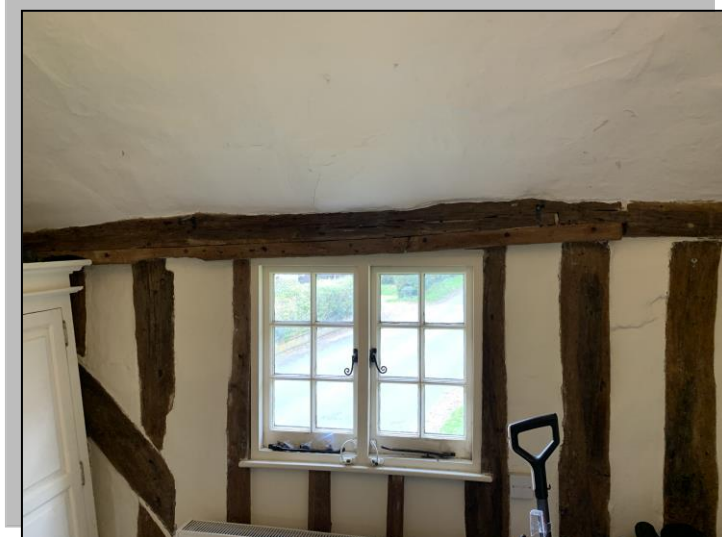
Patch repairs to the ceiling to the south-east end of the room to remedy the damp/mould patches caused by water ingress and poor ventilation in the likely location of the roof hips.

The photographs below provide an indication of the dampness and mould that has occurred to the ceiling over an extensive period of time.

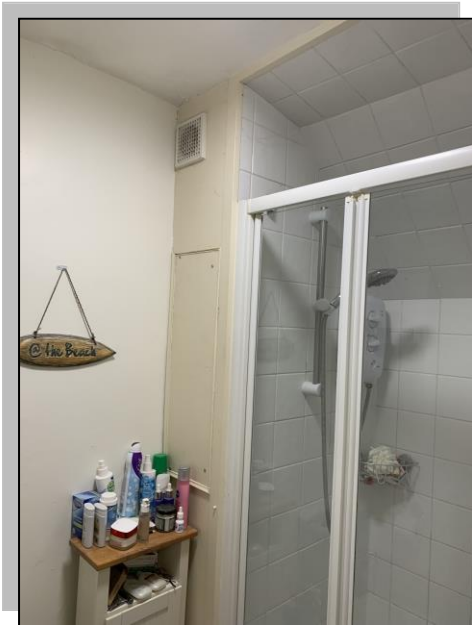
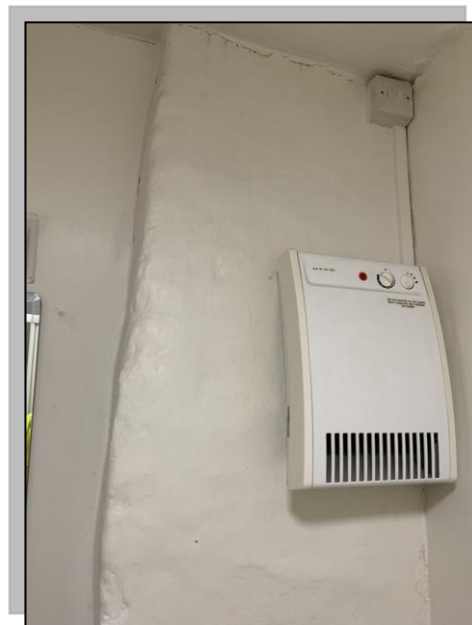
Patch repairs to the ceiling where required to remedy the damage caused by and poor ventilation and dampness.

The current extractor fan is to be replaced with a modern equivalent to cope with the minimum extract rates as described within the Building Regulations.

The heater is to be replaced with a suitable modern equivalent suitable for high humidity and potential dampness.

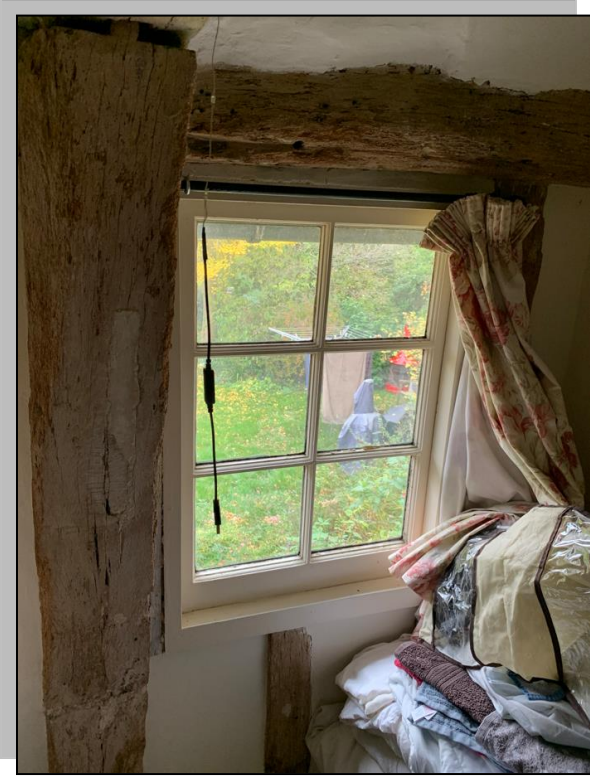
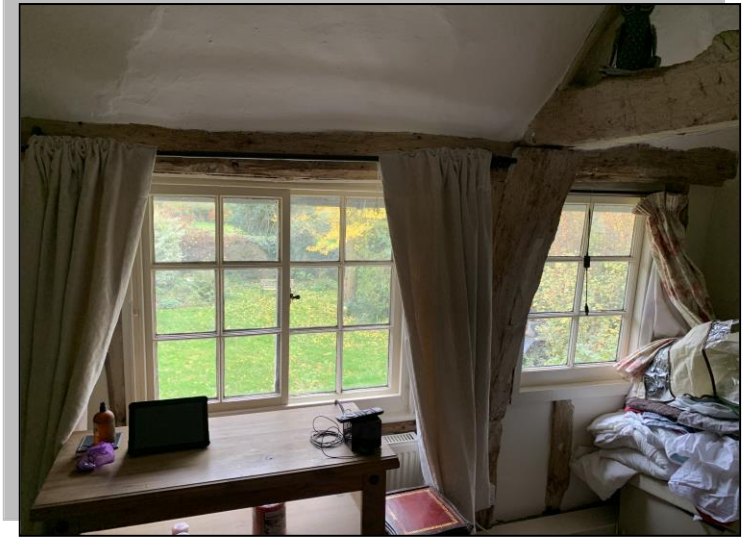
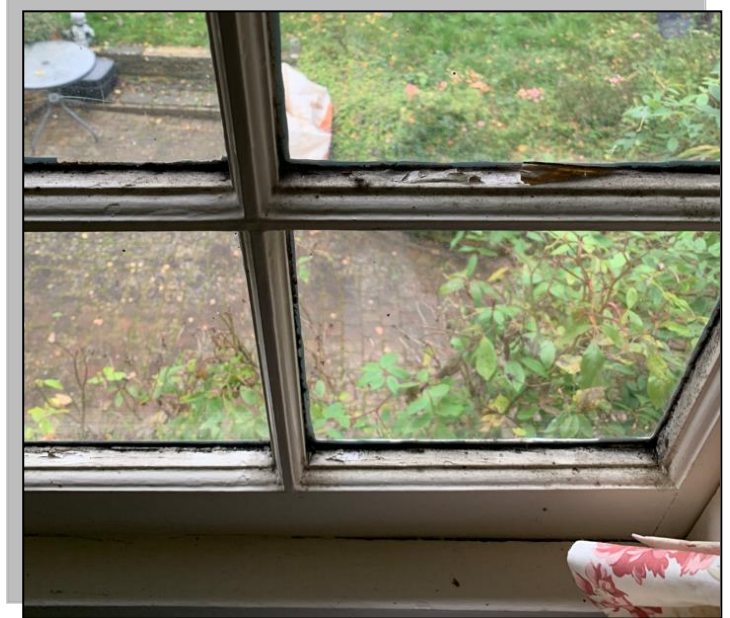
Patch repairs to the ceiling and walls to remedy where it is either loose or unstable. Window to be replaced due to its poor condition and inability to easily open, which is contributing to the lack of ventilation.

*(Photographs above indicate windows in bedroom 2 to be replaced)*

Patching work will incorporate a mixture of lime putty and gypsum (3:1) to a minimum of half part water. The skim coat will utilise a pre-mixed lime topcoat superfine plaster such as 'Ty-Mawr' with water mixed on site. A breathable emulsion finish suitable for lime based plaster is to be used. (See photographs below)

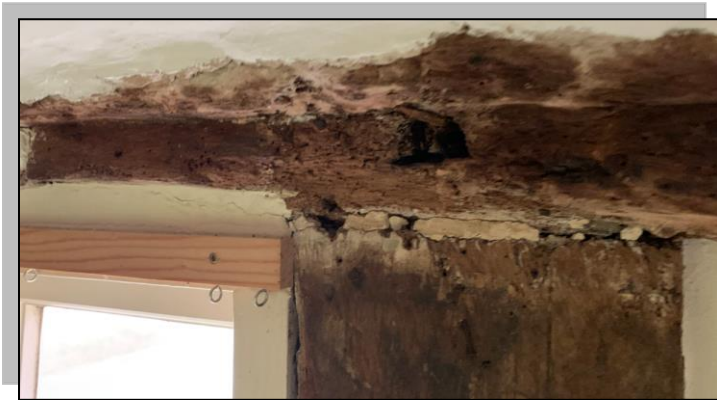
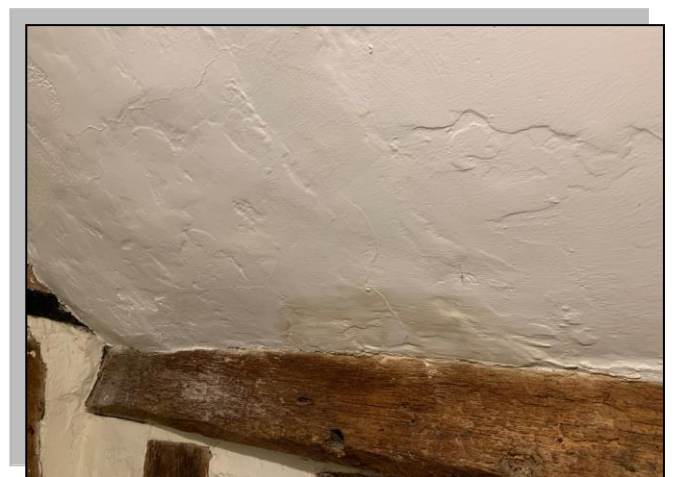
Patch repairs to the ceiling and walls as previously described, and replacement window.  
Damage to the timber wall plate over the landing area to be locally repaired as can be seen in the photograph below.

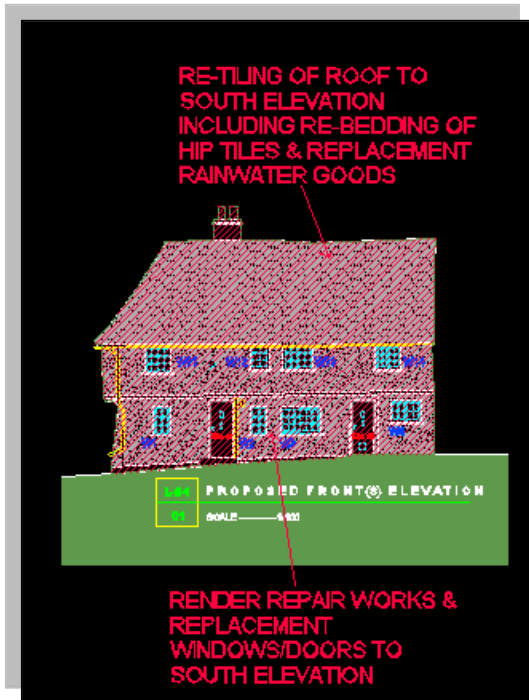
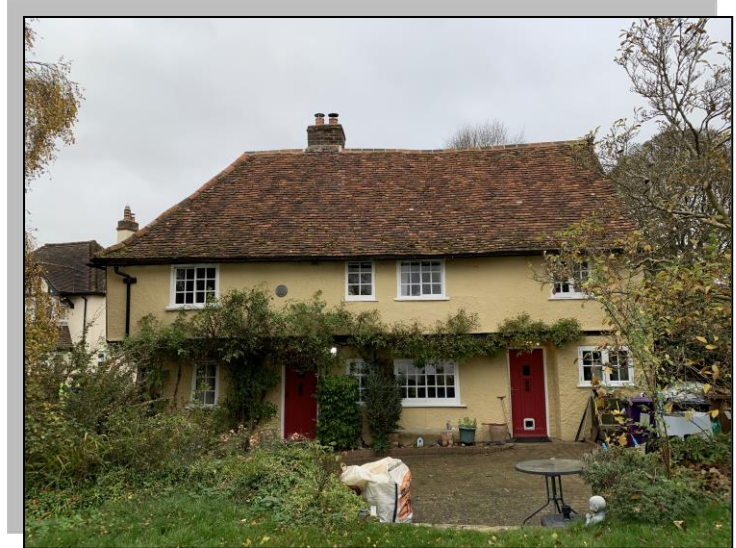
### **FRONT (SOUTH) ELEVATION**

- The existing render to all elevations should be carefully removed as the current finish, including previous repairs is cementitious and thus, does not allow the building to breathe sufficiently. In addition, the render is either live, loose or has fallen off.

- Erect scaffolding to remove existing roof tiles to this elevation only and set aside for re-use. Existing timber battens to be removed and replaced. The existing rafters and other timber members should be carefully inspected for any structural instability, damp, decay and insect attack, and any essential remedial repairs carried out. If required, a specialist report should be carried out and backed with an insurance guarantee prior to repair works being undertaken. The existing roof tiles will be re-fixed to new 25x38mm SW treated battens over 25x38mm counter battens on a vapour permeable sarking membrane. Any additional handmade tiles required will be supplemented with Sahtas Brookhurst handmade clay roof tiles (as recently approved on The Dovecote roof (Listed Building Ref: 18/00585/LBC Condition 4), and to match the north roof slope (which has previously been re-tiled). Existing ridge and hip tiles to be re-bedded and supplemented if necessary. Insulation installed above ceiling level within the loft space such as Knauf Earthwool Loft Roll 44 laid in 2 layers, 100mm thick between and 200mm at right angles across the ceiling joists

- Replace all rainwater goods (gutter and rainwater pipe). All proposed replacement rainwater goods are to be Brett Martin plastic heritage iron effect roundstyle, with a 112mm dia. gutter, fixed back to each rafter end with matching gutter clips and galvanised steel top rafter brackets, and 68mm dia. downpipes. A new downpipe is to be fitted to the front right corner of the house as indicated on the submitted drawings.

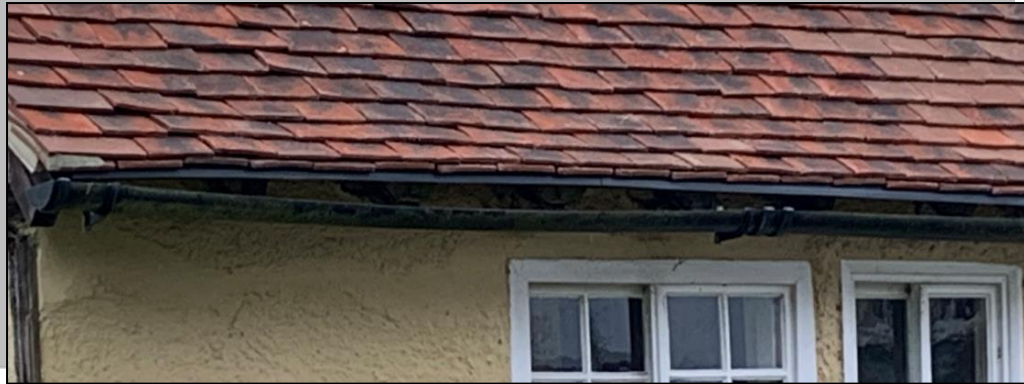
- Replace all gutters as these are not fitted correctly due to large gaps between the underside of the bottom row of tiles and the gutter itself, allowing rainwater to pass through.

*Poorly fitted gutter on north elevation*

All proposed replacement rainwater goods are to be Brett Martin plastic heritage iron effect roundstyle, with a 112mm dia. gutter, fixed back to each rafter end with matching gutter clips and galvanised steel top rafter brackets, and 68mm dia. downpipes. All fittings to be in black from the same range. Include for all running outlets, junctions, stop ends, corners, swan necks

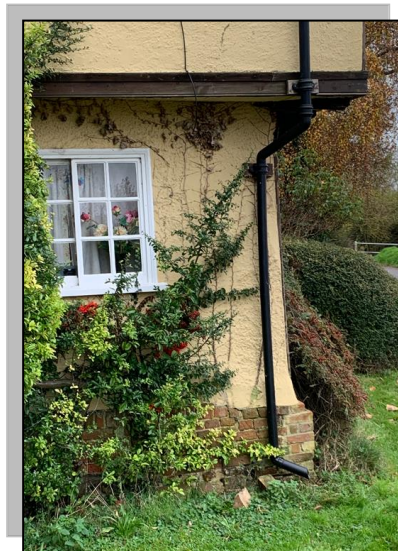
- Only one rainwater pipe discharges rainwater from this roof slope, located on the north-west corner of the building as indicated on the photograph below. It is therefore proposed to fit a new rainwater pipe to the opposite corner, discharging into a new perforated drain as described on Drawing No. L-03 Rev A running to the external perimeter at this end of the building.
