SS25299

## Structural Inspection Report

Historic Boundary wall

Ickleford Mill, Arlesey Road

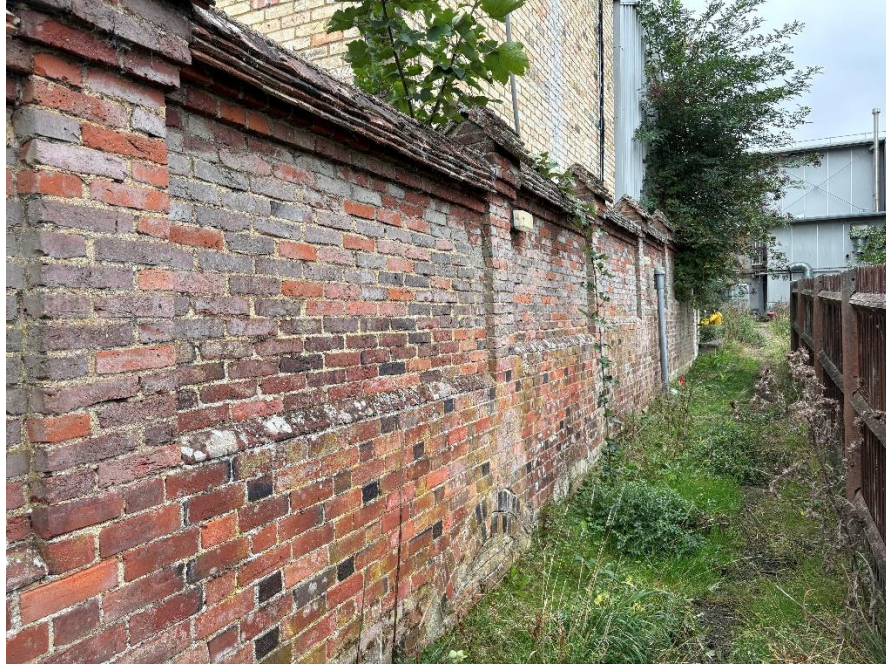
Boundary wall viewed from East Lodge side, Mill building behind

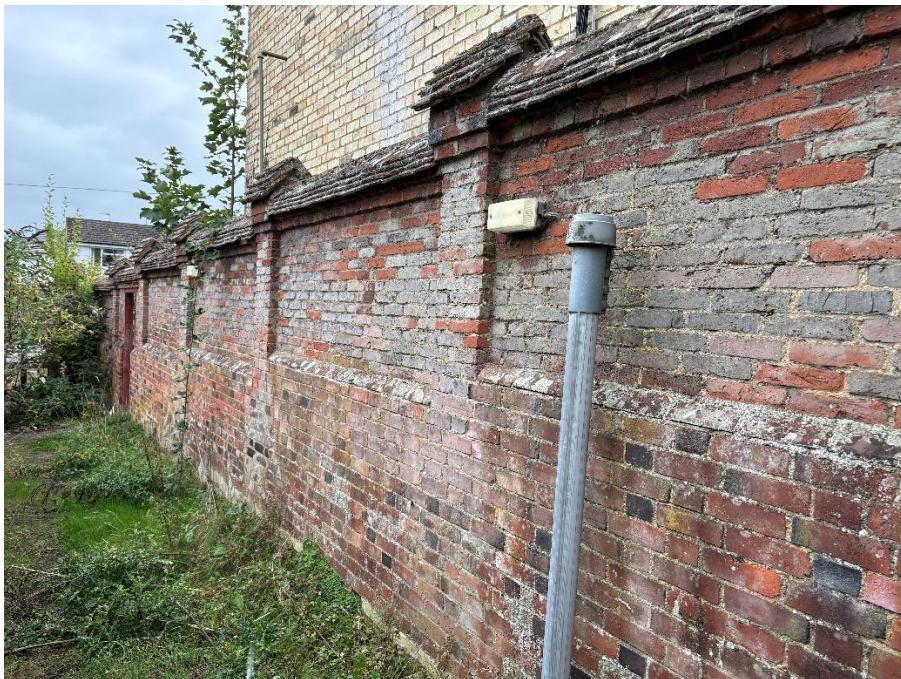
Boundary wall viewed from East Lodge side, Mill building behind

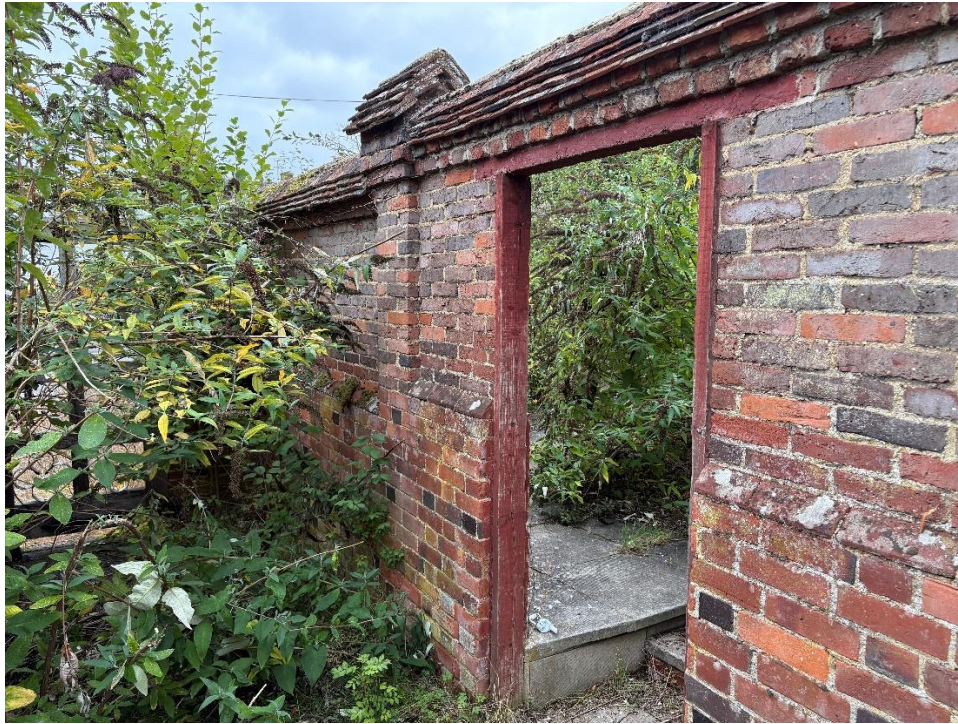
Pedestrian gate through boundary wall

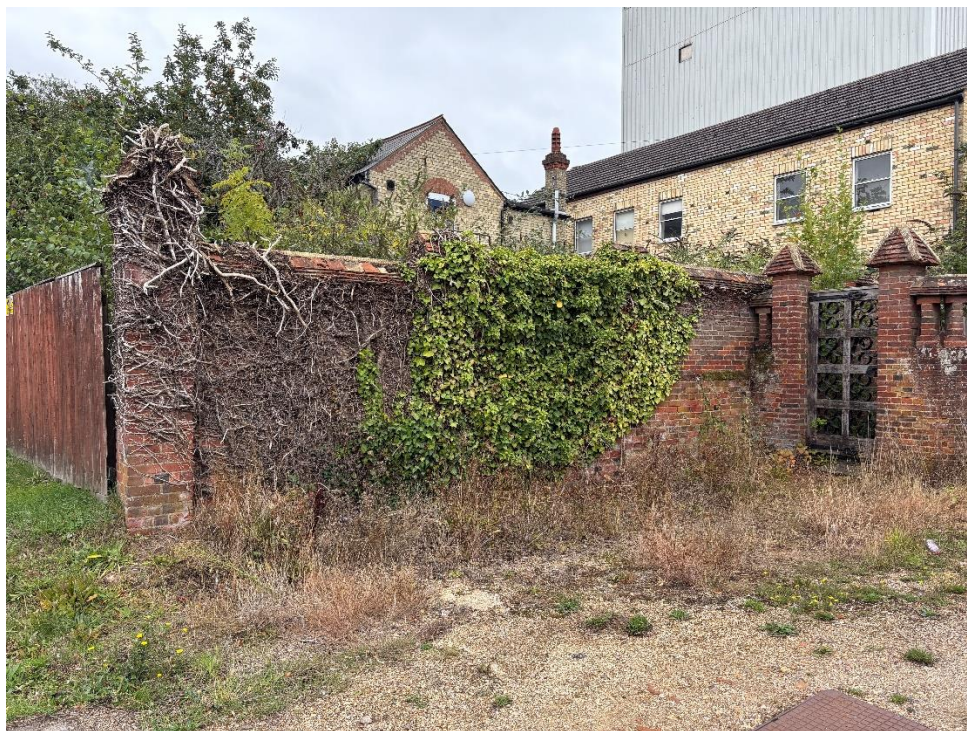
Vegetation is starting to grow in-front of the wall and climb up the wall on both sides particularly towards the road.

Boundary wall viewed from roadside. Significant ivy growth on the wall

The boundary wall, entrance gate wall and piers are all generally in a good condition and structurally stable, requiring minimal repair/restoration. The vegetation growth should be removed and cleaned from the wall and piers, and surrounding shrub and sapling vegetation removed as part of the wider works to the site. Deep rooted Ivy and vegetation should be removed using non destructive measures (e.g. cutting the vines at the base and allowing the growth to die and naturally loosen). A schedule of repair can be found in Appendix B. Any repointing to crack damage should match the original lime mortar composition, texture and colour to meet best practice for historic structures

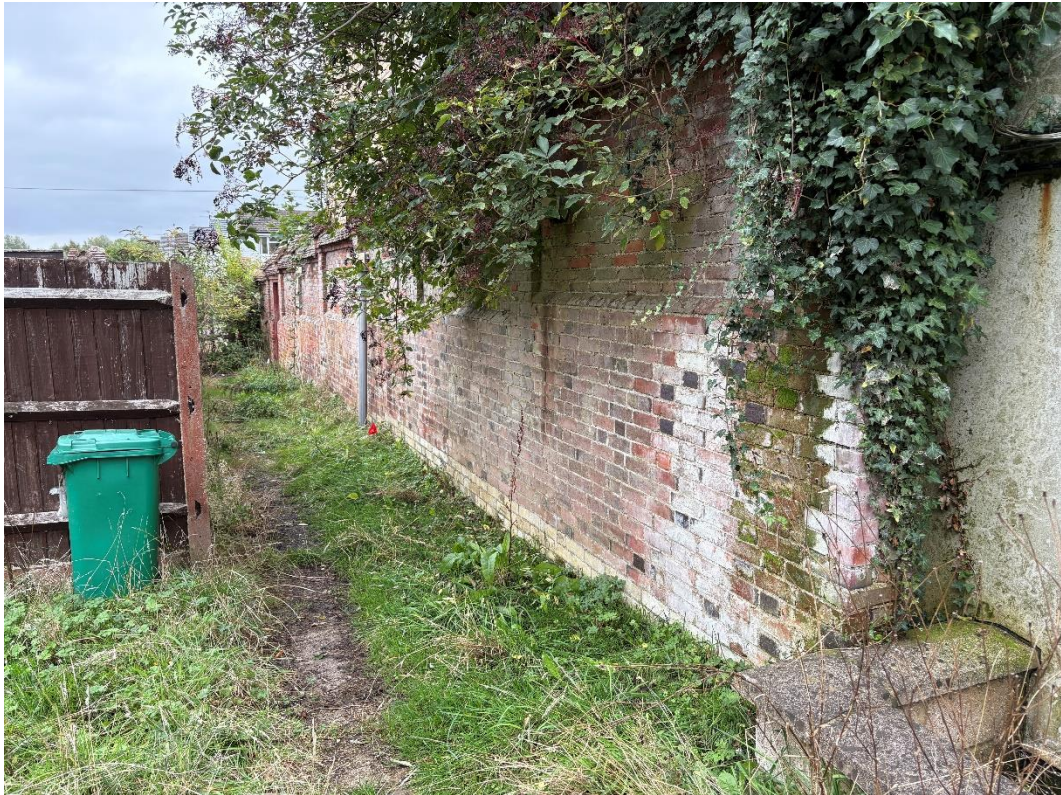
Ivy and moss growth with water staining to the wall from missing rainwater pipe to mill building

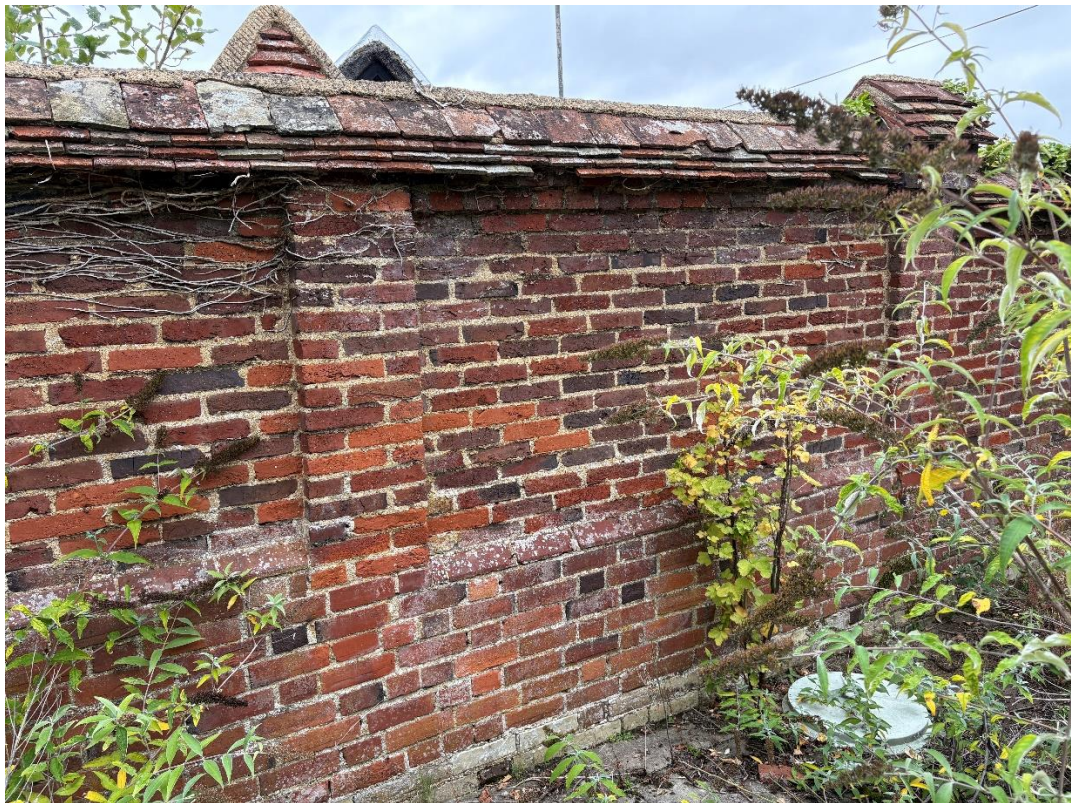
Half of the wall is not visible from the mill complex side, as a mill building is immediate adjacent (within 300mm) to the wall. The boundary wall predates the construction of the mill building.

Wall viewed from Mill side

Due to the very close proximity of the wall to an existing mill building proposed to be demolished, the wall will require protection during the demolition works. A protective scaffold frame should be erected over the wall which is near to the mill building prior to any demolition works designed to withstand any falling demolition debris. The gable wall of the Mill structure will require careful dismantling by hand down to ground level, accessed from the inside of the building. We recommend that existing foundations to the mill building are left in place below ground level to avoid destabilising the boundary wall. The proposed site plans indicate new parking spaces immediately in-front of the wall. To avoid the possibility of damaging the wall during works to excavate and construct new hardstanding, we recommend that a small soft landscaping strip is provided in front of the wall, which includes an upstand kerb edge to prevent vehicles parking close to the wall, surcharging the wall and also prevent impact. This will also prevent the undermining of the boundary wall foundations during any excavation works for new surfacing. Details of the demolition and construction phase works can be found in Appendix B.

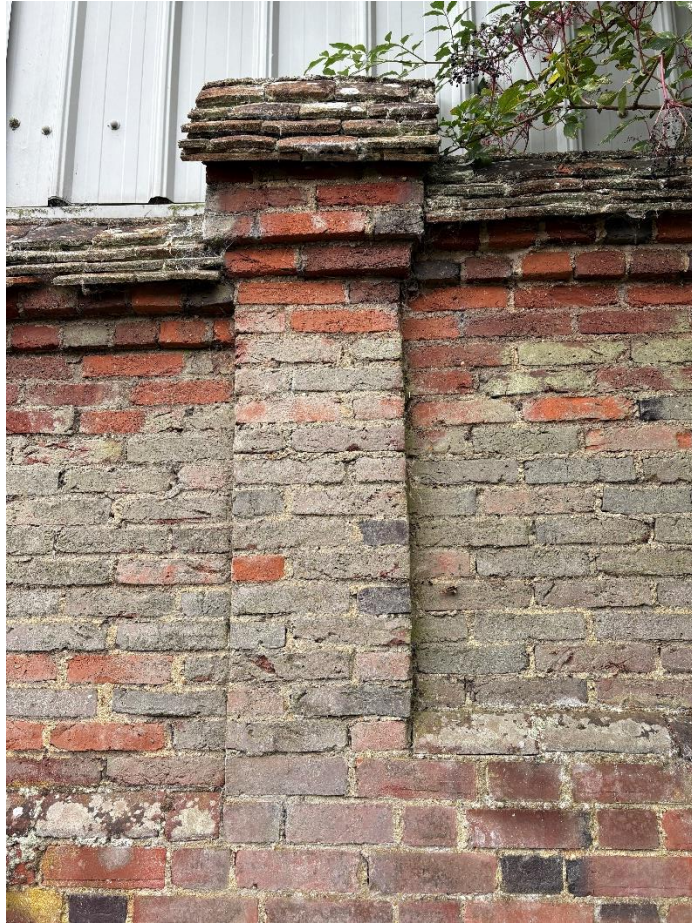
Pier and coping detail to boundary wall

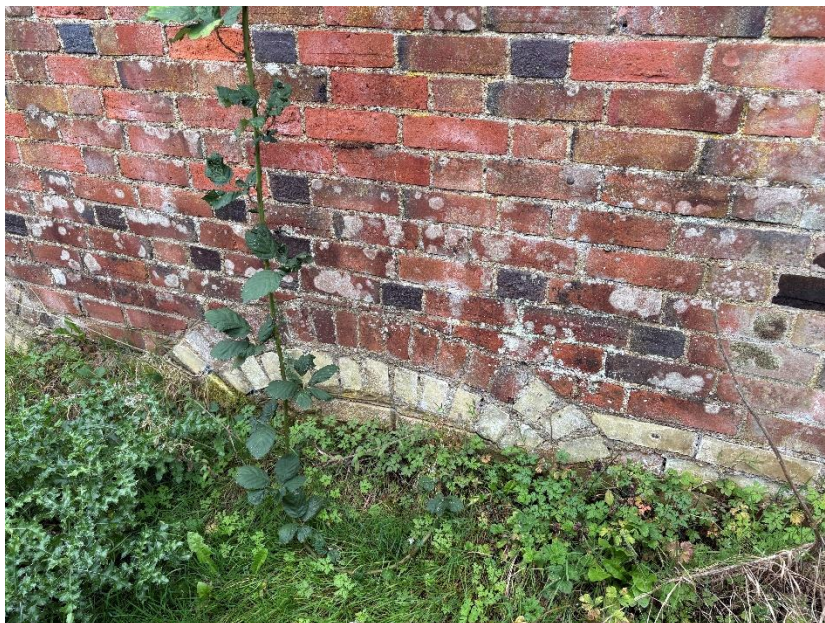
Arch detail to lower wall section

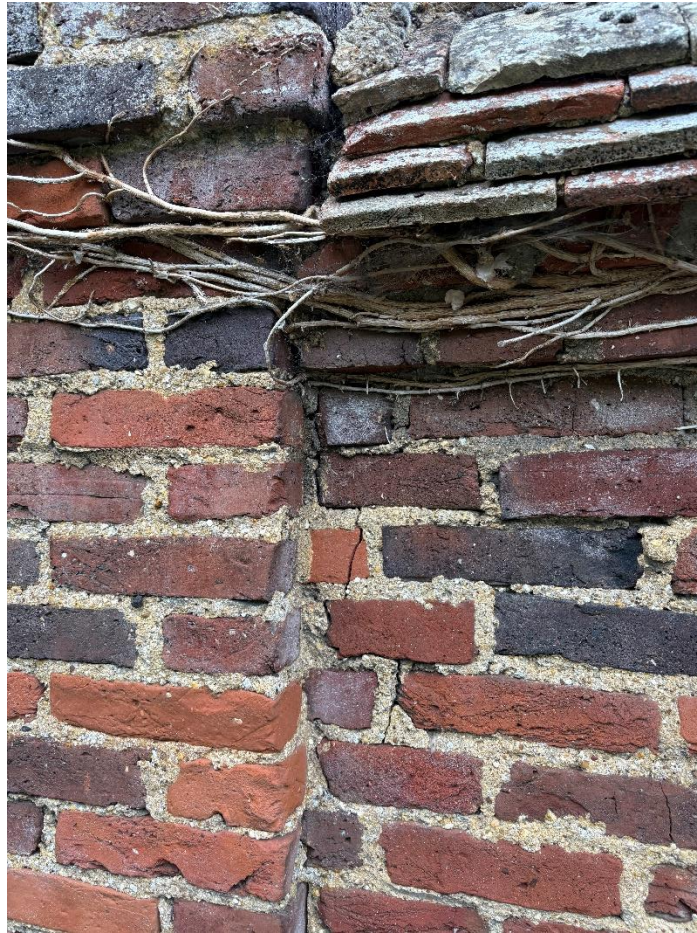
The wall is structurally stable and in a very good condition. The wall is generally plumb and level with only one area of very minor crack damage. The mortar is strong and providing a good bond to the brickwork. The coping tiles are all intact and provide the wall with good weather resistance. On the Western end of the wall there is some moss growth and ivy taking hold on the wall, and the rain water pipe from the mill building is missing, discharging rainwater directly onto the wall. Other than the removal of vegetation, we consider that the wall does not currently require any structural repair.

Minor cracking to boundary wall

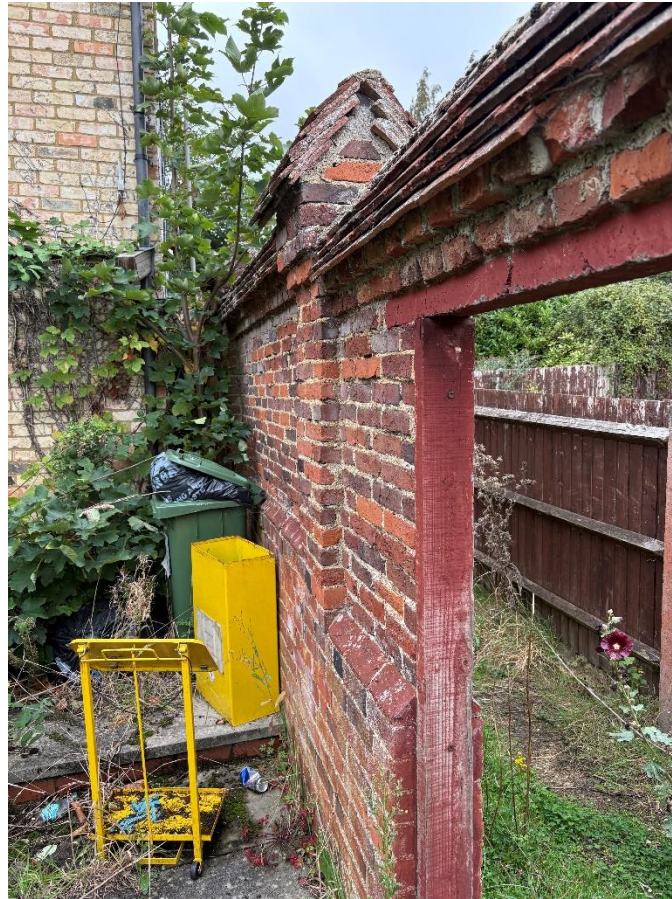
View through pedestrian gate showing section through wall and retained ground on the mill side

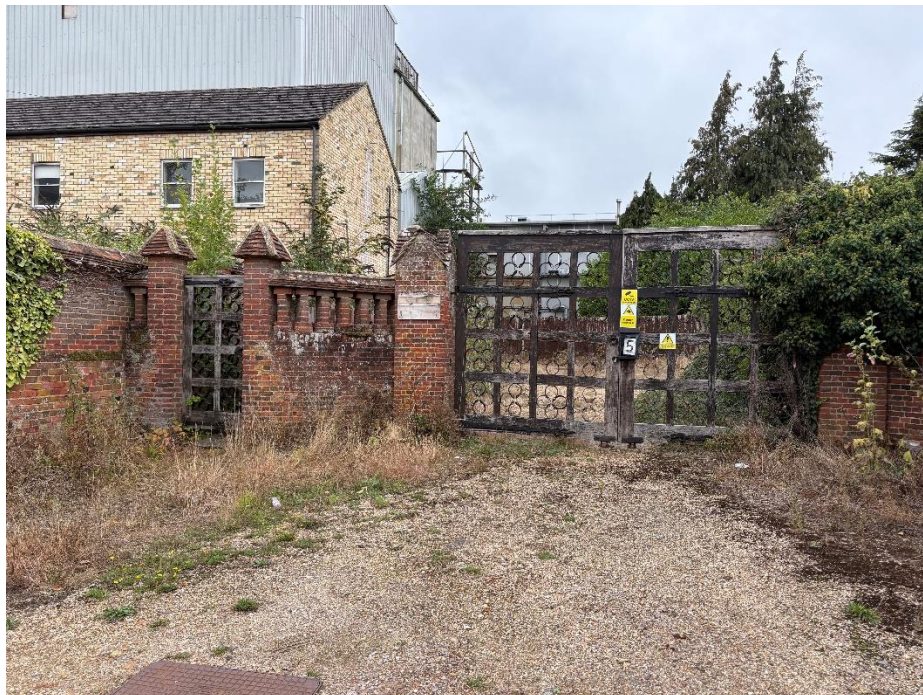
Entrance gate, Piers and wall. Ivy growth on Northern gate pier

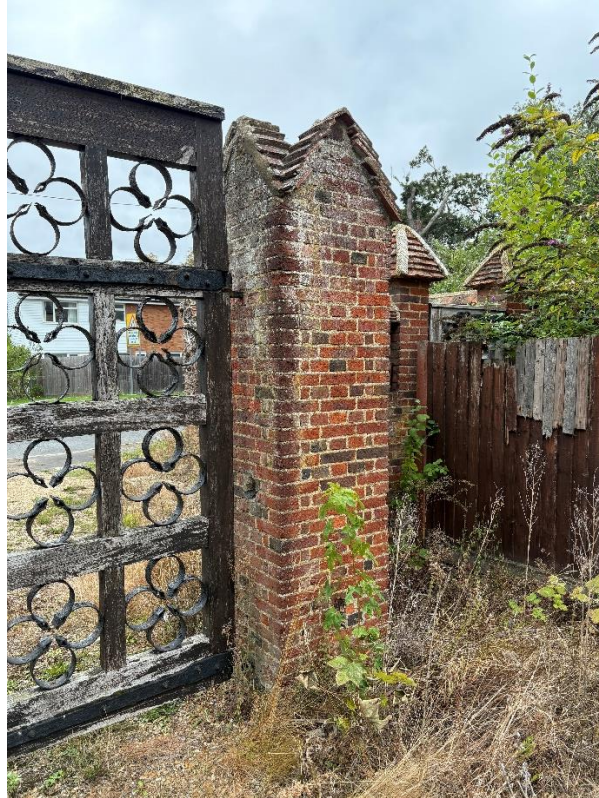
Entrance gate pier with gable coping detail

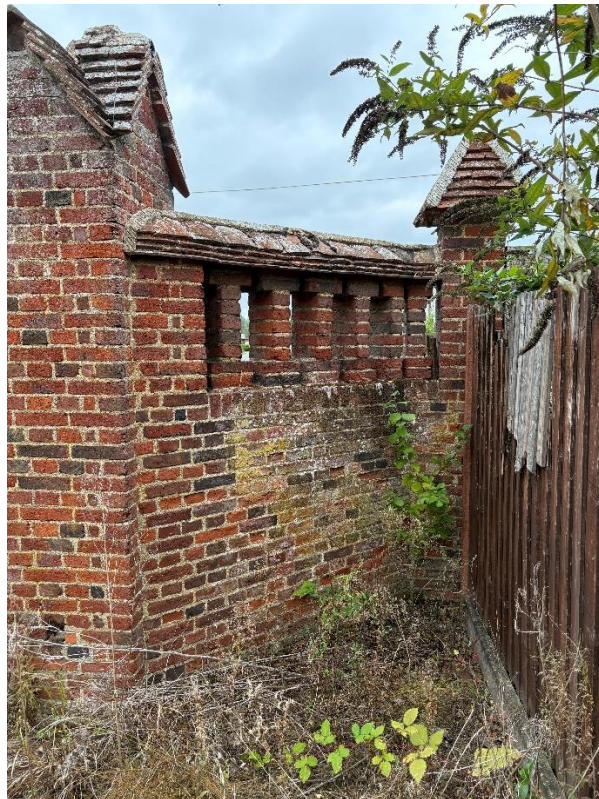
Side wall panel with open vertical detailing to upper section and tiled coping

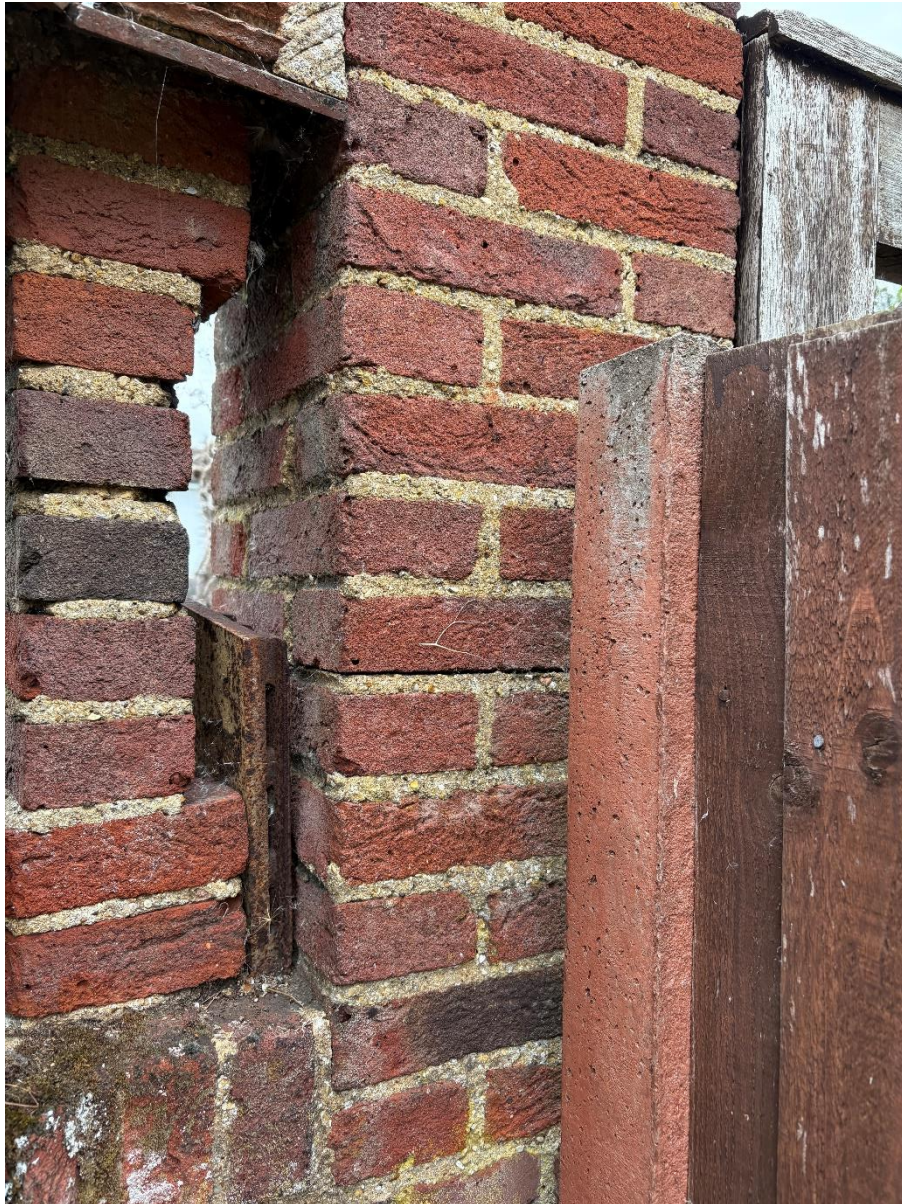
masonry and tiled coping detail as the main boundary wall. On the Southern end of this wall there is a wooden pedestrian gate with masonry gate post piers. These piers are 3m tall and 350x350mm square. There is a horizontal crack in the brickwork on each of these piers.

The walls and piers are structurally stable and in a very good condition. The wall and piers are generally plumb and level with only some minor crack damage to the pedestrian gate piers. The mortar is strong and providing a good bond to the brickwork. The coping tiles are all intact and provide the wall with good weather resistance. Other than the removal of vegetation, and some localised repointing of the cracked brick piers, we consider that the wall does not currently require any structural repair.

Horizontal crack in pier to pedestrian gate pier

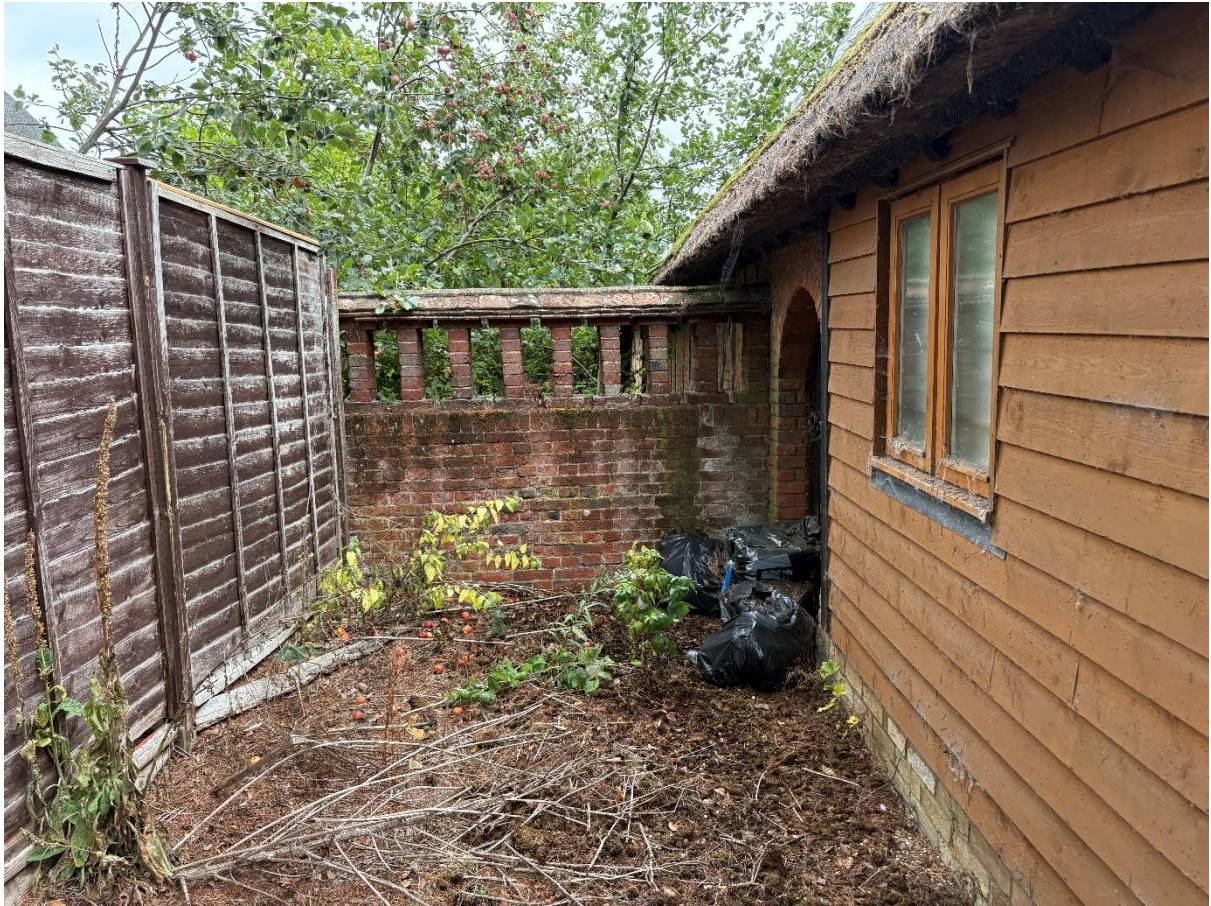
To the North of East lodge there is another short section of wall of the same construction as the Entrance gate wall, featuring the open half brick pier detail to the top section of wall and coping. This forms the boundary to the garden of neighbouring property.

Small section of boundary wall to the North of East Lodge
