# Baldock, St Mary's Church Hall, Bat Survey 2024

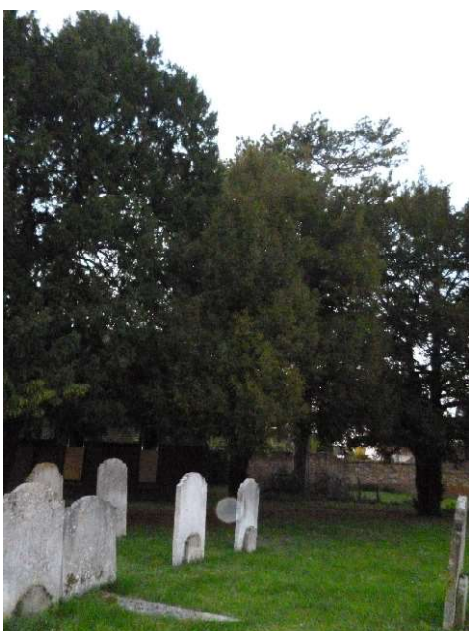
Tree T2, mostly sound without any obvious crevices or hollows. Historic limb failure has healed without issue, leaving no potential roosting features. Potential suitability negligible.

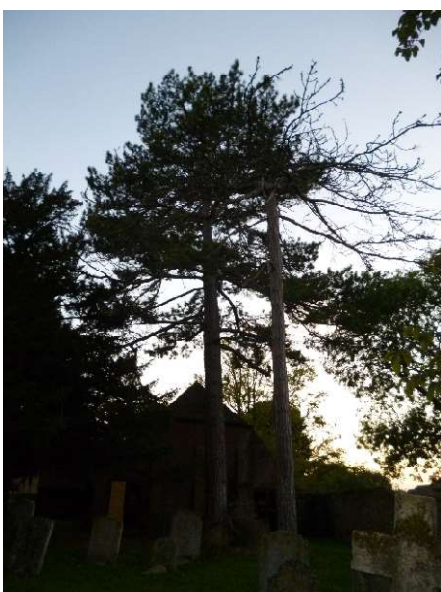
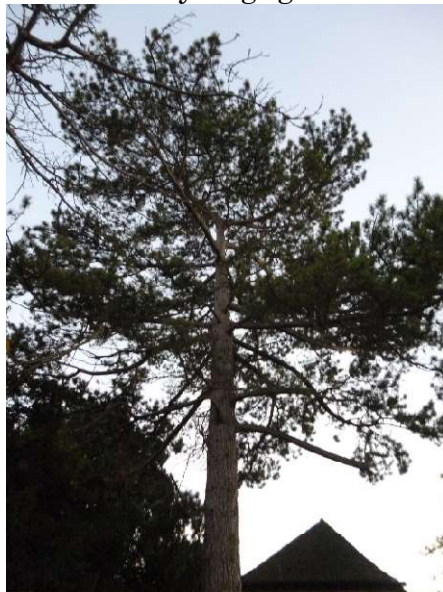
Tree T4, canopy open to apex, completely sound, no crevices or hollows, all exposed to the elements. Potential suitability negligible.
