**PROPOSED DEVELOPMENT**

**HIGHOVER FARM**

**HITCHIN**

**PHASE 1 DESKTOP STUDY**

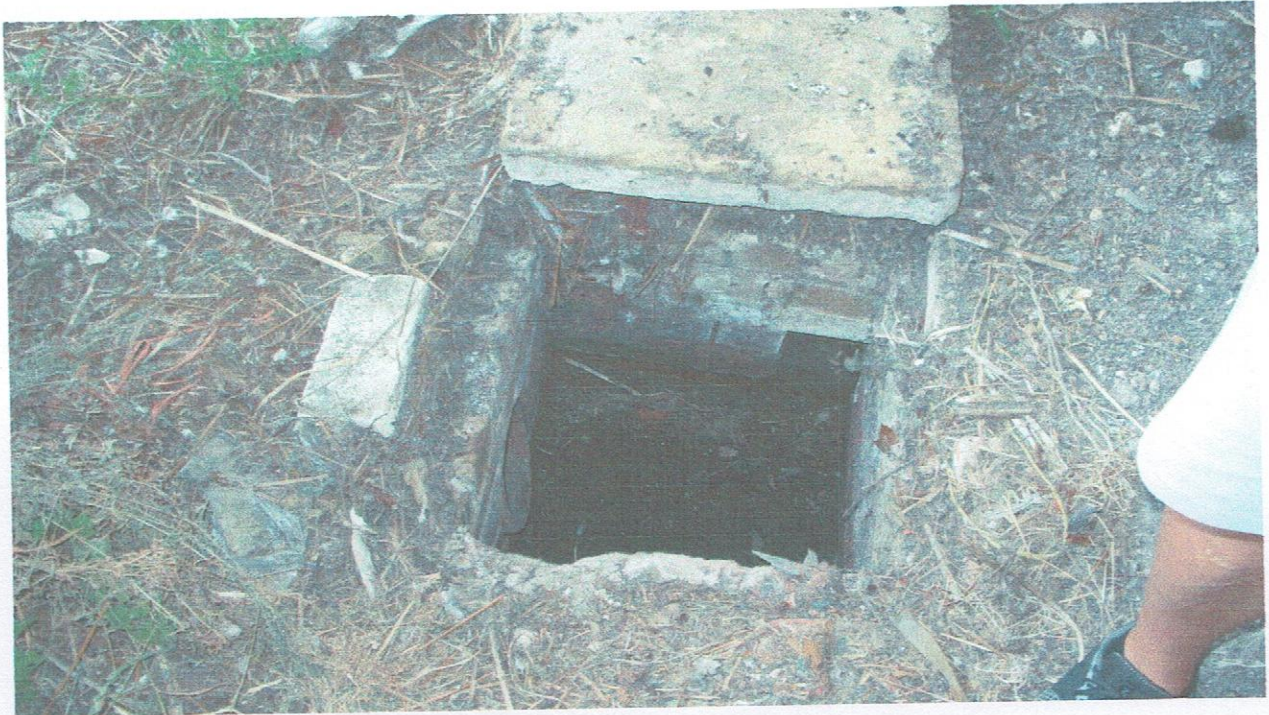
No cess pits were found however a drain linking into the main drainage network was found in building 6.

PHOTO No. 3 Existing Drain

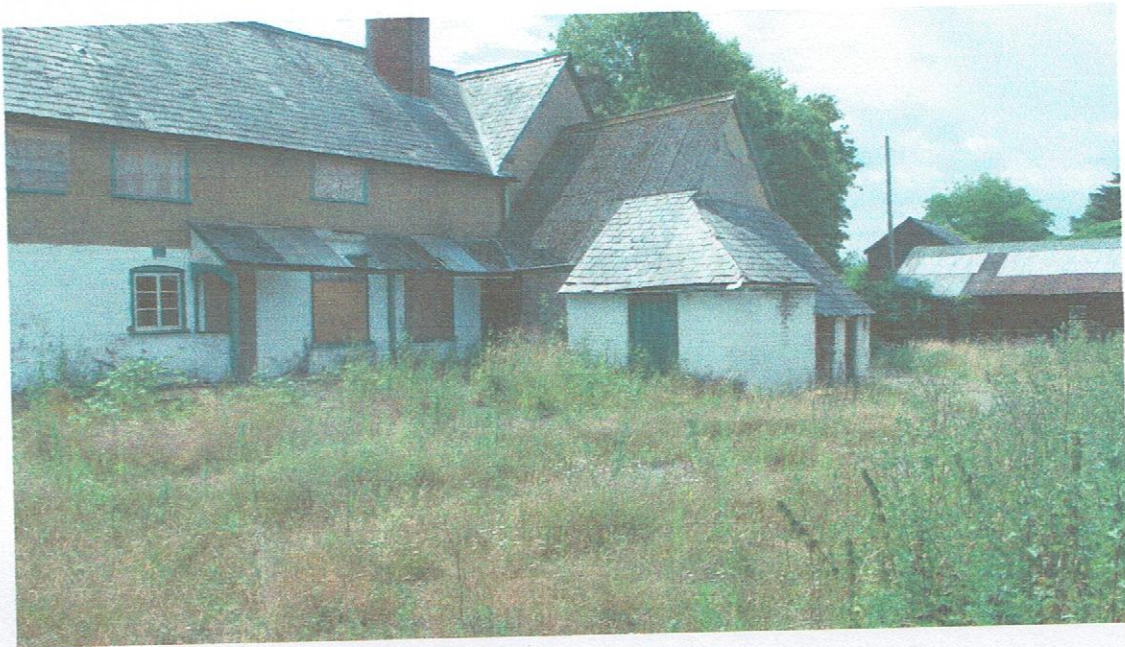
Asbestos, in general the buildings have natural slate roofs with no underfelt. No asbestos was observed in any of the buildings other than the main house that has a sloping roofing at the rear with asbestos sheets. This asbestos will need to be identified and removed under controlled conditions.

PHOTO No.4 Rear of house with sloping asbestos roof.

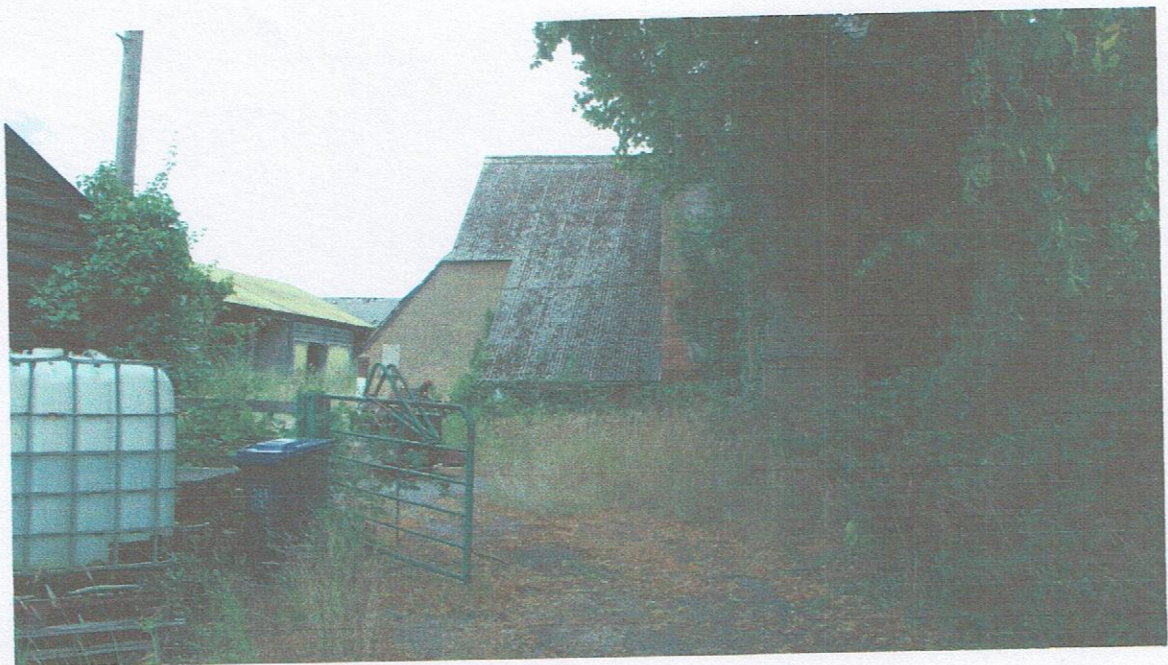
PHOTO No.5 Asbestos roof looking north

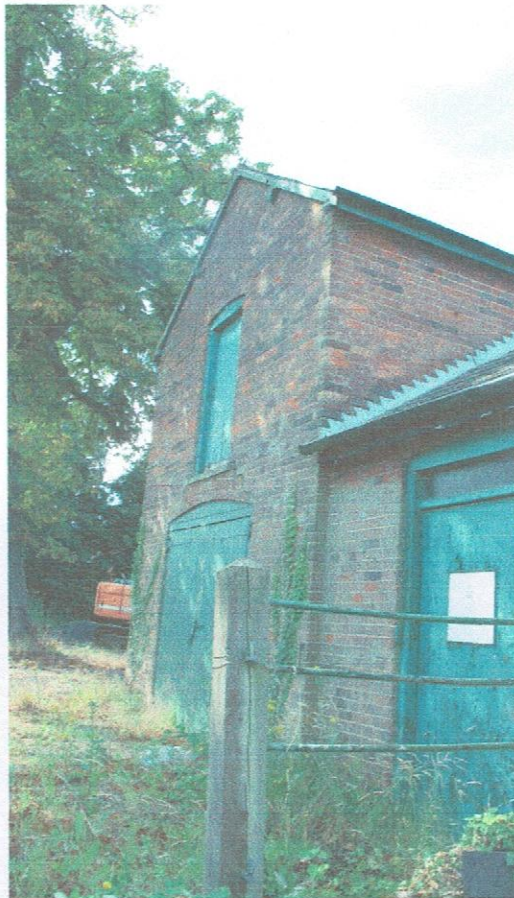
PHOTO No.6 Building B1

Building B1 is a two-storey brick structure with a slate roof without underlay and a timber double door at ground level and single timber door centrally at ground level.

The building has plastic guttering and appears to be in reasonable condition with no significant signs of subsidence or heave.

This buildings floor level is higher than the two attached buildings.

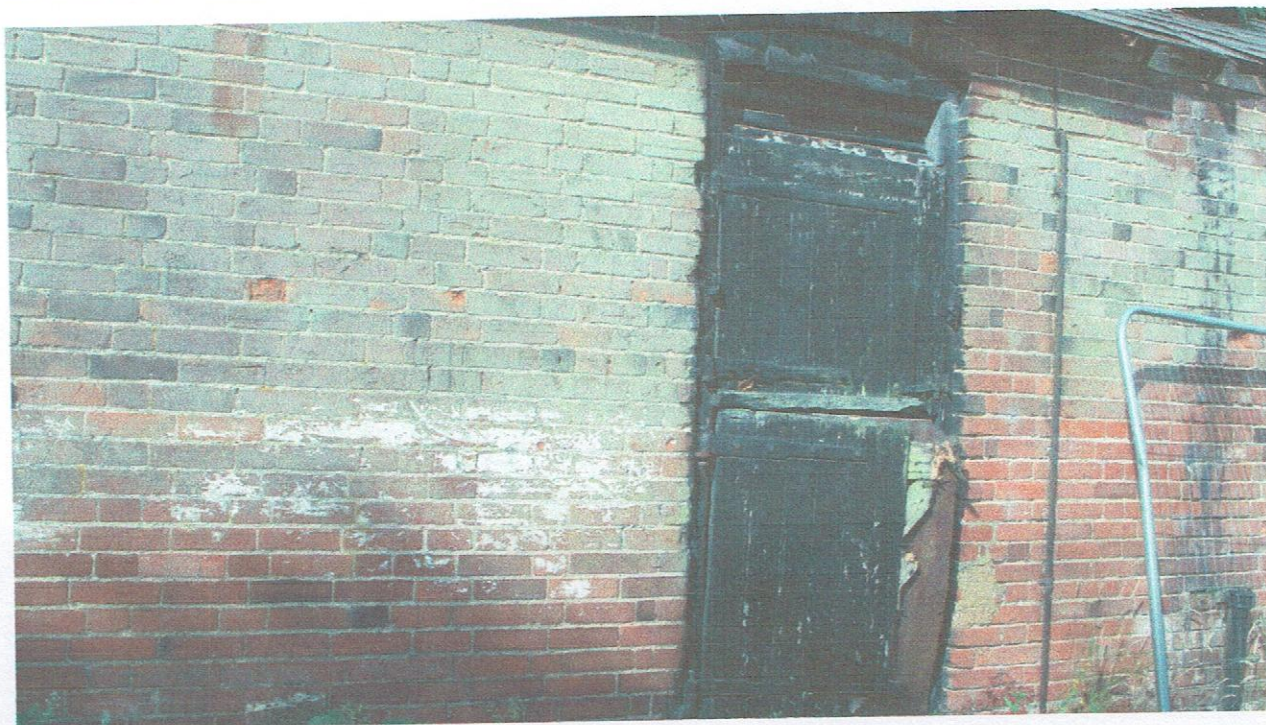
PHOTO No.7 Building B2

Building B2 is a stables with a typical split door the lower half of which has been repaired with wiggly tin. Brickwork is in good condition the interior has a clean paviour floor. Roof is slate with no felt with plastic guttering some of which is missing.

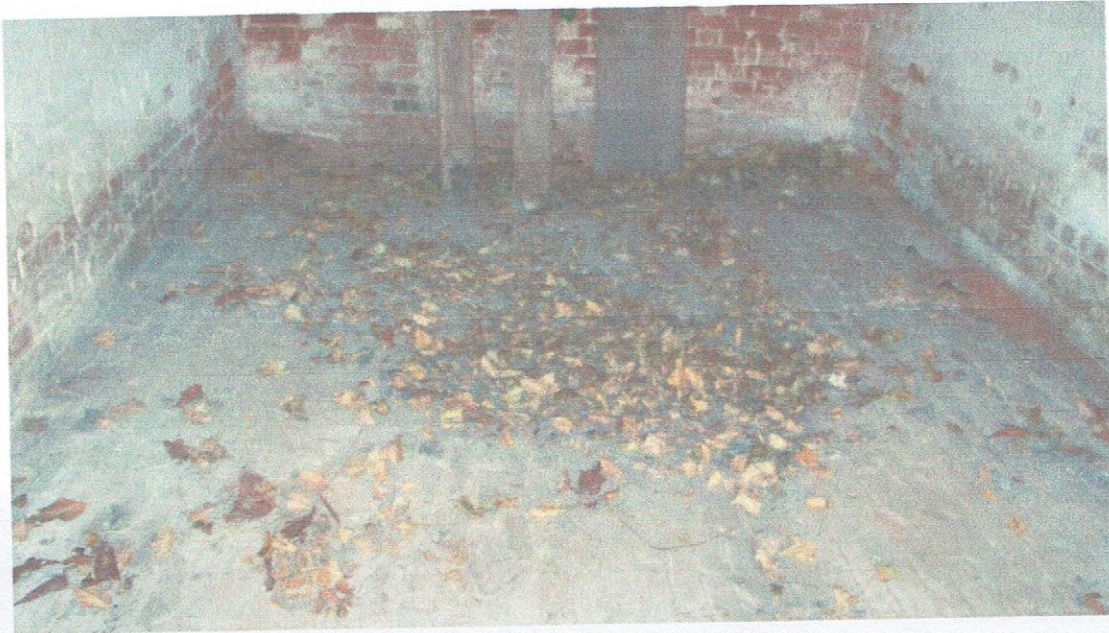
PHOTO No. 8 Interior of Building B2 with clean brick pavior floor

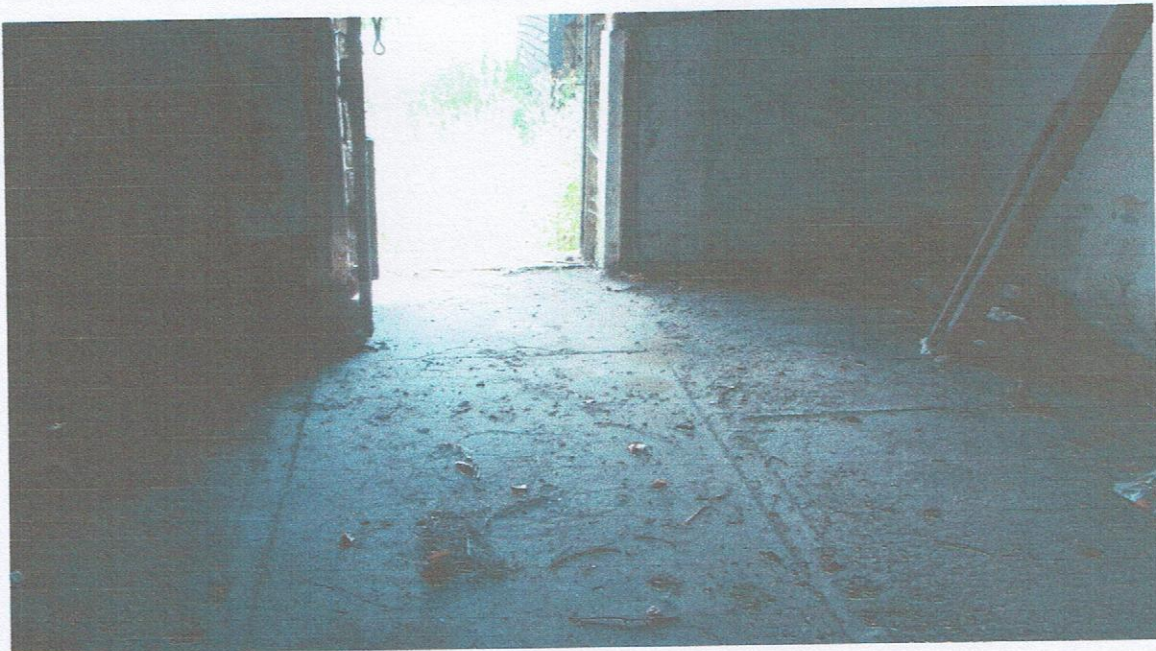
PHOTO No.9 Interior of Building B3

Building 3 is also a stable generally similar but with a concrete rendering on the lower walls. Several holes in roof doors are all timber. Floor is concrete with no sign of spillages.

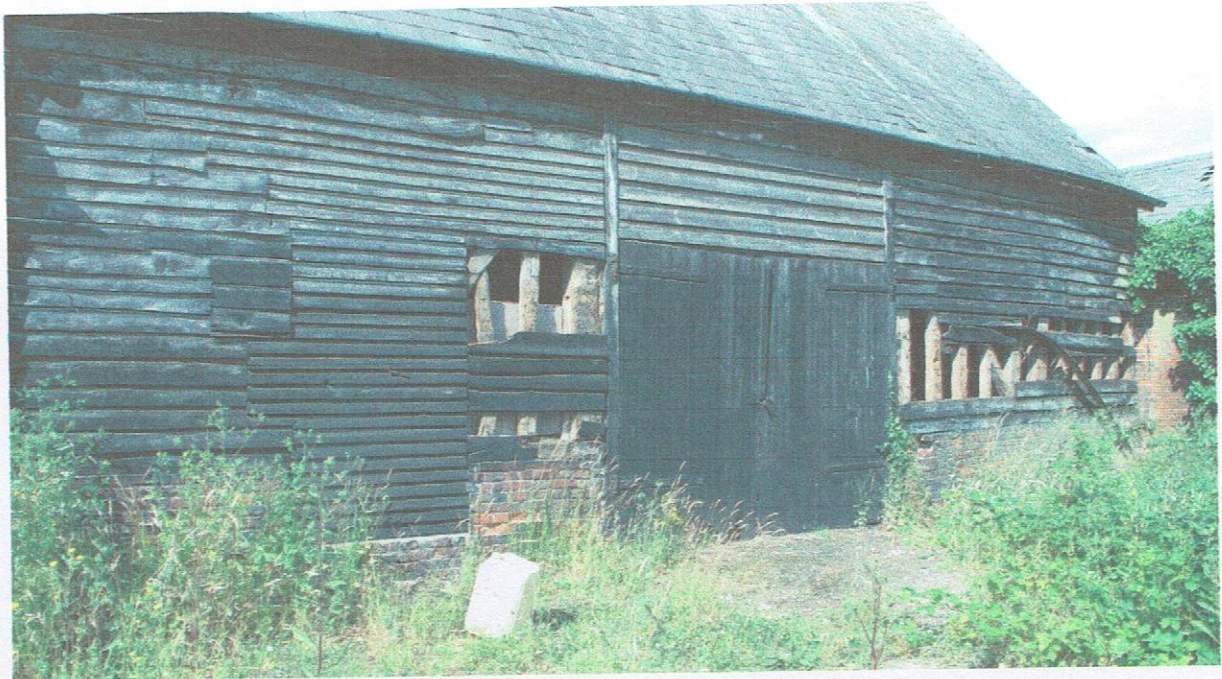
PHOTO No.10 Exterior of Building B4

A timber framed, timber clad barn in poor condition, slate roof incomplete plastic guttering with some metal downpipes. Double timber doors interior has thick coating of bird droppings.

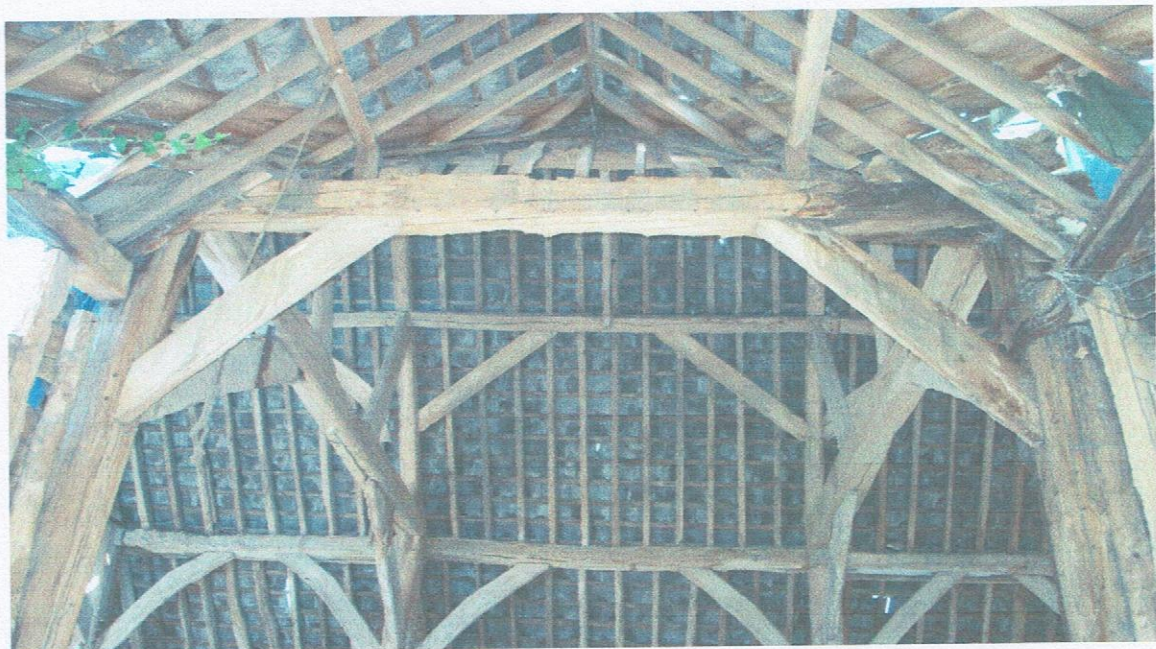
PHOTO No.13 Part of the interior of the splendid Threshing Barn currently in a sad state.

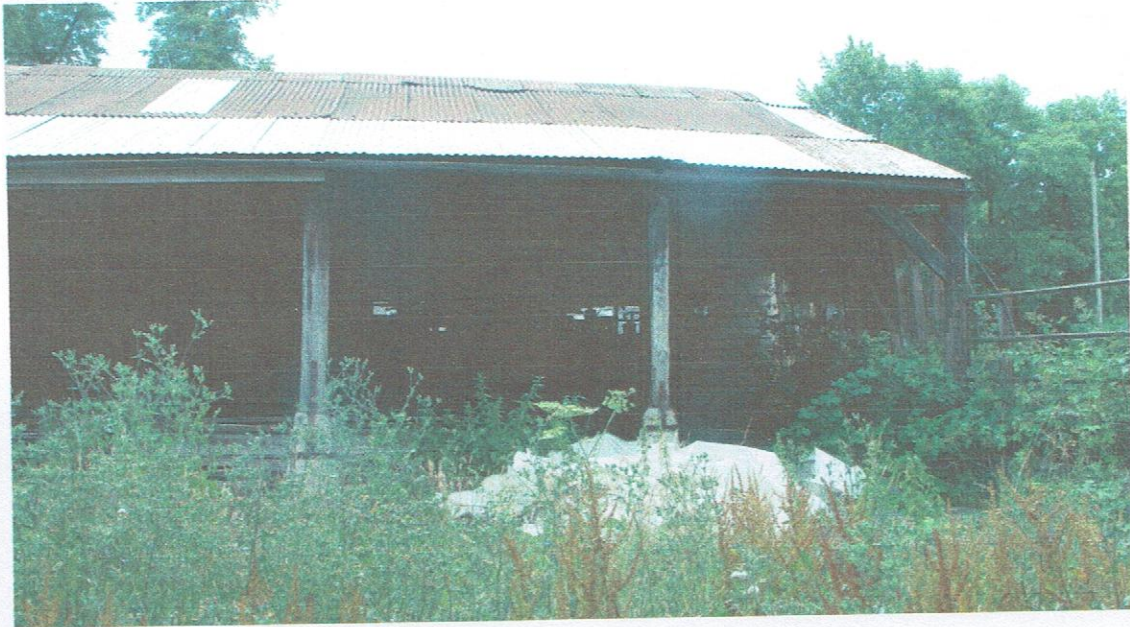
PHOTO No.14 Building B8 open timber frame with some metal support (assumed repairs), wiggly tin roof. Poor condition

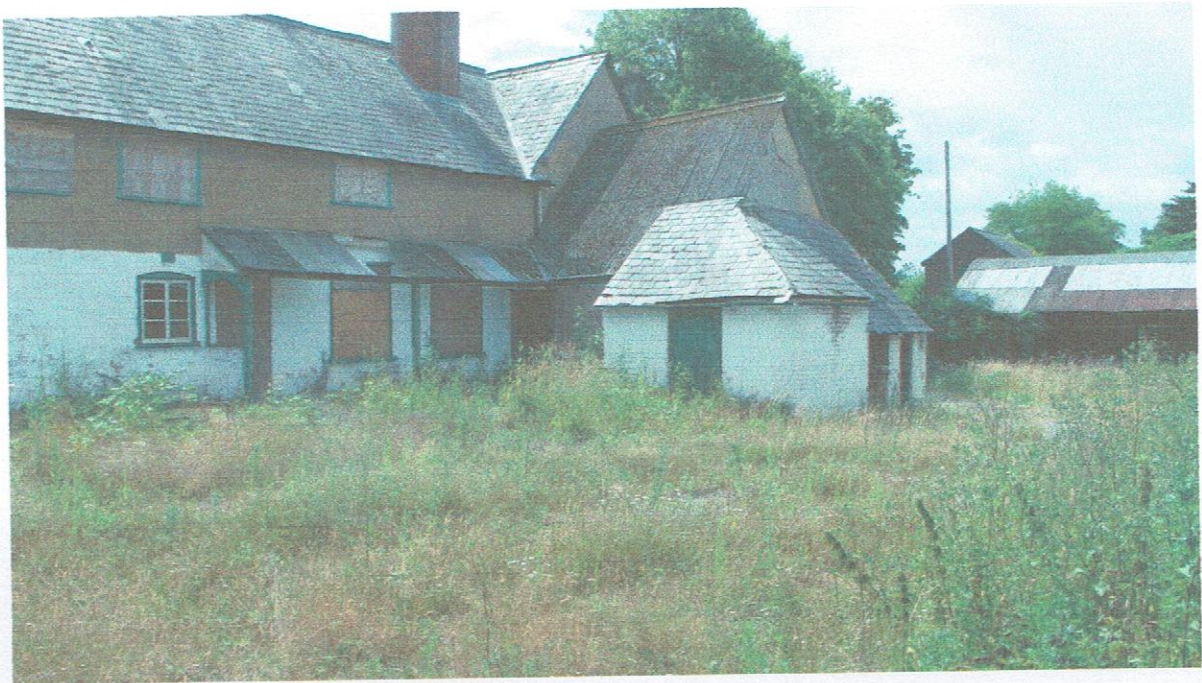
PHOTO No. 16 Building B9 rear with small out building with toilet and kitchen assumed access to basement  
no further access.
