# BS 5837 Arboricultural Report

& Impact Assessment

at  
**Land adjacent to Flint House  
North End  
SG8 9SD**

**Dated  
22<sup>nd</sup> March 2024**

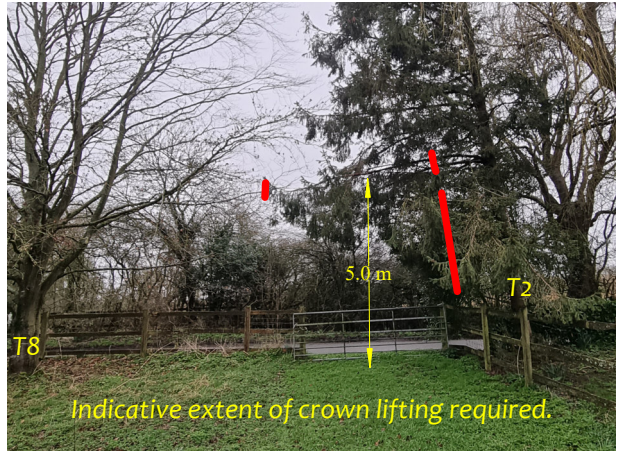
Clearance of 5m beneath the canopies of T2 and T8 will be required for construction vehicle access. Canopies should be neatly pruned to provide the required clearance to avoid any accidental damage to branches. Such pruning shall not have a significant impact on tree health.

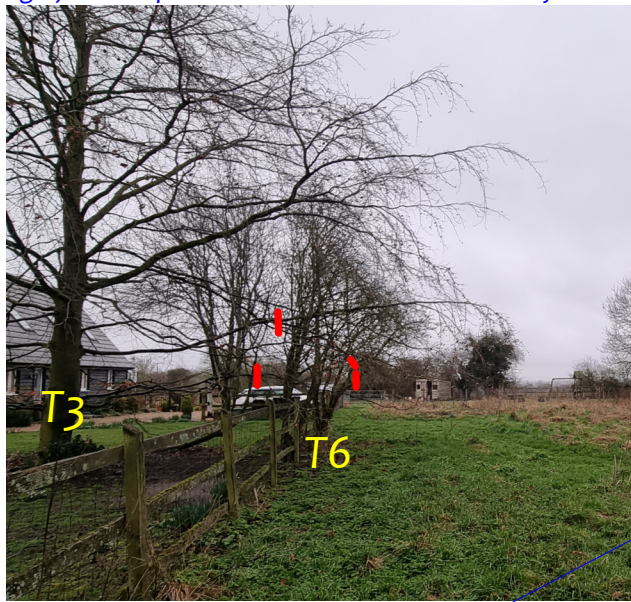
A portion of T6's RPA shall be affected by the proposed surface and its canopy requires pruning back towards the boundary fence to provide clearance for the installation of the garage. It is considered likely that the potential impact on this Elder is within tolerable limits. Hand tools only should be used for excavation in this area to a maximum depth of 150mm and a permeable surface installed.

Less than 8% of the RPA of T8 shall be affected by the proposed driveway. Such an incursion is considered to be relatively minor and is less than half of the maximum recommended limit of 20%, as per BS 5837. Furthermore, a permeable, resin-bound aggregate surface is proposed which shall ensure the roots are not starved of oxygen and rainwater.

In order to ensure minimal impact on RPAs when installing the new surface, the following restrictions are proposed:  
- Excavation depth limited to 150mm.  
- Excavation supervised by the project arborist.  
- 3D cellular confinement system installed to minimise soil compaction over the RPAs of T2 and T8.  
- Permeable surface installed.

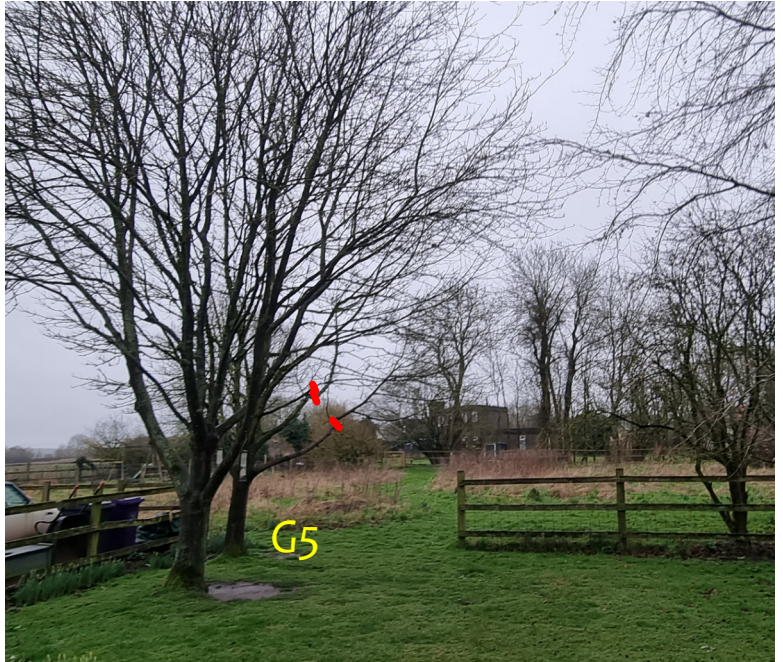
Canopy of G5 (closest to the garage) requires crown lifting to create clearance from the proposal. Only very small branches will require crown lifting to create a clearance height of 3m. Such pruning shall not have a significant impact on the trees health or amenity value.
