# Site Investigation Report

194196.1.USI

Auger were commissioned by Quadra to undertake a site investigation and CCTV inspection of the underground drainage within the area of concern (AOC) at the property.

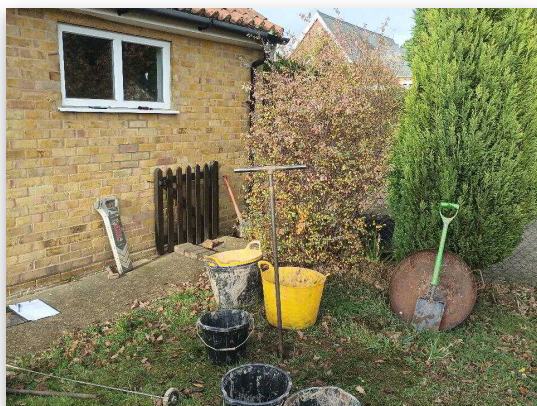
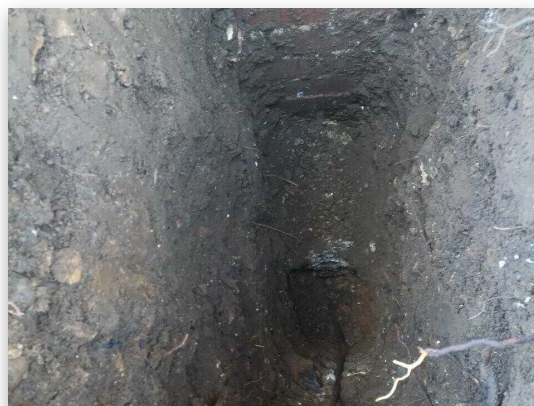
## Trial Hole 1

TH1 was undertaken in the desired location, we were able to expose the footings and we collected the requested soil and root samples. We were unable to reach the required depth in TH1 because we encountered impenetrable ground which our engineer could not auger through.

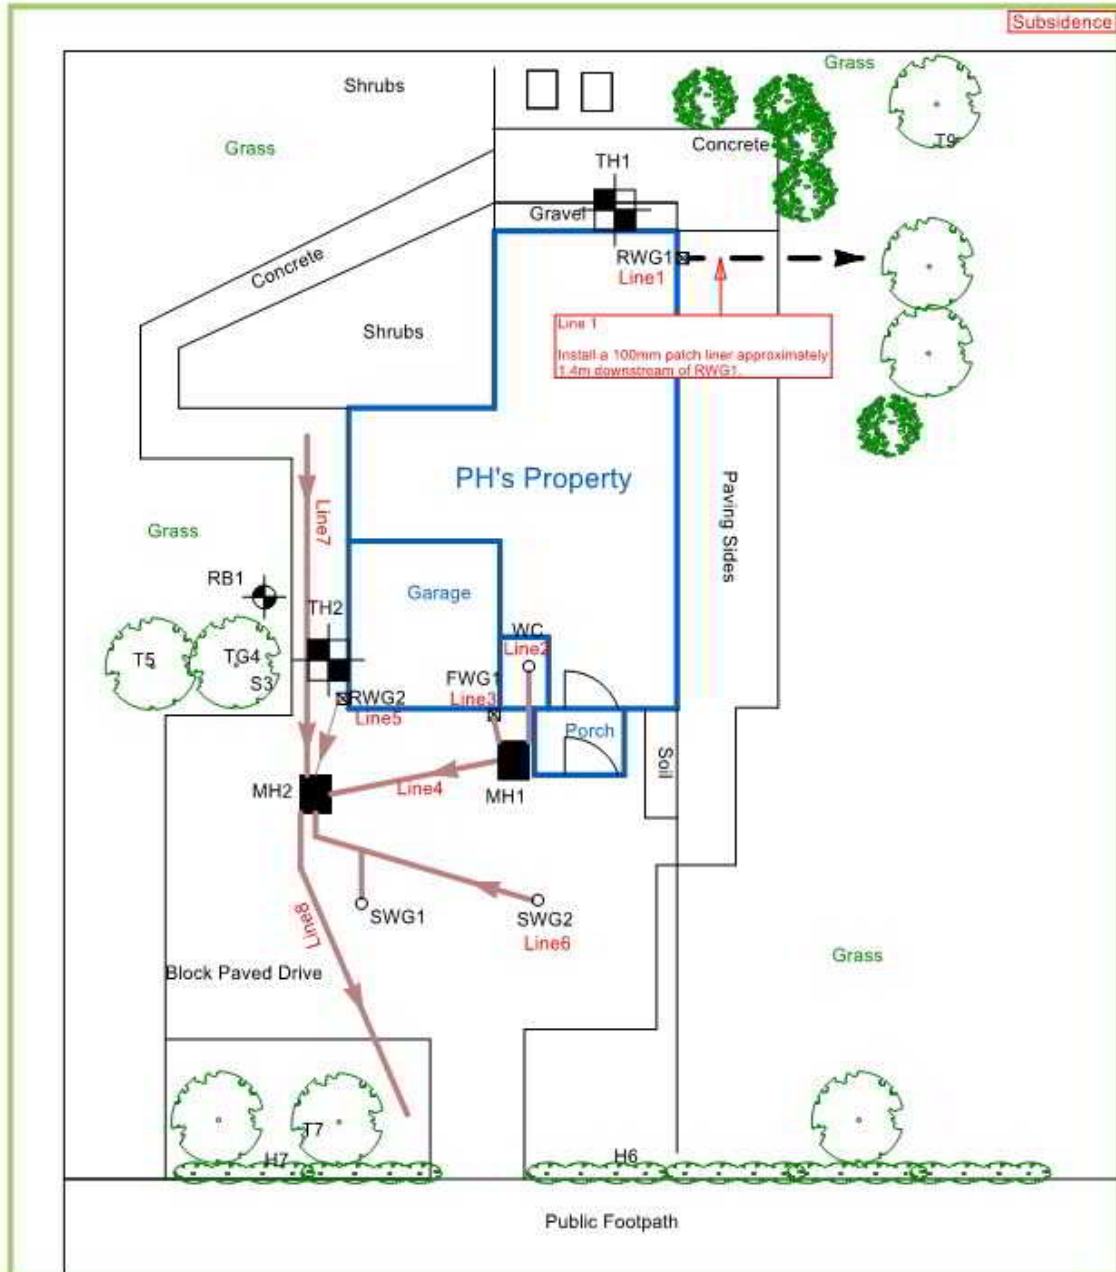
## Proposed Layout

Our survey of line 1 revealed cracking.

Line 1

Install a 100mm patch liner approximately 1.4m downstream of RWG1.

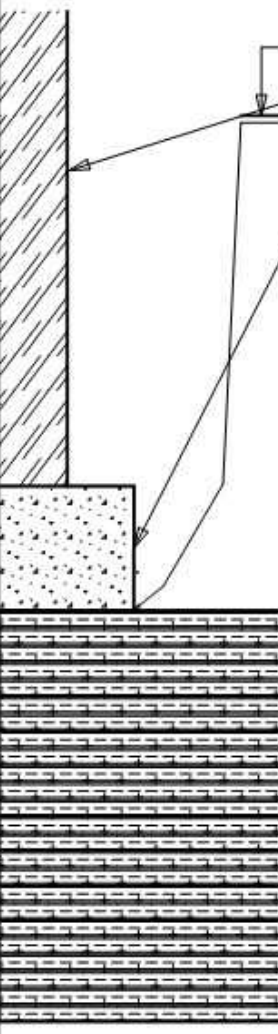
# Trial Hole Log No.1

| Depth<br>(m) | Symbolic Log | Strata Description | Insitu Tests | | Soil<br>Sample | Root<br>Sample |
|---|---|---|---|--|---|---|
| 1.5 | | Dry stiff brown fine to medium gravelly sandy silty CLAY | | | | |
| 2.0 | | Dry stiff brown fine to medium gravelly sandy CLAY | | | | |
| 2.5 | | TRIAL HOLE TERMINATED | | | | |
