# Arboricultural Subsidence Report

## SUBSIDENCE INVESTIGATION AT:

**4 Bury Lane  
Codicote  
Hitchin  
SG4 8XT**

| <b>Report Date:</b> | 09/01/2026 |

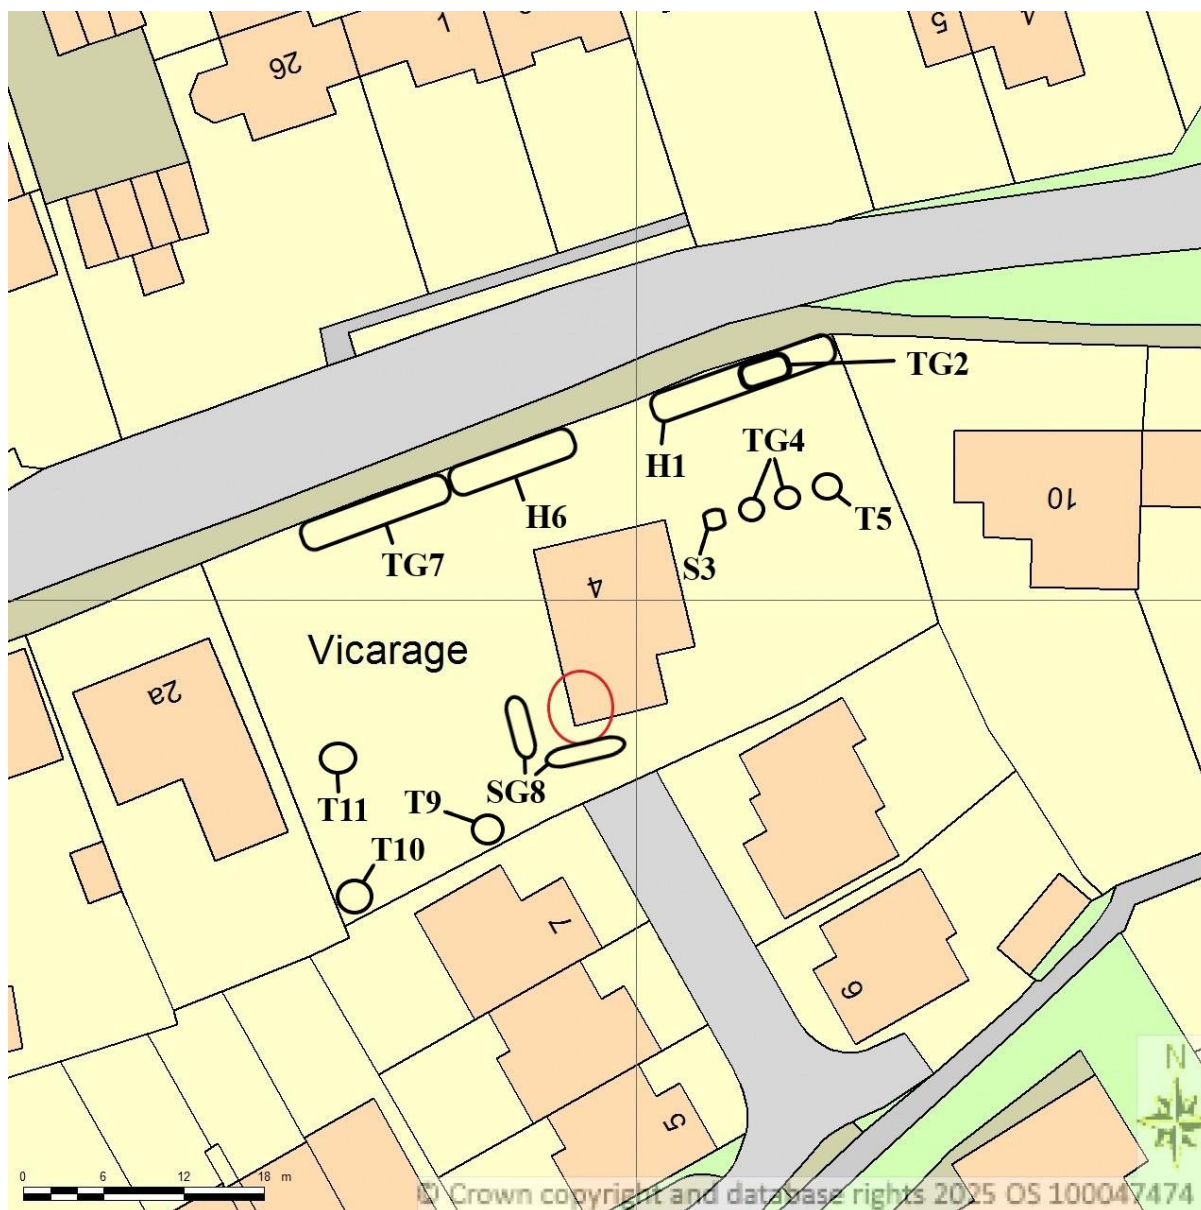
## Tree plan

Tree plan showing area of damage with red circle and location of neighbours as detailed below.

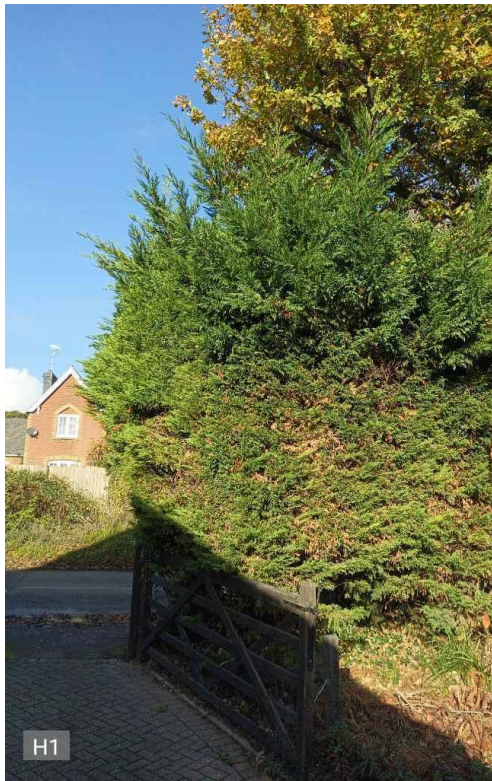
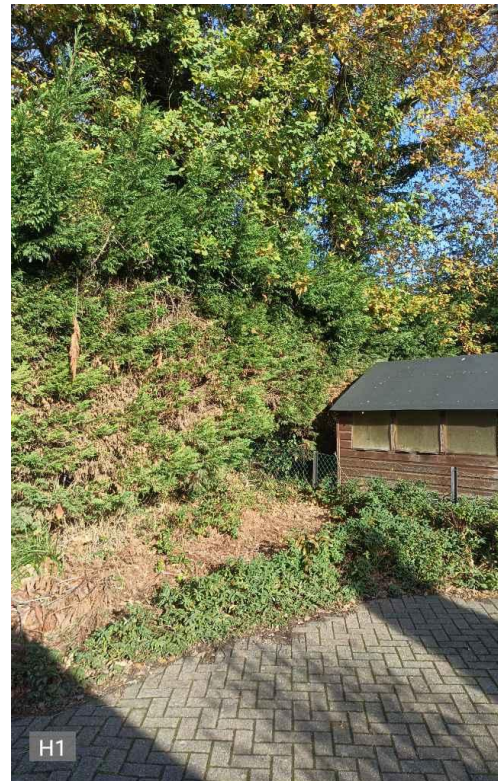
| Ref. | Species | Height (m) | Canopy radius (m) | DBH (cm)<br>No. of stems | Estimated age and Life stage | Distance to area of damage (m) | Tree owner/ location | Vitality, previous works, comments | TPO/ CA |
|---|---|---|---|---|---|---|---|---|---|
| H1 | Cypress | 3.8 | | | | 4.8 | Insured | Poor. Reduced High-water demand. | CA |

- Cypress (H1) has a high-water demand and is toward the maximum distance for damage in the C&R study.
- Oak (TG2) has a high-water demand and is within the 50% distance for damage in the C&R study.

| Ref. | Species & estimated age | Height DBH (m) | Dist. to area of damage (m) | Vitality & previous works | Tree owner/ location | Recommendation | TPO CA |
|---|---|---|---|---|---|---|---|
| H1 | Cypress | 3.8 | 4.8 | Poor Reduced | Insured | Remove stems within 6 metres of area of damage and maintain remainder at no greater than current size through regular pruning. | CA |

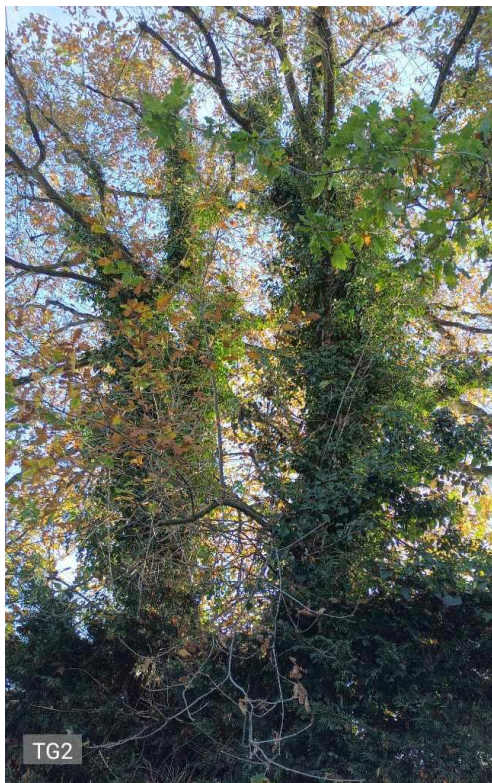
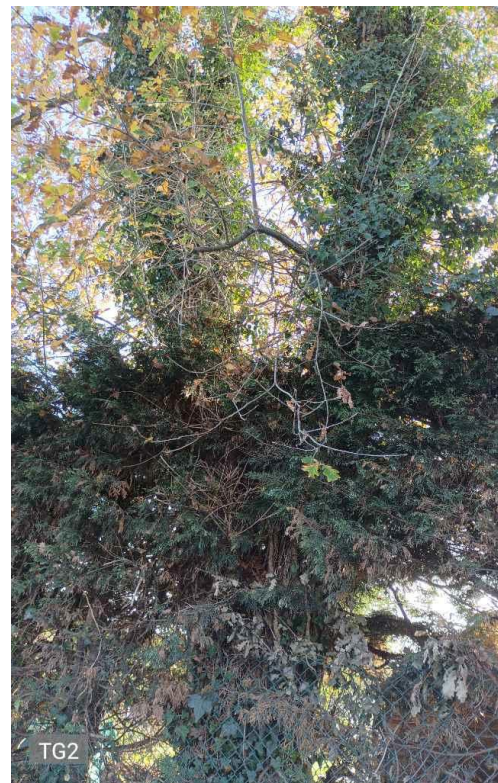
| Ref. | Species | Height (m) | Canopy radius (m) | DBH (cm)<br>No. of stems | Estimated age and Life stage | Distance to area of damage (m) | Tree owner/ location | Vitality, previous works, comments | TPO/ CA |
|---|---|---|---|---|---|---|---|---|---|
| TG2 | Oak | 15 | 3 | 100 # | 200 Mature | 9 | Insured | Good. High-water demand. | CA |

| Ref. | Species & estimated age | Height DBH (m) | Dist. to area of damage (m) | Vitality & previous works | Tree owner/ location | Recommendation | TPO CA |
|---|---|---|---|---|---|---|---|
| TG2 | Oak<br>200<br>Mature | 15<br>(1.00) | 9 | Good | Insured | Remove close to ground level and treat stumps with herbicide to inhibit regrowth. | CA |

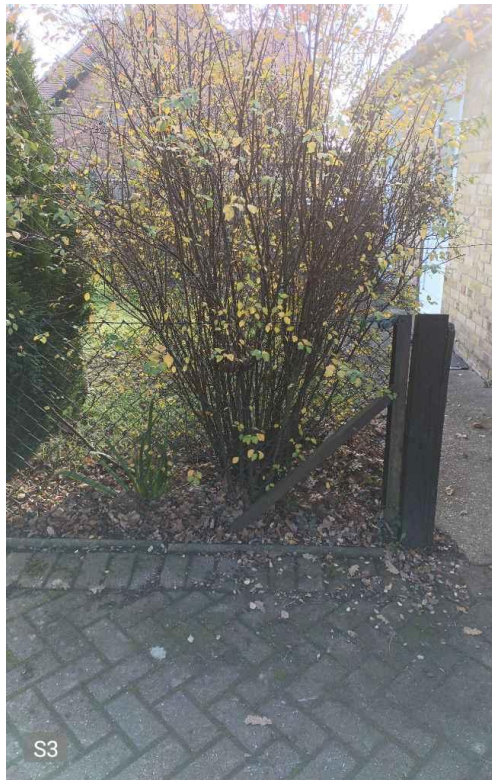
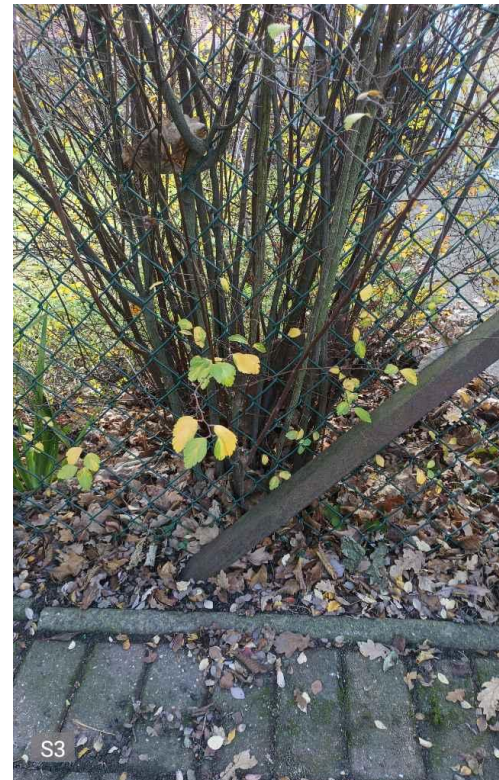
| Ref. | Species | Height (m) | Canopy radius (m) | DBH (cm)<br>No. of stems | Estimated age and Life stage | Distance to area of damage (m) | Tree owner/ location | Vitality, previous works, comments | TPO/ CA |
|---|---|---|---|---|---|---|---|---|---|
| S3 | Spirea | 2 | | | | 1.5 | Insured | Good. Moderate-water demand. | CA |

- Spirea (S3) is toward the outer limit of the zone of influence defined by NHBC.
- Cypress, Juniper (TG4) has a high-water demand and is within the 75% distance for damage in the C&R study.

| Ref. | Species & estimated age | Height DBH (m) | Dist. to area of damage (m) | Vitality & previous works | Tree owner/ location | Recommendation | TPO CA |
|---|---|---|---|---|---|---|---|
| S3 | Spirea | 2 | 1.5 | Good | Insured | Maintain at no greater than current size through periodic pruning. | CA |

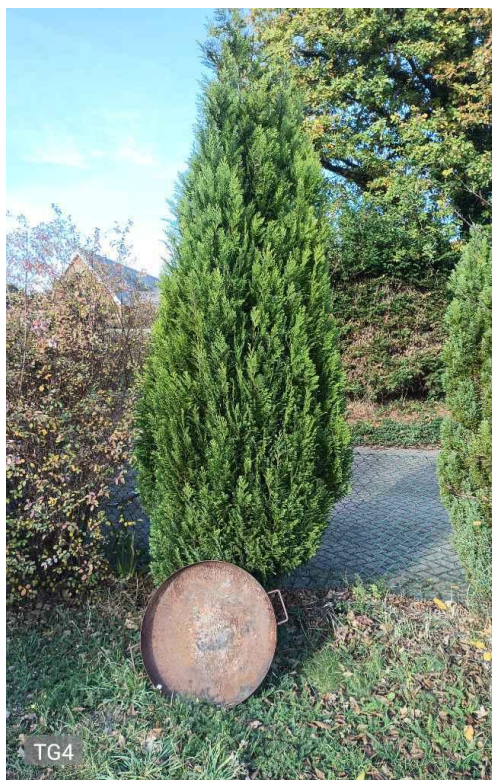
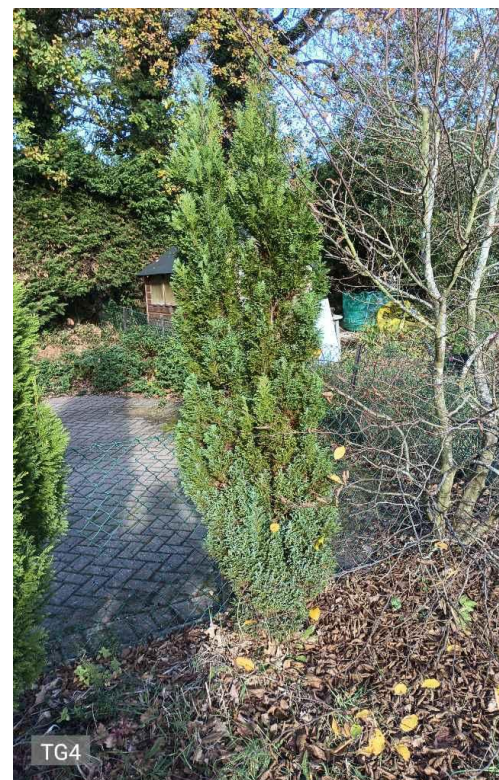
| Ref. | Species | Height (m) | Canopy radius (m) | DBH (cm)<br>No. of stems | Estimated age and Life stage | Distance to area of damage (m) | Tree owner/ location | Vitality, previous works, comments | TPO/ CA |
|---|---|---|---|---|---|---|---|---|---|
| TG4 | Cypress, Juniper | 3 | | 15 # | 30 Semi-mature | 3 | Insured | Good. High-water demand. | CA |

| Ref. | Species & estimated age | Height DBH (m) | Dist. to area of damage (m) | Vitality & previous works | Tree owner/ location | Recommendation | TPO CA |
|---|---|---|---|---|---|---|---|
| TG4 | Cypress,<br>Juniper<br>30<br>Semi-mature | 3<br>(0.15) | 3 | Good | Insured | Remove close to ground level. | CA |

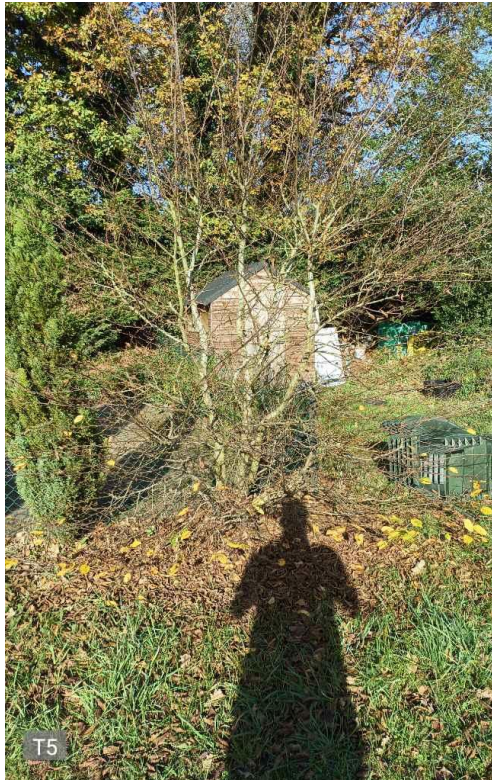
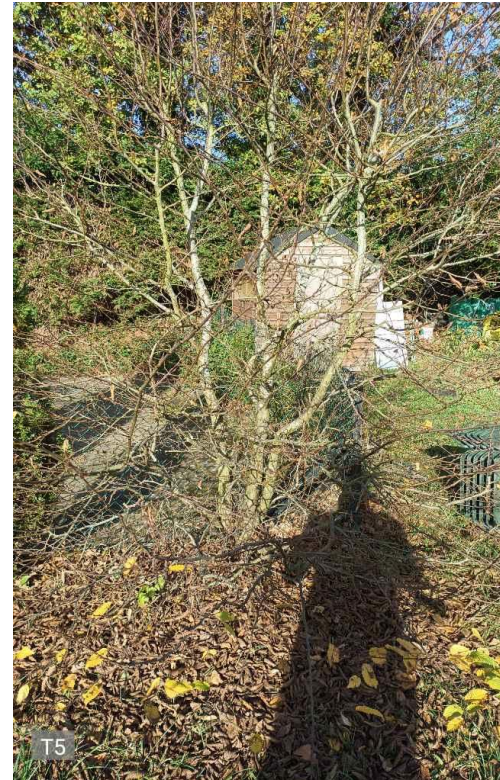
| Ref. | Species | Height (m) | Canopy radius (m) | DBH (cm)<br>No. of stems | Estimated age and Life stage | Distance to area of damage (m) | Tree owner/ location | Vitality, previous works, comments | TPO/ CA |
|---|---|---|---|---|---|---|---|---|---|
| T5 | Spirea | 3 | 1 | 10 #<br>3 | 15 | 5 | Insured | Good. Moderate-water demand. | CA |

- Spirea (T5) is unlikely to be of influence.
- Conifer (H6) has a high-water demand and is toward the maximum distance for damage in the C&R study.
- Oak, Laurel, Holly, Elder, Symphoricarpos, (TG7) has a high-water demand and is within the 75% distance for damage in the C&R study.

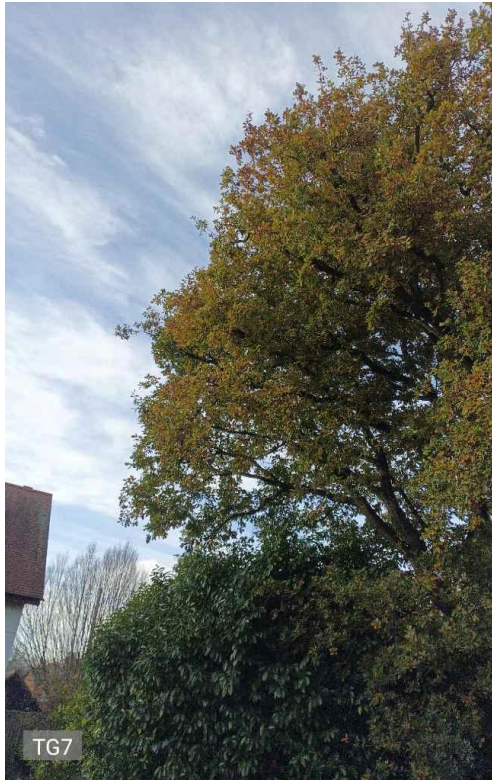
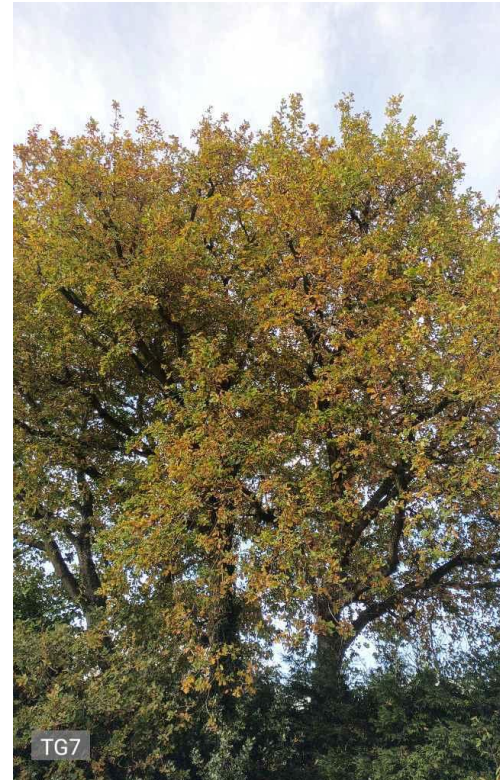
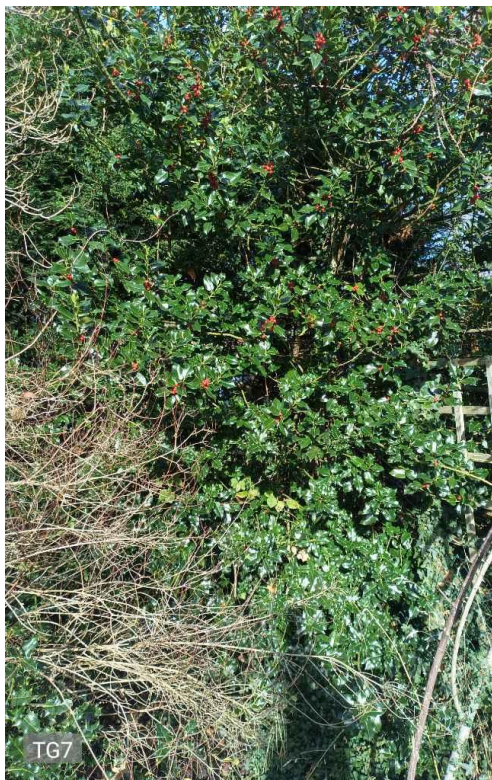
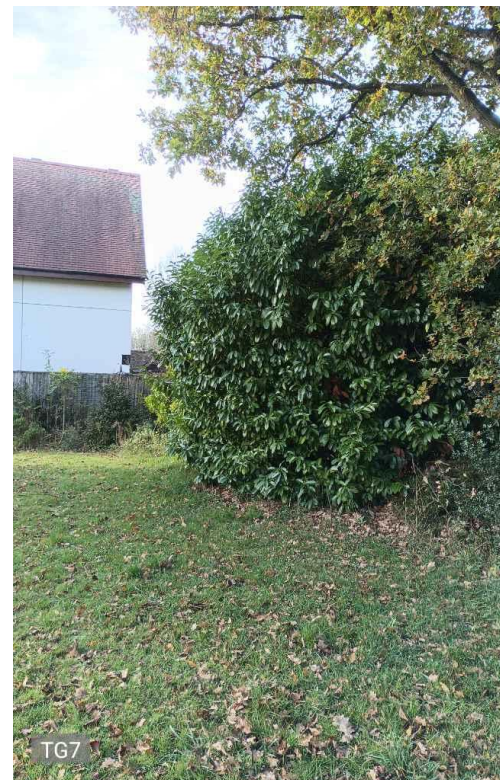
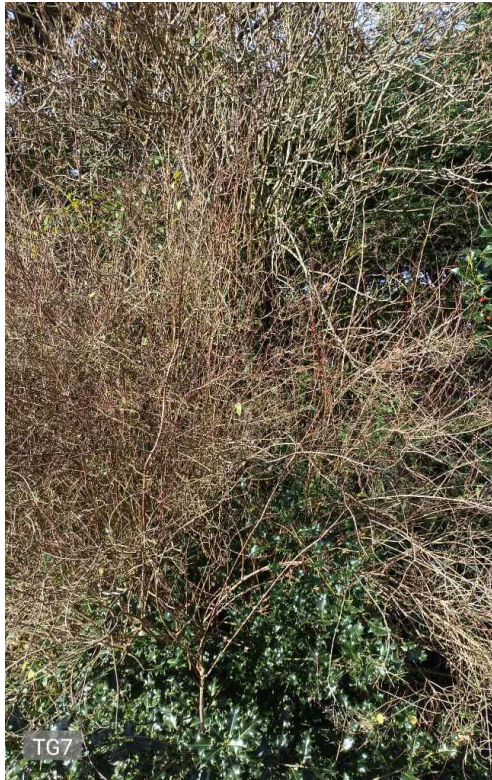
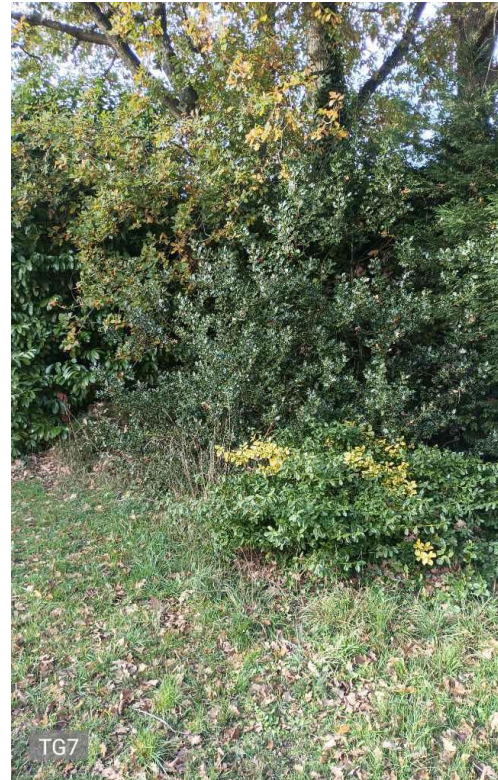
| Ref. | Species | Height (m) | Canopy radius (m) | DBH (cm)<br>No. of stems | Estimated age and Life stage | Distance to area of damage (m) | Tree owner/ location | Vitality, previous works, comments | TPO/ CA |
|---|---|---|---|---|---|---|---|---|---|
| TG7 | Oak, Laurel, Holly, Elder, Symphoricarpos, | 10 | 4 | 75 # | 160 Early-mature | 10 | Insured | Good. High-water demand. | CA |

| Ref. | Species & estimated age | Height DBH (m) | Dist. to area of damage (m) | Vitality & previous works | Tree owner/ location | Recommendation | TPO CA |
|---|---|---|---|---|---|---|---|
| TG7 | Oak, Laurel,<br>Holly, Elder,<br>Symphoricarpos,<br>160<br>Early-mature | 10<br>(0.75) | 10 | Good | Insured | Remove close to ground level and treat stumps with herbicide to inhibit regrowth. | CA |

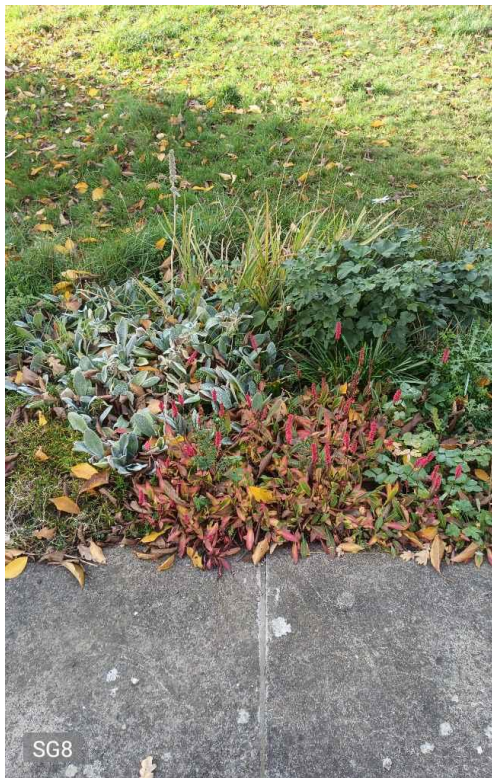
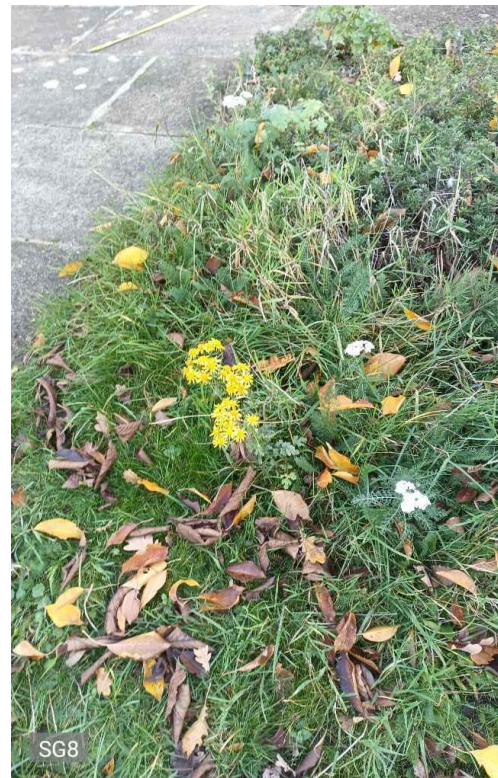
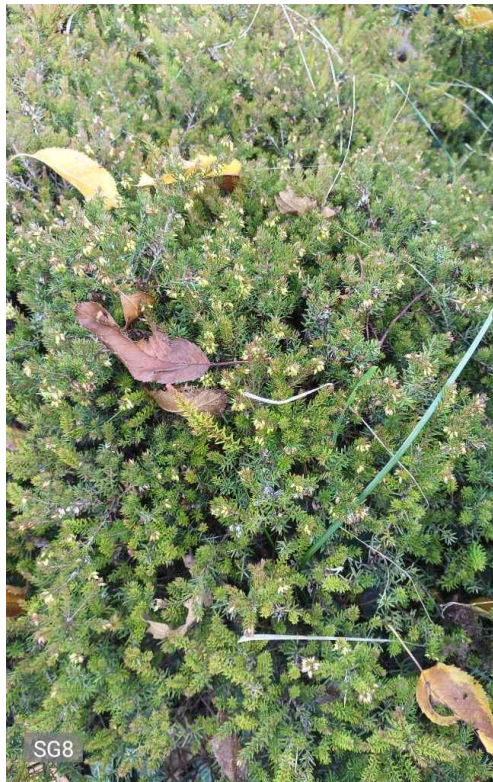
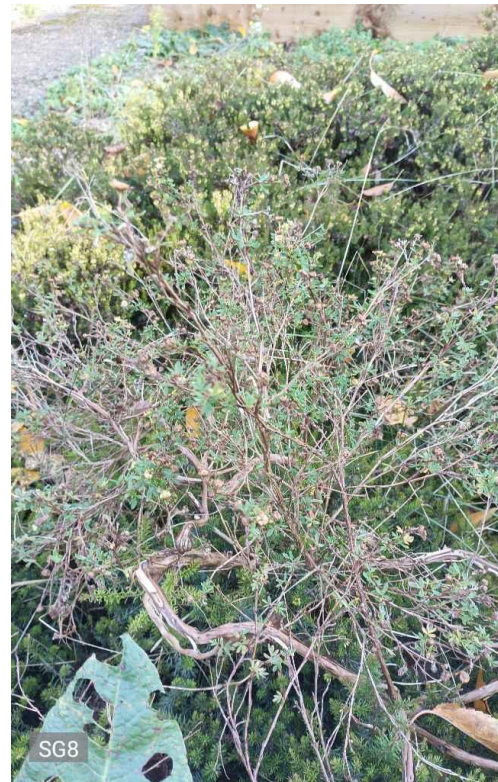
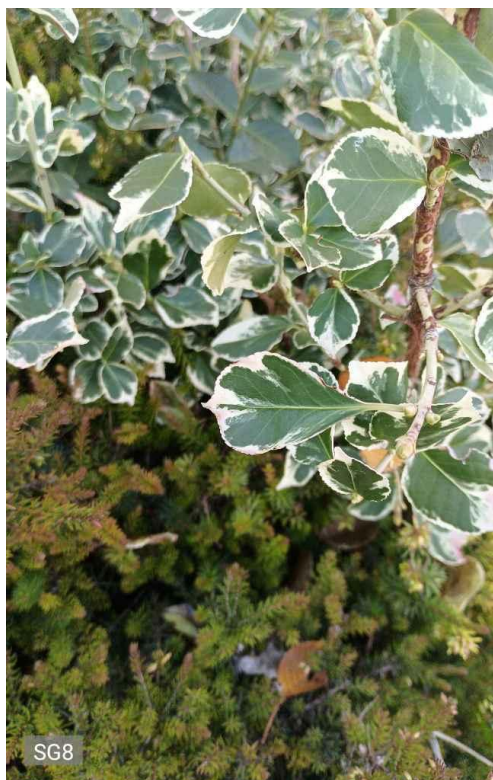
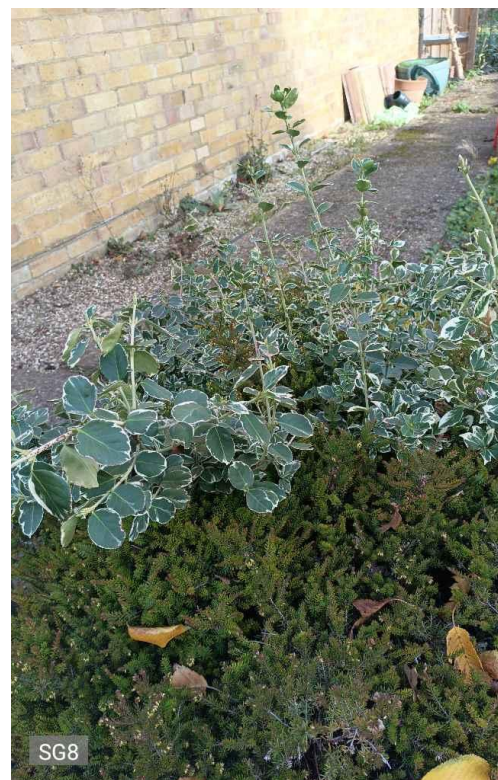
**SG8**

| Ref. | Species | Height (m) | Canopy radius (m) | DBH (cm)<br>No. of stems | Estimated age and Life stage | Distance to area of damage (m) | Tree owner/ location | Vitality, previous works, comments | TPO/ CA |
|---|---|---|---|---|---|---|---|---|---|
| SG8 | Euonymus, Erica, Mixed shrubs | 1.5 | | | | 1.3 | Insured | Good. Moderate-water demand. | CA |

- Euonymus, Erica, Mixed shrubs (SG8) is within 50% of the radius of influence defined by NHBC.
- Cherry (T9) is toward the maximum distance for damage in the C&R study. Laboratory analysis of the roots found below foundation depth during the site investigation identified them as Prunus spp.

| Ref. | Species & estimated age | Height DBH (m) | Dist. to area of damage (m) | Vitality & previous works | Tree owner/ location | Recommendation | TPO CA |
|---|---|---|---|---|---|---|---|
| SG8 | Eunonymus,<br>Erica, Mixed<br>shrubs | 1.5 | 1.3 | Good | Insured | Remove close to ground level and treat stumps with herbicide to inhibit regrowth. | CA |

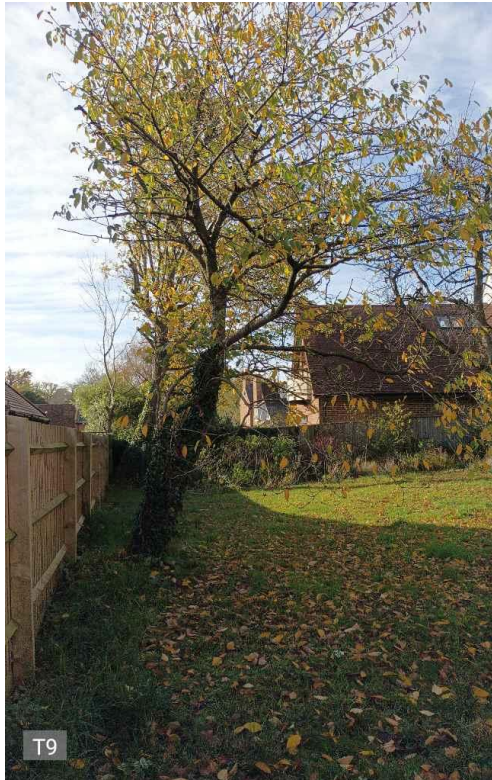
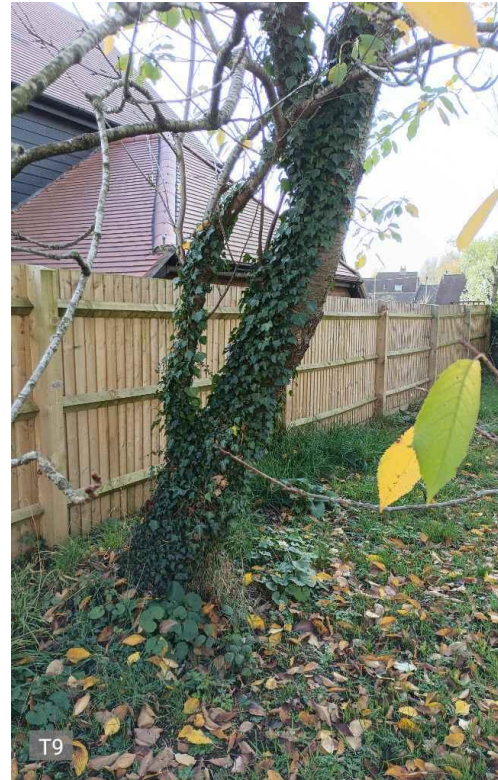
| Ref. | Species | Height (m) | Canopy radius (m) | DBH (cm)<br>No. of stems | Estimated age and Life stage | Distance to area of damage (m) | Tree owner/ location | Vitality, previous works, comments | TPO/ CA |
|---|---|---|---|---|---|---|---|---|---|
| T9 | Cherry | 3.5 | 4 | 35 #<br>2 | 50 Mature | 7 | Insured | Good. Regular pruning Moderate-water demand. | CA |

| Ref. | Species & estimated age | Height DBH (m) | Dist. to area of damage (m) | Vitality & previous works | Tree owner/ location | Recommendation | TPO CA |
|---|---|---|---|---|---|---|---|
| T9 | Cherry<br>50<br>Mature | 3.5<br>(0.35) | 7 | Good<br>Regular pruning | Insured | Remove close to ground level and treat stumps with herbicide to inhibit regrowth. | CA |

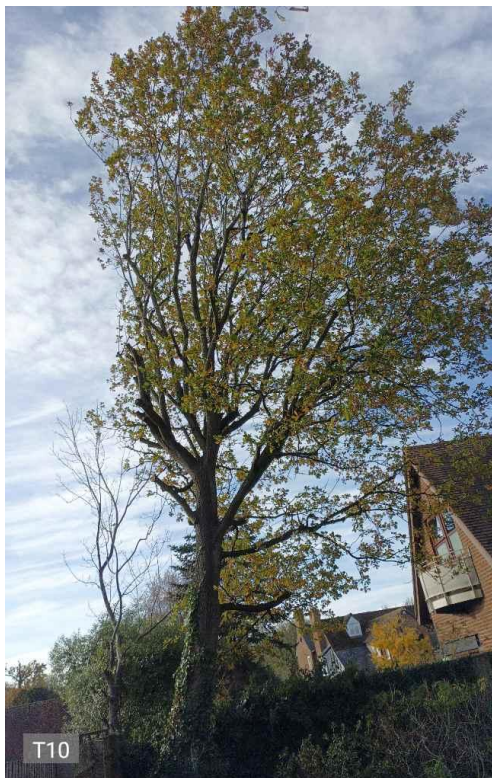
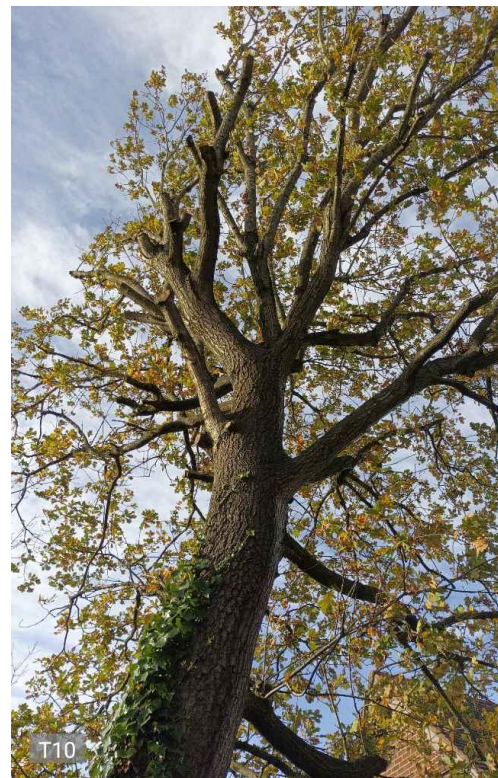
| Ref. | Species | Height (m) | Canopy radius (m) | DBH (cm)<br>No. of stems | Estimated age and Life stage | Distance to area of damage (m) | Tree owner/ location | Vitality, previous works, comments | TPO/ CA |
|---|---|---|---|---|---|---|---|---|---|
| T10 | Oak | 13 | 4.5 | 125 #<br>1 | 260 Mature | 18 # | Insured | Good. Regular pruning High-water demand. | CA |

- Oak (T10) has a high-water demand and is toward the maximum distance for damage in the C&R study.
- Cherry (T11) is unlikely to be of influence.
- At time of writing, no level monitoring reports were available to confirm seasonal movement therefore any recommendations to mitigate current or future risk are based on the limited data available.

| Ref. | Species & estimated age | Height DBH (m) | Dist. to area of damage (m) | Vitality & previous works | Tree owner/ location | Recommendation | TPO CA |
|---|---|---|---|---|---|---|---|
| T10 | Oak 260 Mature | 13 (1.25) | 18 # | Good Regular pruning | Insured | Maintain at no greater than current size through periodic pruning. | CA |

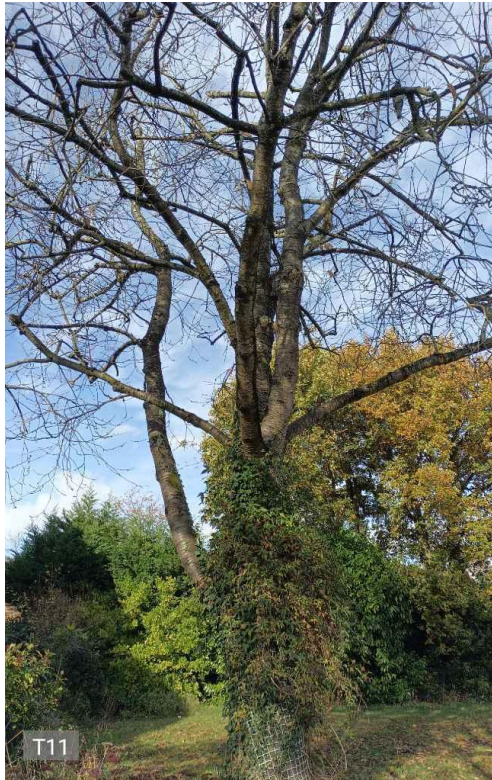
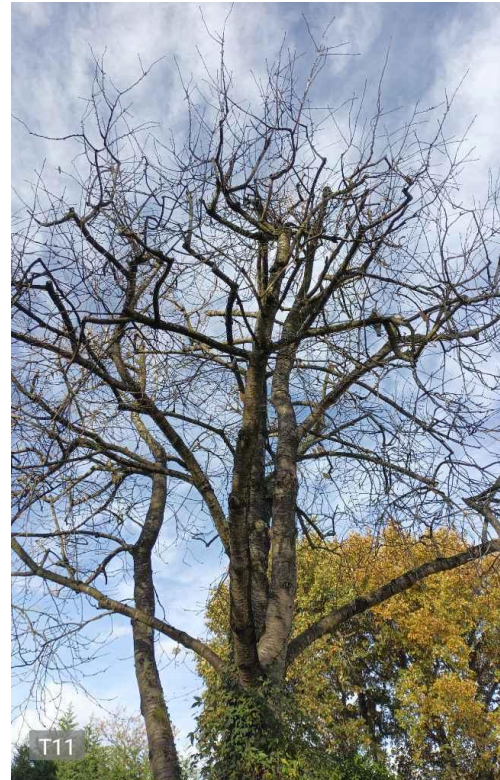
T11

| Ref. | Species | Height (m) | Canopy radius (m) | DBH (cm)<br>No. of stems | Estimated age and Life stage | Distance to area of damage (m) | Tree owner/ location | Vitality, previous works, comments | TPO/ CA |
|---|---|---|---|---|---|---|---|---|---|
| <b>T11</b> | Cherry | 7 | 3 | 50 #<br>2 | 80<br>Mature | 16 # | Insured | Good. Regular pruning<br>Moderate-water demand. | CA |
