Walnut Tree Farm  
Luffenhall  
Stevenage SG2 7PX

WINDOW DETAILS  
EXISTING & PROPOSED

20079-P005

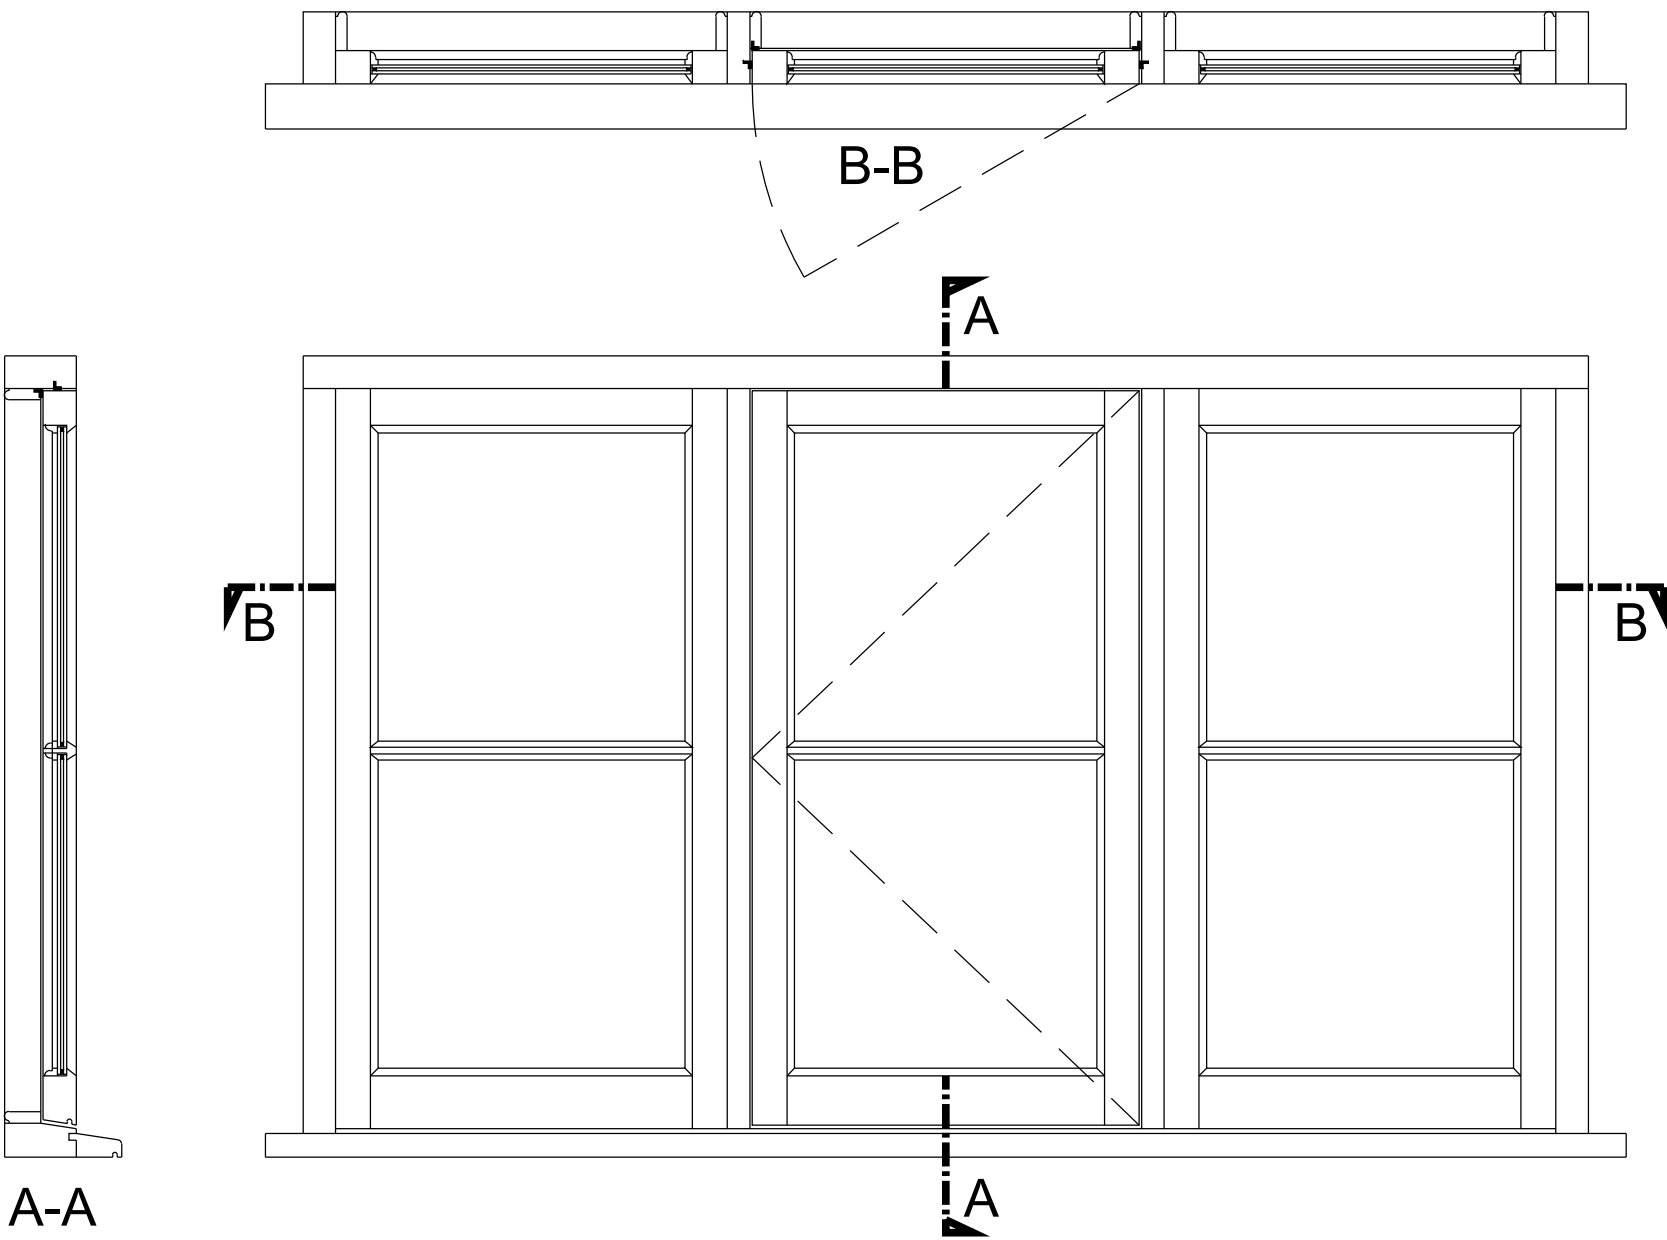
W1,W2,W3,W4,W5

This triple sash window shows a very high moisture content with failed glazing bars to the casement sashes resulting in moisture ingress over a long period of time resulting in the sash base rails cracking and softening particularly around the joints with distortion and loss of strength and discolouration of the exposed bear wood with some fungal growth which is a trait of “wet rot”. The cill also has been affected in the same way it would not be possible to patch repair the affected areas at the structural integrity of the window has been compromised. We recommend replacement of this window as the most cost-effective long-term solution.

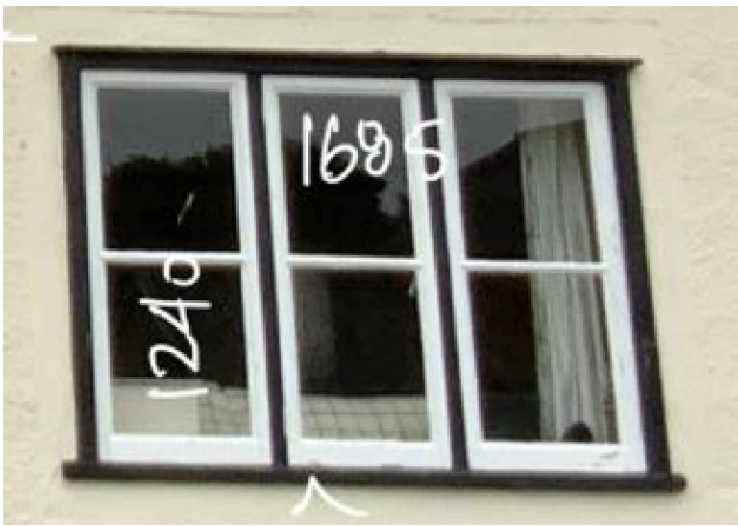
## Window 1

This triple sash window shows a very high moisture content with failed glazing bars to the casement sashes resulting in moisture ingress over a long period of time resulting in the sash base rails cracking and softening particularly around the joints with distortion and loss of strength and discolouration of the exposed bear wood with some fungal growth which is a trait of “wet rot”. The cill also has been affected in the same way it would not be possible to patch repair the affected areas at the structural integrity of the window has been compromised. We recommend replacement of this window as the most cost-effective long-term solution.

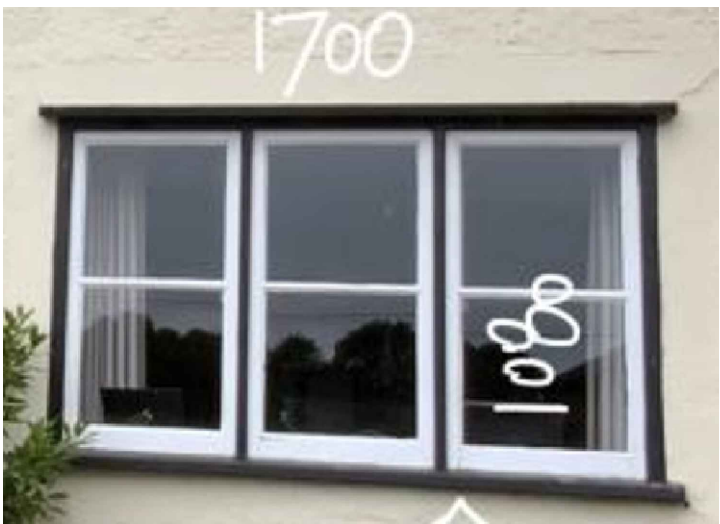
## Window 2

This triple sash window shows a very high moisture content with failed glazing bars to the casement sashes resulting in moisture ingress over a long period of time resulting in the sash base rails cracking and softening particularly around the joints with distortion and loss of strength and discolouration of the exposed bear wood with some fungal growth which is a trait of “wet rot”. The cill also has been affected in the same way it would not be possible to patch repair the affected areas at the structural integrity of the window has been compromised. We recommend replacement of this window as the most cost-effective long-term solution.

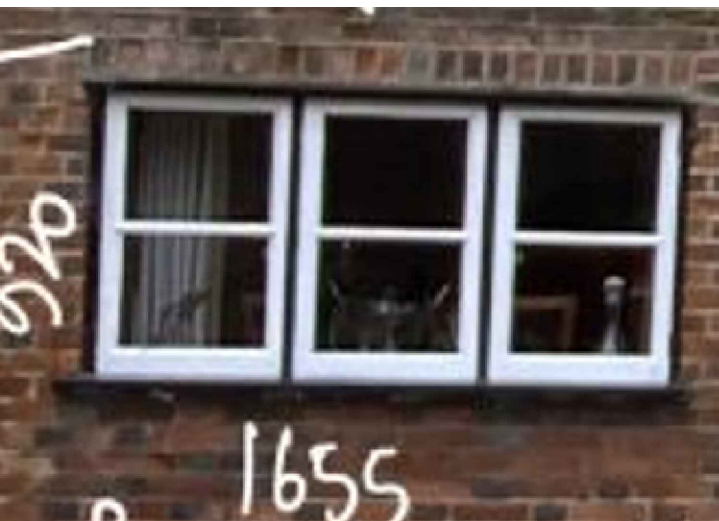
## Window 3

This triple casement style window shows a very high moisture content with loose failed putties to the casement sashes resulting in moisture ingress over a long period of time resulting in the sash base rails cracking and softening particularly around the joints with distortion and loss of strength and discolouration of the exposed bear wood with some fungal growth which is a trait of “wet rot”. The cill also has been affected in the same way it would not be possible to patch repair the affected areas at the structural integrity of the window has been compromised. We recommend replacement of this window as the most cost-effective long-term solution.

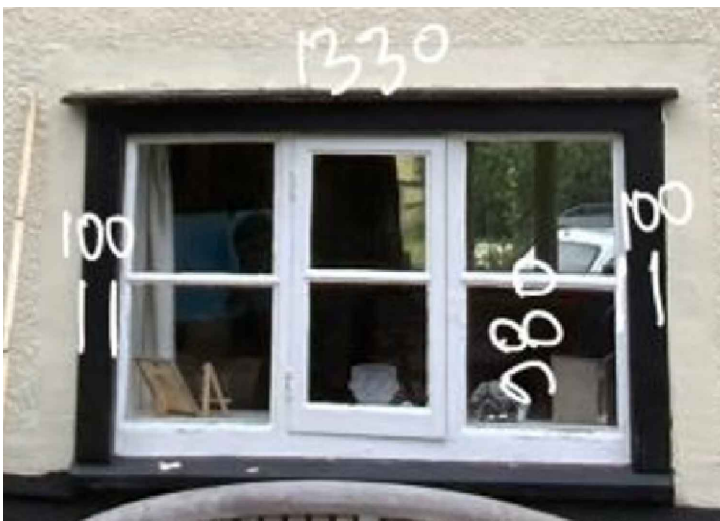
## Window 4

This triple casement style window shows a very high moisture content with loose failed putties to the casement sashes resulting in moisture ingress over a long period of time resulting in the sash base rails cracking and softening particularly around the joints with distortion and loss of strength and discolouration of the exposed bear wood with some fungal growth which is a trait of “wet rot”. The cill also has been affected in the same way it would not be possible to patch repair the affected areas at the structural integrity of the window has been compromised. We recommend replacement of this window as the most cost-effective long-term solution.
