**W9,W10,W11,W12,W13,W14,W15**

| Project | Walnut Tree Farm<br>Luffenhall<br>Stevenage SG2 7PX |
| Drawing | WINDOW DETAILS<br>EXISTING & PROPOSED |

20079-P007

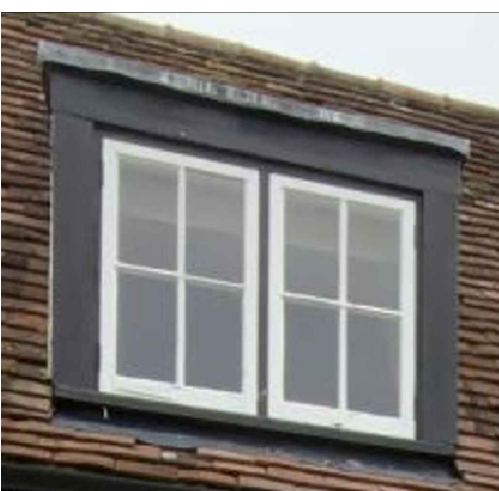
## Window 12

This double sash dual opening window which forms the fenestration to a historic dormer window as with the aforementioned windows this has with loose failed putties to the casement sashes resulting in moisture ingress over a long period of time resulting in the sash base rails cracking and softening particularly around the joints with distortion and loss of strength and discolouration of the exposed bear wood with some fungal growth which is a trait of “wet rot”. The cill also has been affected in the same way it would not be possible to patch repair the affected areas at the structural integrity of the window has been compromised, it’s worth noting that the window frame forms part of the support for the dormer flat roof. We recommend replacement of this window as the most cost-effective long-term solution as this window provides support to the dormer flat roof.

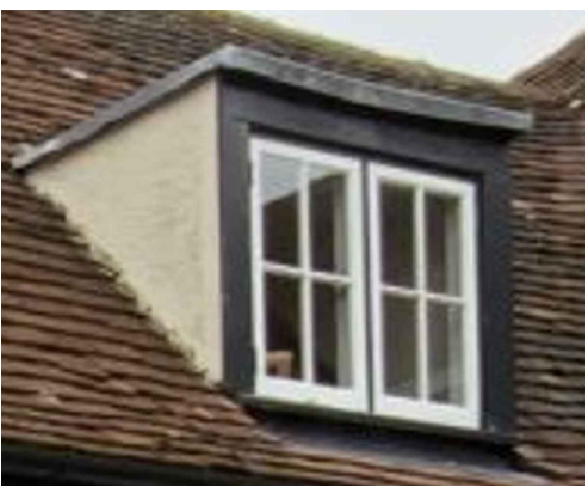
## Window 14

This double sash dual opening window which forms the fenestration to a historic dormer window as with the aforementioned windows this has with loose failed putties to the casement sashes resulting in moisture ingress over a long period of time resulting in the sash base rails cracking and softening particularly around the joints with distortion and loss of strength and discolouration of the exposed bear wood with some fungal growth which is a trait of “wet rot”. The cill also has been affected in the same way it would not be possible to patch repair the affected areas at the structural integrity of the window has been compromised, it’s worth noting that the window frame forms part of the support for the dormer flat roof. We recommend replacement of this window as the most cost-effective long-term solution as this window provides support to the dormer flat roof.

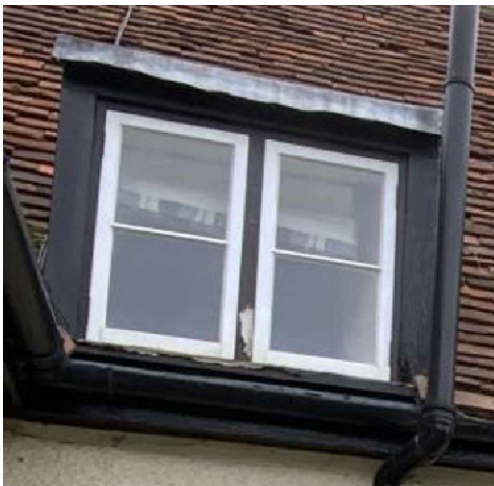
## Window 9

This double sash dual opening window which forms the fenestration to a historic dormer window as with the aforementioned windows this has with loose failed putties to the casement sashes resulting in moisture ingress over a long period of time resulting in the sash base rails cracking and softening particularly around the joints with distortion and loss of strength and discolouration of the exposed bear wood with some fungal growth which is a trait of "wet rot". The cill also has been affected in the same way it would not be possible to patch repair the affected areas at the structural integrity of the window has been compromised, it's worth noting that the window frame forms part of the support for the dormer flat roof. We recommend replacement of this window as the most cost-effective long-term solution as this window provides support to the dormer flat roof.

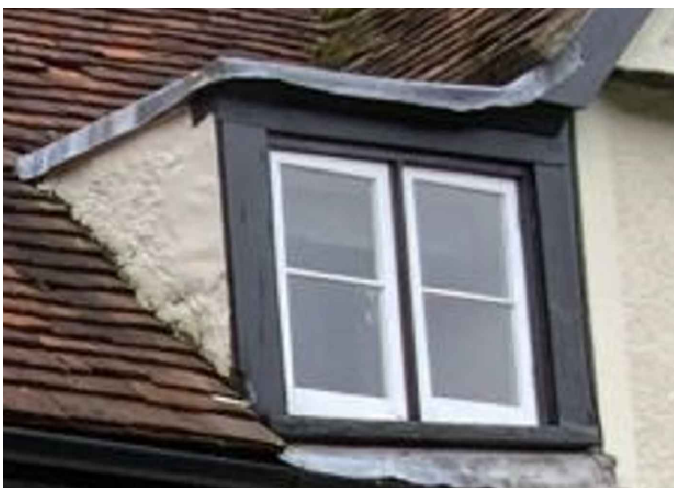
# Window 10

This double casement style window shows a very high moisture content with loose failed putties to the casement sashes resulting in moisture ingress over a long period of time resulting in the sash base rails cracking and softening particularly around the joints with distortion and loss of strength and discolouration of the exposed bear wood with some fungal growth which is a trait of “wet rot”. The cill also has been affected in the same way it would not be possible to patch repair the affected areas at the structural integrity of the window has been compromised. We recommend replacement of this window as the most cost-effective long-term solution.

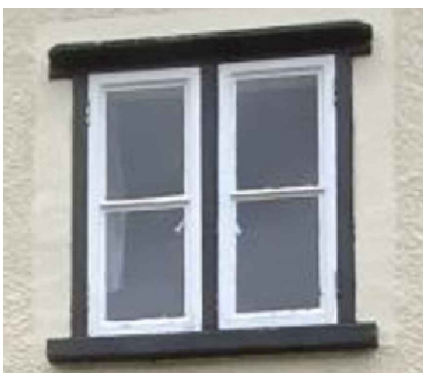
## Window 11

This double casement style window shows a very high moisture content with loose failed putties to the casement sashes resulting in moisture ingress over a long period of time resulting in the sash base rails cracking and softening particularly around the joints with distortion and loss of strength and discolouration of the exposed bear wood with some fungal growth which is a trait of “wet rot”. The cill also has been affected in the same way it would not be possible to patch repair the affected areas at the structural integrity of the window has been compromised. We recommend replacement of this window as the most cost-effective long-term solution.

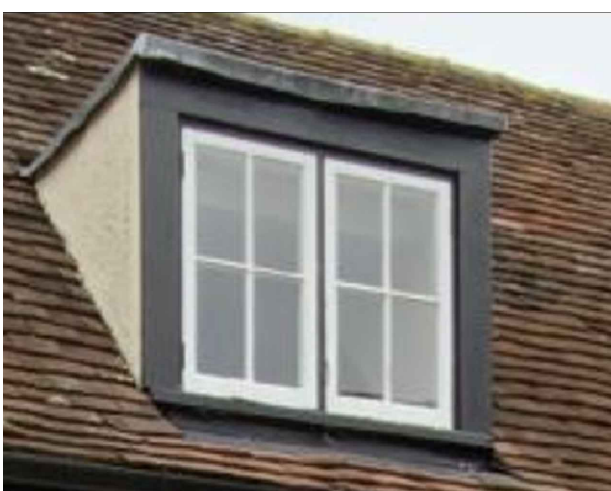
## Window 13

This double sash dual opening window which forms the fenestration to a historic dormer window as with the aforementioned windows this has with loose failed putties to the casement sashes resulting in moisture ingress over a long period of time resulting in the sash base rails cracking and softening particularly around the joints with distortion and loss of strength and discolouration of the exposed bear wood with some fungal growth which is a trait of "wet rot". The cill also has been affected in the same way it would not be possible to patch repair the affected areas at the structural integrity of the window has been compromised, it's worth noting that the window frame forms part of the support for the dormer flat roof. We recommend replacement of this window as the most cost-effective long-term solution as this window provides support to the dormer flat roof.

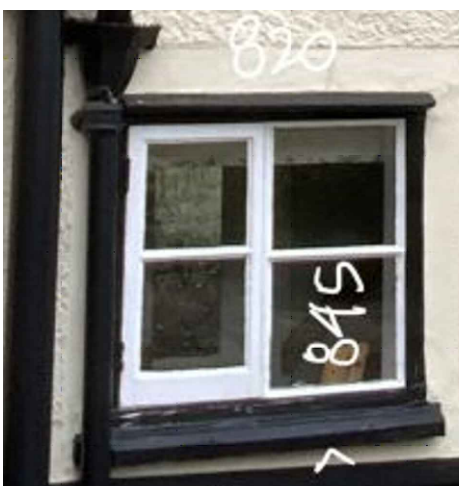
## Window 15

This double sash dual opening window which forms the fenestration to a historic dormer window as with the aforementioned windows this has with loose failed putties to the casement sashes resulting in moisture ingress over a long period of time resulting in the sash base rails cracking and softening particularly around the joints with distortion and loss of strength and discolouration of the exposed bear wood with some fungal growth which is a trait of “wet rot”. The cill also has been affected in the same way it would not be possible to patch repair the affected areas at the structural integrity of the window has been compromised, it’s worth noting that the window frame forms part of the support for the dormer flat roof. We recommend replacement of this window as the most cost-effective long-term solution as this window provides support to the dormer flat roof.
