WALNUT TREE FARM  
LUFFENHALL  
STEVENAGE SG2 7PX

WINDOW DETAILS  
EXISTING & PROPOSED

20079-P008

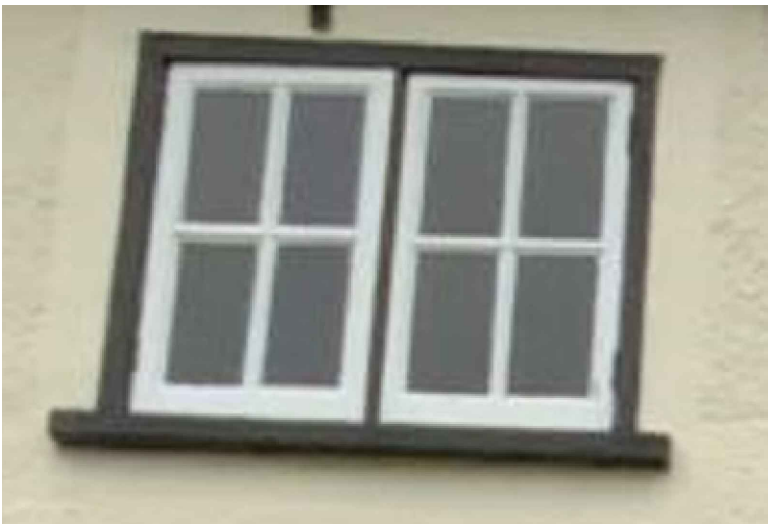
Window 16

This double casement style window shows a very high moisture content with loose failed putties to the casement sashes resulting in moisture ingress over a long period of time resulting in the sash base rails cracking and softening particularly around the joints with distortion and loss of strength and discolouration of the exposed bear wood with some fungal growth which is a trait of “wet rot”. The cill also has been affected in the same way it would not be possible to patch repair the affected areas at the structural integrity of the window has been compromised. We recommend replacement of this window as the most cost-effective long-term solution.

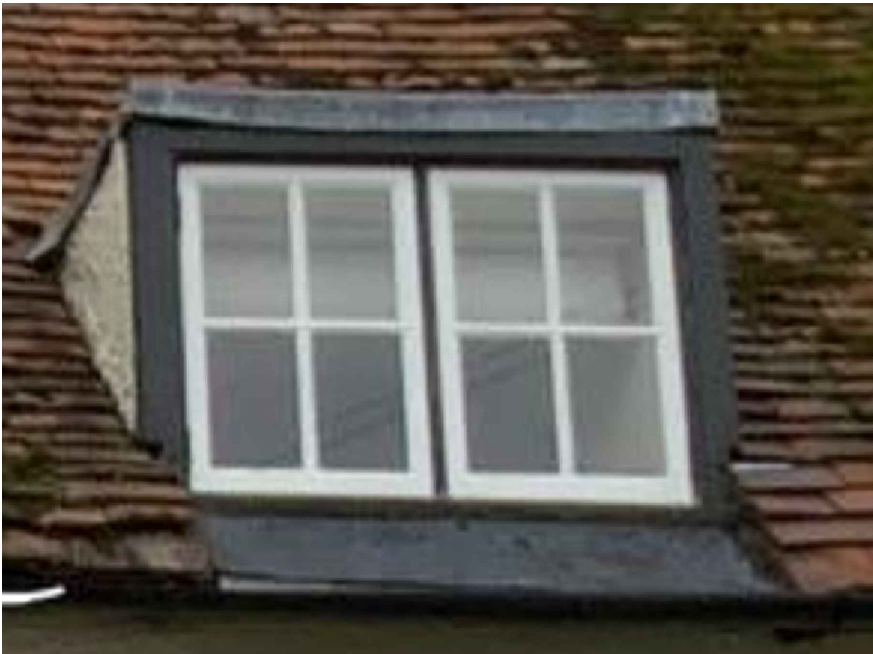
Window 17

This double sash dual opening window which forms the fenestration to a historic dormer window as with the aforementioned windows this has with loose failed putties to the casement sashes resulting in moisture ingress over a long period of time resulting in the sash base rails cracking and softening particularly around the joints with distortion and loss of strength and discolouration of the exposed bear wood with some fungal growth which is a trait of “wet rot”. The cill also has been affected in the same way it would not be possible to patch repair the affected areas at the structural integrity of the window has been compromised, it's worth noting that the window frame forms part of the support for the dormer flat roof. We recommend replacement of this window as the most cost-effective long-term solution as this window provides support to the dormer flat roof.

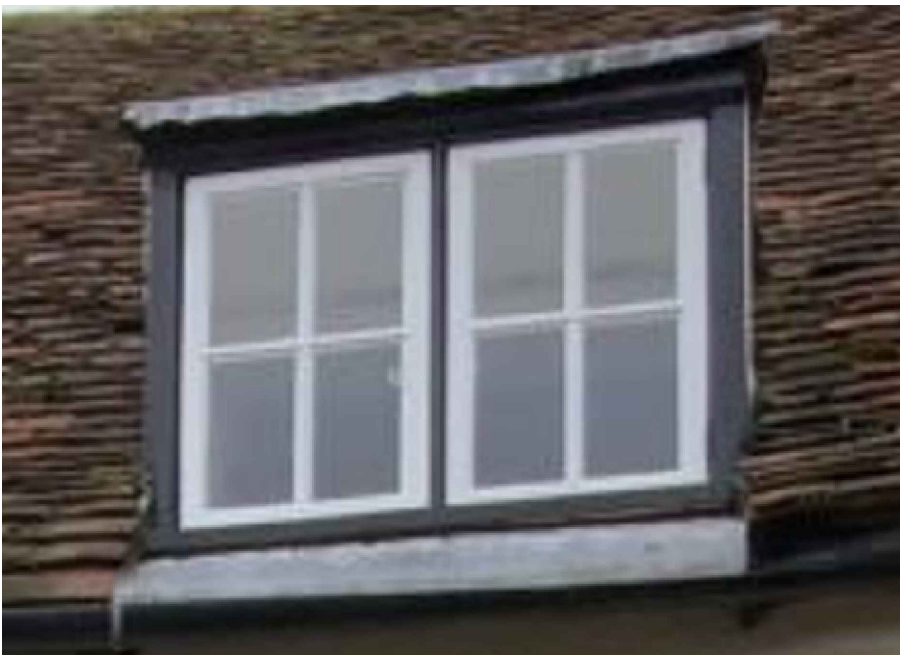
Window 18

This double sash dual opening window which forms the fenestration to a historic dormer window as with the aforementioned windows this has with loose failed putties to the casement sashes resulting in moisture ingress over a long period of time resulting in the sash base rails cracking and softening particularly around the joints with distortion and loss of strength and discolouration of the exposed bear wood with some fungal growth which is a trait of “wet rot”. The cill also has been affected in the same way it would not be possible to patch repair the affected areas at the structural integrity of the window has been compromised, it's worth noting that the window frame forms part of the support for the dormer flat roof. We recommend replacement of this window as the most cost-effective long-term solution as this window provides support to the dormer flat roof.

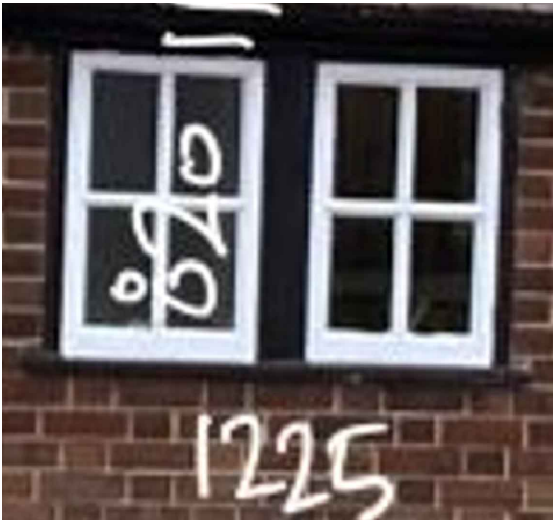
Window 19

This double casement style window shows a very high moisture content with loose failed putties to the casement sashes resulting in moisture ingress over a long period of time resulting in the sash base rails cracking and softening particularly around the joints with distortion and loss of strength and discolouration of the exposed bear wood with some fungal growth which is a trait of “wet rot”. The cill also has been affected in the same way it would not be possible to patch repair the affected areas at the structural integrity of the window has been compromised. We recommend replacement of this window as the most cost-effective long-term solution.
