## **STRUCTURAL REPORT**

**TEMPLE DINSLEY  
PRESTON, HITCHIN  
(Our Job No: CE24/4030)**

**Date: REV A. MAY 2024**

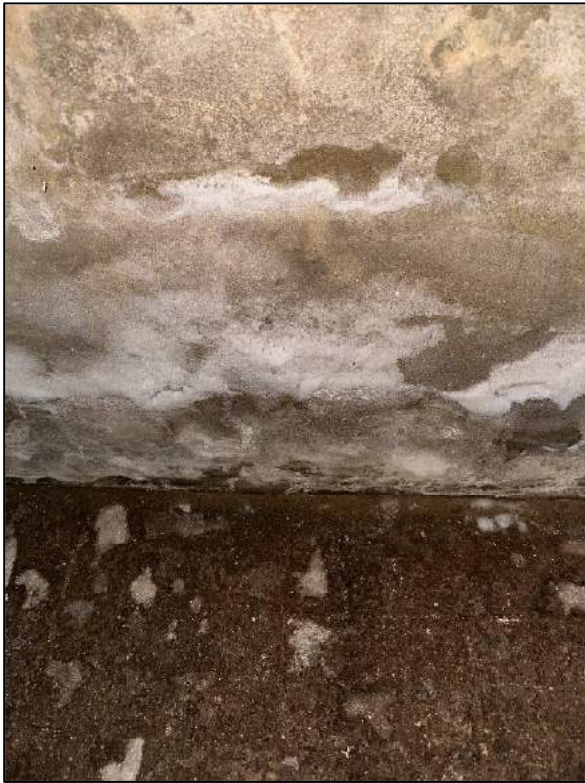
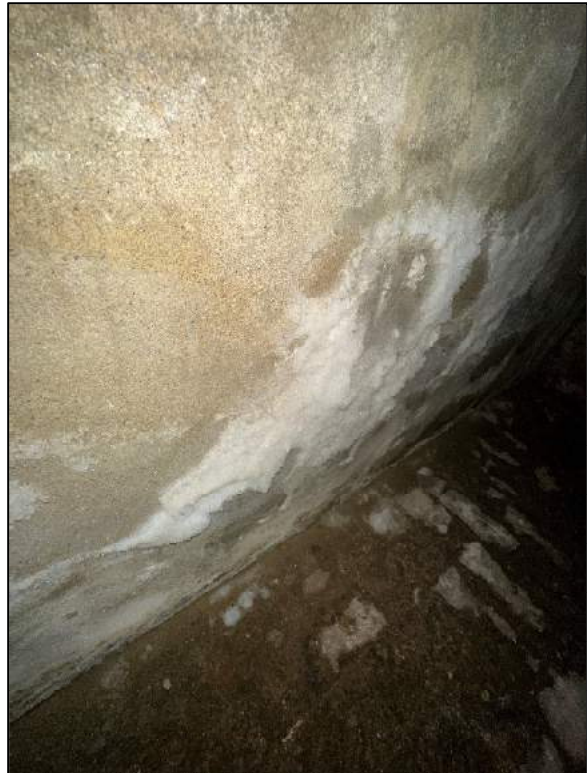
**Photograph 1 (Ref: 4.1.4)**

- 4.1.3 The proposals are to convert to domestic private accommodation. The proposals, where possible limit the amendments to any historic fabric.
- 4.1.4 The basement structure appeared structurally sound with only minor areas of damp and signs of efflorescence. See photographs 1 & 2.

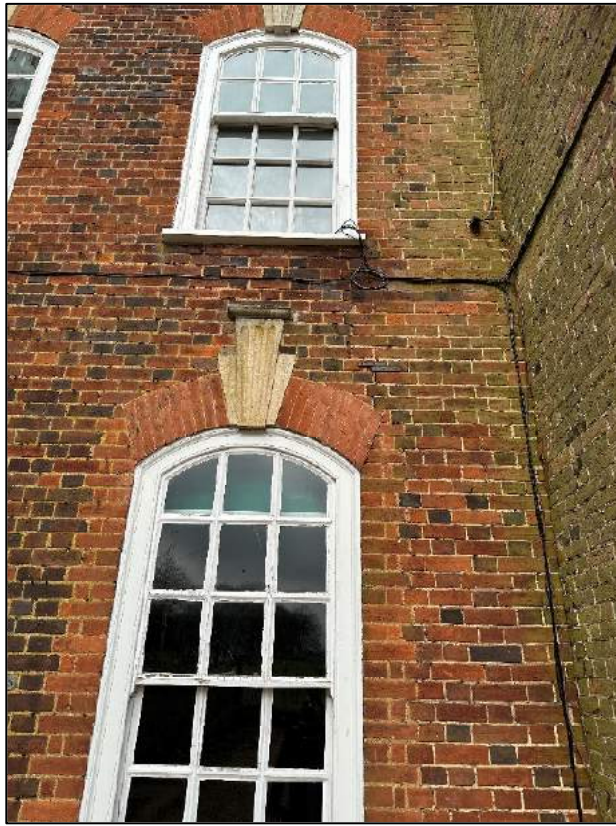
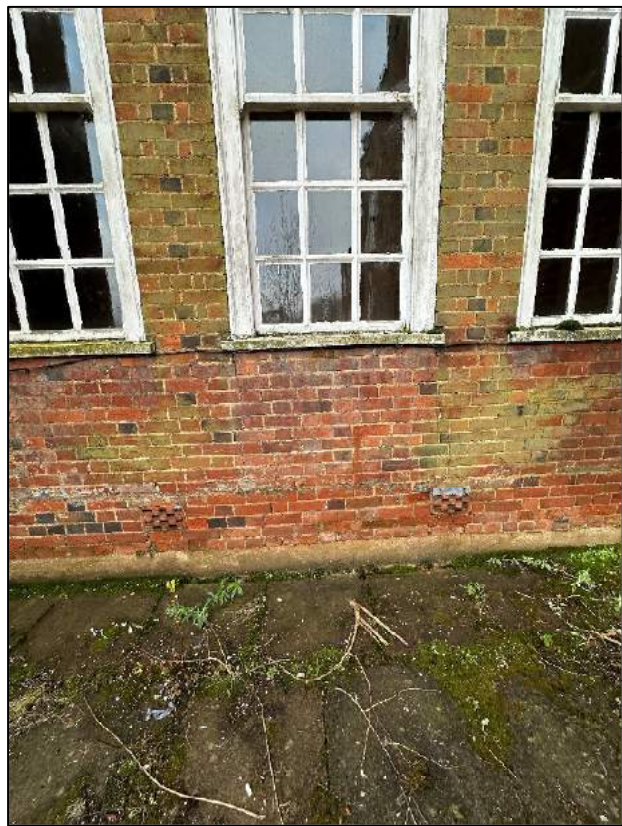
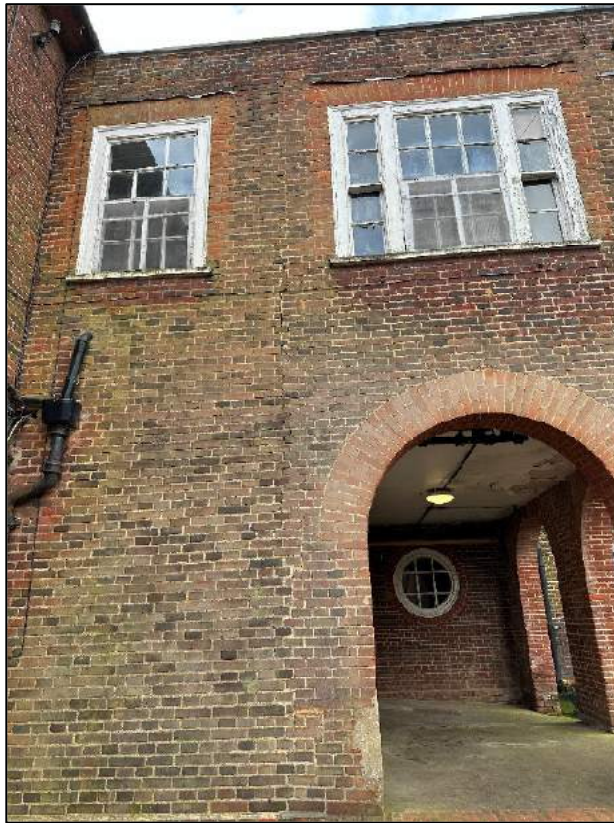
**Photograph 3 (Ref: 4.1.6)**

- 4.1.5 The ground floors all appeared to be in satisfactory structural condition.
- 4.1.6 The external walls appeared to generally be in satisfactory structural condition with only a few locations with cracking present which can be repaired with Helibar crack stitching. See photographs 3, 4 & 5,

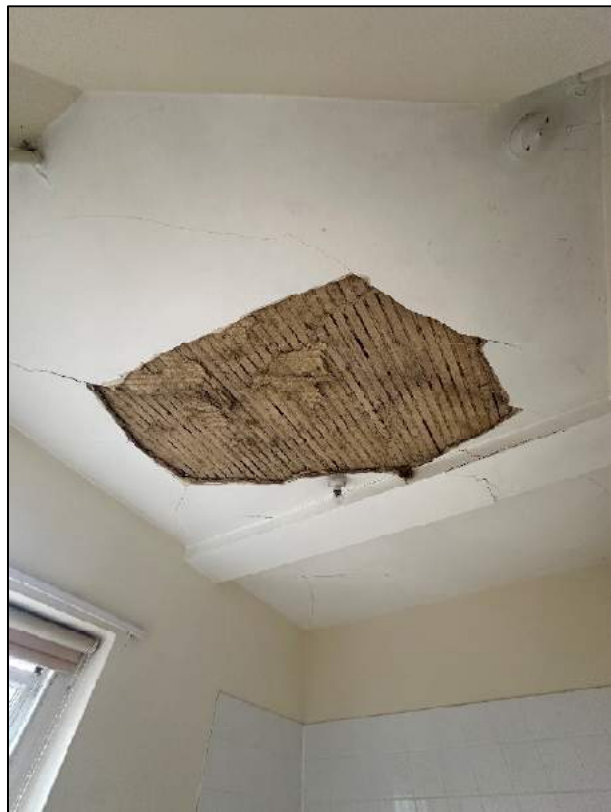
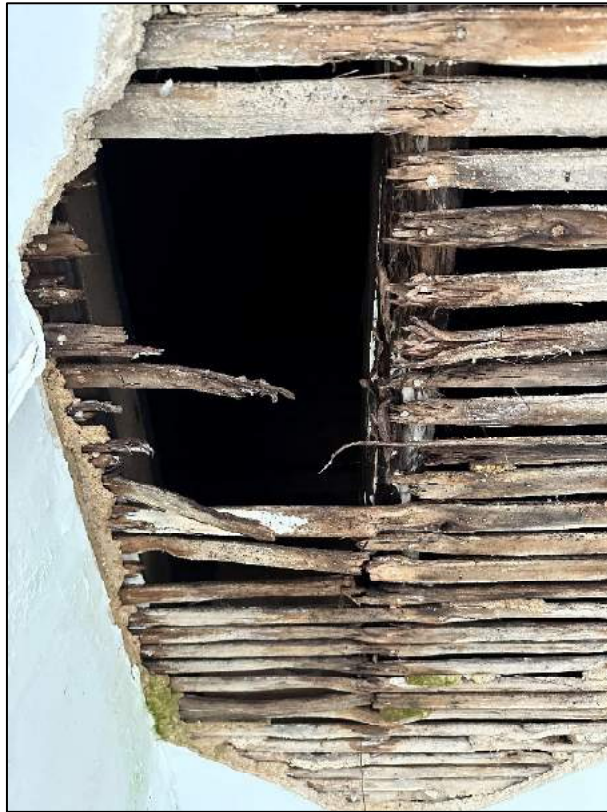
**Photograph 6 (Ref: 4.1.8)**

- 4.1.8 Some ceilings had locally failed due to water ingress from rainwater or leaks. These can be made good using conservation techniques to suit the ceiling construction type. See photographs 6 & 7.

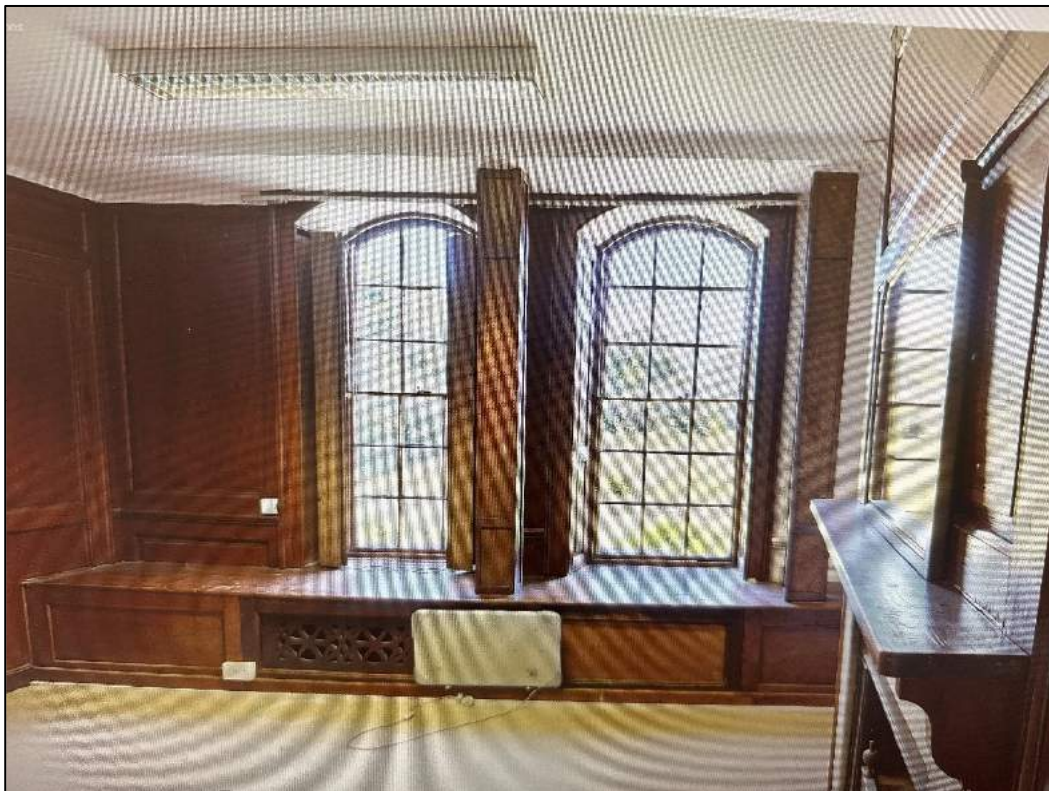
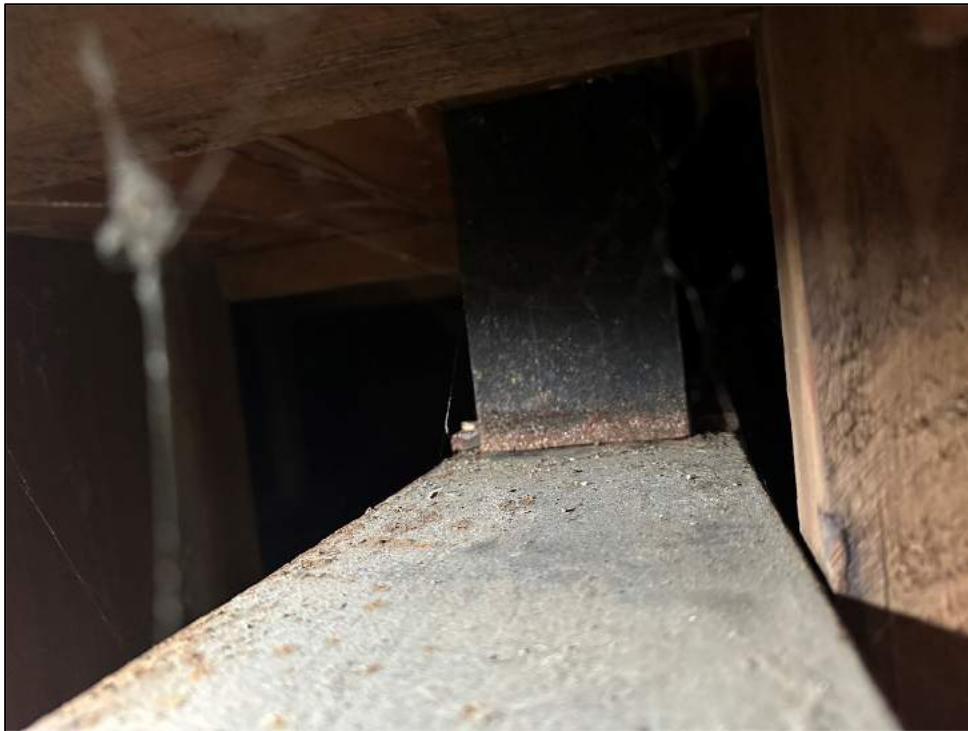
**Photograph 8 (Ref: 4.1.10)**

- 4.1.9 Wholesale, the roof structure appeared to be in satisfactory structural condition. However, no opening up was carried out.
- 4.1.10 Modern roof/floor repair has been carried out in the main building, central wing, rear elevation at first floor level. It appears a timber beam at second floor level may have failed. 2 steel posts have been installed to prop the timber in turn supported on a concealed steel beam above first floor level supported on loadbearing walls below. A revised arrangement will be required for the conversion. See photographs 8 & 9.

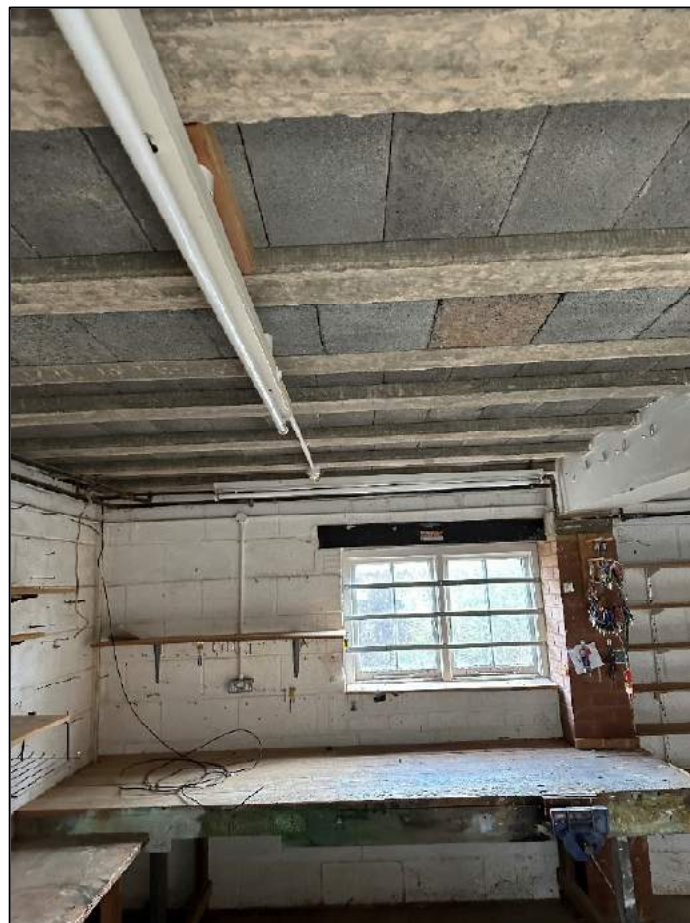
**Photograph 10 (Ref: 4.2.5)**

- 4.2.5 Where exposed in the 3 storey element the first floors appear to be a beam and block arrangement. See photograph 10.
- 4.2.6 There appears to be no significant structural defects. Therefore, a successful conversion should not require high levels of structural intervention.

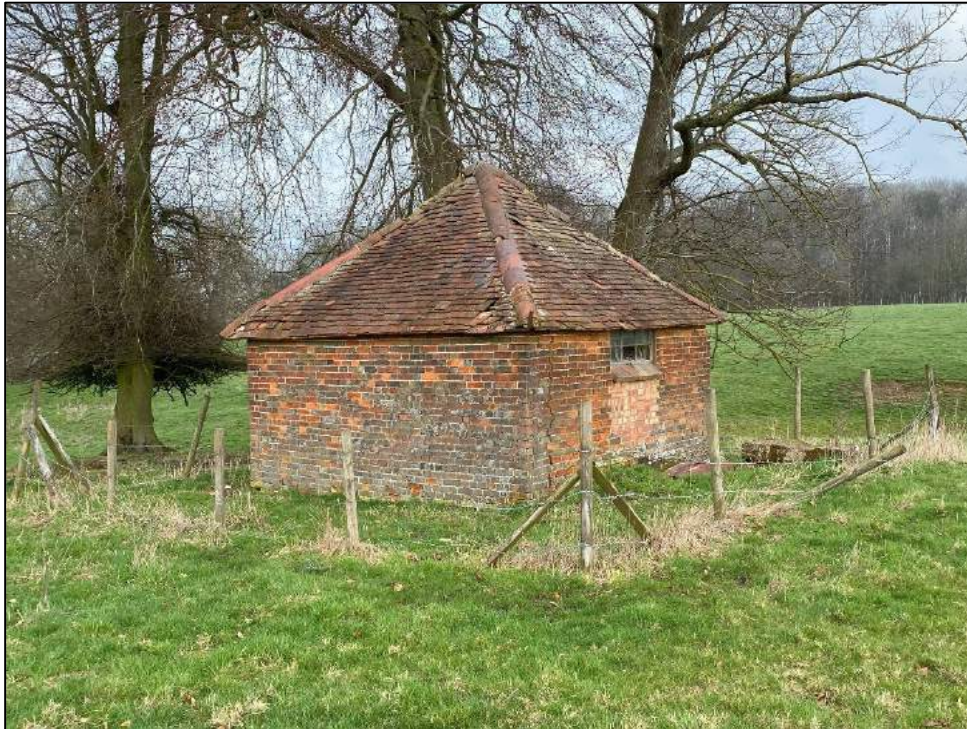
**Photograph 12 (Ref: 4.3.1)**

- 4.3.1 The piggery building is a single story solid brick Grade II listed former Piggery built circa early C20. The roof is a timber hipped roof with clay tiles. See photograph 12.
- 4.3.2 This building is to be repaired and restored.
- 4.3.3 There are significant cracks in the walls likely caused by a lack of adequate foundation on a clay subsoil near trees. See photograph 13.
- 4.3.4 Crack stitching using Helibar will be required to eliminate any future movement then some enhancement to the foundations may be required.
- 4.3.5 The timber roof structure is generally in a satisfactory structural condition. However, some water ingress has caused some localised damage to some of the timber work which will require part replacement

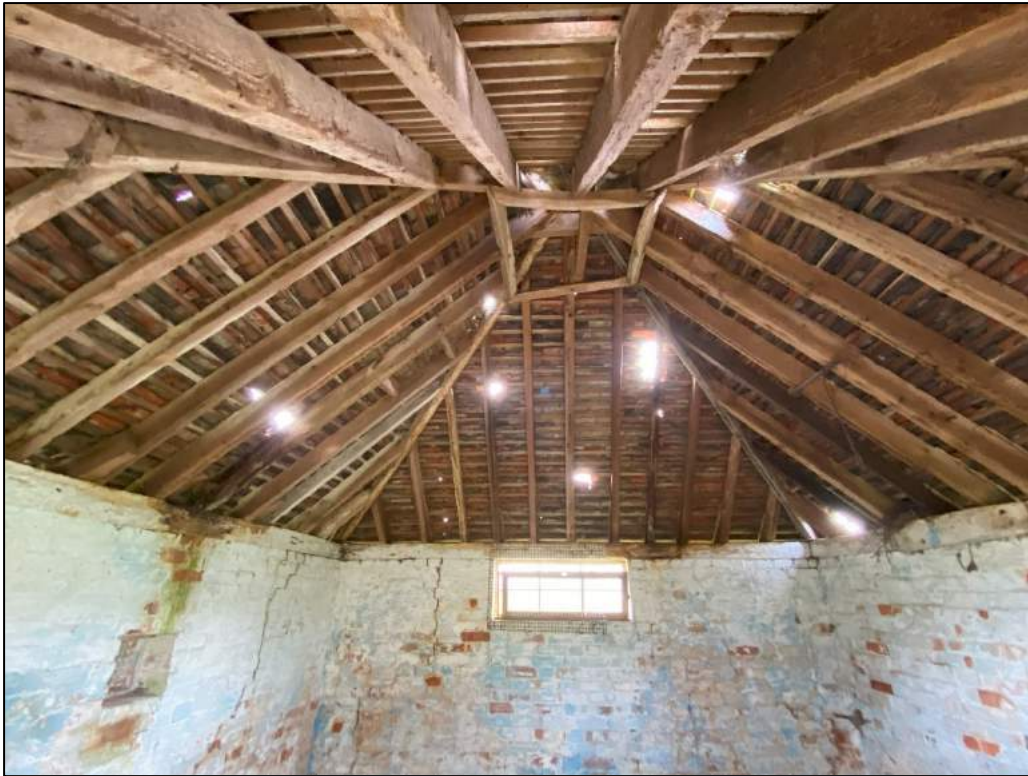
**Photograph 14 (Ref: 4.3.5)**

via splicing new timber with the existing sound timber using conservation techniques. See photograph 14.

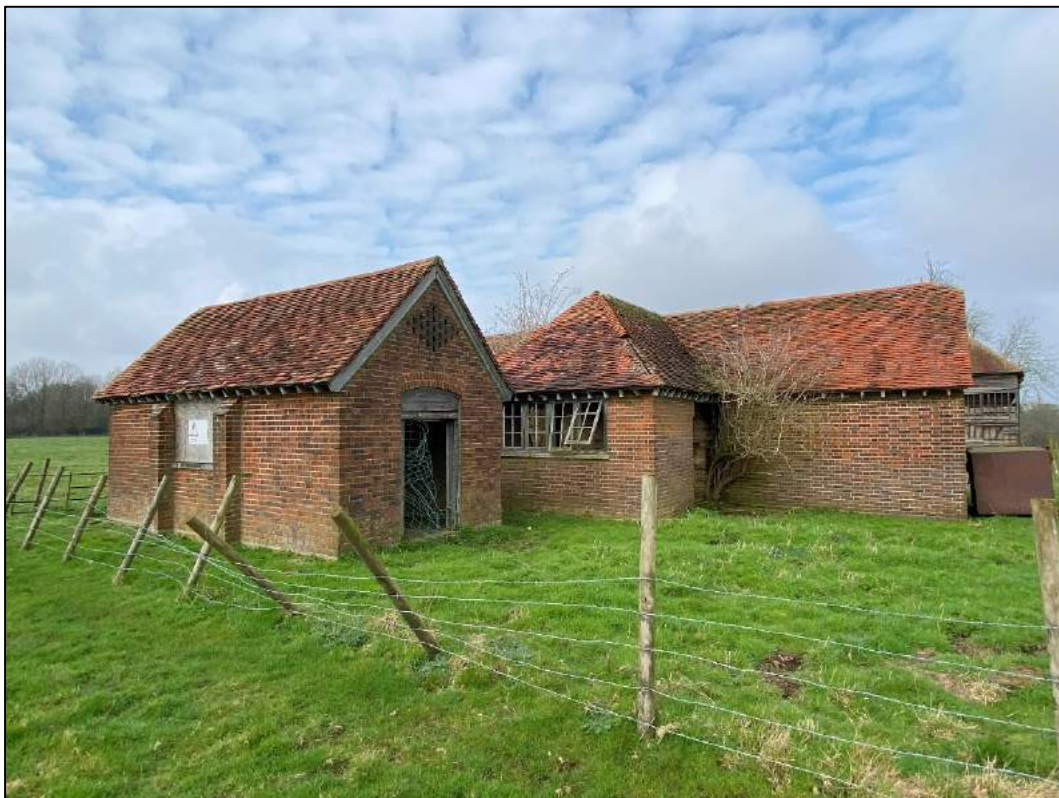
**Photograph 15 (Ref: 4.4.1)**

- 4.4.1 The Pumping Station is formed of two single storey 9-inch brick curtilage listed buildings. The roof structures are vaulted cut timber with a clay tiled finish. See photograph 15.

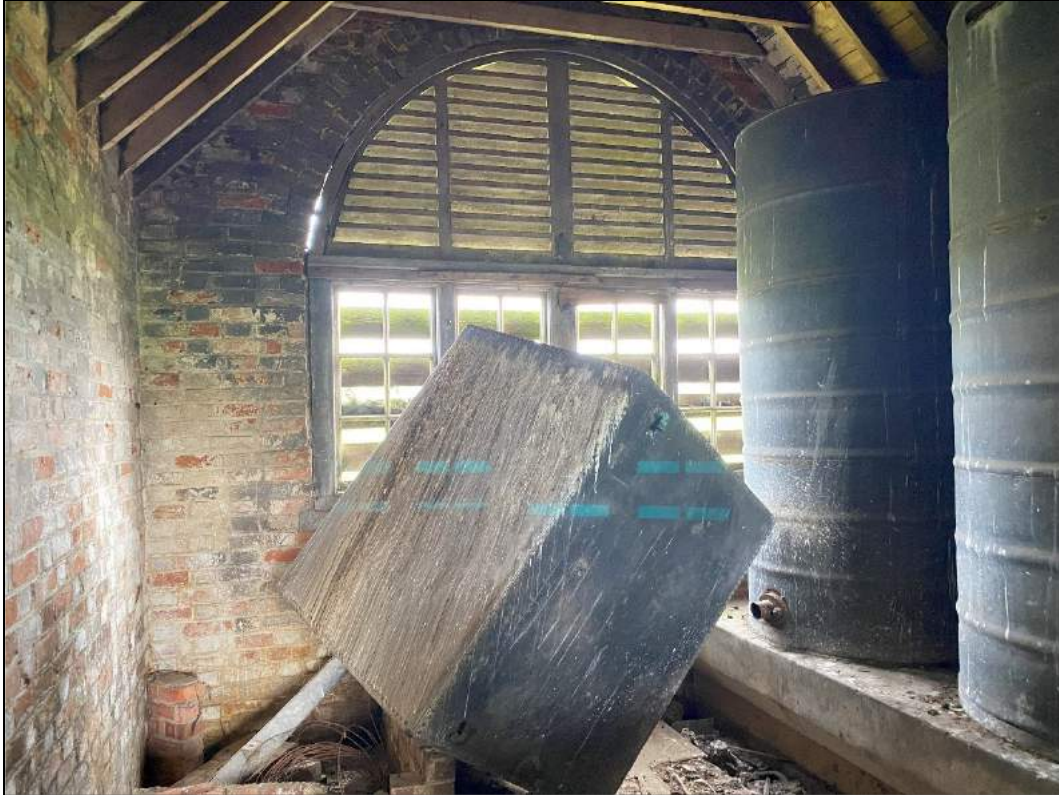
**Photograph 16 (Ref: 4.4.3)**

- 4.4.2 These buildings are to be converted to domestic accommodation.
- 4.4.3 The northern building currently houses 3no cylindrical tanks mounted on a 0.5m high concrete plinth. These are to be fully removed for the conversion. See photograph 16.

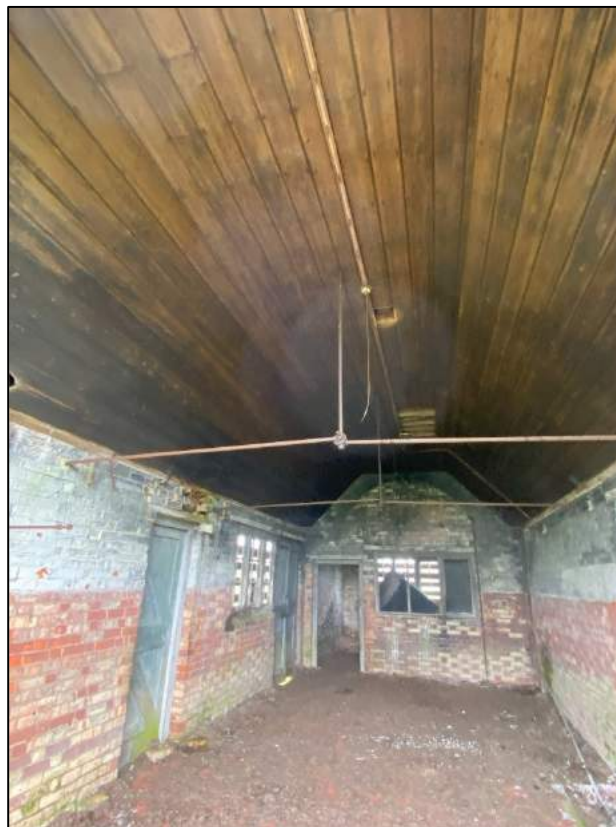
**Photograph 17 (Ref: 4.4.4)**

- 4.4.4 Various modifications have taken place in this building including an infilled arch in the dividing wall of the front rear blocks. A door opening has been created under one side of the arch base, and the wall does not appear to have been toothed into the external wall. See photograph 17.

- 4.4.5 The main section roof has a series of horizontal steel rod ties just below eaves level. In this area the timber roof structure has been boarded over, so an inspection of the condition was not possible. See photograph 17.

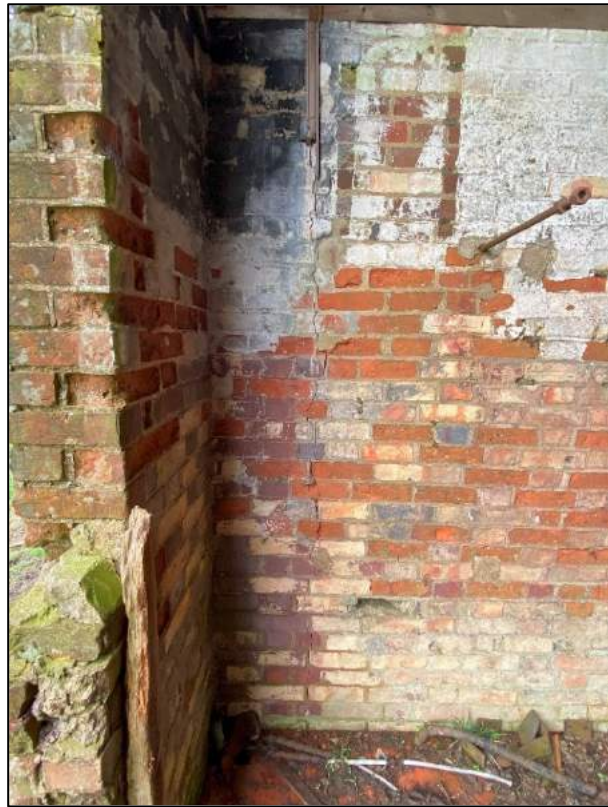
**Photograph 18 (Ref: 4.4.7)**

- 4.4.6 The timber in the rear section roof appears to be in a satisfactory condition.
- 4.4.7 There are various cracks present which will require Helibar crack stitching. See photograph 18.

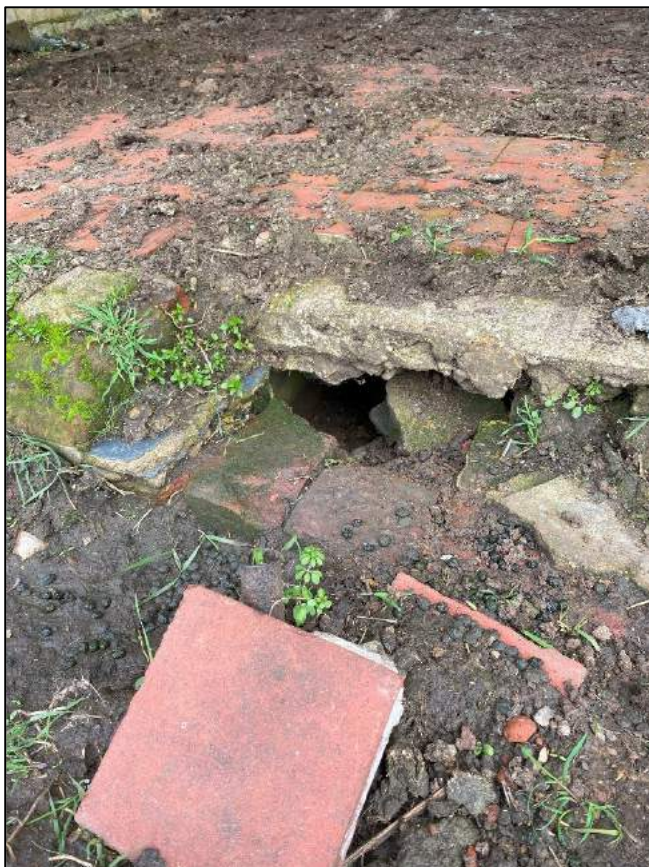
**Photograph 19 (Ref: 4.4.8)**

- 4.4.8 The floor slab appeared to be circa 100mm thick concrete on loose rubble. This will need upgrading to a more robust base. See photograph 19.
- 4.4.9 There are two small, attached side buildings built off a similar construction to the main building. There are signs of water ingress which as caused some timbers to rot at the apex and some timbers including the hip rafter have lost structural integrity at their base. Replacement and repair of these timbers will be required. See photographs 20 & 21.

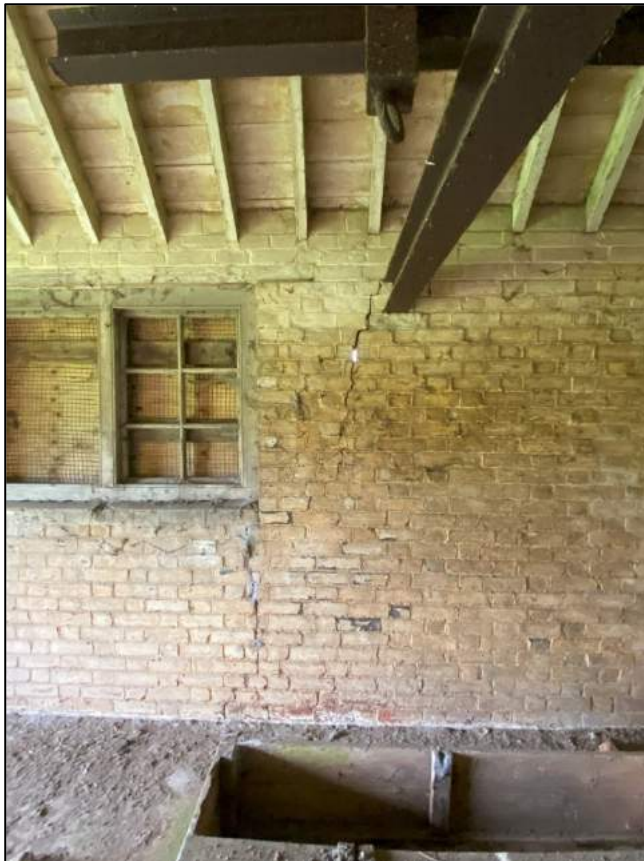
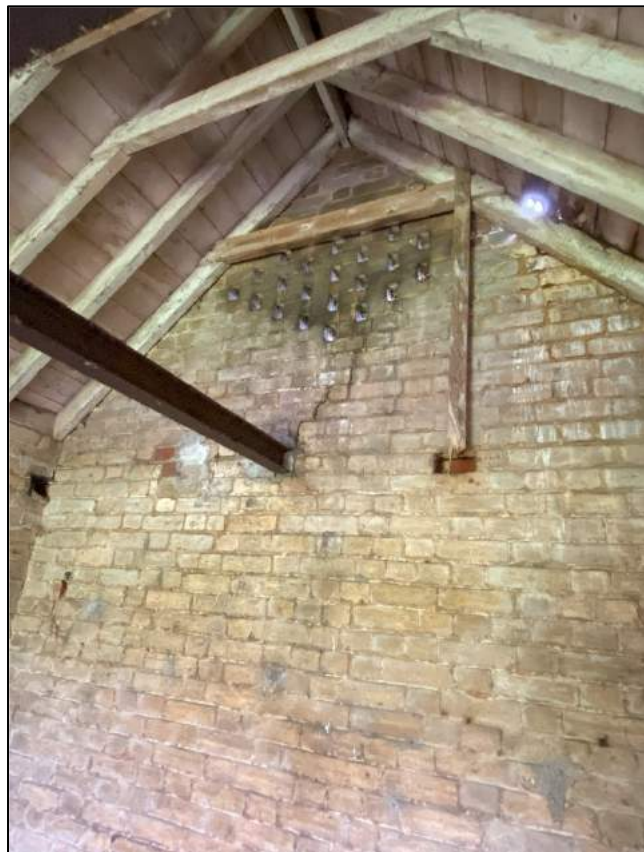
**Photograph 22 (Ref: 4.4.11)**

- 4.4.11 This building is suffering from masonry cracking throughout. There is a steel beam which is part of the pumping system which has stressed the masonry at its bearings which could be attributed to thermal expansion of the beam and/or stress caused by movement from when the pumping equipment was active. See photographs 22 & 23.

- 4.4.15 It is likely however that the main contributing factor to the movement seen is from ground movement. Subject to trial hole investigation underpinning may be required to both buildings.

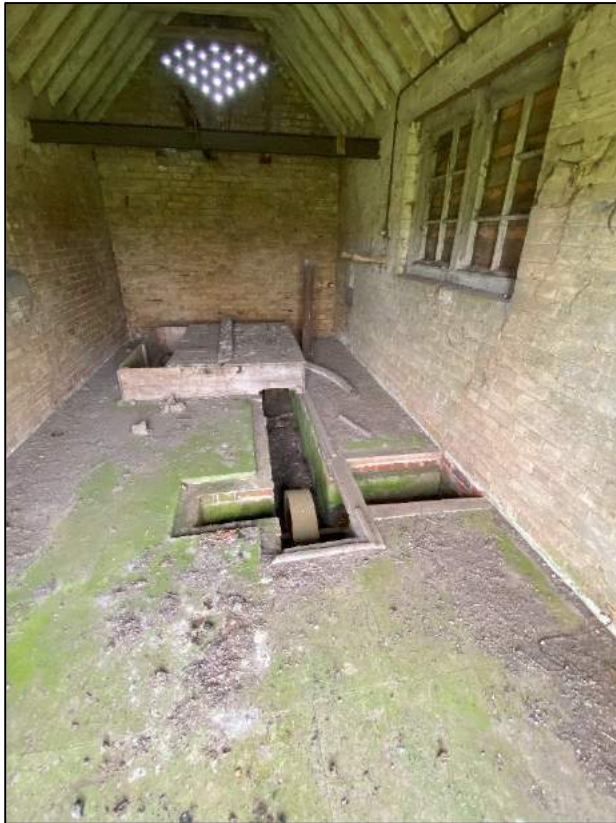
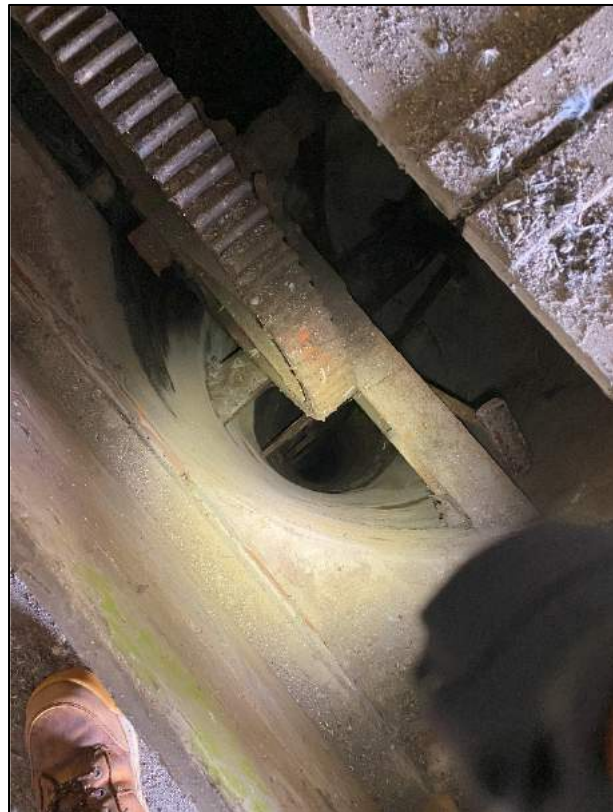
**Photograph 24 (Ref: 4.4.12)**

- 4.4.12 Below this beam is the original pumping equipment which includes a circa 1.2m diameter exceptionally deep well. No safety barriers are in place, and we recommend that this area is cordoned off immediately. Any future works will need to take into account the well especially if it will remain as a feature. See photographs 24 & 25.

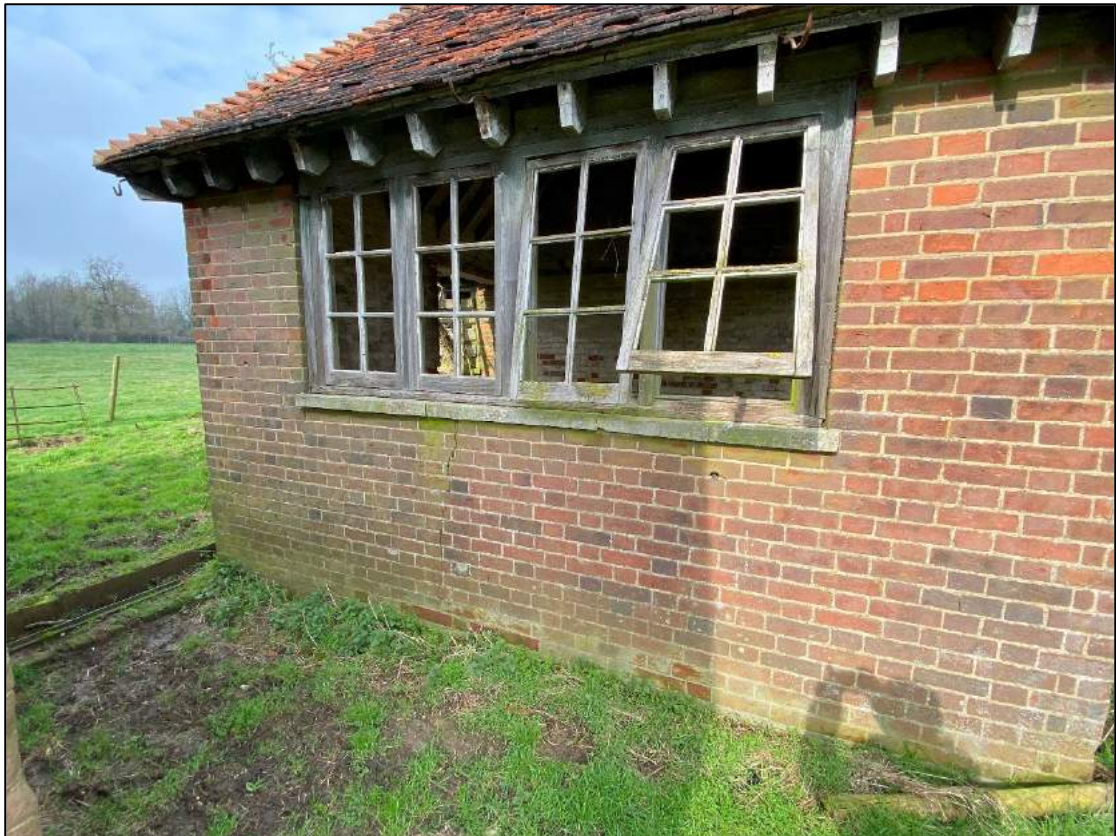
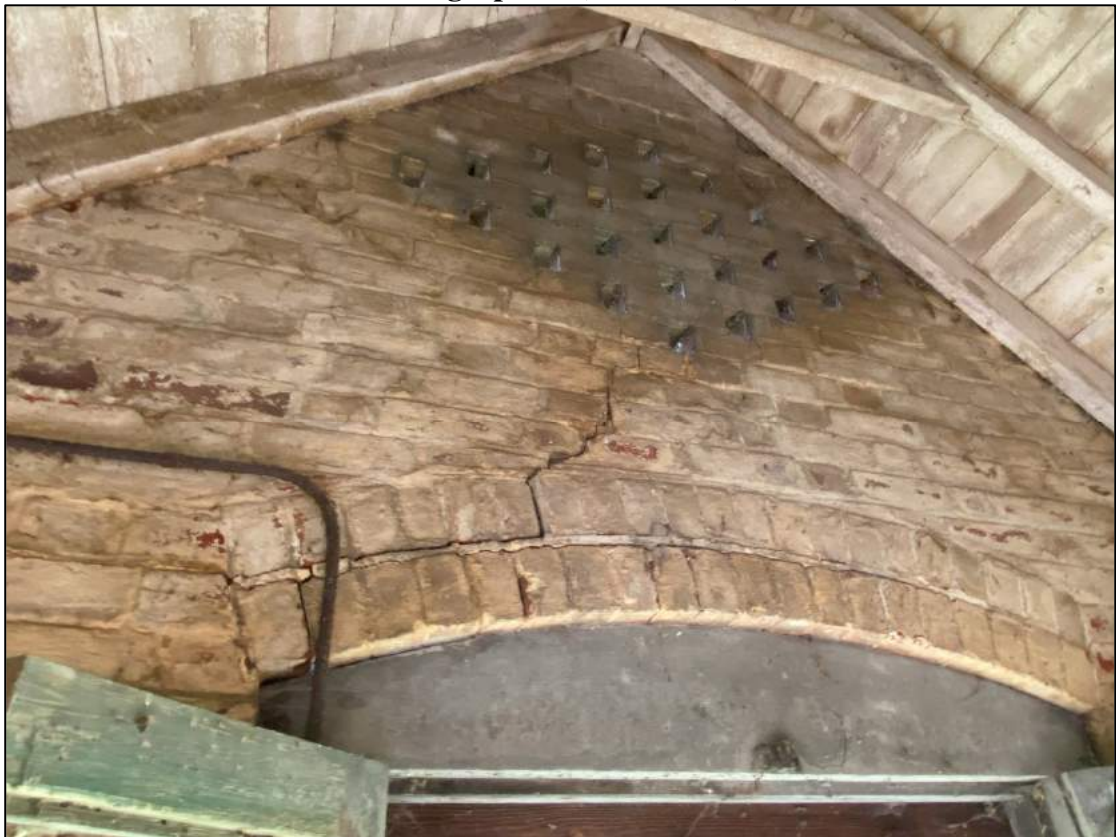
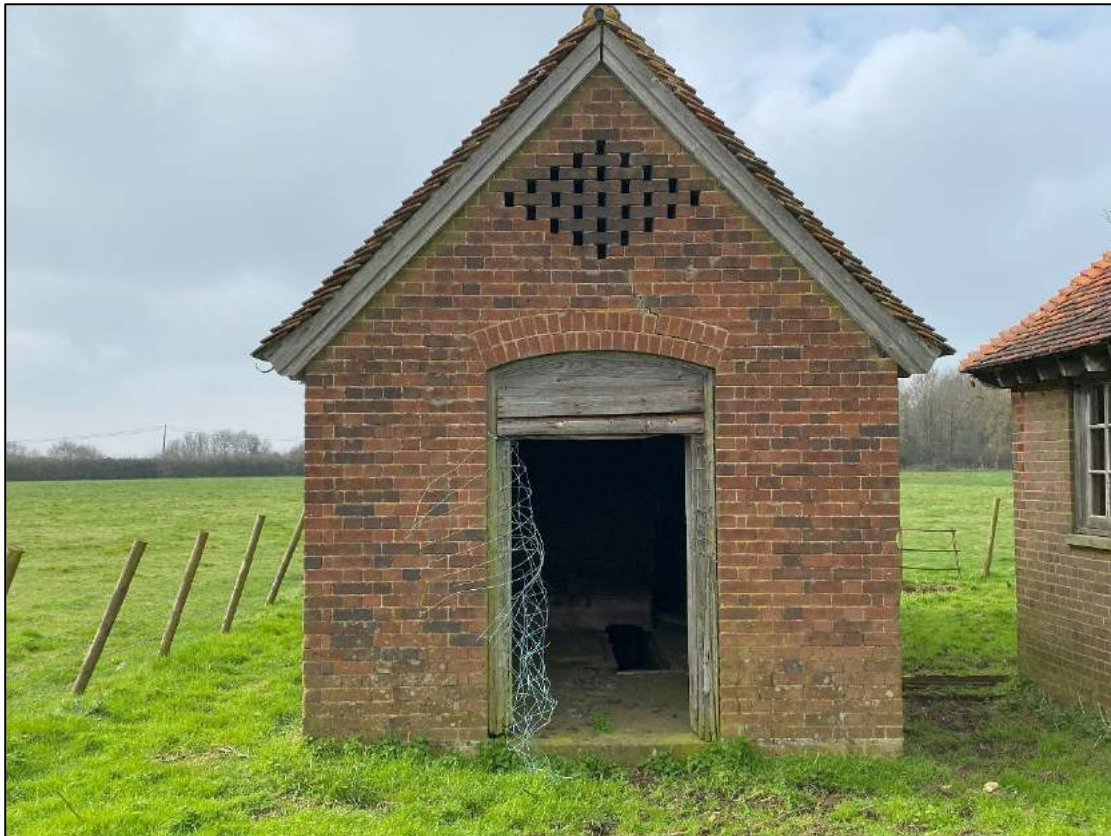
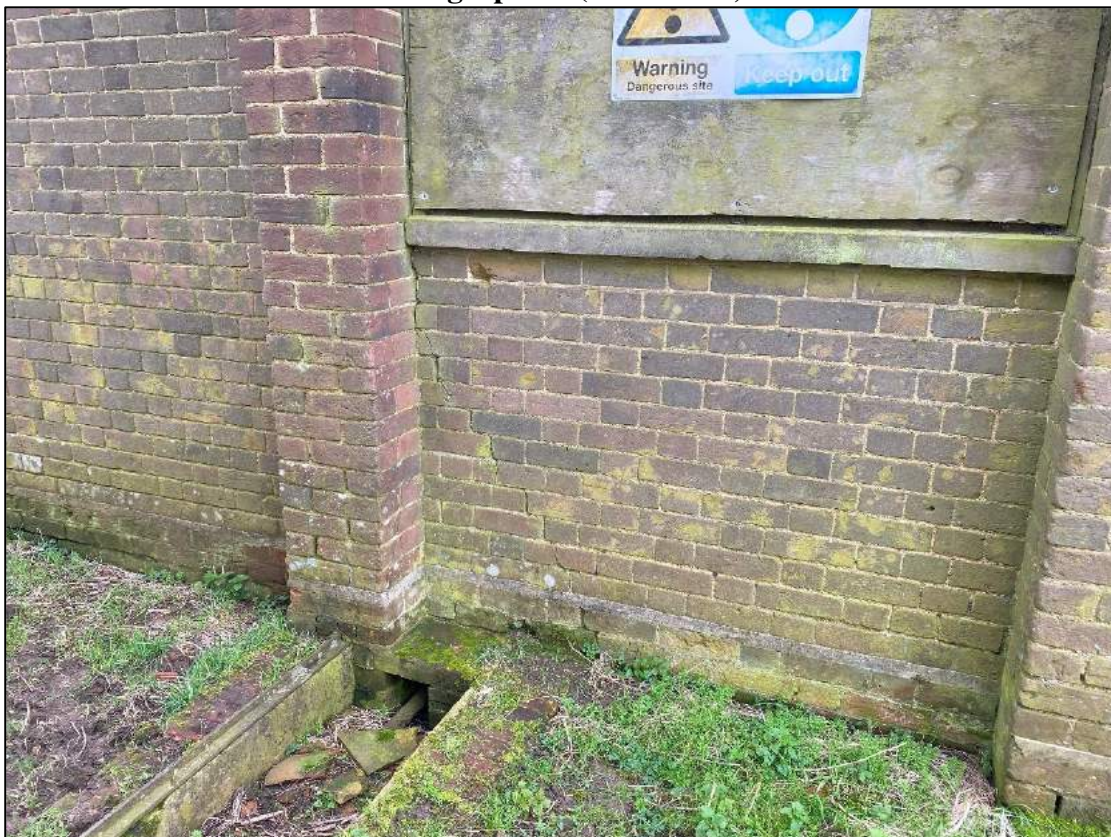
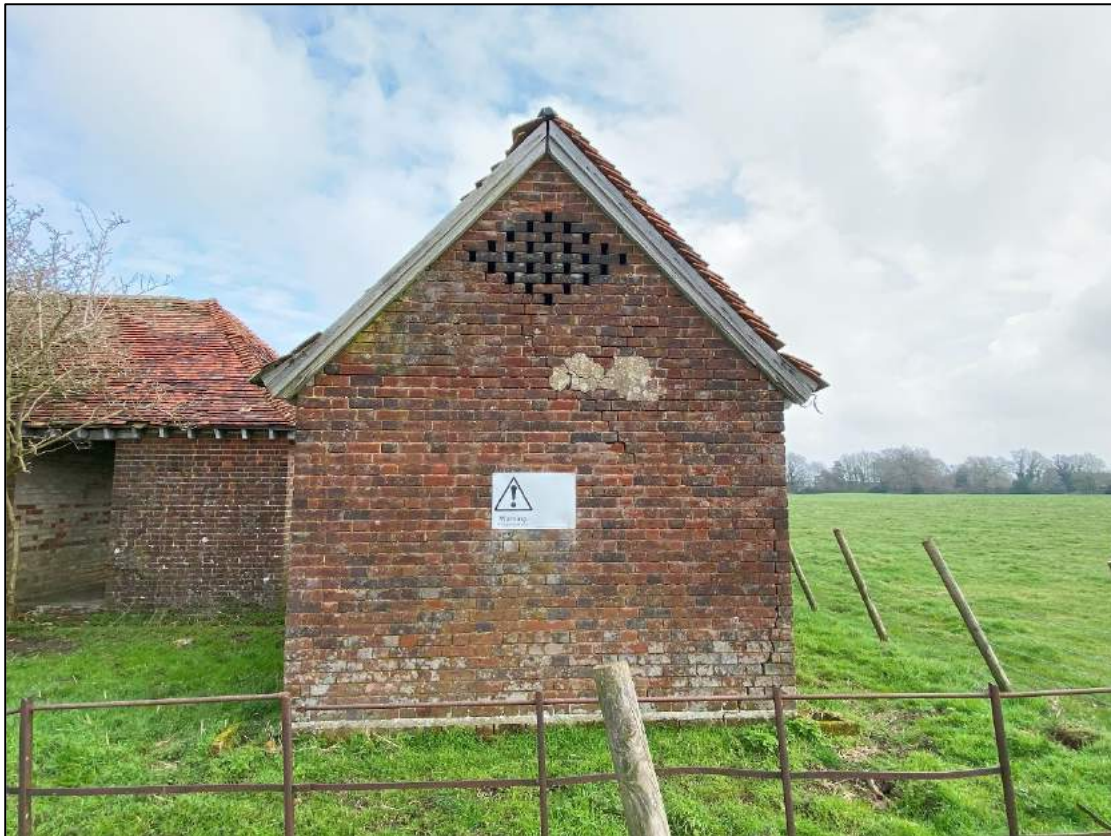
**Photograph 26 (Ref: 4.4.13)**

- 4.4.13 Cracks are present around windows and doors both internally and externally and on gable ends which will require repair. See photographs 26, 27, 28, 29 and 30.

- 4.4.14 We note collar ties are absent within the roof and movement in the roof could be contributing to some of the masonry cracking. Ties will need to be inserted as part of the conversion works.

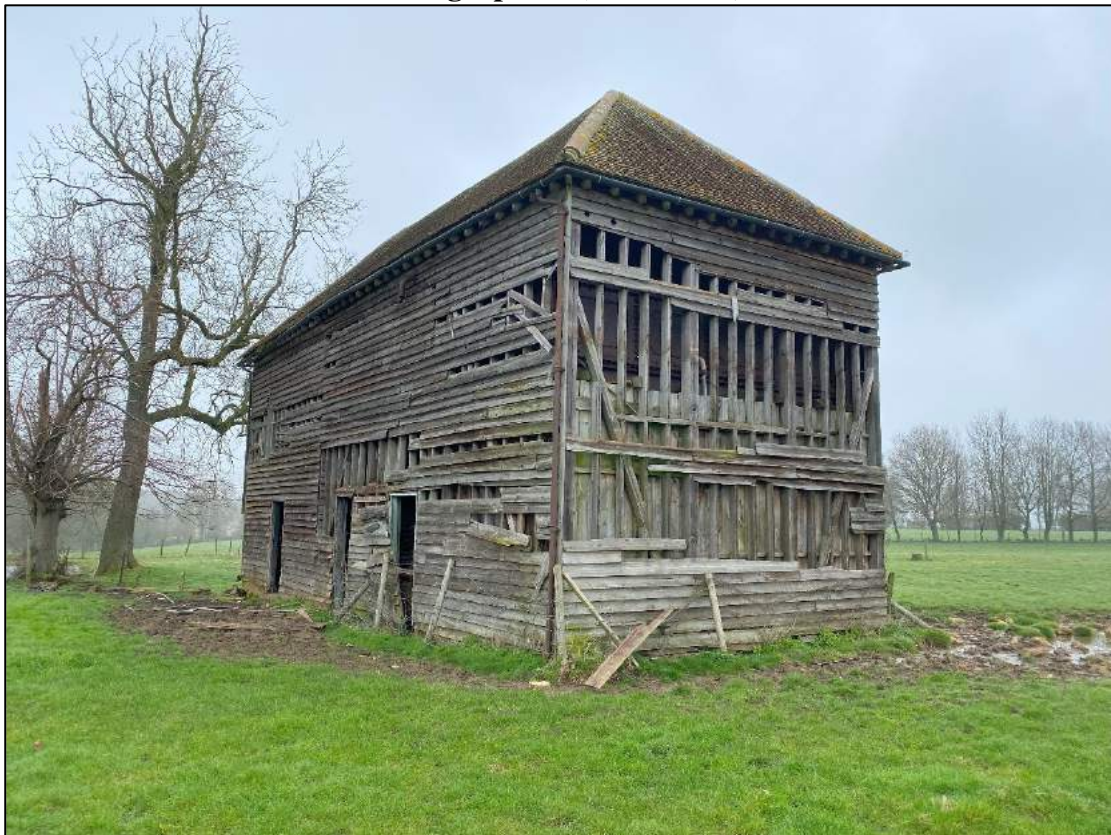
**Photograph 31 (Ref: 4.5.1)**

- 4.5.1 The Curtilage Listed Tank House is an isolated cladded timber frame building northwest of the Pumping Station. The roof is a timber hipped arrangement with clay tiles. See photograph 31.
- 4.5.2 The building houses 2 steel frames supporting water tanks at first floor level. See photograph 32 and 33.
- 4.5.3 The proposal is to convert to domestic accommodation.
- 4.5.4 Our visit was after a prolonged period of rain and as such the ground around the barn was saturated. It may be prudent to allow for land drainage as part of the proposals.
- 4.5.5 The internal steel framework does not appear to be tied into the timber structure and is likely the timber structure was built around the frames and tanks at a later date. Therefore, both being structurally independent. See photograph 34.

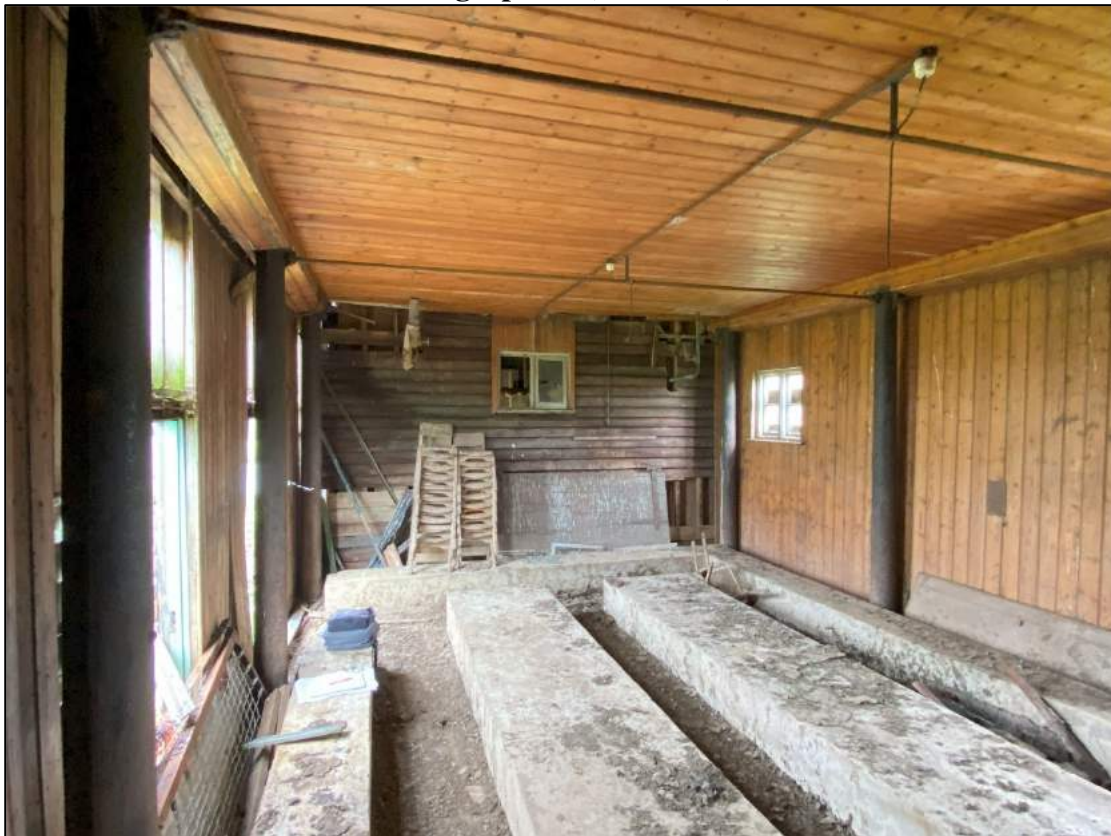
**Photograph 35 (Ref: 4.5.9)**

- 4.5.9 The southern area has a series of concrete blocks/plinths at ground floor level which likely supported additional equipment as part of the water tank arrangement. See photograph 35.

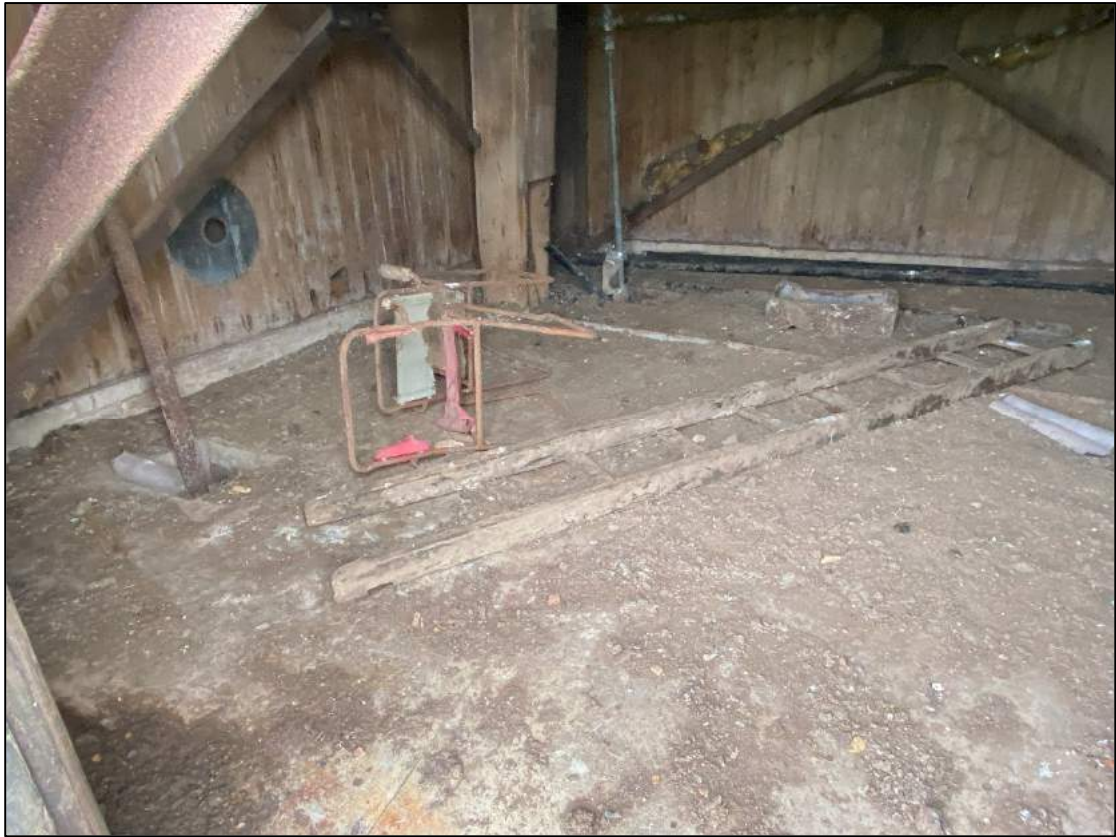
**Photograph 36 (Ref: 4.5.10)**

- 4.5.10 There is no structural ground floor present with the base forming of compacted earth. See photograph 36.
- 4.5.11 The exterior timber wall structure consists of softwood primary posts and secondary studs clad internally with vertical timber boarding and externally with horizontal timber cladding. See photographs 37 & 38.
