## **STRUCTURAL REPORT**

**TEMPLE DINSLEY  
PRESTON, HITCHIN  
(Our Job No: CE24/4030)**

**Date: REV A. MAY 2024**

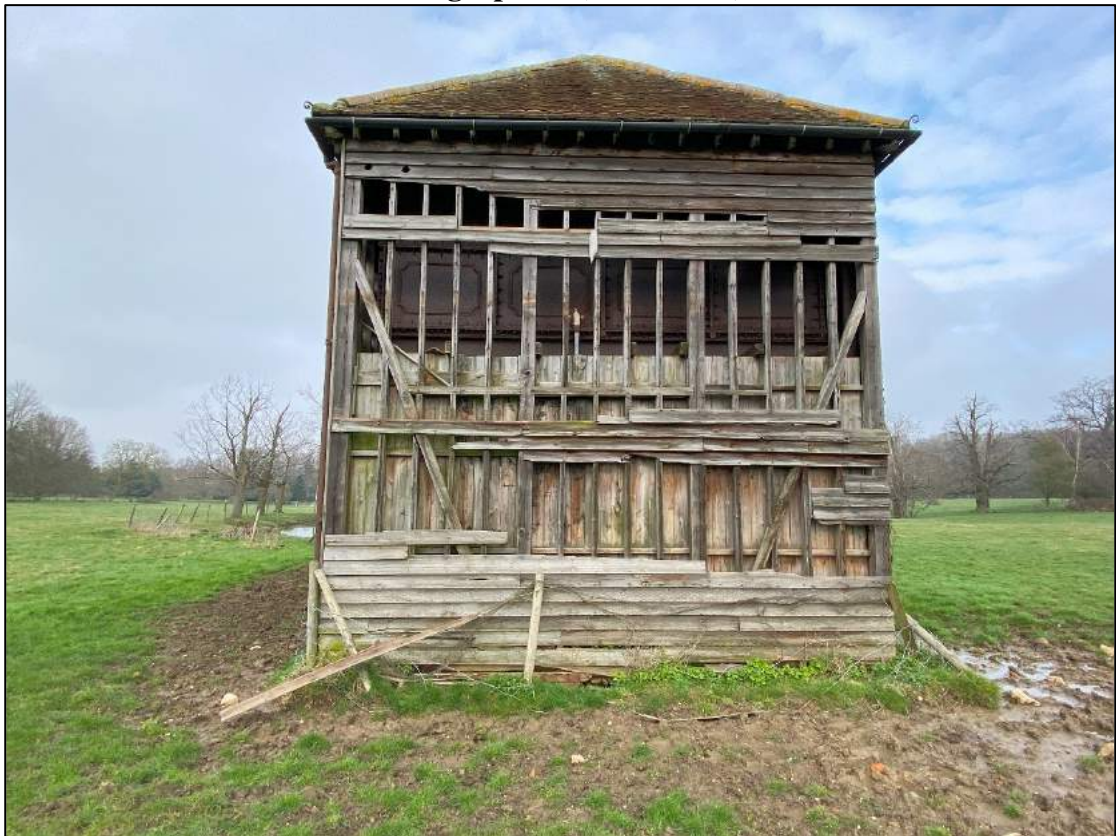
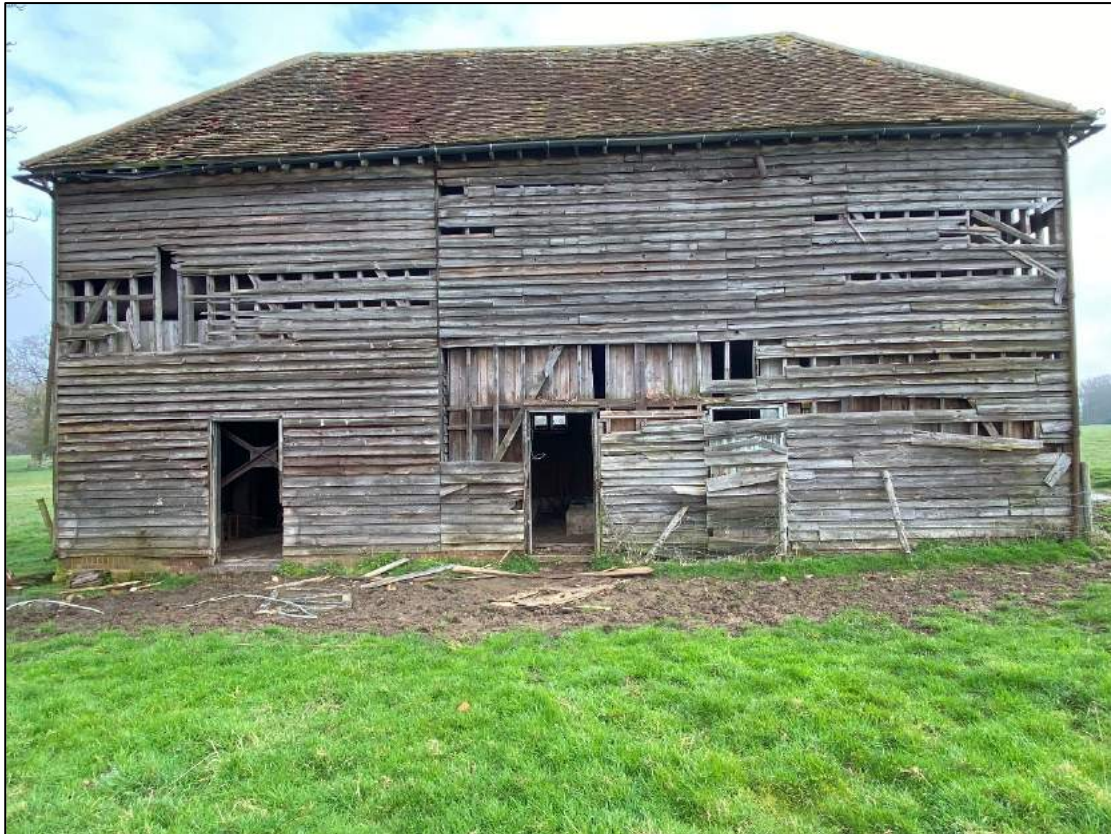
**Photograph 37 (Ref: 4.5.11)**

- 4.5.10 There is no structural ground floor present with the base forming of compacted earth. See photograph 36.
- 4.5.11 The exterior timber wall structure consists of softwood primary posts and secondary studs clad internally with vertical timber boarding and externally with horizontal timber cladding. See photographs 37 & 38.

- 4.5.12 Much of the external cladding is either missing or damaged. Because of this the frame is exposed and subject to further degradation.
- 4.5.13 The roof tiles are damaged and water ingress could be damaging timber structure although access was not possible to confirm any damage.

- 4.5.14 To avoid further degradation of the timber wall and roof structure it would be prudent to temporarily cover the structure.
- 4.5.15 The steelwork is generally exposed and is suffering from surface corrosion. However, the frame appears to be structurally sound.

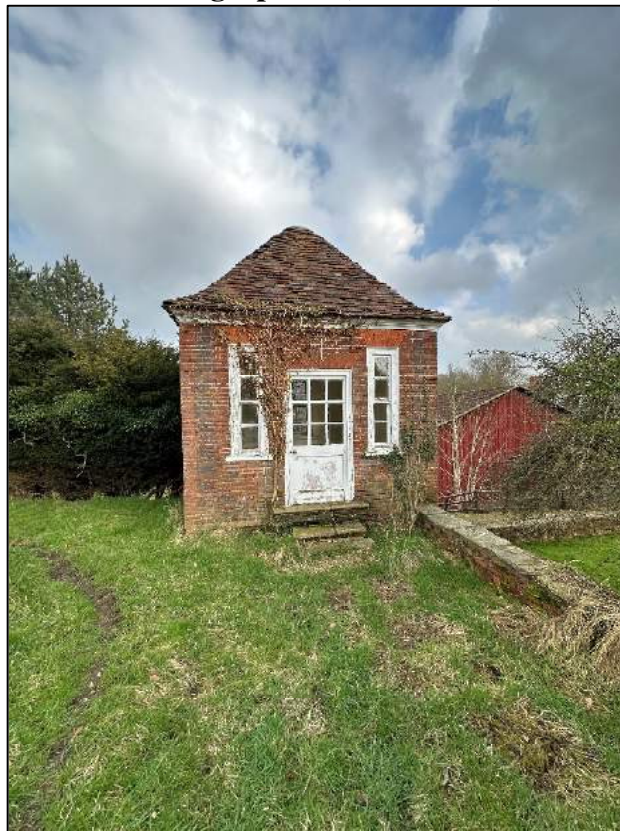
**Photograph 39 (Ref: 4.6.1)**

- 4.6.1 The Belvedere building is a square two storey Grade II listed brick building with a clay tiled hipped roof. See photograph 39.
- 4.6.2 This building is to be repaired and reinstated as a feature Belvedere building.

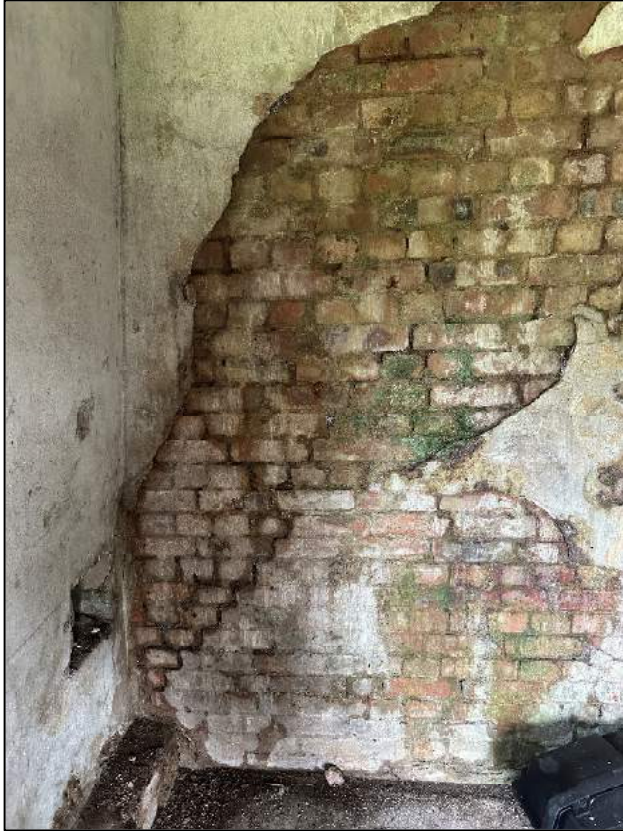
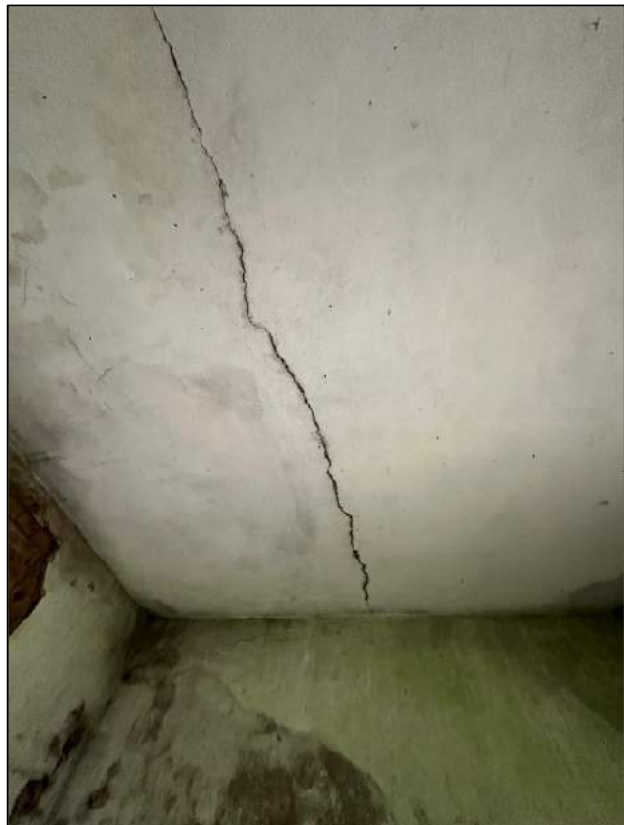
**Photograph 40 (Ref: 4.6.4)**

- 4.6.3 The ground floor is buried on two sides, so the wall is acting as a retaining wall in these positions.
- 4.6.4 There is evidence of movement in the ground retaining walls as seen in the photos in the appendix. These will require repair using Helibar stitch repairs. See photographs 40 & 41.

- 4.6.5 Additional buttressing will be required to stop any further movement. Either via wall thickening or buttressing piers internally to retain the ground.

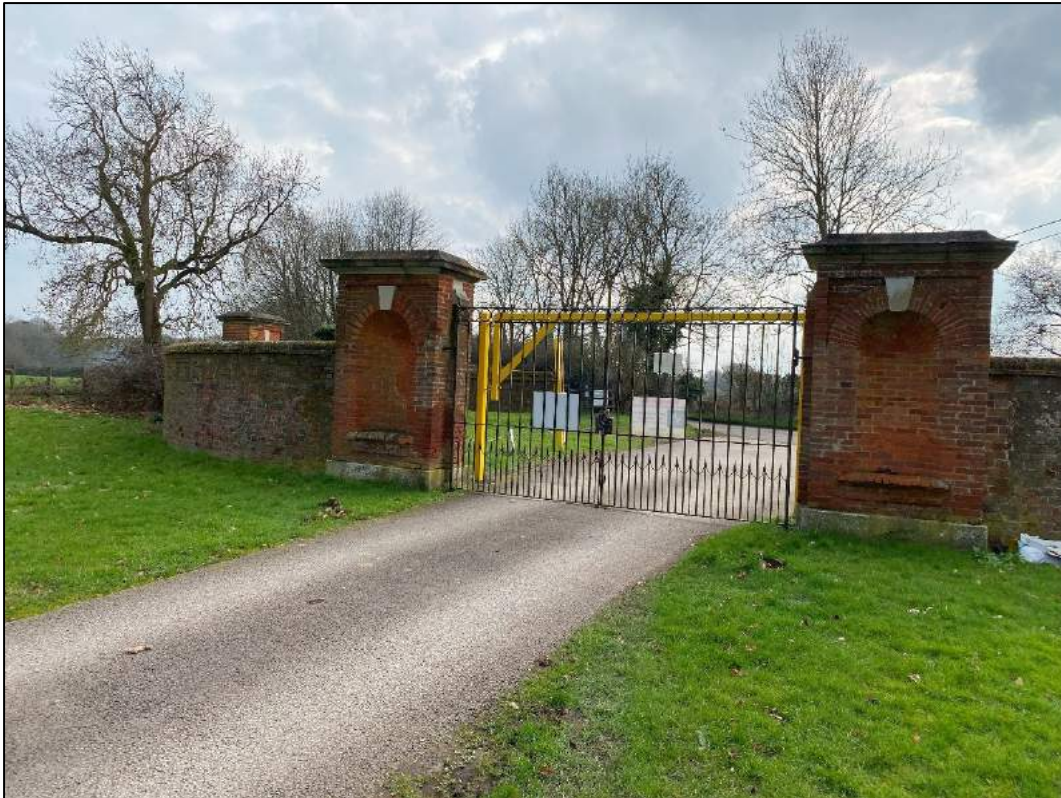
**Photograph 42 (Ref: 4.7.2)**

- 4.7.1 AFP carried out a limited survey of the boundary park wall.
- 4.7.2 The wall is early C16 Grade II listed comprising of solid masonry English bond brickwork with feature gate piers at the entrances. Photograph 42.
- 4.7.3 Generally the walls are in satisfactory condition.
- 4.7.4 There are some cracks which will require stitching with Helibar and localised replacement of damaged bricks to match. See photograph 43.
- 4.7.5 Localised repointing in lime mortar will be required to loose or missing mortar joints. See photographs 43.
- 4.7.6 There are localised areas of vegetation on the wall which we recommend to be removed. See photographs 44.
