# **CAMBRIDGE ASBESTOS REMOVAL LTD**

**R & D for Asbestos containing materials at**

**The Icehouse  
Temple Dinsley  
School Lane  
Preston, Hitchin  
Hertfordshire, SG4 7RT**

REFERENCE; ECB/5344

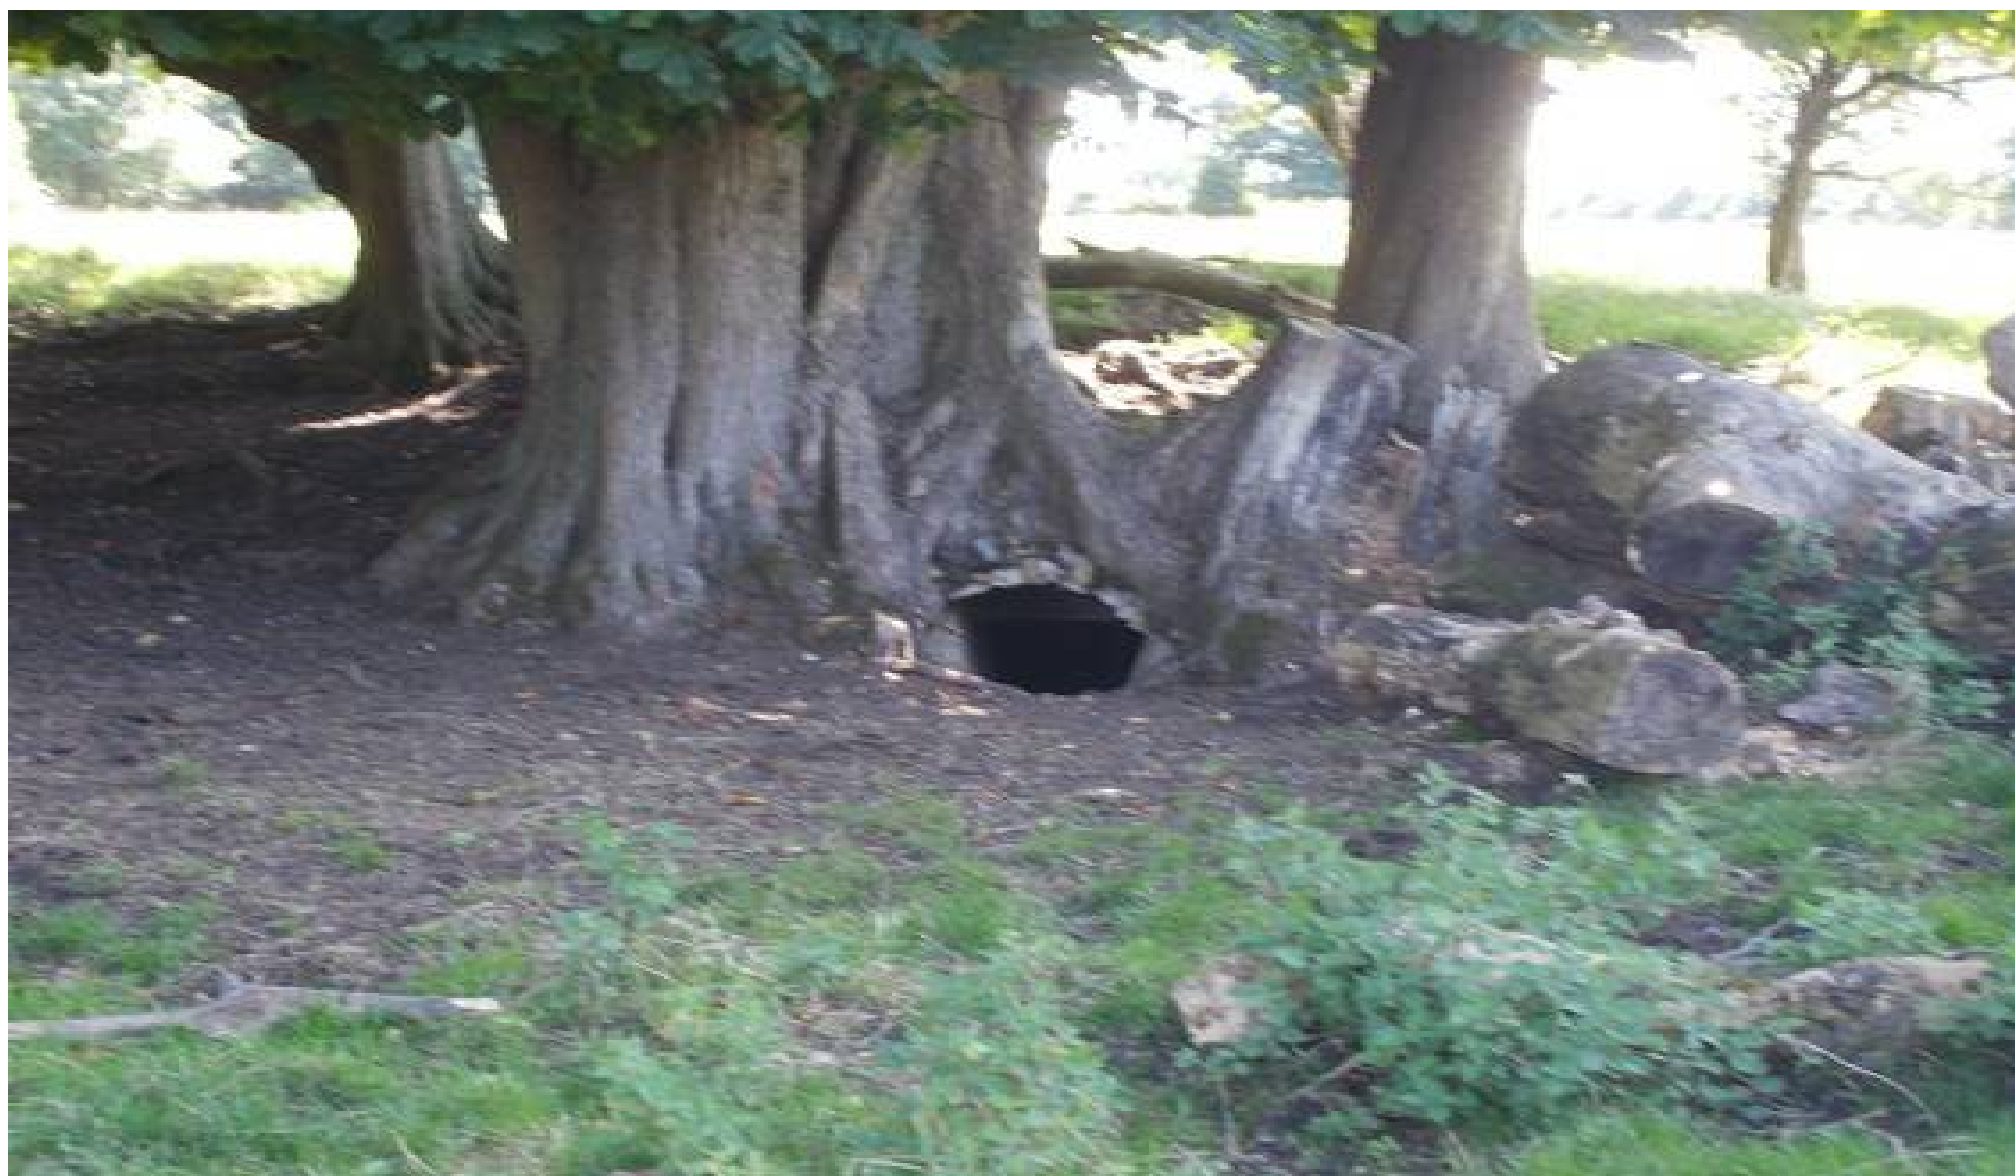
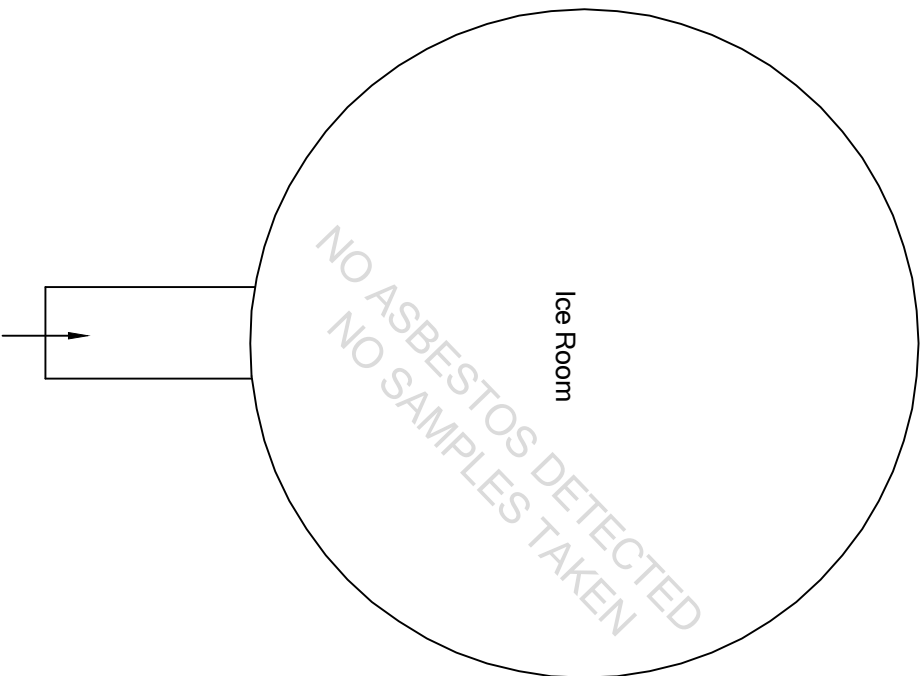
GROUND FLOOR

| Sample Date | Location Ref | Location ID | Drawing Reference | Area | Room | Asbestos Type | Product Name | Material Risk Score | Material Risk Band | Priority Risk Score | Comments | Action | Survey Type |
|---|---|---|---|---|---|---|---|---|---|---|---|---|---|
| 11/08/23 | Visual | 29432 | 1 | Main | All Areas | Not Applicable | N/A | 0 | Not Applicable | N/A | No asbestos was detected and no samples taken. | No Action Required | RDS |

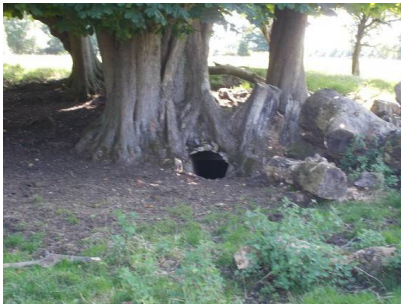
29432

No asbestos was detected and no  
samples taken.

No Action Required
