Planning application: Ref 24/01546/FPH: supplementary information (1 page)

7 High Street, Barkway, Herts SG8 8EA

No 7 High Street, Barkway, SG8 8EA

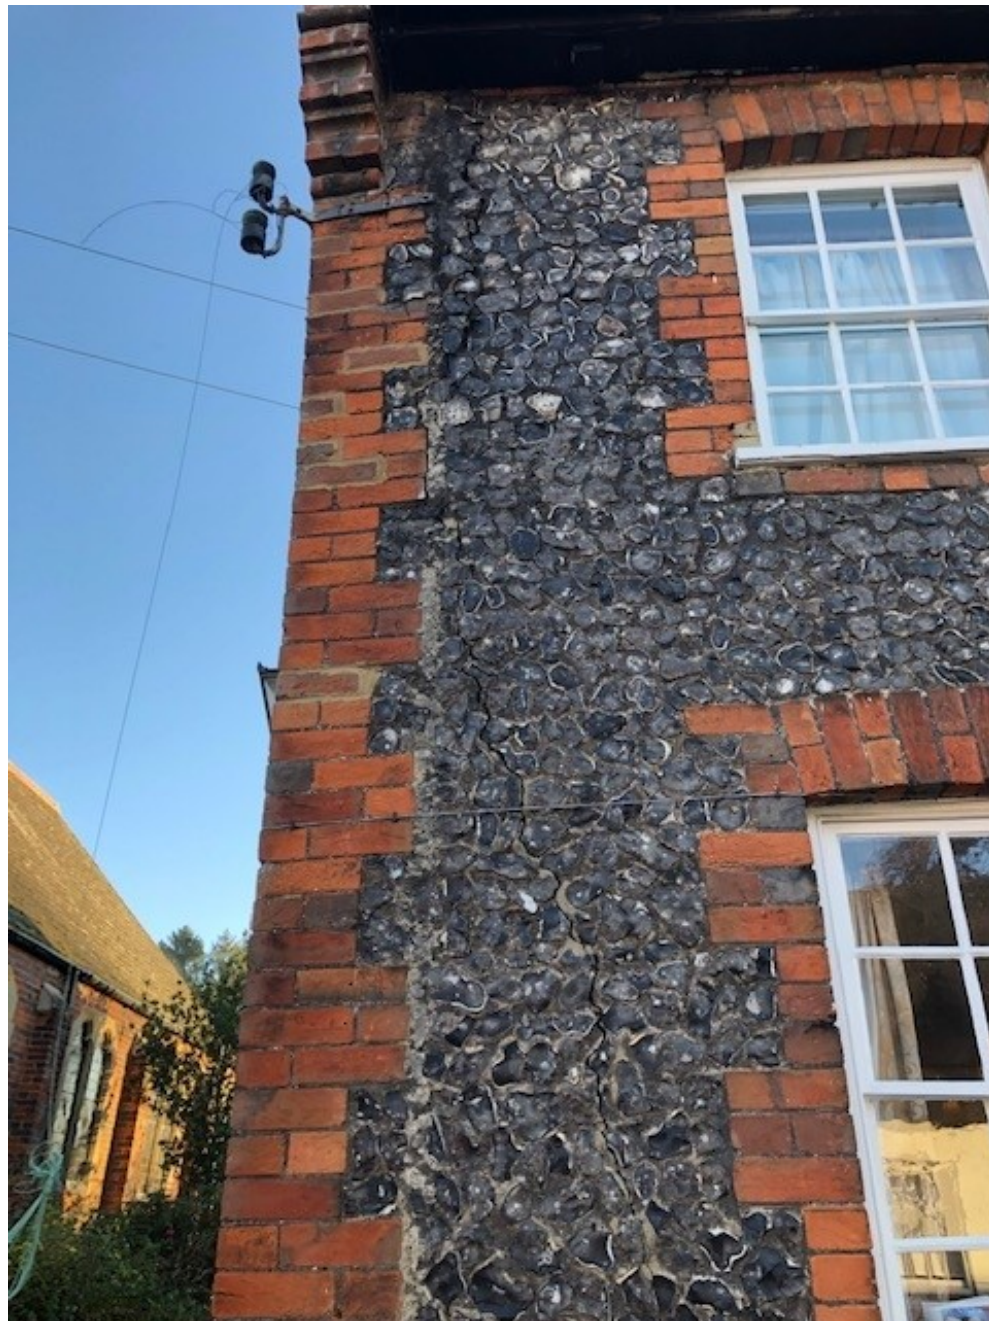
Proposed works: per drawings supplied with the application.  
The photograph here shows a crack down part of the front elevation of the building.

There has been some movement in the front elevation wall, causing a narrow crack in the flintwork to widen over a number of years. While the cause of the crack cannot be ascertained with any certainty, it seems wise to arrest further movement now. Here is an extract from the structural engineer's report (Mr Stuart Ellis of Mason Navarro Pledge):

4.2.1 It appears probable that the current pattern of movement, albeit slow, will continue.

4.3.2 The floor joists are poorly connected to the floor beams and the beams seem minimally attached to the wall timbers.

4.3.3 Movement is slow and the building's walls just need to be held in check by securing them back to the body of the house.

4.4.1 Apply restraint girdles around the areas of wall affected by movement.

4.4.2 Tie the girdles back to internal structure (roof and floor members) and then ensure connection of that structure back to the members that give them support.

4.4.3 Excavate externally to check for deteriorated mortar and point as necessary.
