## **Natwest Group – Capital Investment Programme (CIP)**

**Natwest Hitchin  
12 High Street  
Hitchin  
Hertfordshire  
SG5 1BH**

### **Photographic condition report**

Reference: 26-035-BS-R

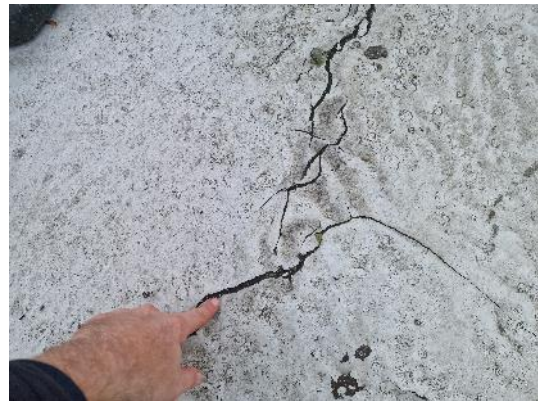
**Photograph A – Cracking to asphalt**

3.3 Photograph A shows the asphalt to the flat crown portion appeared to be slumping and fractured and further evidence of moisture ingress was noted internally, indicating a problem has been sustained for a prolonged period.

Asphalt is susceptible to wear due to variable weather conditions, particularly the heating and cooling effects of solar radiation. Where the surface is not adequately protected creasing commonly occurs, leading to blistering and splitting of the waterproofing material.

3.4 The perforations in the asphalt provide an avenue for water ingress, commonly leading to penetrating moisture ingress. Based on the findings of the inspection, it is recommended that the roof be refurbished in its entirety in order to mitigate the risk of further moisture ingress.

3.6 It is recommended consideration be given to replacing the asphalt with a built-up elastomeric mineral felt waterproofing system complete with polyisocyanurate (PIR) insulation, in order to improve thermal performance.

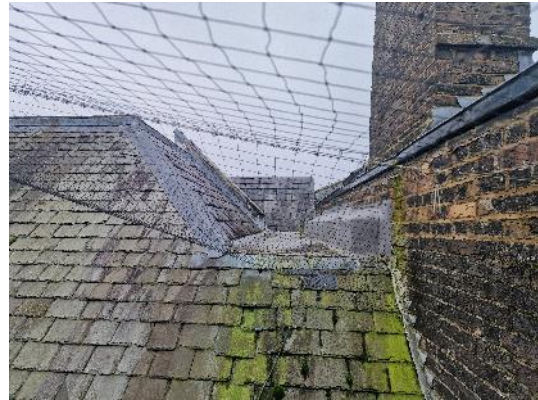
**Photograph B – Channel gutter**

- 3.7 Photograph B shows a channel gutter is provided to the left hand side, adjacent to the adjoining property. It appears to have been originally weathered in asphalt, although a liquid waterproofing system has been applied retrospectively.

Despite the liquid coating being in reasonable condition, this is considered to be a temporary repair only, with a requirement for full refurbishment.

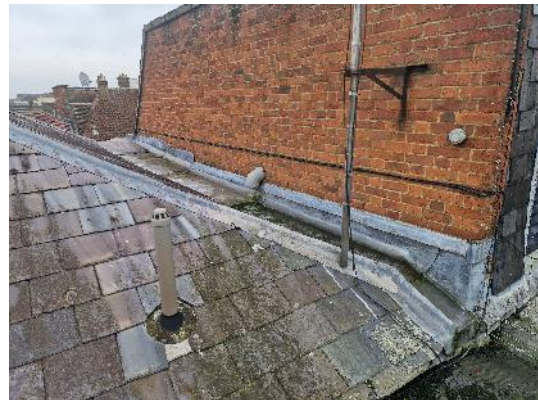
**Photograph C – Pitched roof and valley**

- 3.9 A second pitched roof portion is provided to the rear of the property, albeit generally in fairer condition than that to the main roof above (photograph 6). There is evidence that localised slate repairs have been carried out and it is recommended that similar replacement works be undertaken – Photograph C.

A valley gutter is sited at the junction between the two building portions weathered in lead. This was visibly lifting in areas and it is recommended it be redressed, including renewal of the lead flashing to the wall adjacent.

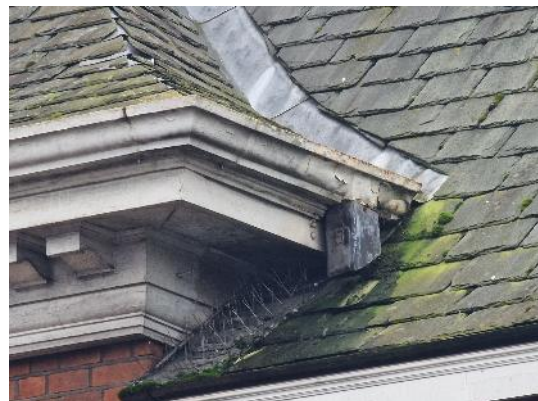
**Photograph D – Main roof eaves**

- 3.10 Photograph D shows timber joinery items to the front of the property include fascia, soffit and cornice detailing, decorated in gloss paint.

Evidence of flaking paintwork was noted in multiple locations with early indications of rot infestation (photograph 2). It is therefore recommended the timber sections be repaired and decorated, to avoid further deterioration and the need for costly replacement.

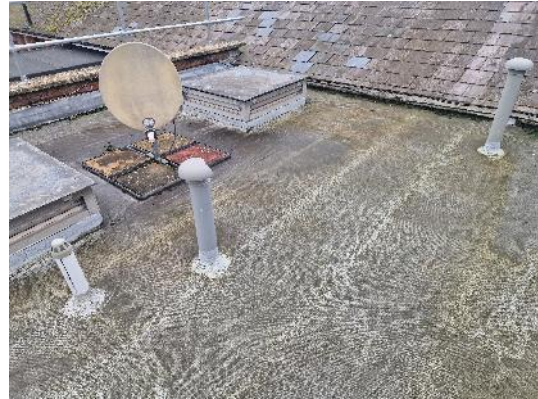
**Photograph E – Lower flat roof**

- 3.12 Photograph E shows the lower flat roof appears to be overlaid with a glass reinforced plastic (GRP) waterproofing system that was found to be suffering from *alligating* and loss of adhesion.

Defects of this type are typically caused by solar exposure and/ or the aging of the coating. The fissures pose a risk of water ingress, with remedial action strongly recommended.

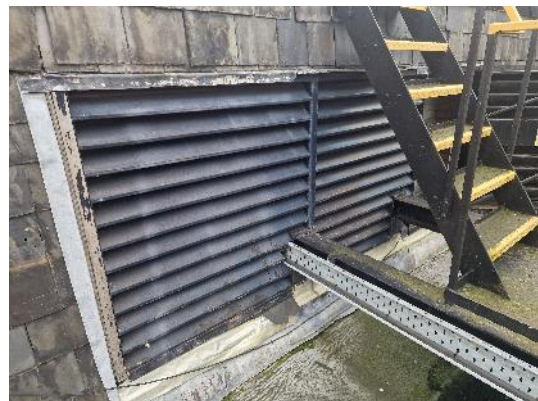
**Photograph F – Louvre screen**

- 3.14 Access to the roof areas is gained via a doorway located in a louvred panel measuring approximately 3m (width) x 1.2m (height) – Photograph F.

The louvre is surrounded by a lead flashing and located in a partition constructed with vertical slates to the outer face. Full refurbishment is recommended including re-hanging of the slates, together with repair and decoration of the timber subframe and metal louvre.

| Louvre screen | Refurbishment of louvre screen including, rehangng of slates, together with repair and decoration of all metalwork and timber joinery. |

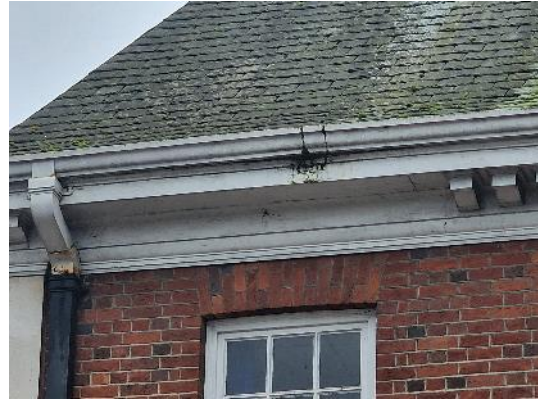
**Photograph G – Rainwater goods**

- 3.16 Photograph G shows rainwater goods to the building are of cast iron manufacture decorated in gloss paint.

As with the roof joinery, the installation was found to be damaged in areas and suffering from corrosion, with a requirement for localised repair and redecoration.

| Rainwater goods | <p>Repair and decorate cast iron rainwater goods to front facing elevations.</p> <p>Replacement of defective rainwater good to rear elevations.</p> |

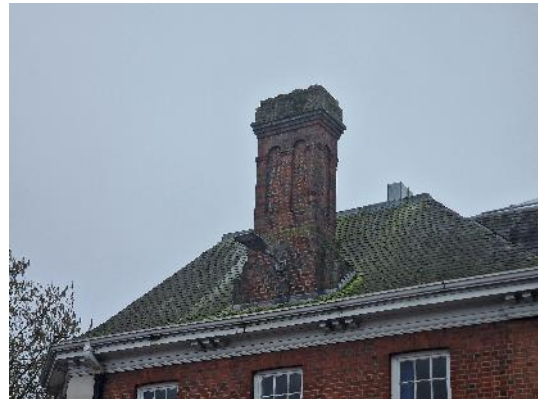
**Photograph H – Chimneystack**

- 3.18 Despite no evidence of progressive structural movement, slight deterioration was noted to mortar and it is recommended localised re-pointing works be carried out.

Replacement of the lead flashing at the junction with the slate covering adjacent should be carried, as part of the refurbishment of the latter.

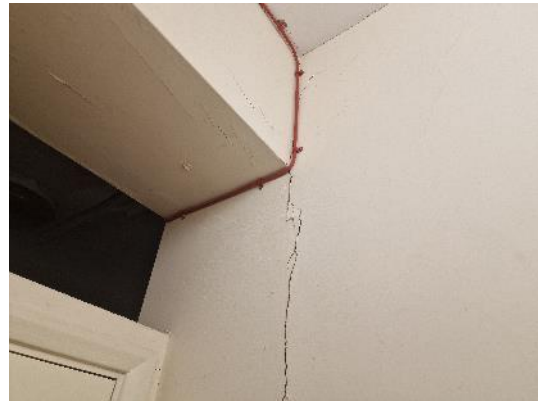
**Photograph I – Evidence of cracking at first floor level**

- 3.20 It is understood the building has suffered from structural movement and evidence of cracking was identified internally, within the accommodation at first floor level. Where visible, fractures measure between hairline and 3mm in thickness, predominantly located at the junction between the load bearing walls and masonry partitioning (photographs 17 & 18).
- 3.21 The Building Research Establishment (BRE) Digest 251 classifies cracking based on its width - providing guidance accordingly:

*“Cracking that measures between 1mm to 5mm is classified as Category 2 – Slight. These cracks can be easily filled and redecoration is probably required. Cracks are often not visible externally and recurrent cracks can be masked by suitable linings. Some external re-pointing may be required to ensure weather-tightness. Doors and windows may stick slightly.”*

- 3.22 Based on the findings of the inspection, it is recommended that the condition of the walls be monitored in accordance with BRE Digest 343 for twelve months to ensure any evidence of seasonal movement is recorded.

Should further movement be noted, it is recommended that additional advice be sought. It is envisaged that possible remedial repairs would involve the installation of steel strapping, although it should be noted that at the time of the inspection it is deemed unlikely that this will be required.

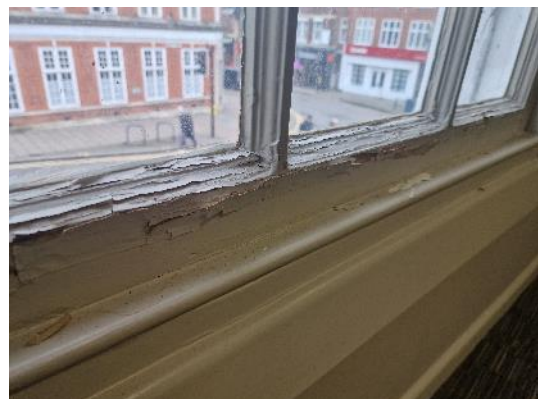
**Photograph J – Water ingress emanating from window frames**

- 3.23 The windows to the property are of solid timber manufacture in a vertical sliding sash design, fitted with single glazing.
- 3.24 Photograph J shows that despite generally being in fair condition there is evidence that moisture ingress is emanating from the perimeter of some frames, indicating that the mortar fillets have failed.

Although decorations are considered reasonable, it would be prudent to consider refurbishment during any planned erection of a scaffold, in order to maximise capital expenditure.

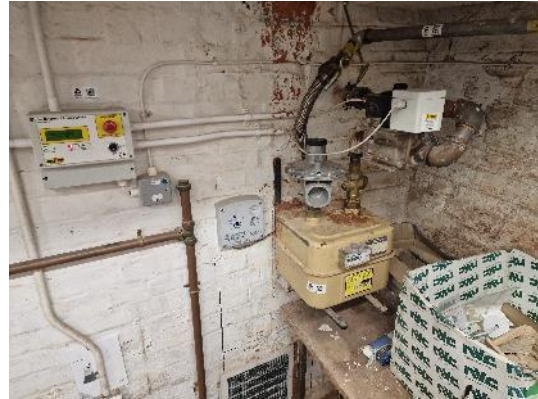
**Photograph K – Damp ingress at basement level**

- 3.26 The inspection within the basement revealed evidence of moisture ingress envisaged to be caused by hydroscopic pressure. Depending on the proposed use for the space, localised repairs and the application of a moisture resistant render may suffice, with specific attention given to the affected areas located adjacent to the gas meter.

Evidence of corrosion was noted in the gas supply pipework and it is recommended plaster repairs be undertaken at this location.

| Basement | <p>Repair and decoration of gas supply pipework together with damp proofing works.</p> <p>Replacement of roof-lights.</p> |

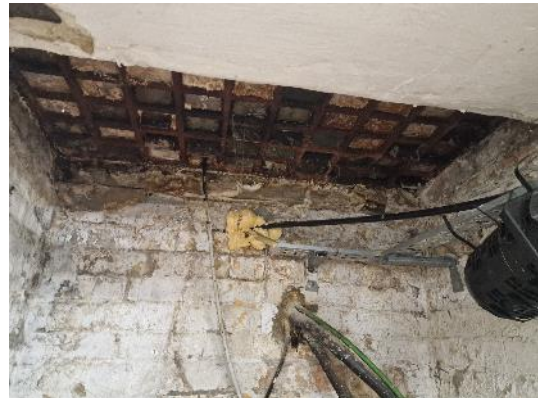
**Photograph L – Pavement light**

- 3.27 The inspection revealed evidence of damp ingress at basement level, deemed to be emanating from a combination of the high water table and defective pavement lights – Photographs L.

It is common for pavement lights of this type to suffer from degradation, and it is recommended they be refurbished to ensure a suitable seal is maintained.

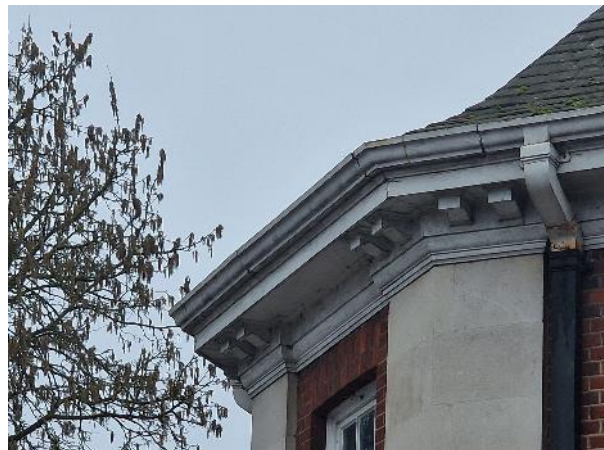
2. Roof joinery

| Roof joinery | Repair and decoration of timber roof joinery. |

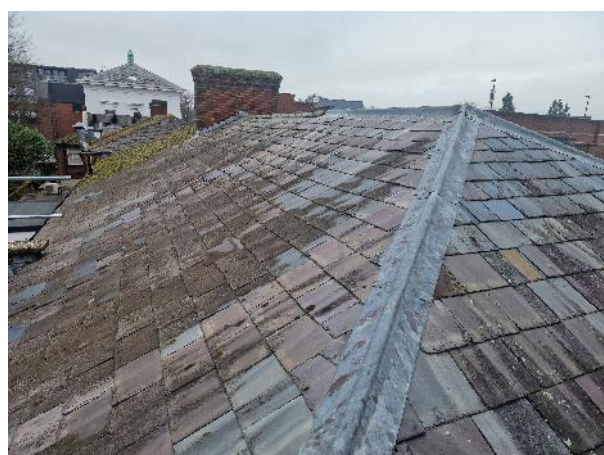
6. Roof to rear projection

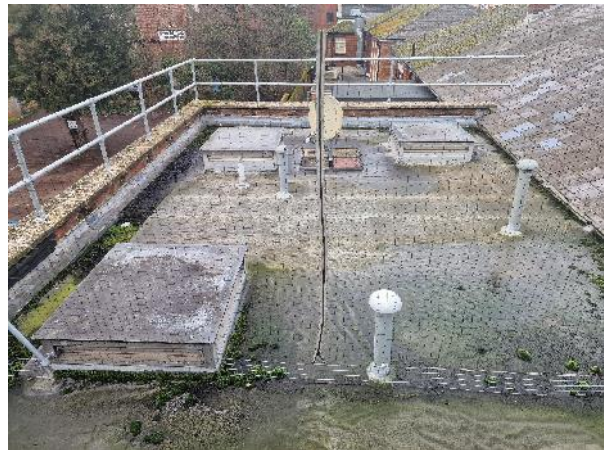
- 3.11 The building is constructed with two additional flat roof portions at the rear, both weathered in asphalt, similar to the crown roof above (photograph 8). The asphalt was found to be blistering, slumping and fractured and again evidence of extensive moisture ingress was noted internally within the accommodation at second and first floor level. Full refurbishment is therefore recommended including the introduction of PIR insulation, in order to improve thermal performance.

8. Flat roof to rear

| Flat roofs | <p>Installation of a built-up multi-layer elastomeric mineral felt waterproofing system, complete with PIR insulation to improve thermal performance.</p> <p>Replacement of single timber framed roof window.</p> |

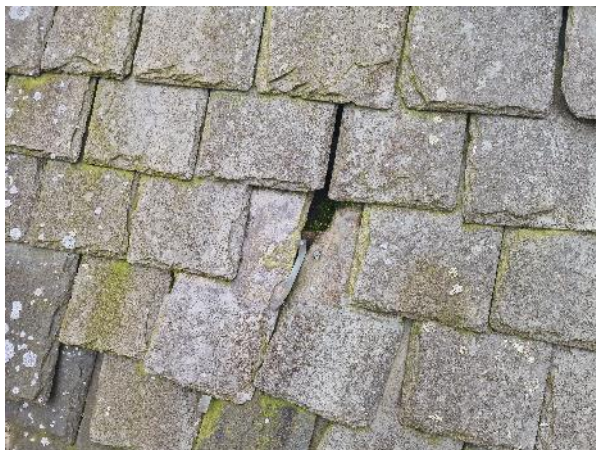
9. Damaged slates

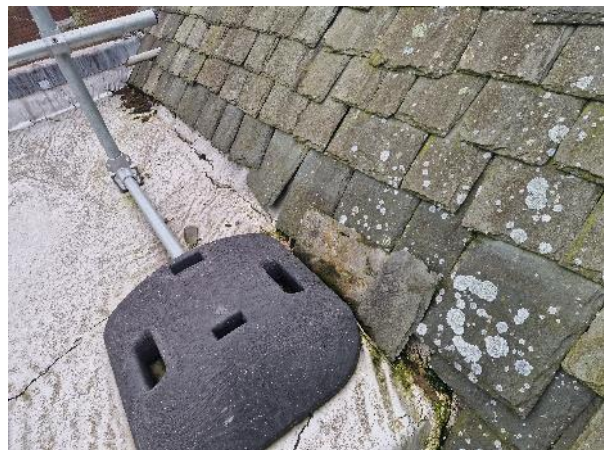
10. Loose slates

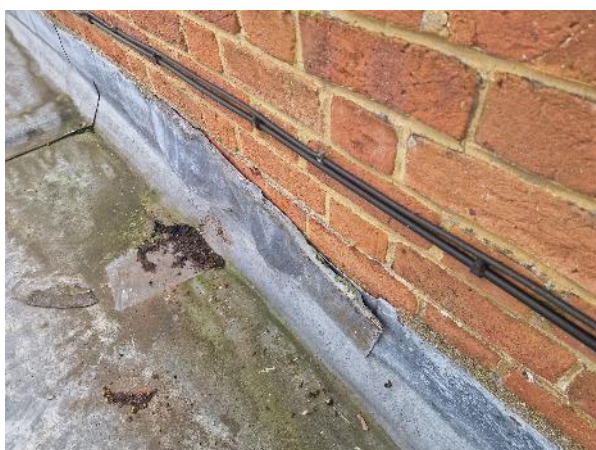
11. Poor flashing detail

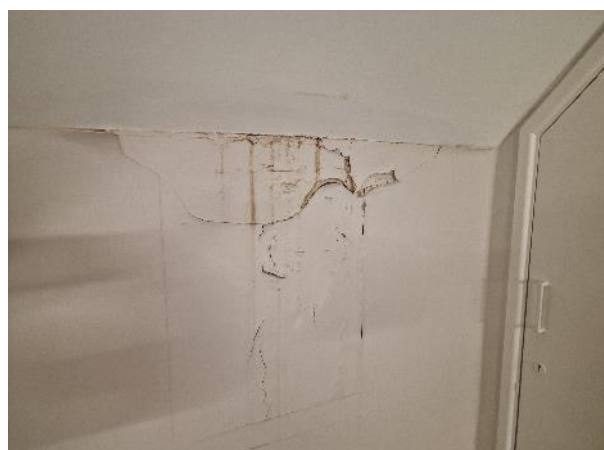
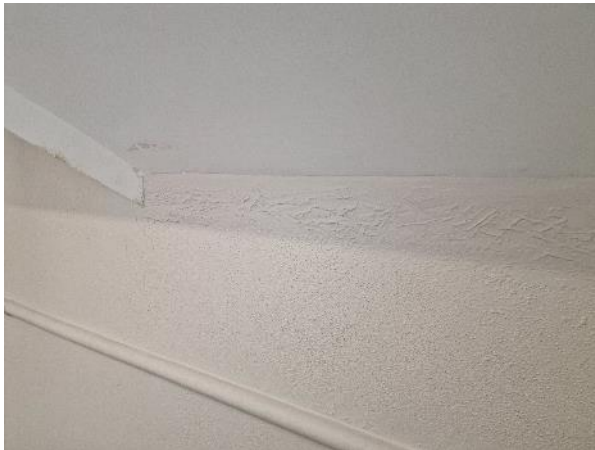
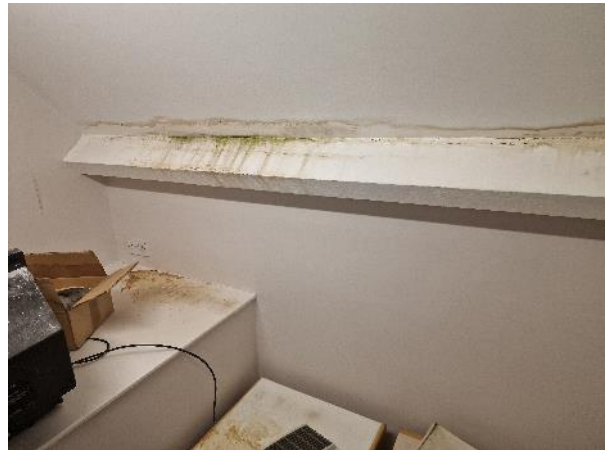
The main roof to the building is dual pitched and constructed with a central crown weathered in asphalt. The pitched portions are clad with natural slate and were generally found to be in poor condition in areas, with a number of damaged and missing sections were identified (photograph 9 & 10). This has resulted in moisture ingress internally within the second floor accommodation, indicating that the covering has failed with a requirement for full refurbishment (photographs 12, 13, 14 & 15).

12. Water ingress from main roof

| Main roof | <p>Full refurbishment of main roof including stripping and reinstatement of existing natural slate covering with a nominal allowance for replacement.</p> <p>Slate covering to be re-hung off new battens with the installation of a breathable membrane, replacement battens and insulation.</p> |

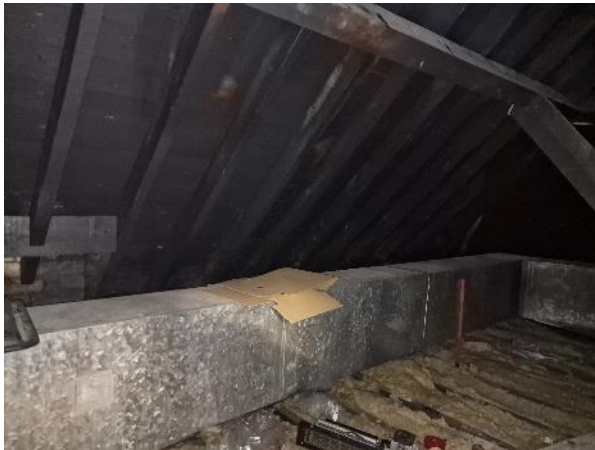
3.2 The inspection within the eaves' storage indicates the roof is close boarded, with an absence of sarking felt (photograph 15). It is therefore recommended this be overlaid with a breathable membrane to provide both weathering and drafting mitigation. The principal role of sarking felt is to prevent draughts, with the added benefit of protection of the roof-space from driving rain. Installing a new breathable membrane would improve the thermal performance of the building.

15. Mian roof-space

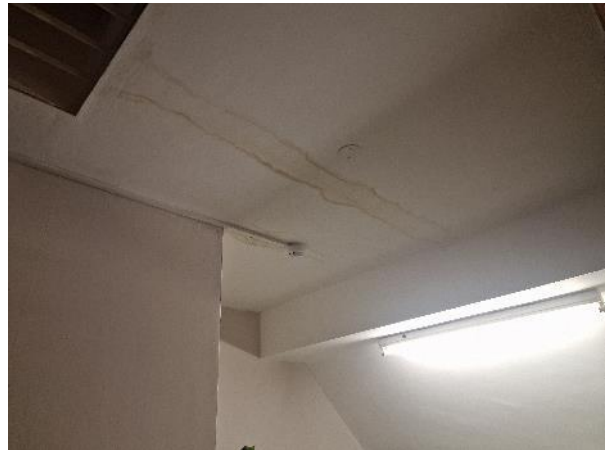
16. Water ingress from central crown

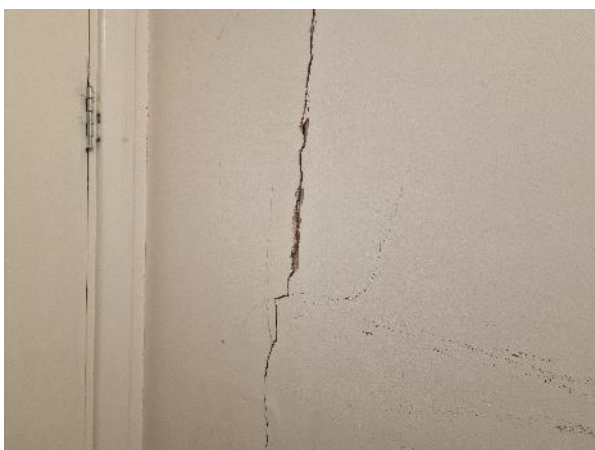
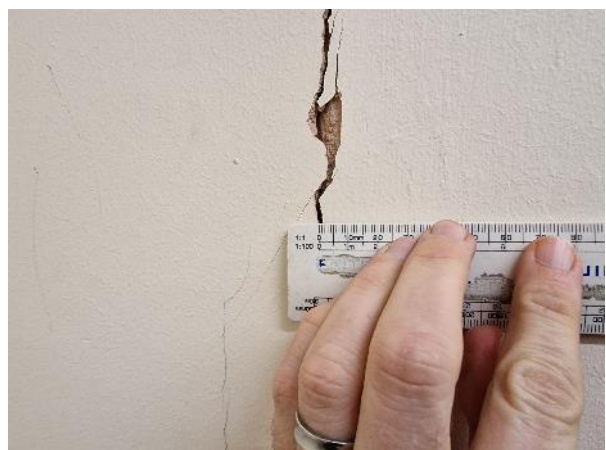
17. Cracking at first floor level

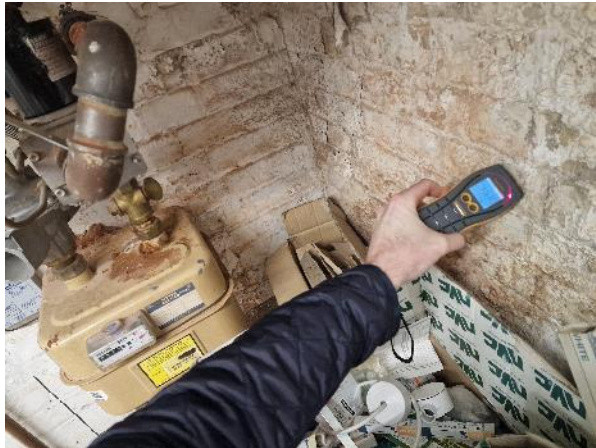
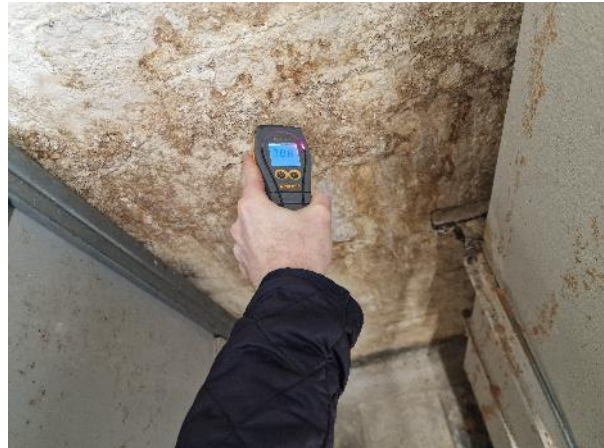
19. Penetrating moisture ingress at basement level

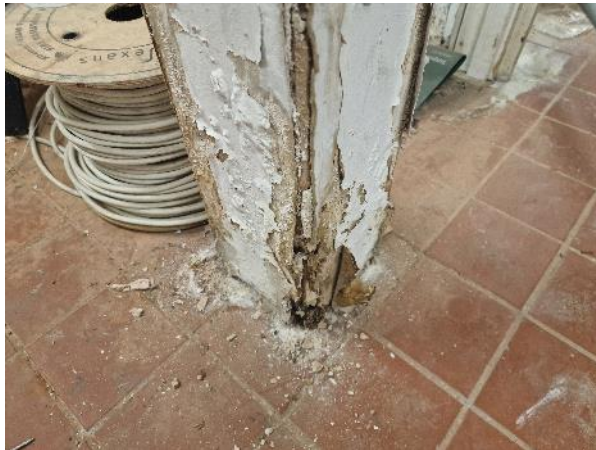
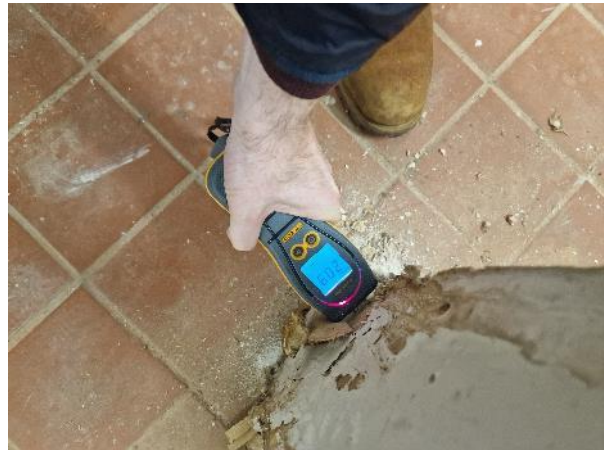
21. Timber decay to supporting post

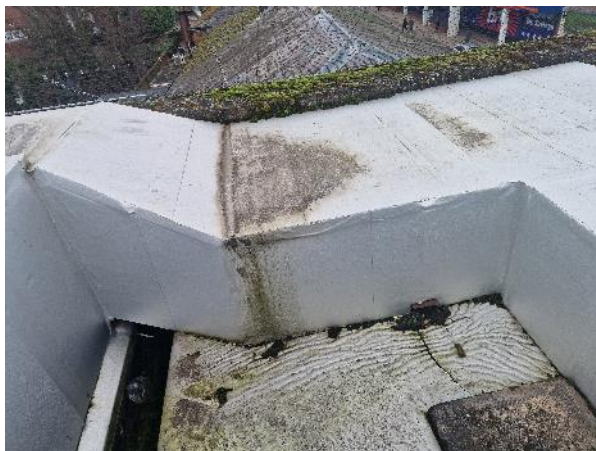
- 3.13 The upper flat roof houses an air handling unit (AHU) and ductwork. It is recommended this be adapted and temporarily removed in order to enable refurbishment of the roof covering and address the water ingress being experienced within the accommodation beneath (photograph 23).

The ductwork to the AHU is generally in poor condition, envisaged to be a contributing factor to the water ingress being experienced within the accommodation beneath. It is therefore recommended it be overclad to ensure suitable weathering is provided.

23. Defective ductwork

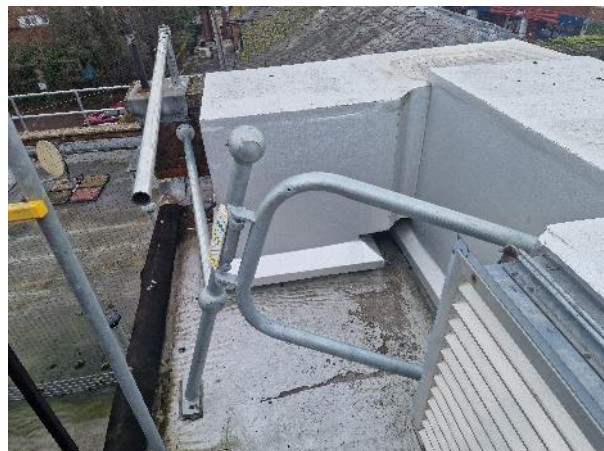
- 3.15 Despite evidence that edge protection has been installed within the two year period prior to the inspection, a defective section was noted to the upper flat roof and it is recommended this be adapted, as it fixes through the waterproofing beneath (photograph 24).

24. Defective edge protection

| Edge protection | Repair existing non-compliant and defective free standing edge protection to rear flat roof. |
