# **Photographic Survey - Windows**

**Old Sextons  
Sandon  
Buntingford  
Hertfordshire  
SG9 0QX**

**Conservation Officer Site Visit – 17 September 2025**

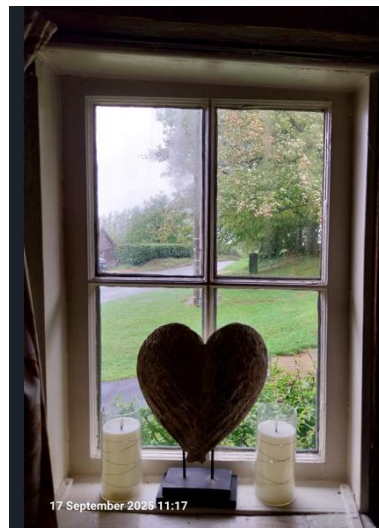
### Drafting error to rear (north) elevation – W8 (quarter-pane not 6-pane)

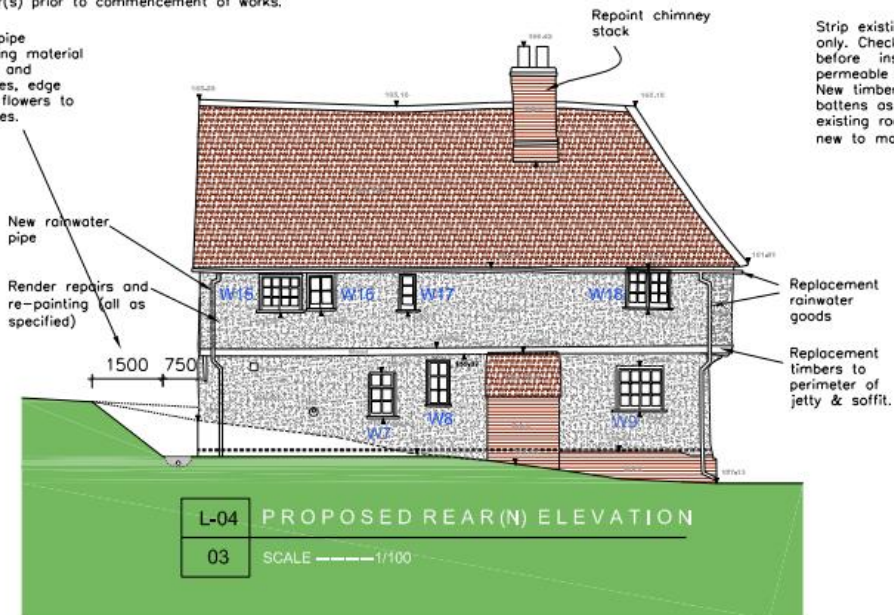
Trial hole exploration required to confirm condition/extent of buried structure.

Area of soil cut back to an incline and french drain provided to external perimeter of dwelling at bottom of sloped area, to suit site levels. French drain to be set approx 150mm below slab level.

Structural Engineer to confirm and all agreements to be secured with land owner(s) prior to commencement of works.

100mm dia perforated pipe surrounded in free flowing material wrapped in a geotextile and topped with large pebbles, edge planning of ornamental flowers to be agreed with all parties.
