## STRUCTURAL INSPECTION

Barn Structure  
Rook's Nest Farm  
Therfield  
Hertfordshire

Report No. 4698/001

November 2010

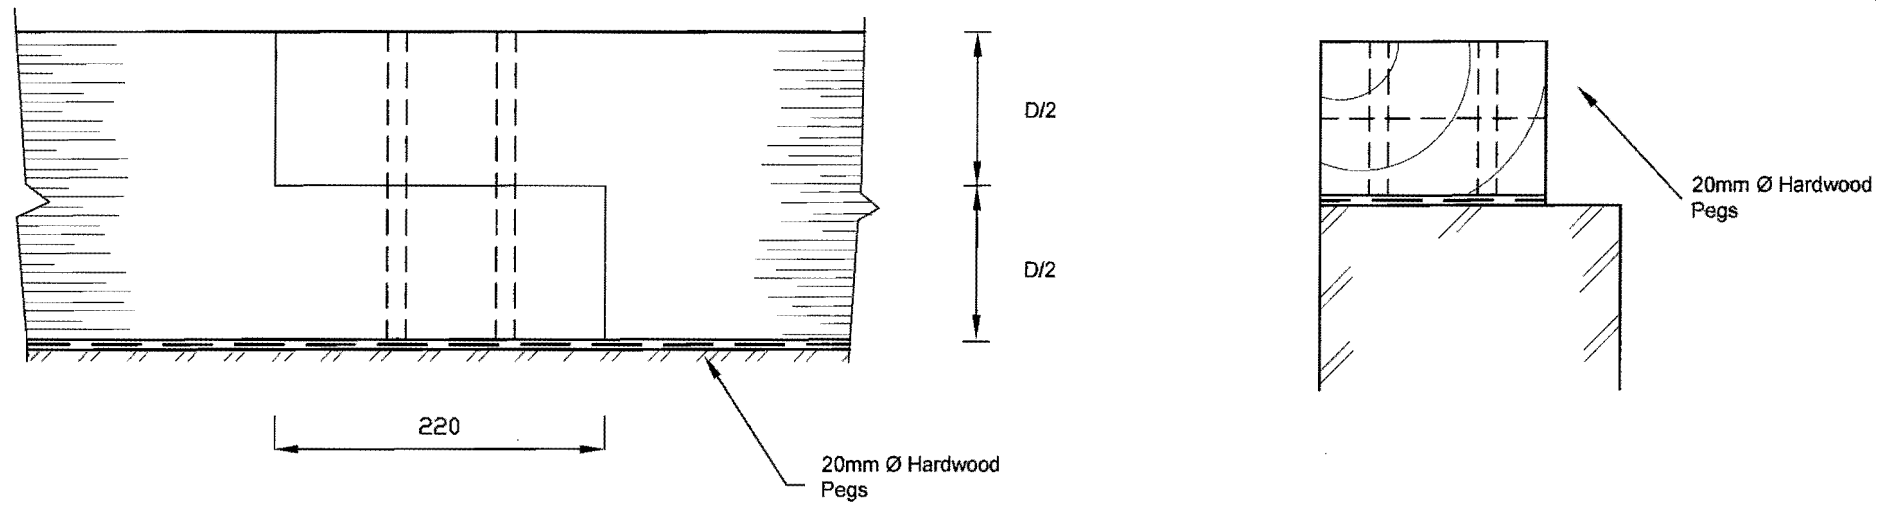
## CILL-PLATE HALF-LAP JOINT (1:5)

Post D3 will require surgery to the lower 300mm section, where it has rotted away due to rainwater saturation. The cill plates locally will also require half-lap surgery to approximately 400mm of the front elevation cill plate and the formation of a new mortice. It is recommended that the existing blacksmith-formed corner strap to the adjacent cill plates is retained in this location.

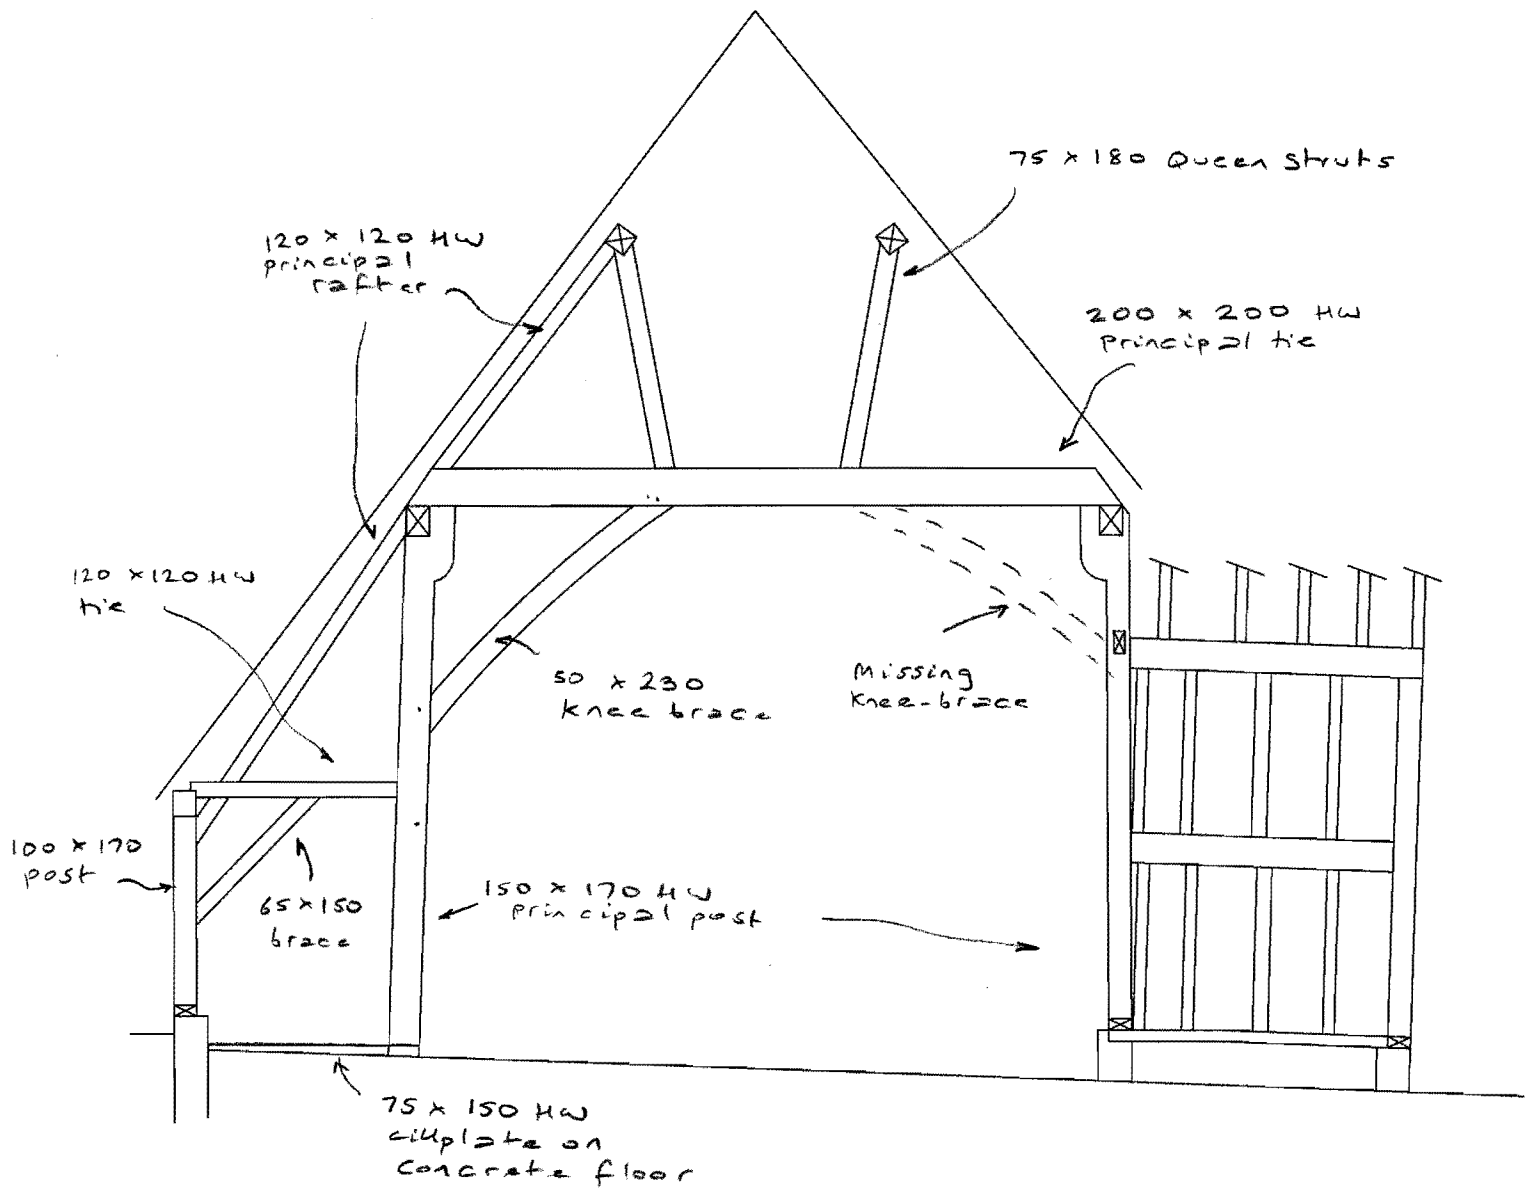
TYPICAL QUEEN-POST FRAME  
(1:50)

Post 1C has a significant number of historic mortices which have weakened the member. It is recommended that the mortices are infilled by resin-bonding cut shims of hardwood into the voids. Mortice and tenon of the knee brace will also require surgery in this location.

The frame on Gridline C has displaced towards the front elevation by up to 150mm, as a result of the settlement of the foundations to bay C to D. It should be possible to pull the distorted frame back into vertical alignment following the recommended underpinning works, before repair and strengthening is carried out.

The knee brace to post 2C has displaced due to fractured pegs. This will need to be realigned and re-pegged, once the frame has been pulled back into vertical alignment.

There is a major split at the knee-brace junction with the principal tie underside. This will need to be repaired using resin injection and ensure pegs that new hardwood timber pegs are introduced to secure it in position.
