On Site Survey Form

| Site Address: | Mill Farm, High Street, Whitwell Hitchen, SG4 8AG |
| What is the purpose of the works? | Drain Mapping Only |

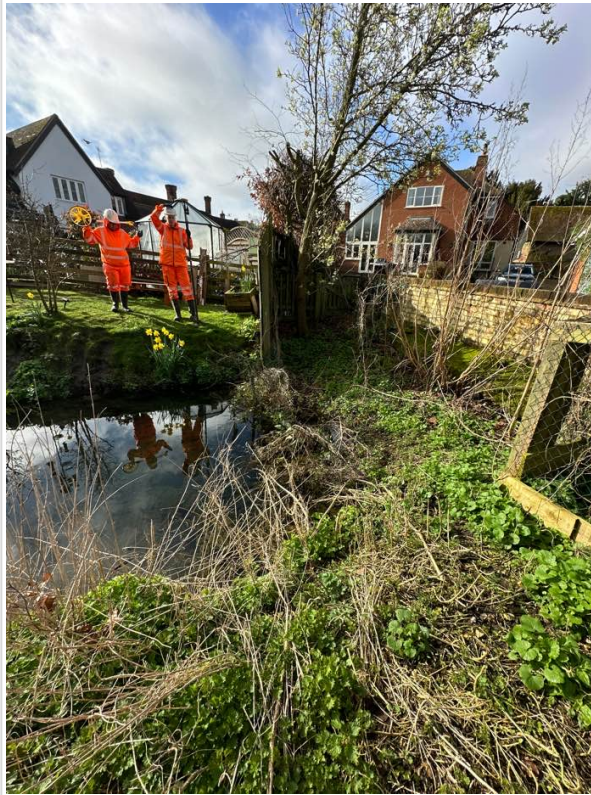
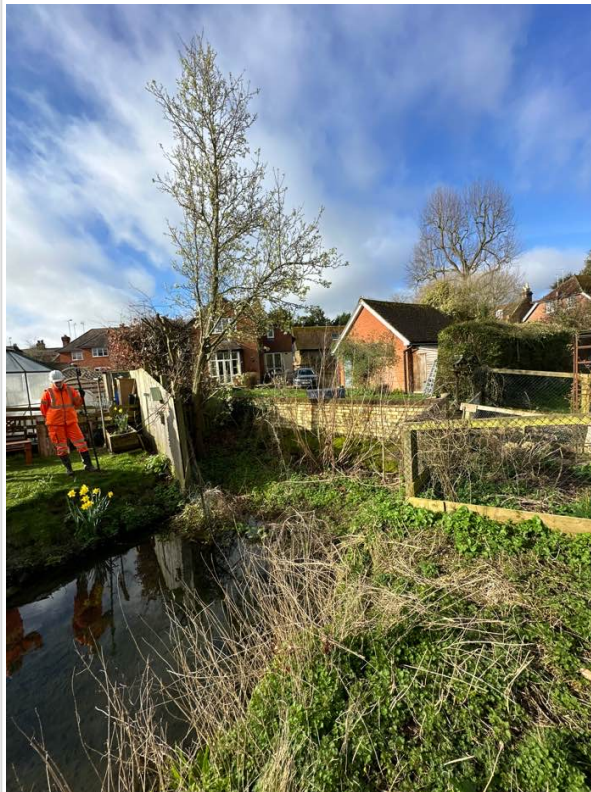
Figure 2.

Upon our arrival at the site, our preliminary investigation focused on examining the designated outfall of the culvert as indicated by the client and depicted in the accompanying images (Figure 2 and Figure 3)

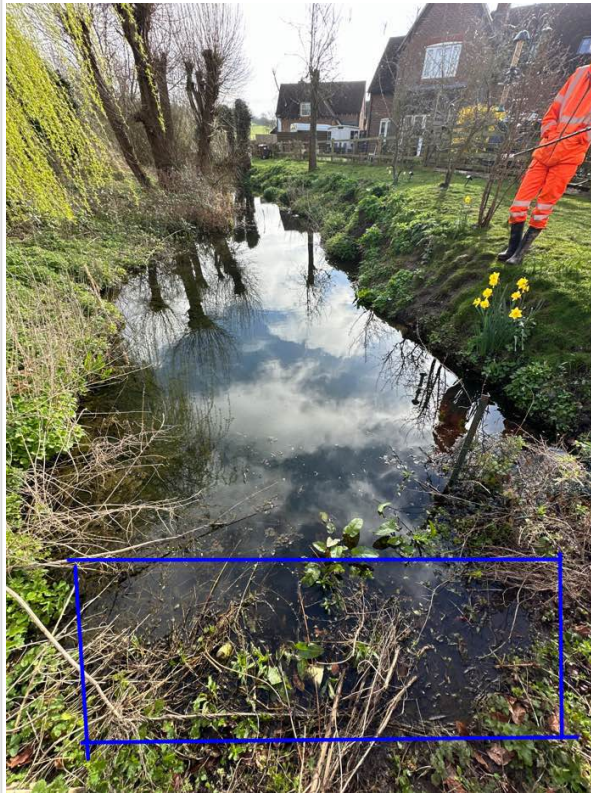
Figure 4.

Our examination of the culvert's pipework hinted at possible burial or substantial blockage, suggesting its non-operational status

Unfortunately, during the site visit, the pipe was not visible, preventing us from confirming the existence of an outfall at this location.

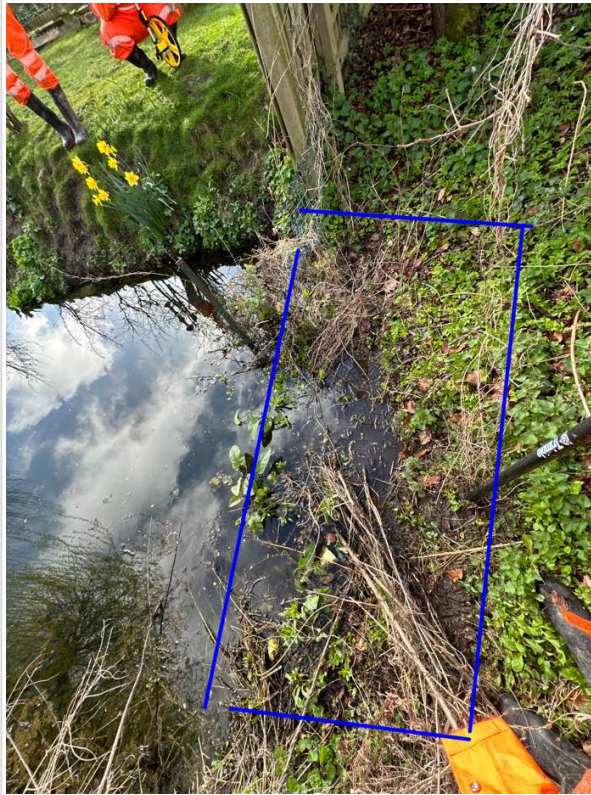
Figure 5.

We utilized the GIS stick to conduct water probing, confirming that the ground beneath our current position is solid.

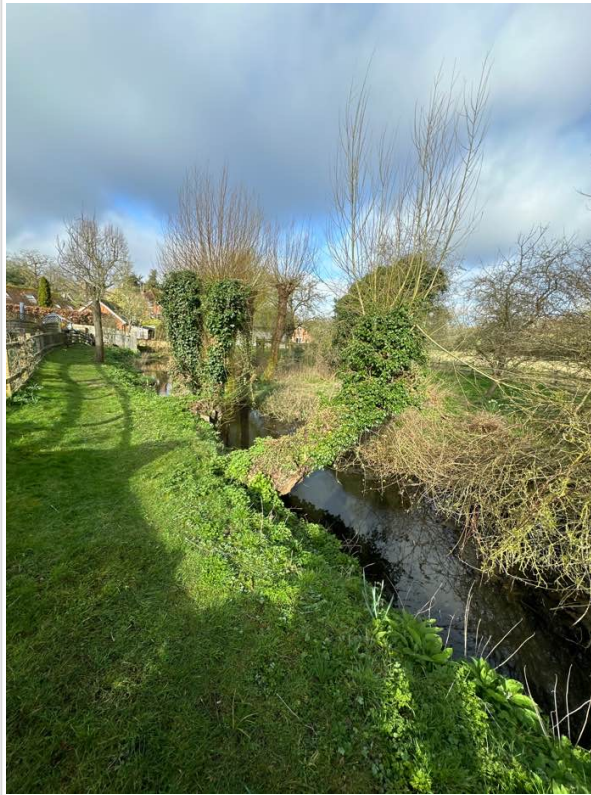
Figure 8.

We conducted a comprehensive examination downstream along the brook to verify the cause of its stagnation.

Our investigation conclusively determined that the brook remains stagnant due to the absence of any contributing discharge to facilitate its flow.

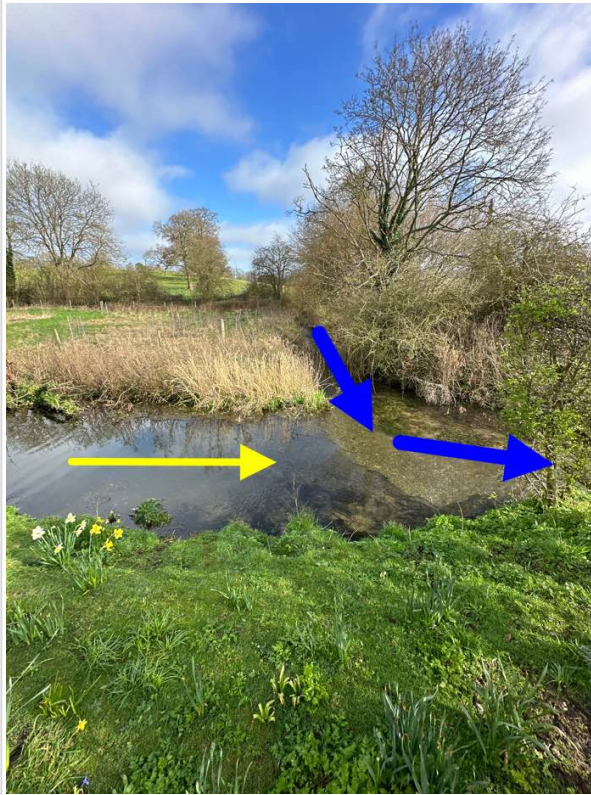
Figure 8.

This is the point of convergence between the stagnant brook and the River Mimram. The blue arrow indicates the Mimram River, while the yellow arrow marks the stagnant brook.

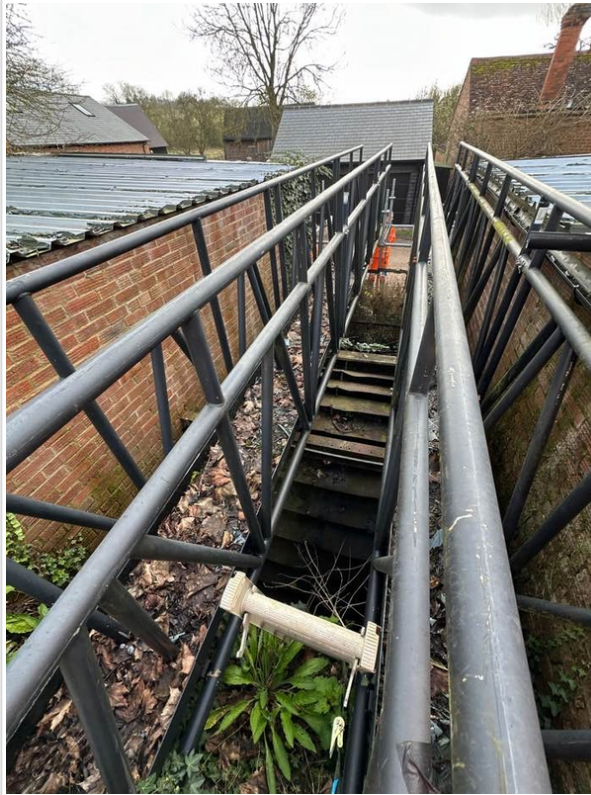
Figure 11.

As we investigated Upstream of the presumed culvert, we had the opportunity to meet with a property owner who generously provided access to the old watermill on the premises which is presently inactive.

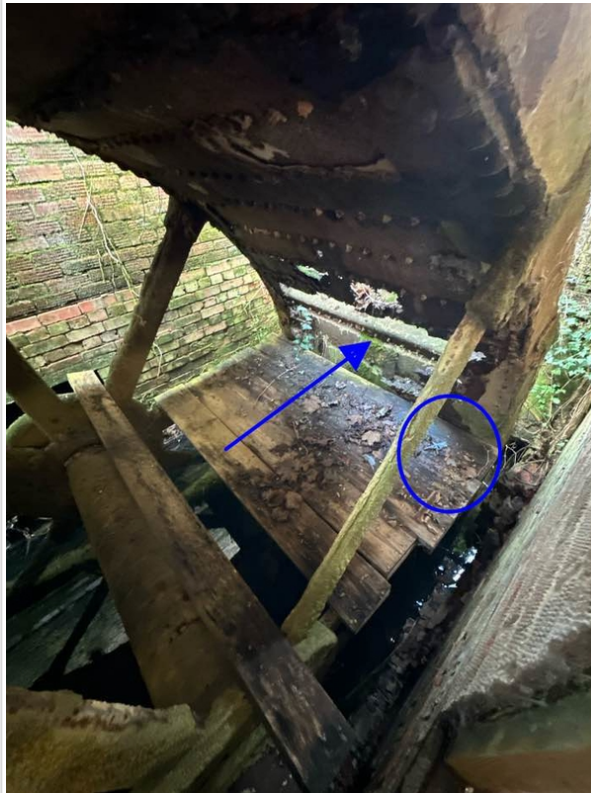
Figure 12.

The provided image depicts the area beneath the watermill, with the blue circle representing the culvert extending towards the stagnant brook.

Upon examination of the watermill, it became apparent that the culvert consists of pipework measuring approximately 600mm to 700mm in diameter.

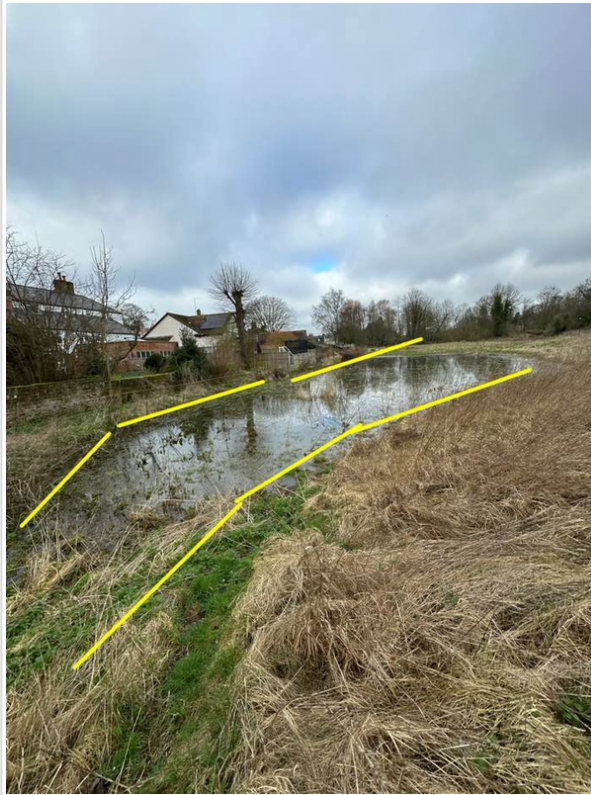
Figure 13.

Referring to the map, our position corresponds to the existing brook pathway leading toward the watermill. (Highlighted in yellow lines)

The stagnant water indicates the original channel through which water previously flowed, ultimately joining the River Mimram

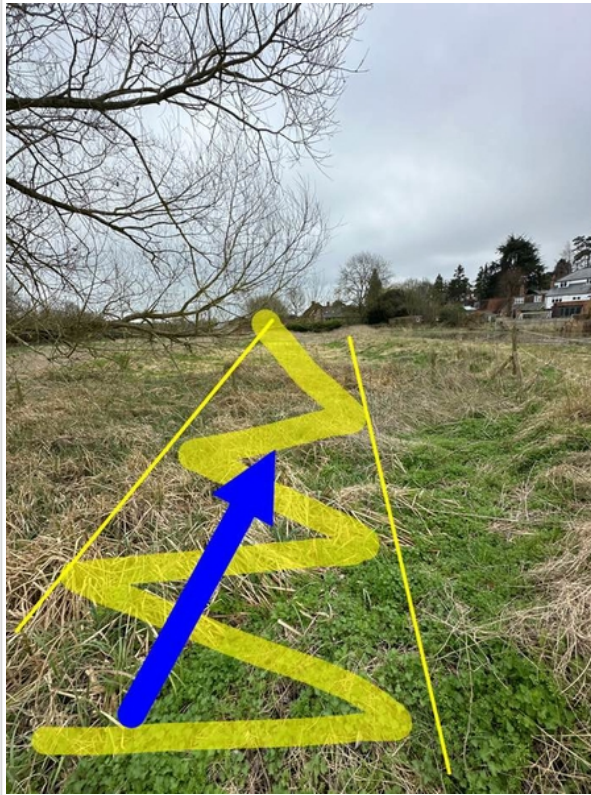
Figure 18.

The marked line represents the existing channel directing flow towards the Watermill. As depicted in the image, the area now features solid ground covered in grass, devoid of any water flow

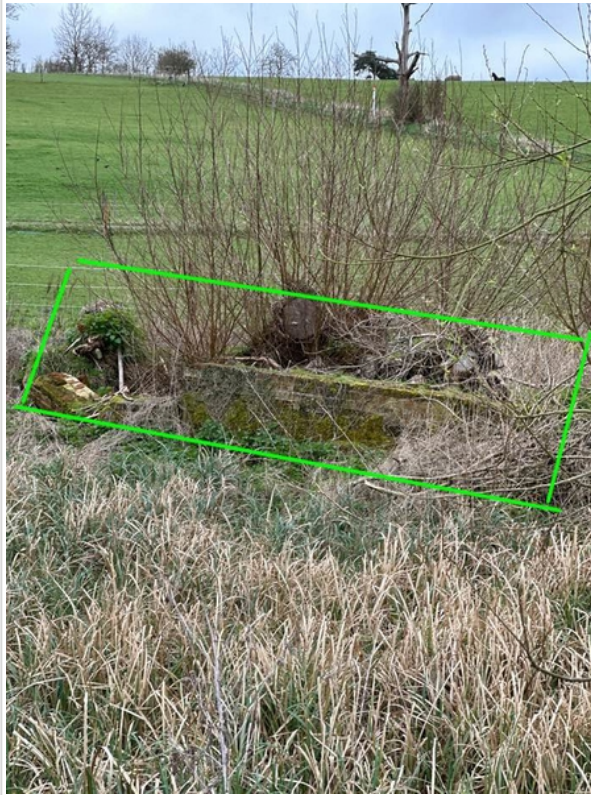
Figure 19.

The highlighted green area suggests the presence of a wall, possibly indicating the historical presence of a brook in this vicinity.

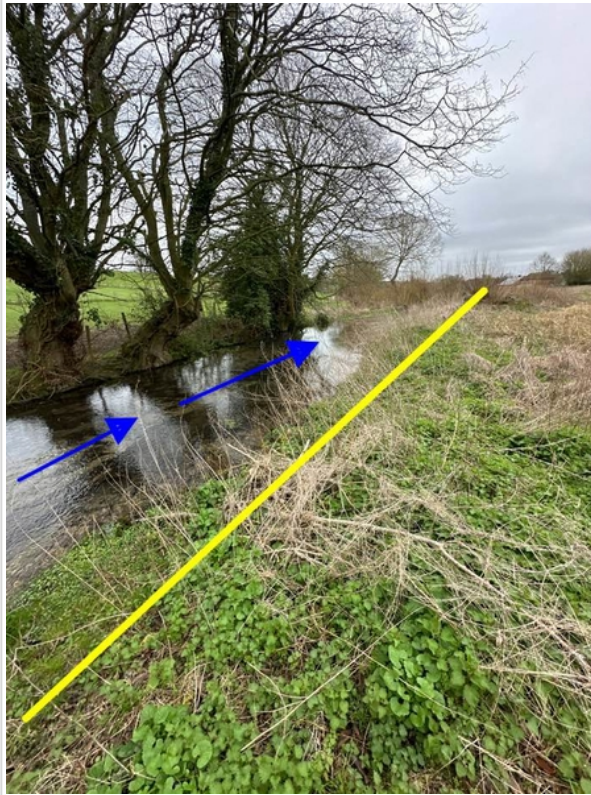
Figure 20.

River Mimram

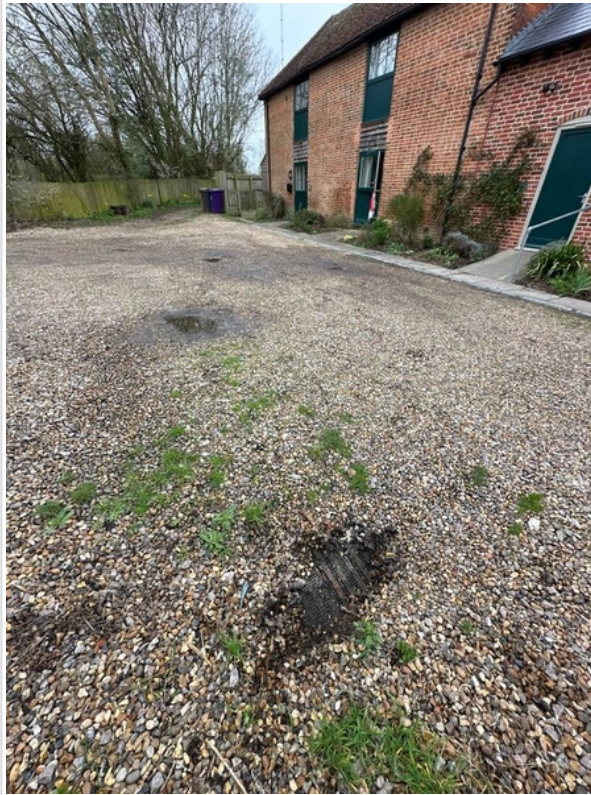
Figure 23.

Road gully located in the state
