# Arboricultural Subsidence Report

## SUBSIDENCE INVESTIGATION AT:

North Lodge  
High Street  
Codicote  
Hitchin  
SG4 8XB

| <b>Report Date:</b> | 01/06/2026 |

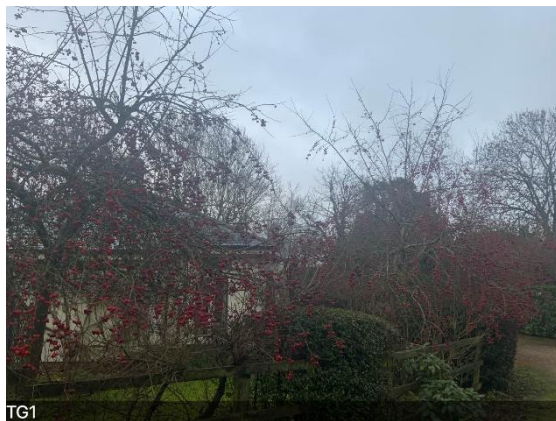
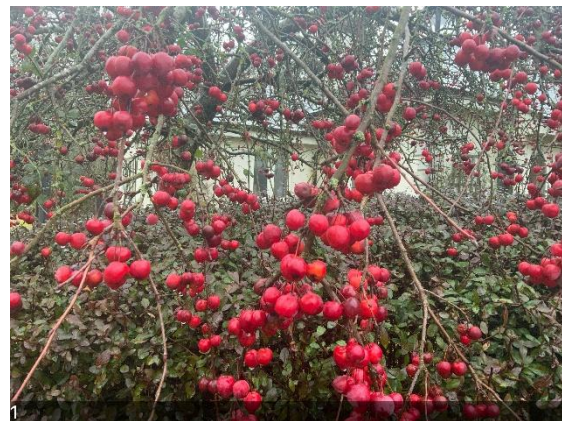
TG1

| Ref. | Species | Height (m) | Canopy radius (m) | DBH (cm)<br>No. of stems | Estimated age and Life stage | Distance to area of damage (m) | Tree owner/ location | Vitality, previous works, comments | TPO/ CA |
|---|---|---|---|---|---|---|---|---|---|
| <b>TG1</b> | Crabapple | 4 | 2.9 | 6 # | 10 Young | 4.2 | Insured | Good. No recent management. Moderate-water demand. | CA |

- Crabapple (TG1) is within the 75% distance for damage in the C&R study.
- Cherry (T2) is within the 50% distance for damage in the C&R study.
- Coast Redwood (T3) has a high-water demand and is within the maximum distance for damage in the C&R study.

| Ref. | Species & estimated age | Height DBH (m) | Dist. to area of damage (m) | Vitality & previous works | Tree owner/ location | Recommendation | TPO CA |
|---|---|---|---|---|---|---|---|
| <b>TG1</b> | Crabapple<br>10<br>Young | 4<br>(0.06) | 4.2 | Good | Insured | Maintain at no greater than current size through periodic pruning. | CA |

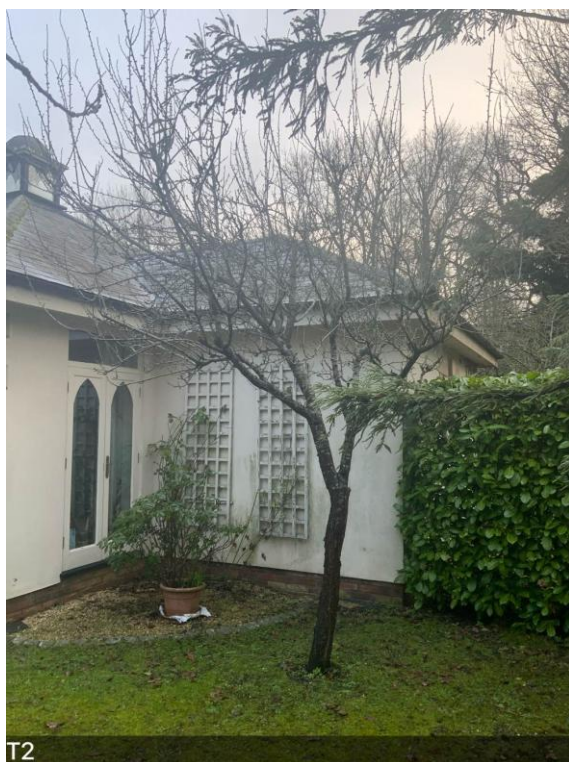
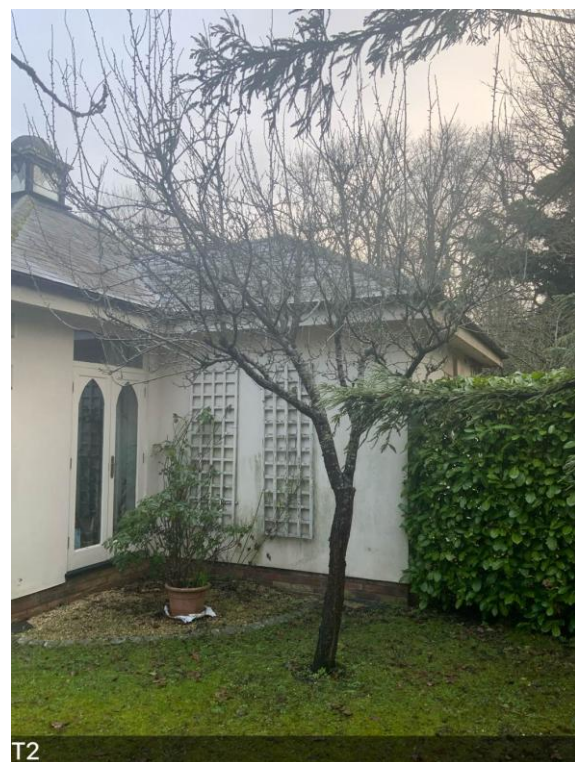
T2

| Ref. | Species | Height (m) | Canopy radius (m) | DBH (cm)<br>No. of stems | Estimated age and Life stage | Distance to area of damage (m) | Tree owner/ location | Vitality, previous works, comments | TPO/ CA |
|---|---|---|---|---|---|---|---|---|---|
| <b>T2</b> | Cherry | 4 | 2.5 | 6 #<br>1 | 10 Young | 2.7 | Insured | Good. Regular pruning. Moderate-water demand. | CA |

| Ref. | Species & estimated age | Height DBH (m) | Dist. to area of damage (m) | Vitality & previous works | Tree owner/ location | Recommendation | TPO CA |
|---|---|---|---|---|---|---|---|
| <b>T2</b> | Cherry<br>10<br>Young | 4<br>(0.06) | 2.7 | Good<br>Regular pruning | Insured | Remove close to ground level and treat stumps with herbicide to inhibit regrowth. | CA |

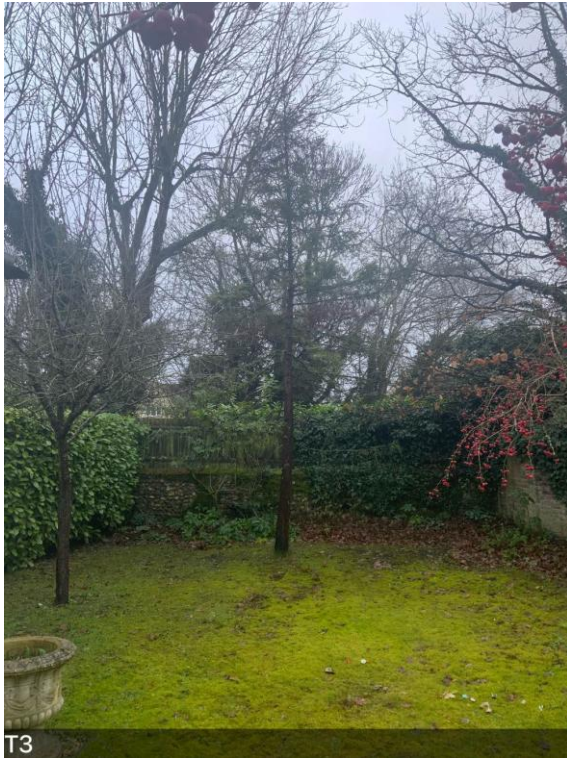
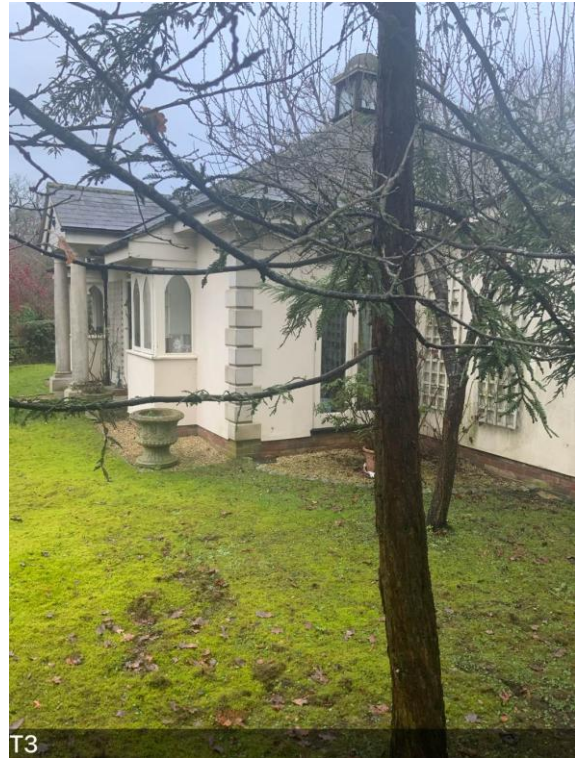
T3

| Ref. | Species | Height (m) | Canopy radius (m) | DBH (cm)<br>No. of stems | Estimated age and Life stage | Distance to area of damage (m) | Tree owner/ location | Vitality, previous works, comments | TPO/ CA |
|---|---|---|---|---|---|---|---|---|---|
| <b>T3</b> | Coast Redwood | 5 | 1.6 | 10 #<br>1 | 10 Young | 5.1 | Insured | Good. No recent management. High-water demand. | CA |

| Ref. | Species & estimated age | Height DBH (m) | Dist. to area of damage (m) | Vitality & previous works | Tree owner/ location | Recommendation | TPO CA |
|---|---|---|---|---|---|---|---|
| <b>T3</b> | Coast Redwood<br>10<br>Young | 5<br>(0.10) | 5.1 | Good | Insured | Remove close to ground level. | CA |

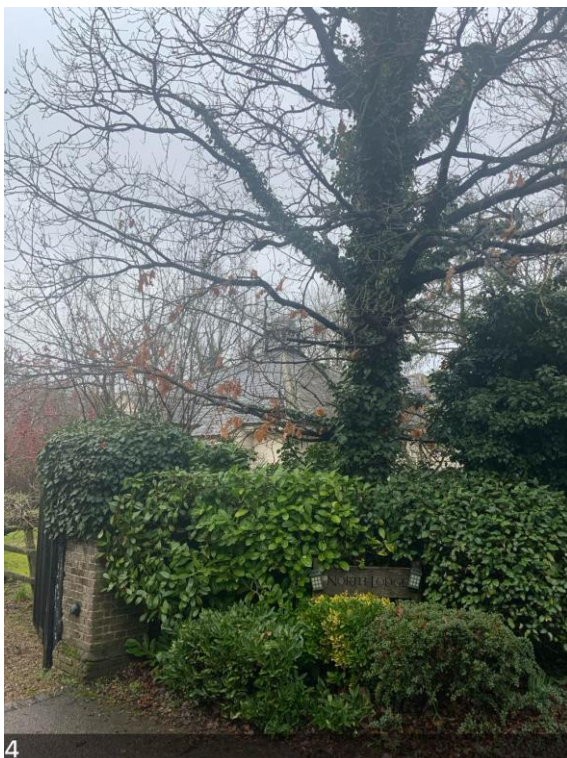
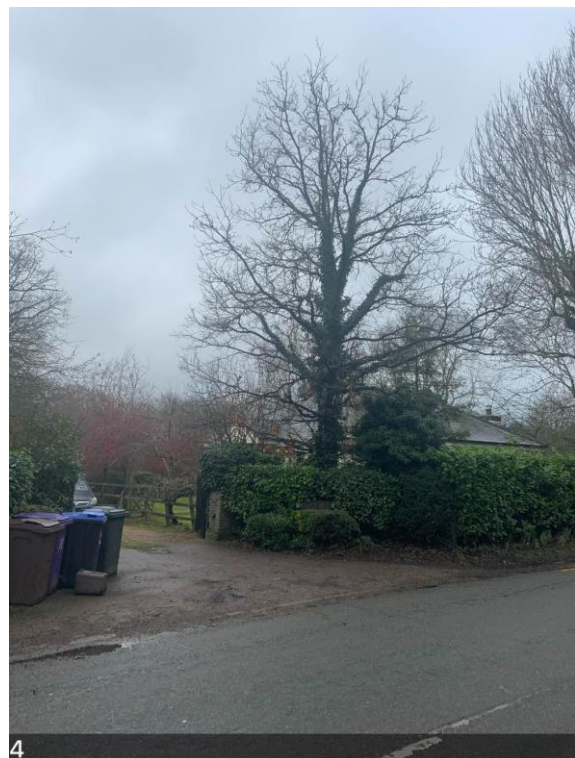
T4

| Ref. | Species | Height (m) | Canopy radius (m) | DBH (cm)<br>No. of stems | Estimated age and Life stage | Distance to area of damage (m) | Tree owner/ location | Vitality, previous works, comments | TPO/ CA |
|---|---|---|---|---|---|---|---|---|---|
| <b>T4</b> | Oak | 10 | 3.2 | 30 #<br>1 | 60 Early-mature | 8 | Council | Good. No recent management. High-water demand. | CA |

- Oak (T4) has a high-water demand and is within the 50% distance for damage in the C&R study.
- Ash (TG5) is within the 50% distance for damage in the C&R study.

| Ref. | Species & estimated age | Height DBH (m) | Dist. to area of damage (m) | Vitality & previous works | Tree owner/ location | Recommendation | TPO CA |
|---|---|---|---|---|---|---|---|
| <b>T4</b> | Oak<br>60<br>Early-mature | 10<br>(0.30) | 8 | Good | Council | Remove close to ground level and treat stumps with herbicide to inhibit regrowth. | CA |

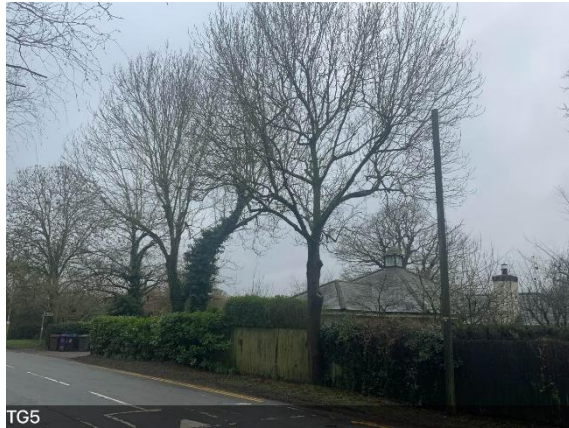
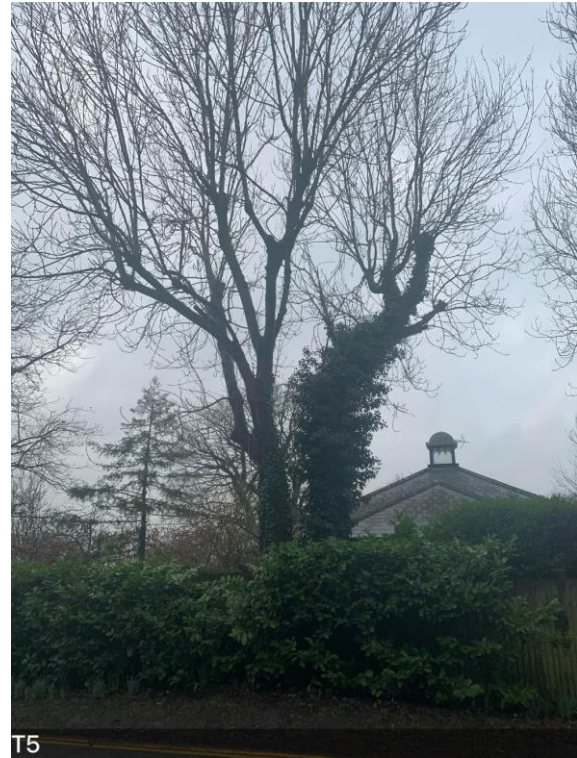
TG5

| Ref. | Species | Height (m) | Canopy radius (m) | DBH (cm)<br>No. of stems | Estimated age and Life stage | Distance to area of damage (m) | Tree owner/ location | Vitality, previous works, comments | TPO/ CA |
|---|---|---|---|---|---|---|---|---|---|
| <b>TG5</b> | Ash | 12 | 5.9 | 22 # | 20 Semi-mature | 4.4 | Council | Good. No recent management. Moderate-water demand. | CA |

| Ref. | Species & estimated age | Height DBH (m) | Dist. to area of damage (m) | Vitality & previous works | Tree owner/ location | Recommendation | TPO CA |
|---|---|---|---|---|---|---|---|
| <b>TG5</b> | Ash<br>20<br>Semi-mature | 12<br>(0.22) | 4.4 | Good | Council | Remove close to ground level and treat stumps with herbicide to inhibit regrowth. | CA |

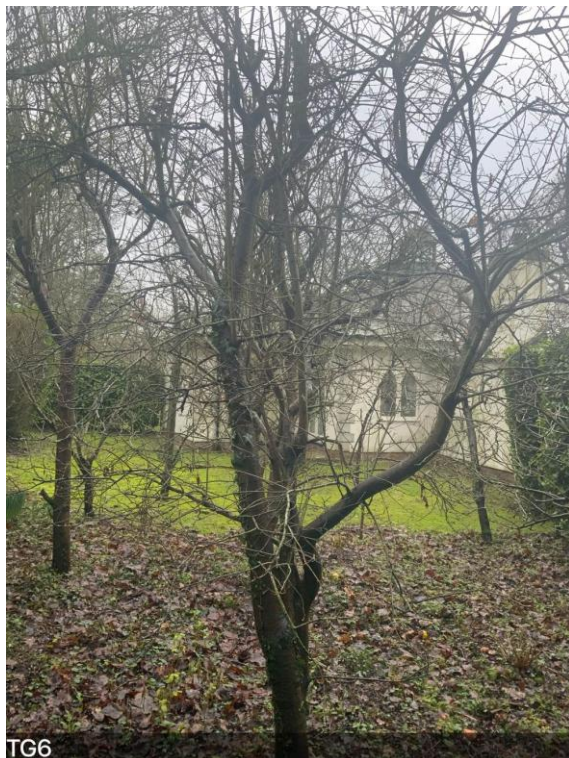
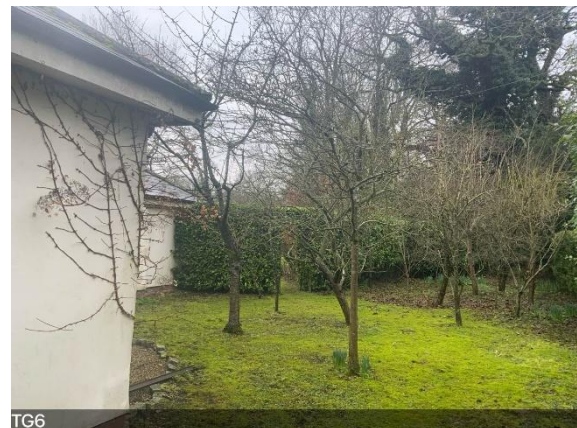
TG6

| Ref. | Species | Height (m) | Canopy radius (m) | DBH (cm)<br>No. of stems | Estimated age and Life stage | Distance to area of damage (m) | Tree owner/ location | Vitality, previous works, comments | TPO/ CA |
|---|---|---|---|---|---|---|---|---|---|
| <b>TG6</b> | Apple | 4 | 2 | 9 # | 20 Semi-mature | 2.2 | Insured | Good. Reduced. Moderate-water demand. | CA |

- Apple (TG6) is within the 50% distance for damage in the C&R study.
- Laurel (SG7) is within the 75% distance for damage in the C&R study.
- Hornbeam (T8) is toward the maximum distance for damage in the C&R study.

| Ref. | Species & estimated age | Height DBH (m) | Dist. to area of damage (m) | Vitality & previous works | Tree owner/ location | Recommendation | TPO CA |
|---|---|---|---|---|---|---|---|
| <b>TG6</b> | Apple<br>20<br>Semi-mature | 4<br>(0.09) | 2.2 | Good<br>Reduced | Insured | Remove close to ground level and treat stumps with herbicide to inhibit regrowth. | CA |

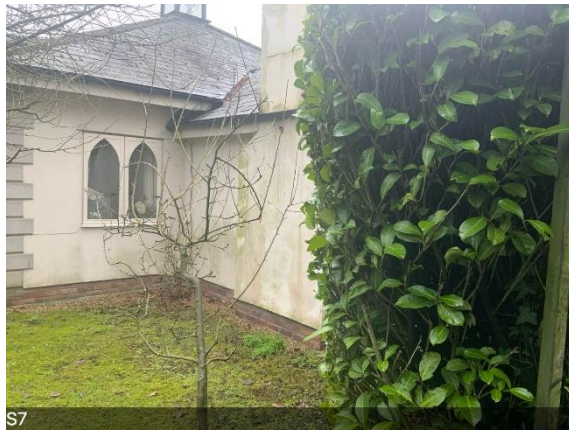
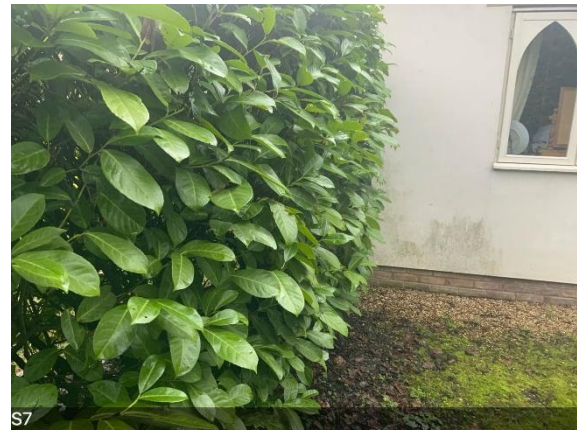
**SG7**

| Ref. | Species | Height (m) | Canopy radius (m) | DBH (cm)<br>No. of stems | Estimated age and Life stage | Distance to area of damage (m) | Tree owner/ location | Vitality, previous works, comments | TPO/ CA |
|---|---|---|---|---|---|---|---|---|---|
| <b>SG7</b> | Laurel | 3 | | | | 5.8 | Insured | Good. Regular pruning. Moderate-water demand. | No |

| Ref. | Species & estimated age | Height DBH (m) | Dist. to area of damage (m) | Vitality & previous works | Tree owner/ location | Recommendation | TPO CA |
|---|---|---|---|---|---|---|---|
| <b>SG7</b> | Laurel | 3 | 5.8 | Good<br>Regular pruning | Insured | Maintain at no greater than current size through regular pruning. | No |

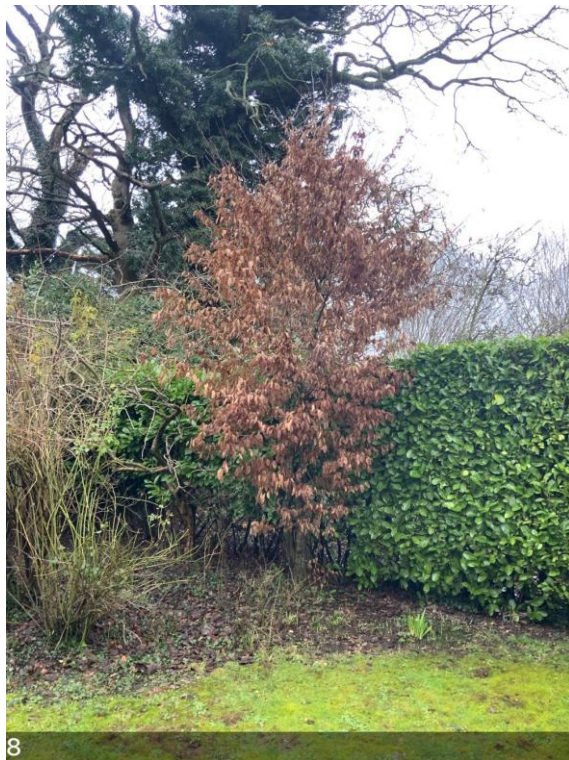
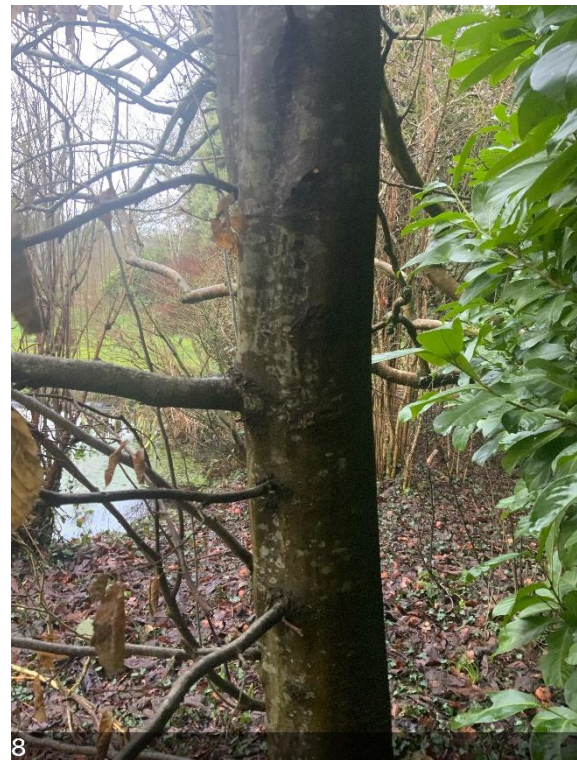
**T8**

| Ref. | Species | Height (m) | Canopy radius (m) | DBH (cm)<br>No. of stems | Estimated age and Life stage | Distance to area of damage (m) | Tree owner/ location | Vitality, previous works, comments | TPO/ CA |
|---|---|---|---|---|---|---|---|---|---|
| <b>T8</b> | Hornbeam | 4 | 0.8 | 10 #<br>1 | 20 Semi-mature | 5.1 | Insured | Good. No recent management. Low-water demand. | CA |

| Ref. | Species & estimated age | Height DBH (m) | Dist. to area of damage (m) | Vitality & previous works | Tree owner/ location | Recommendation | TPO CA |
|---|---|---|---|---|---|---|---|
| <b>T8</b> | Hornbeam<br>20<br>Semi-mature | 4<br>(0.10) | 5.1 | Good | Insured | Maintain at no greater than current size through periodic pruning. | CA |

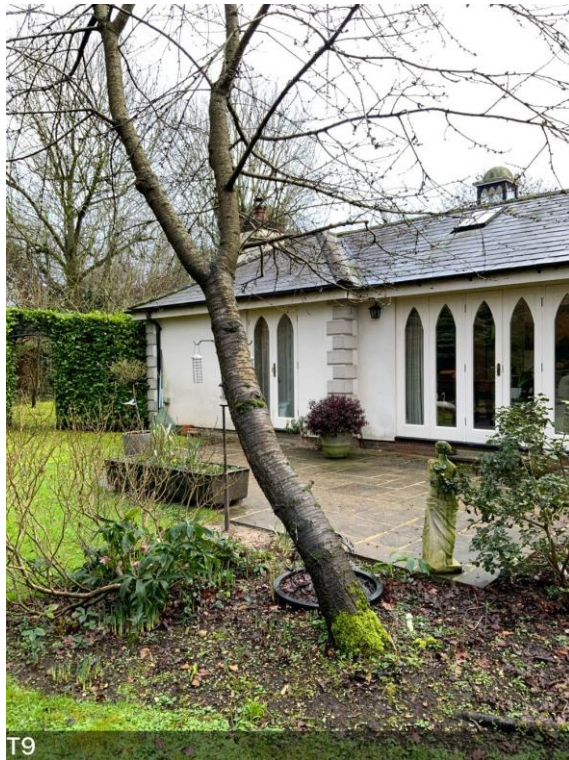
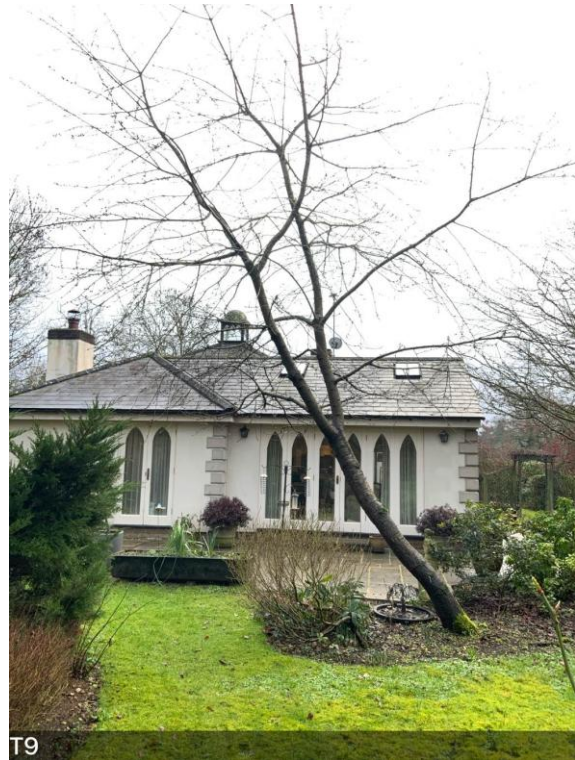
T9

| Ref. | Species | Height (m) | Canopy radius (m) | DBH (cm)<br>No. of stems | Estimated age and Life stage | Distance to area of damage (m) | Tree owner/ location | Vitality, previous works, comments | TPO/ CA |
|---|---|---|---|---|---|---|---|---|---|
| <b>T9</b> | Cherry | 7 | 4.4 | 9 #<br>1 | 15 Semi-mature | 6 | Insured | Good. No recent management. Moderate-water demand. | CA |

- Cherry (T9) is within the maximum distance for damage in the C&R study.
- Oak (TG10) has a high-water demand and is within the maximum distance for damage in the C&R study.

| Ref. | Species & estimated age | Height DBH (m) | Dist. to area of damage (m) | Vitality & previous works | Tree owner/ location | Recommendation | TPO CA |
|---|---|---|---|---|---|---|---|
| <b>T9</b> | Cherry<br>15<br>Semi-mature | 7<br>(0.09) | 6 | Good | Insured | Maintain at no greater than current size through periodic pruning. | CA |

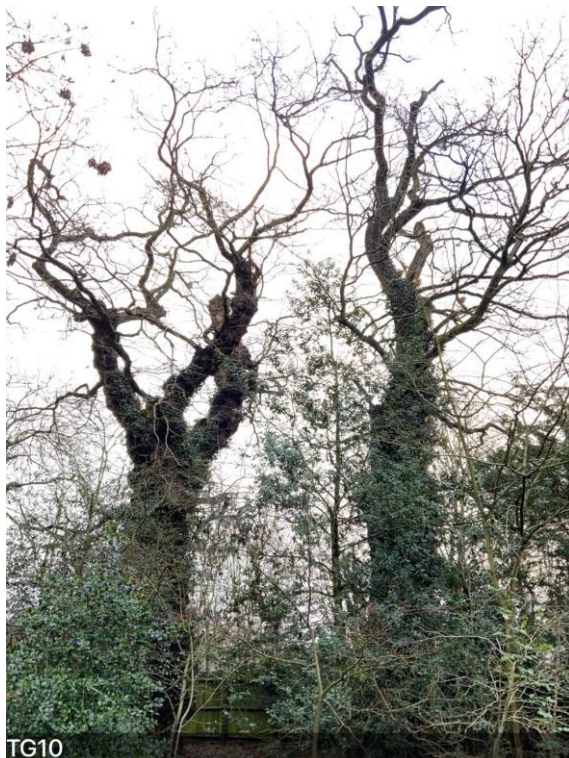
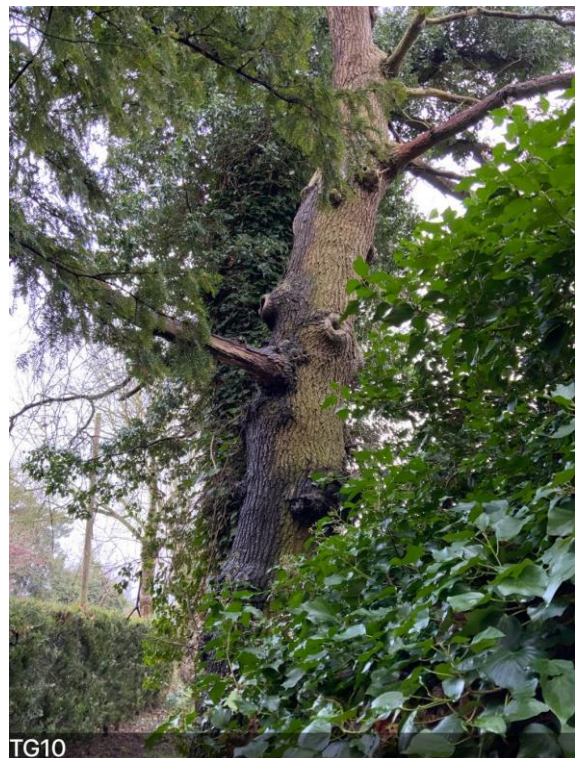
| Ref. | Species | Height (m) | Canopy radius (m) | DBH (cm)<br>No. of stems | Estimated age and Life stage | Distance to area of damage (m) | Tree owner/ location | Vitality, previous works, comments | TPO/ CA |
|---|---|---|---|---|---|---|---|---|---|
| <b>TG10</b> | Oak | 15 | 12.6 | 80 # | 160 Mature | 17 | Insured | Good. No recent management. High-water demand. | CA |

| Ref. | Species & estimated age | Height DBH (m) | Dist. to area of damage (m) | Vitality & previous works | Tree owner/ location | Recommendation | TPO CA |
|---|---|---|---|---|---|---|---|
| TG10 | Oak 160 Mature | 15 (0.80) | 17 | Good | Insured | Maintain at no greater than current size through periodic pruning. | CA |

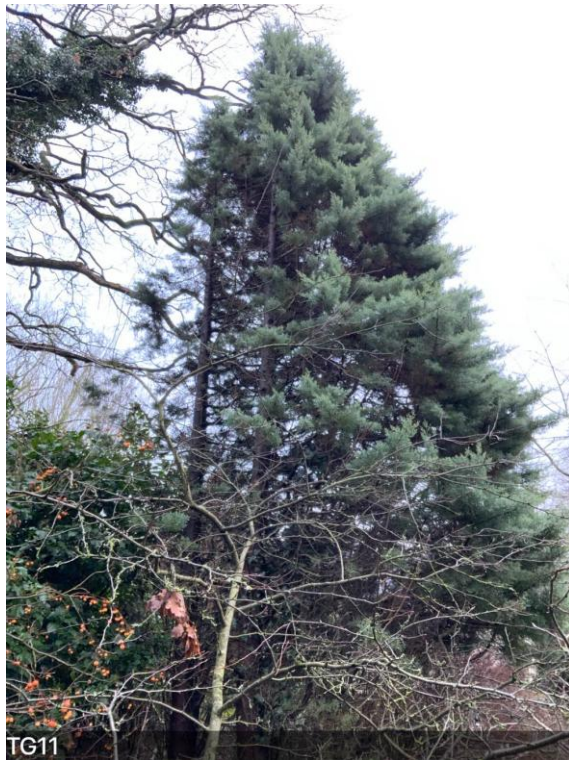
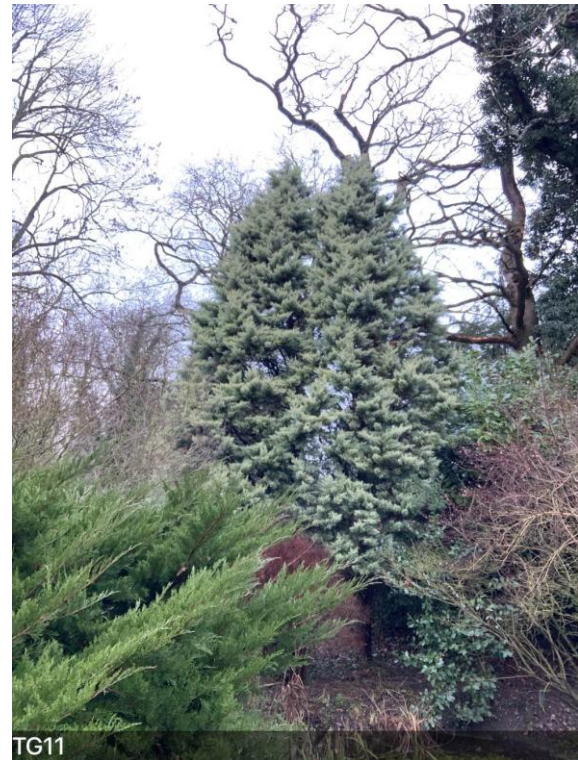
| Ref. | Species | Height (m) | Canopy radius (m) | DBH (cm)<br>No. of stems | Estimated age and Life stage | Distance to area of damage (m) | Tree owner/ location | Vitality, previous works, comments | TPO/ CA |
|---|---|---|---|---|---|---|---|---|---|
| <b>TG11</b> | Cypress | 7 | 1.8 | 8 # | 15<br>Semi-mature | 12.9 | Insured | Good. No recent management.<br>High-water demand. | CA |

- Cypress (TG11) has a high-water demand and is toward the maximum distance for damage in the C&R study.
- Hawthorn (T12) has a high-water demand and is within the 75% distance for damage in the C&R study.

| Ref. | Species & estimated age | Height DBH (m) | Dist. to area of damage (m) | Vitality & previous works | Tree owner/ location | Recommendation | TPO CA |
|---|---|---|---|---|---|---|---|
| TG11 | Cypress 15 Semi-mature | 7 (0.08) | 12.9 | Good | Insured | Maintain at no greater than current size through periodic pruning. | CA |

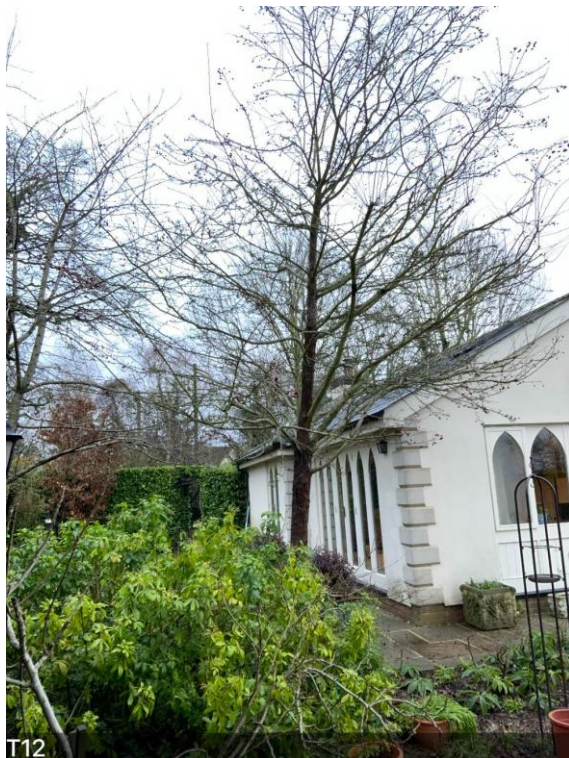
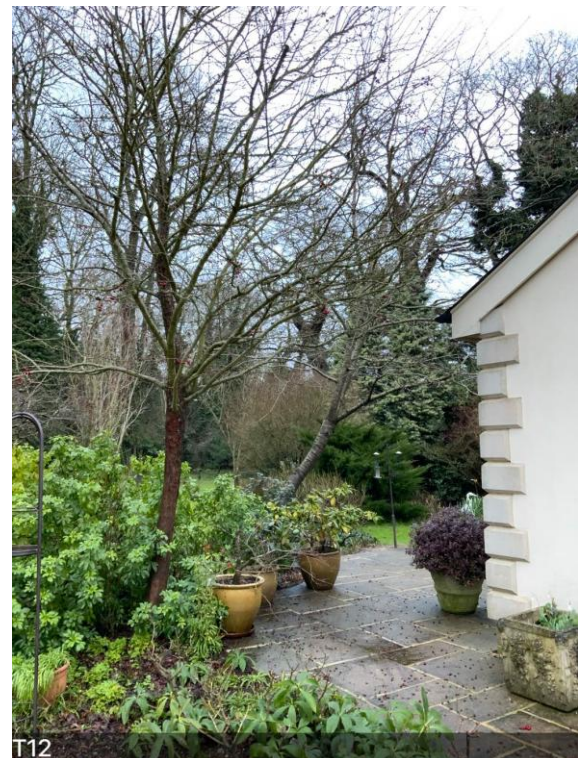
T12

| Ref. | Species | Height (m) | Canopy radius (m) | DBH (cm)<br>No. of stems | Estimated age and Life stage | Distance to area of damage (m) | Tree owner/ location | Vitality, previous works, comments | TPO/ CA |
|---|---|---|---|---|---|---|---|---|---|
| <b>T12</b> | Hawthorn | 5 | 2.1 | 6 #<br>1 | 15<br>Young | 6.4 | Insured | Good. No recent management.<br>High-water demand. | CA |

| Ref. | Species & estimated age | Height DBH (m) | Dist. to area of damage (m) | Vitality & previous works | Tree owner/ location | Recommendation | TPO CA |
|---|---|---|---|---|---|---|---|
| <b>T12</b> | Hawthorn<br>15<br>Young | 5<br>(0.06) | 6.4 | Good | Insured | Remove close to ground level and treat stumps with herbicide to inhibit regrowth. | CA |

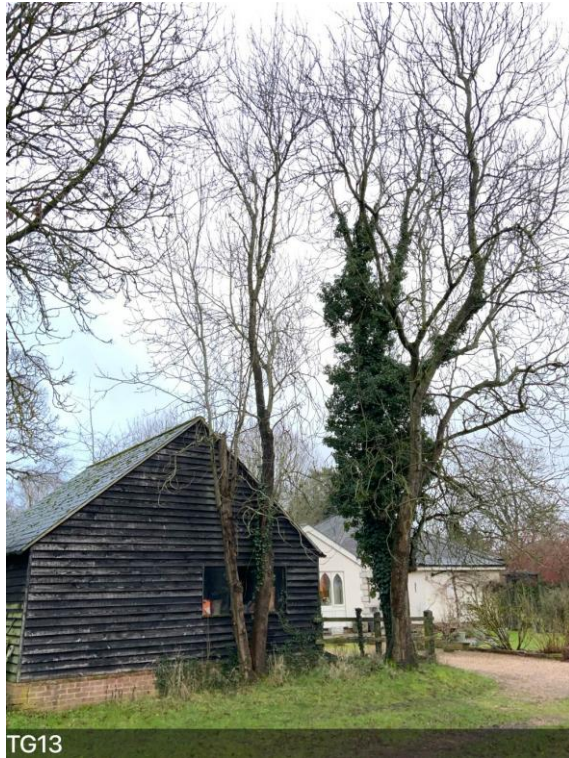
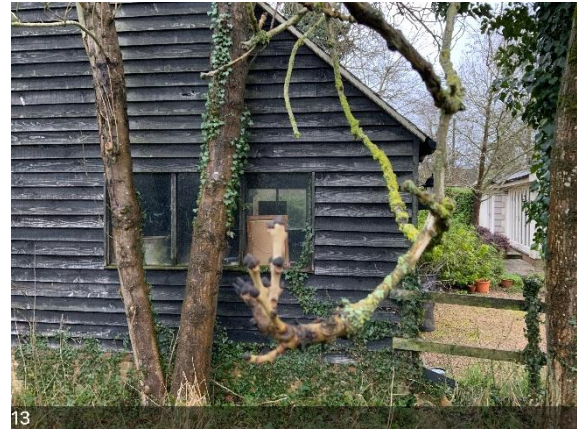
| Ref. | Species | Height (m) | Canopy radius (m) | DBH (cm)<br>No. of stems | Estimated age and Life stage | Distance to area of damage (m) | Tree owner/ location | Vitality, previous works, comments | TPO/ CA |
|---|---|---|---|---|---|---|---|---|---|
| <b>TG13</b> | Ash | 12 | 5.2 | 35 # | 40<br>Early-mature | 15 | Neighbour | Good. No recent management.<br>Moderate-water demand. | CA |

- Ash (TG13) is toward the maximum distance for damage in the C&R study.
- At time of writing, no level monitoring reports were available to confirm seasonal movement therefore any recommendations to mitigate current or future risk are based on the limited data available.

| Ref. | Species & estimated age | Height DBH (m) | Dist. to area of damage (m) | Vitality & previous works | Tree owner/ location | Recommendation | TPO CA |
|---|---|---|---|---|---|---|---|
| TG13 | Ash 40 Early-mature | 12 (0.35) | 15 | Good | Neighbour (see plan) | Maintain at no greater than current size through periodic pruning. | CA |
