**Annex 1: Windows to be replaced at 49 Silver Street, Ashwell SG7 5QL**

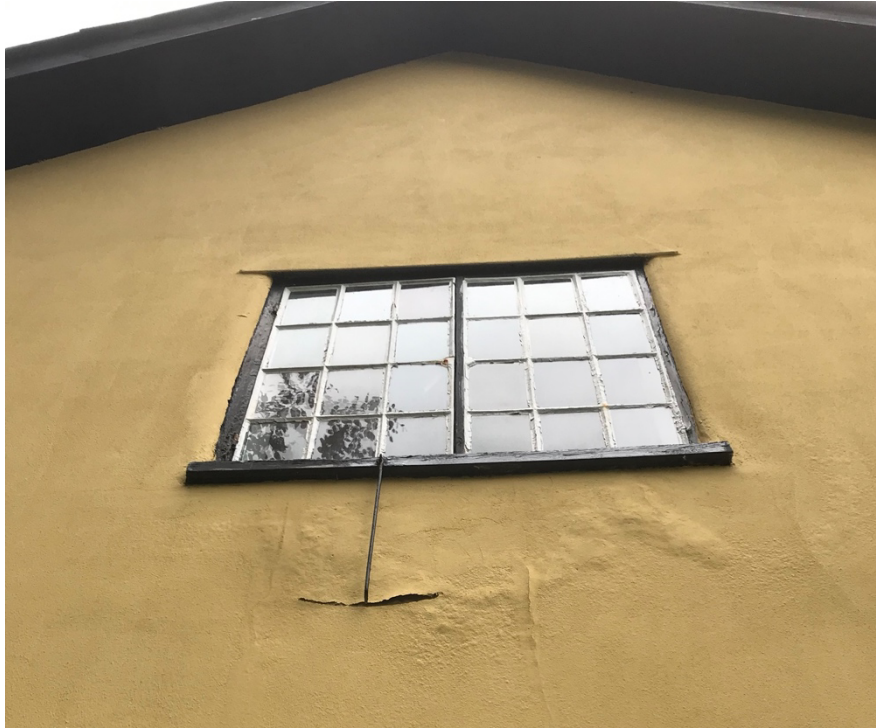
Picture 1: Damage to render caused by traditional window hook under first floor main bedroom window to rear

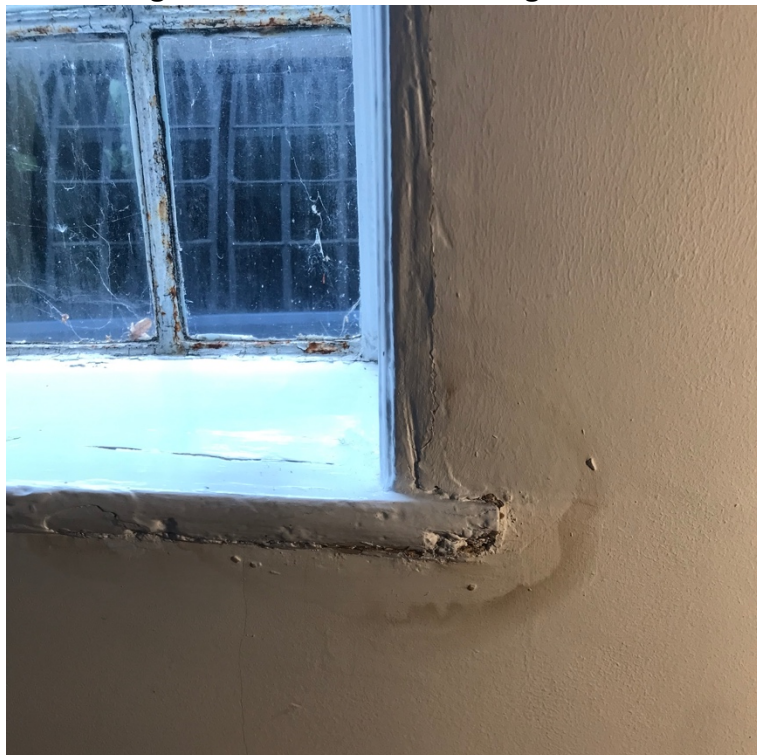
Picture 2: Water damage to internal wall due to condensation run off from double casement ground floor window in living room

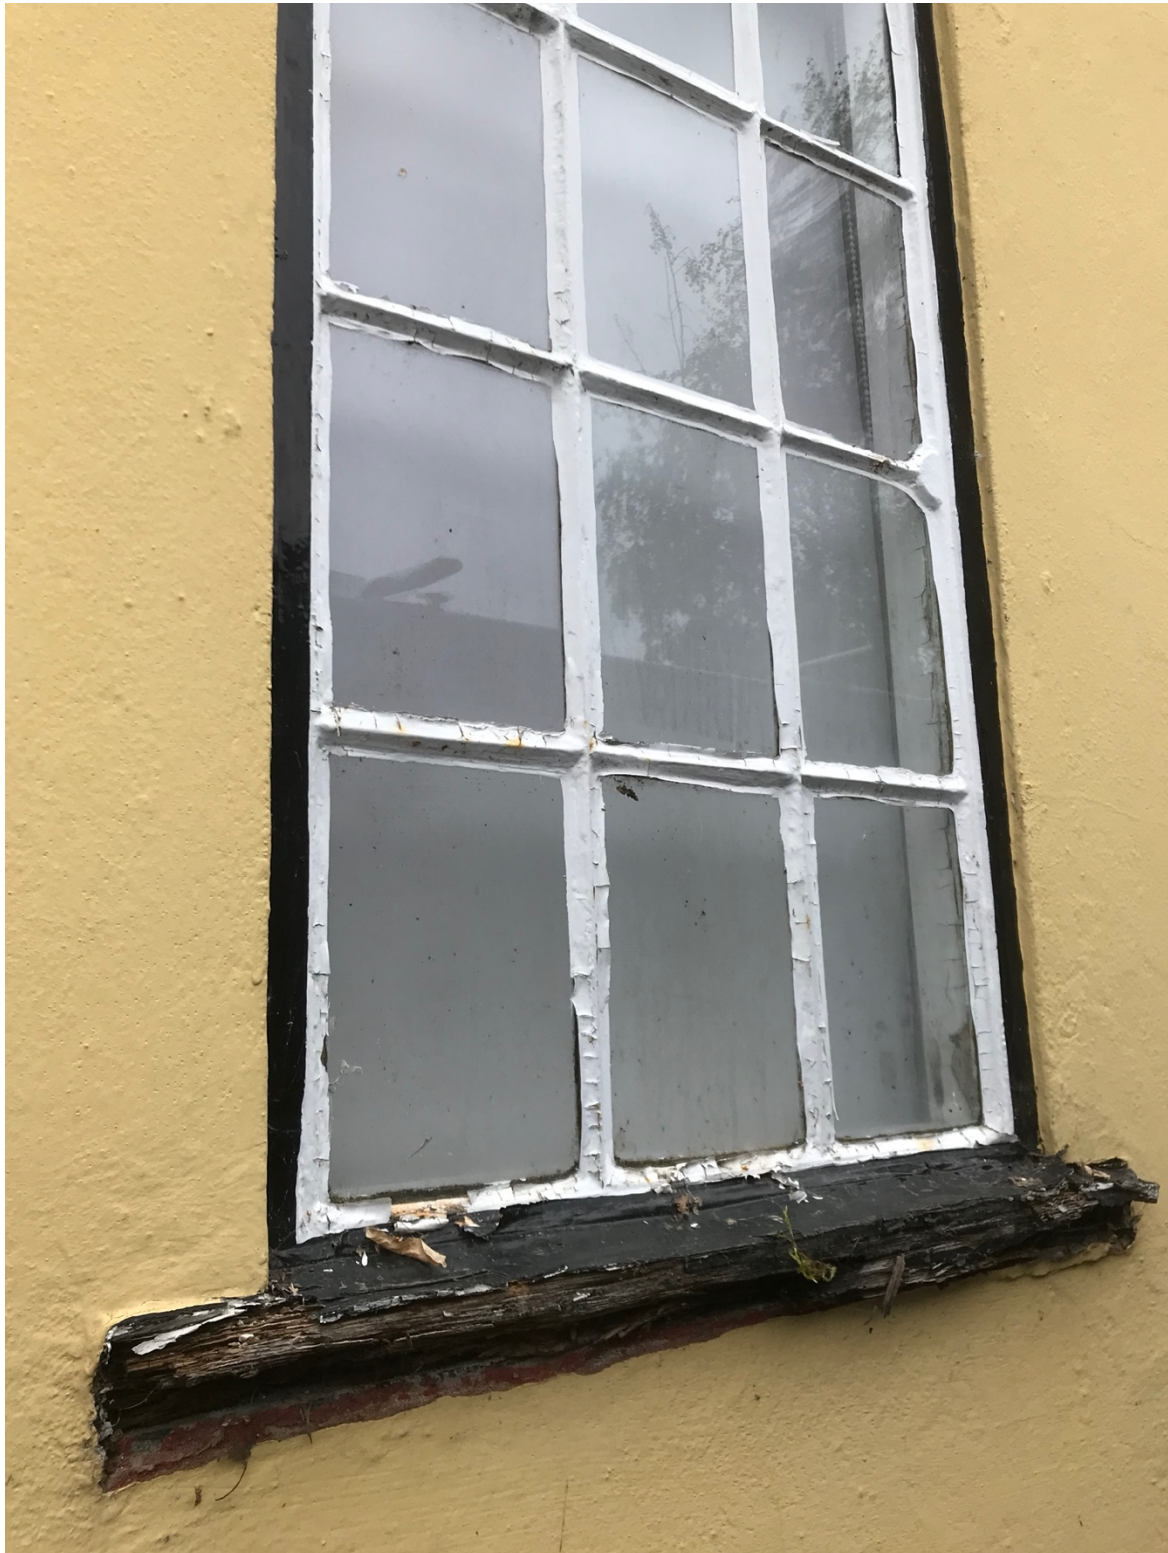
Picture 3: Single casement ground floor living room window - rotten sill. The rotten sill was knocked off by someone walking between vehicles and house and there is now very significant water ingress

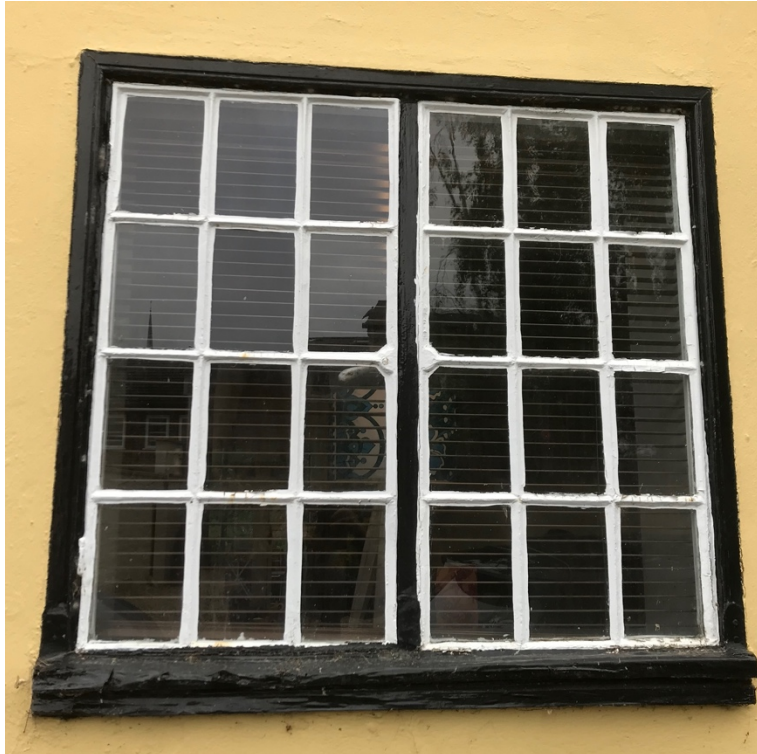
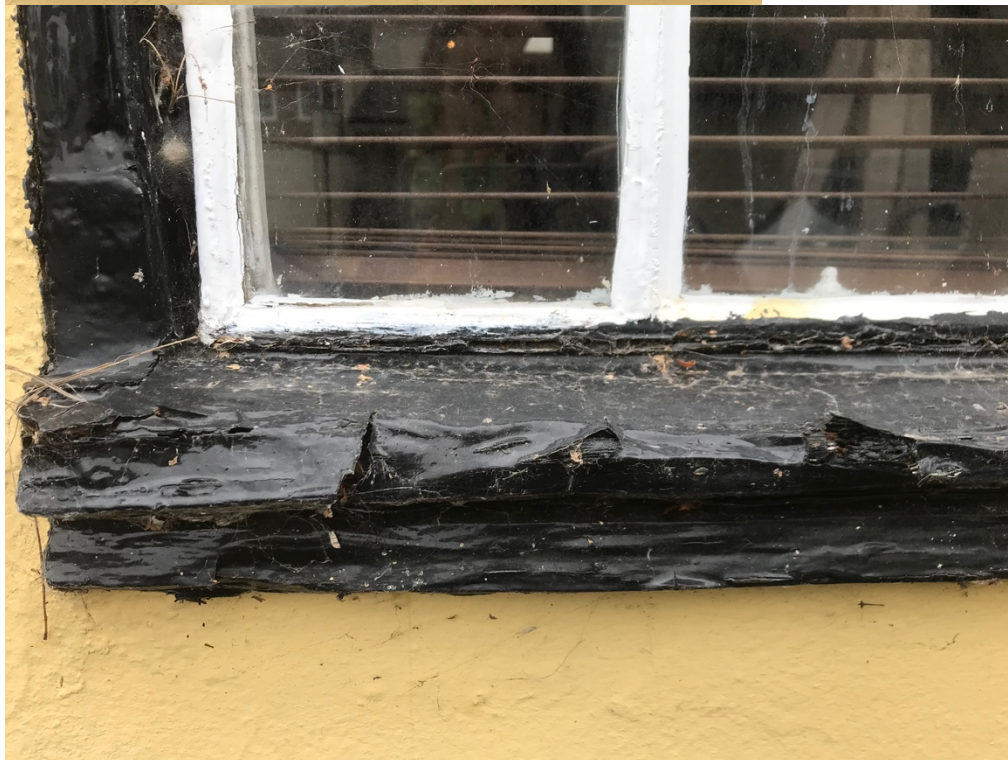
Picture 4 & 5: Double casement ground floor entrance hall, external

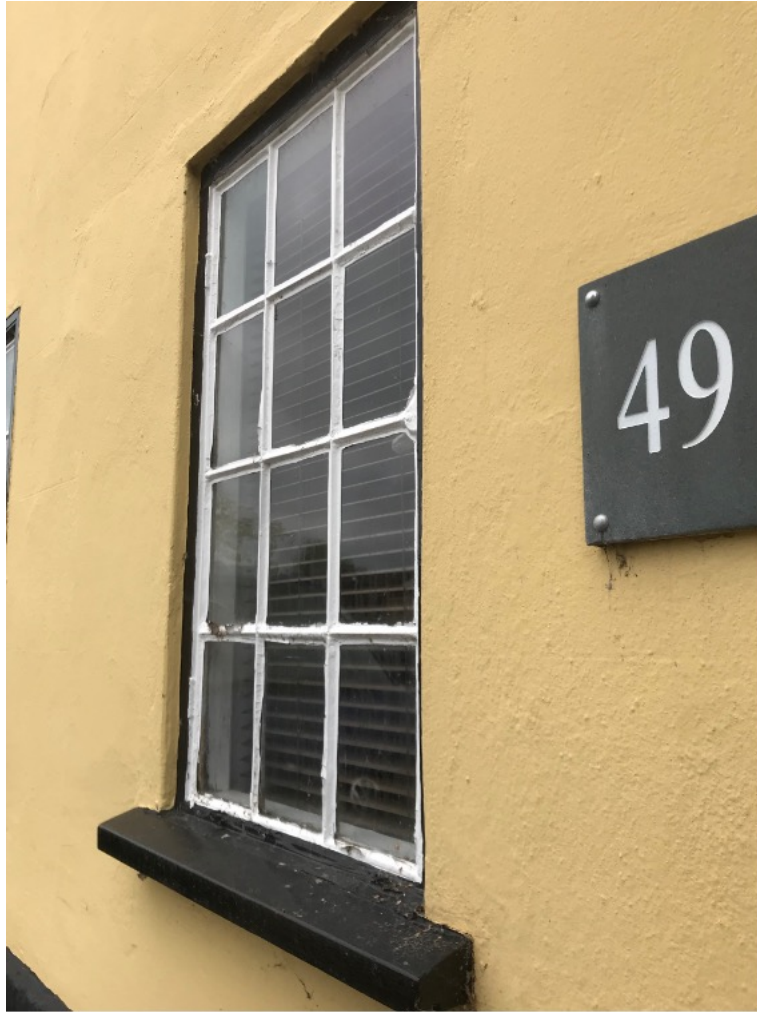
Picture 6: Single casement ground floor entrance hall, external (plastic sill)

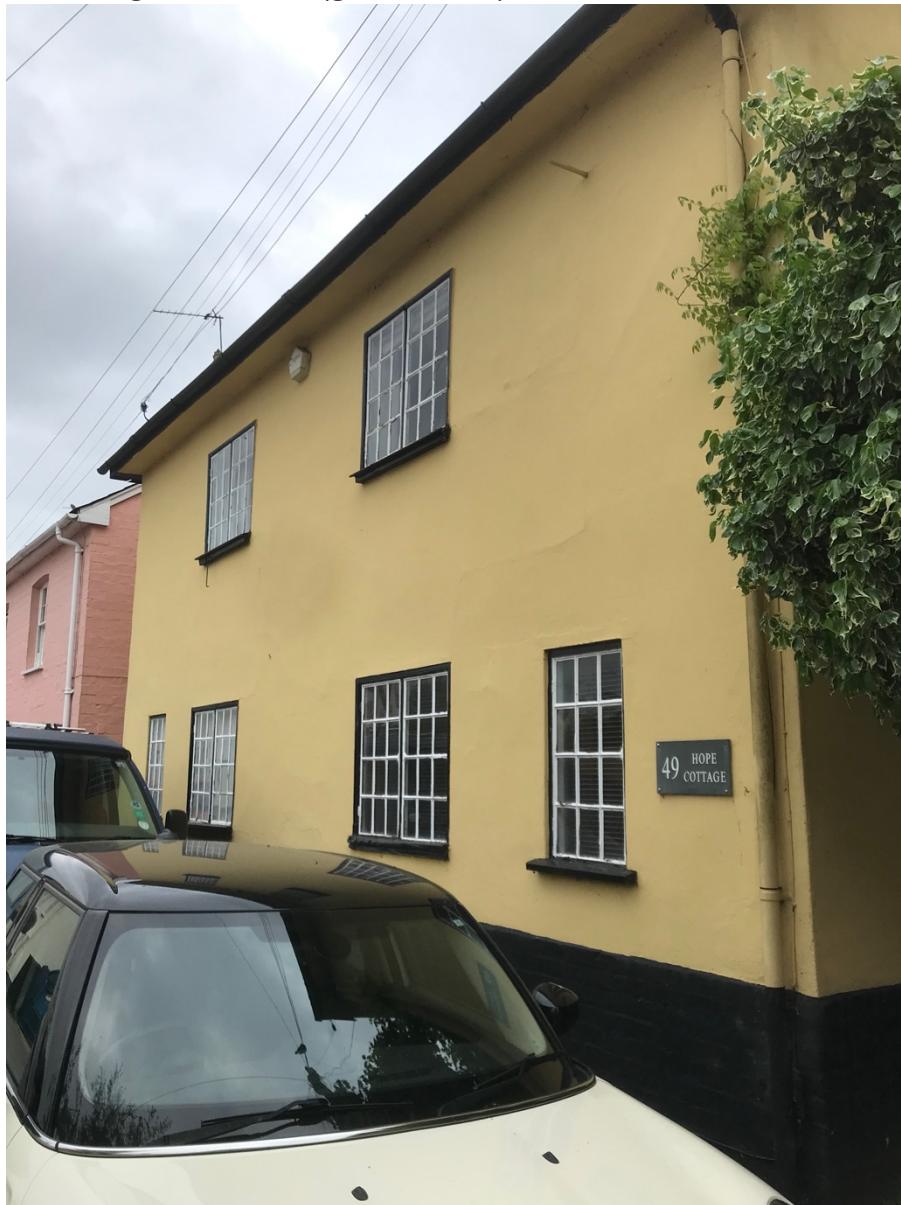
Picture 7: Front of house showing 4 double casement (two first floor, two ground floor), and 2 single casement (ground floor) windows

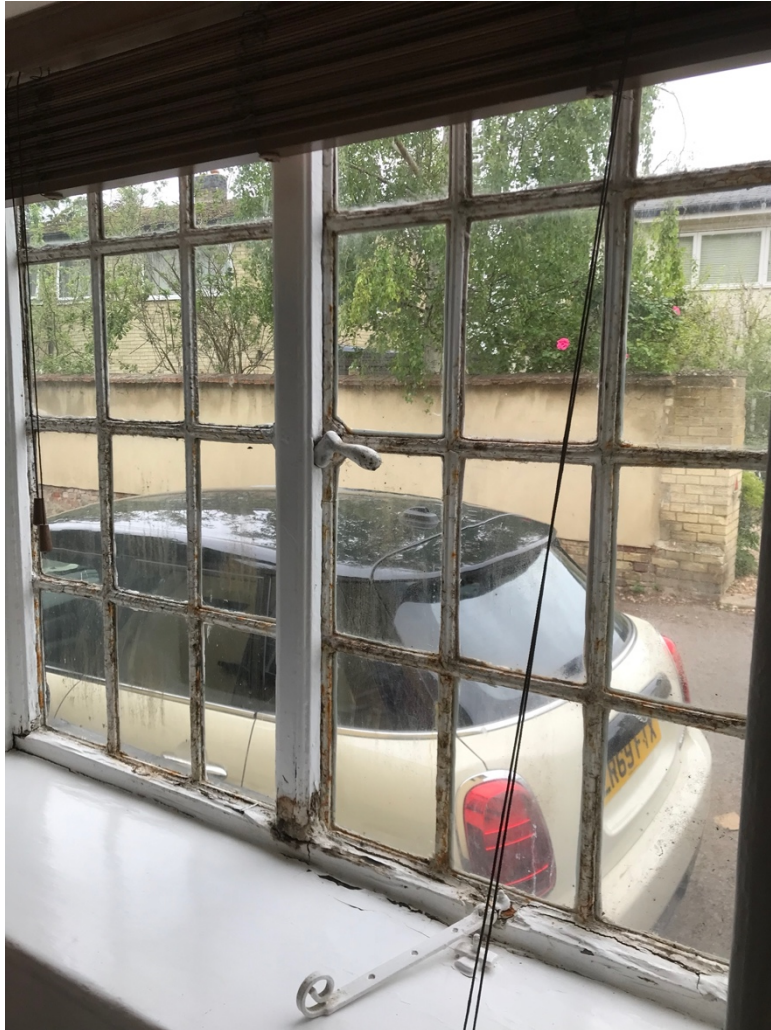
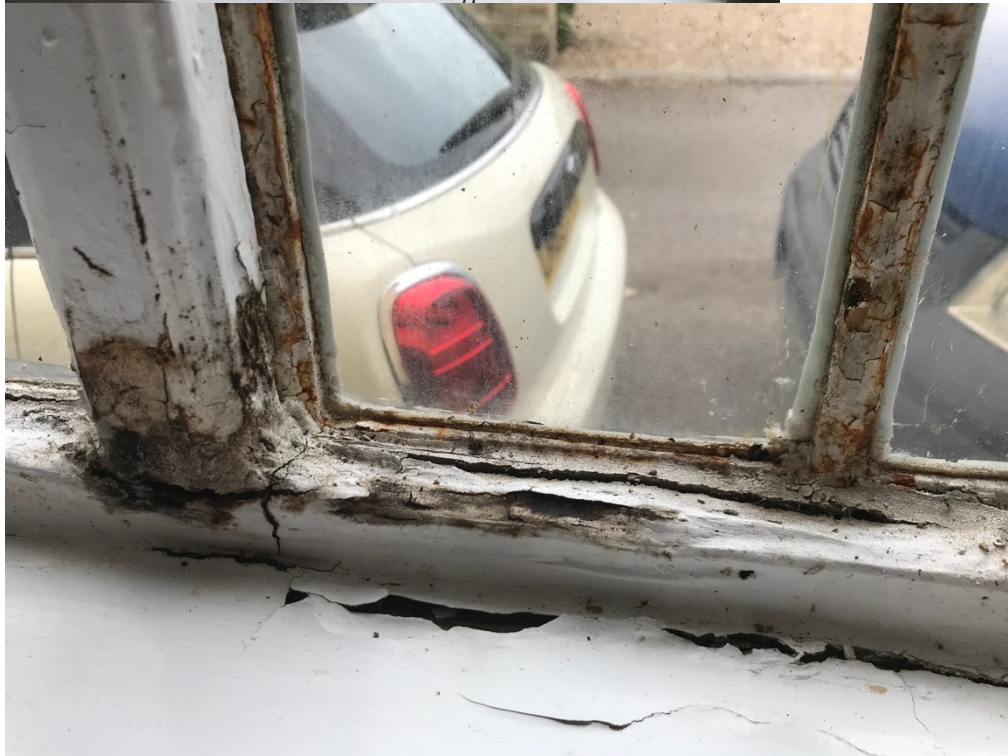
Picture 8 and 9: Double casement ground floor entrance hall, internal (painted shut)

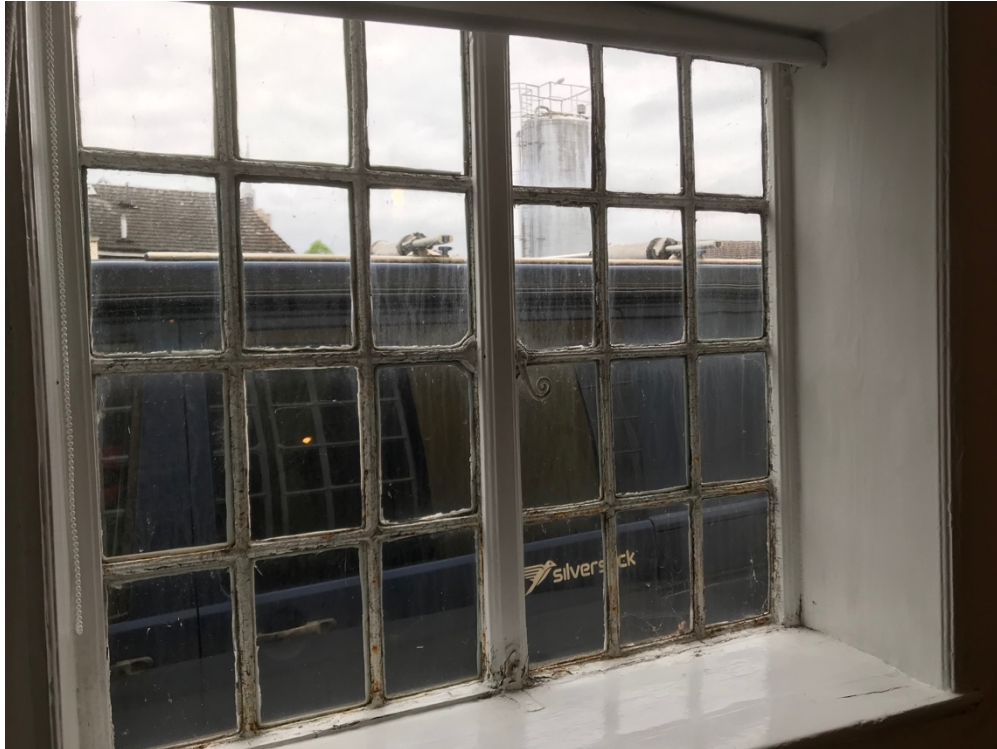
Picture 10: Double casement ground floor living room window internal (painted shut)

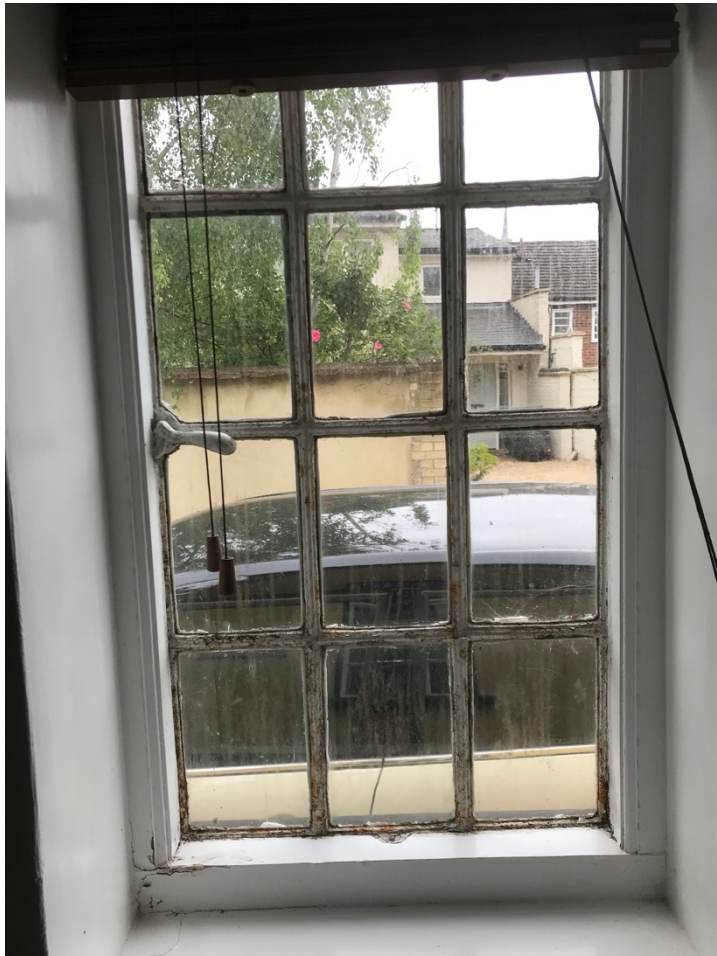
Picture 11: Single casement ground floor entrance hall window, internal (painted shut)

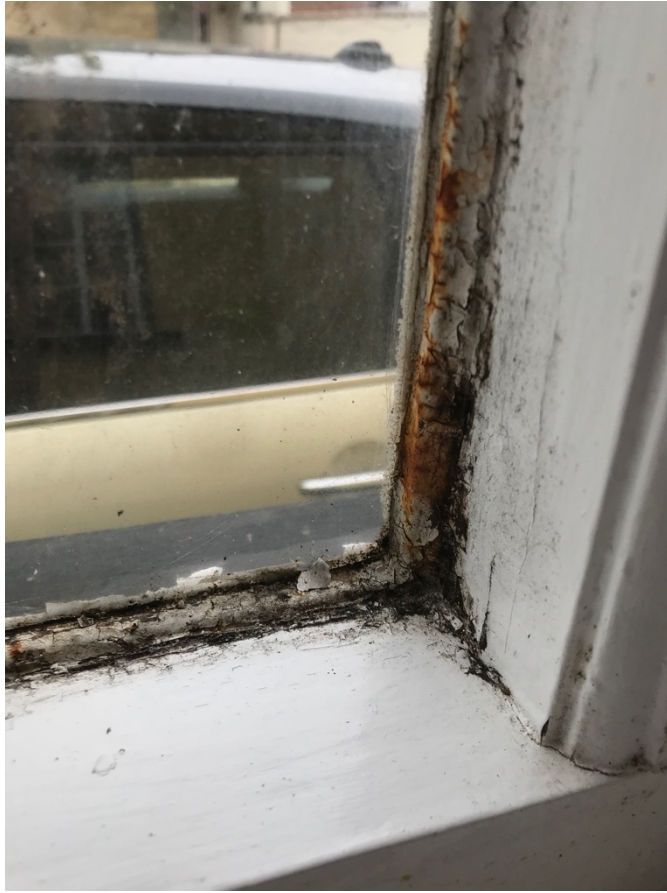
Picture 12: Rotten corners in single casement ground floor entrance hall window

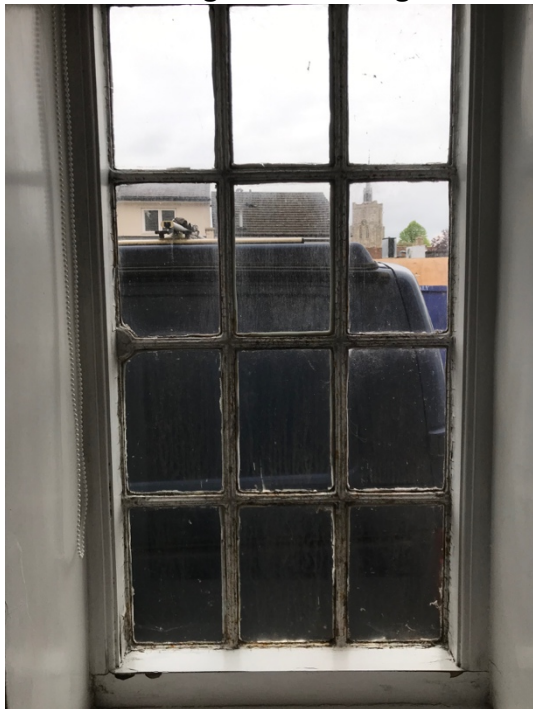
Picture 13: Single casement ground floor living room window

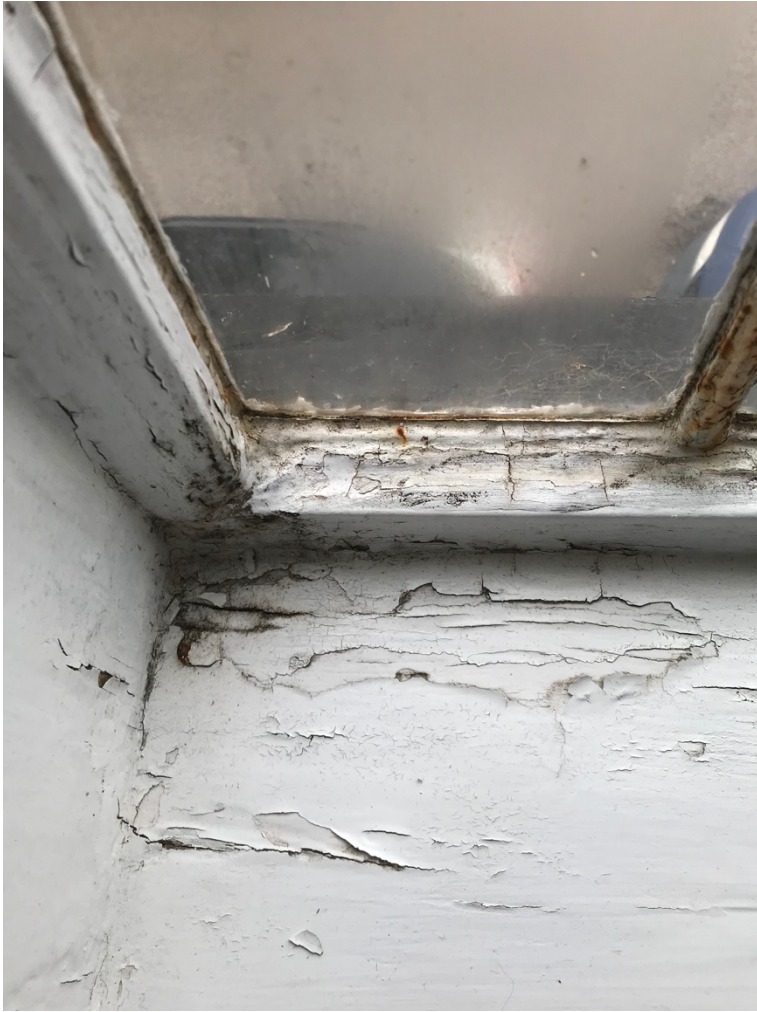
Picture 12: Double casement first floor bathroom window corner

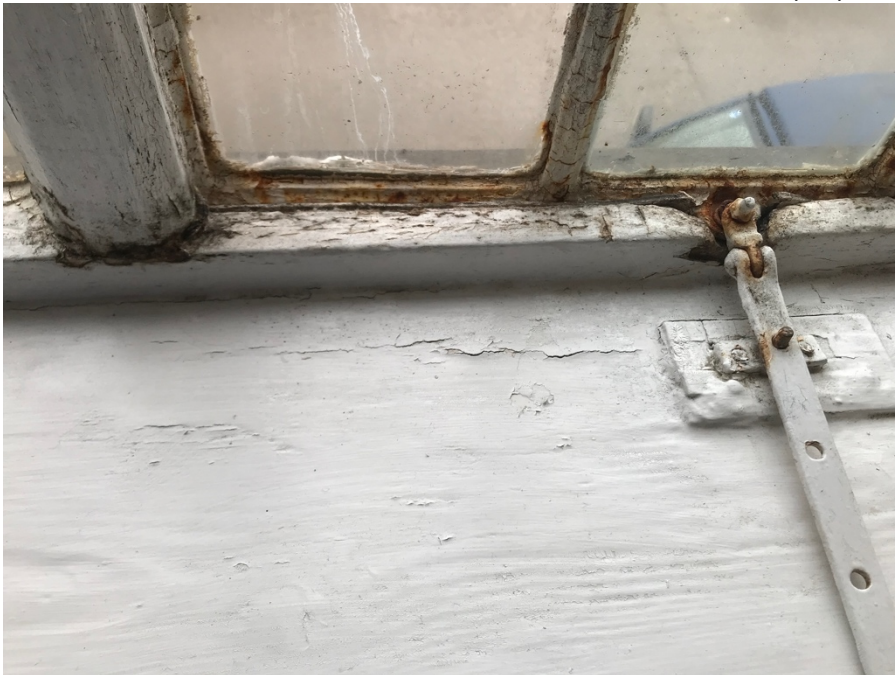
Picture 13: double casement first floor bathroom internal (rot)

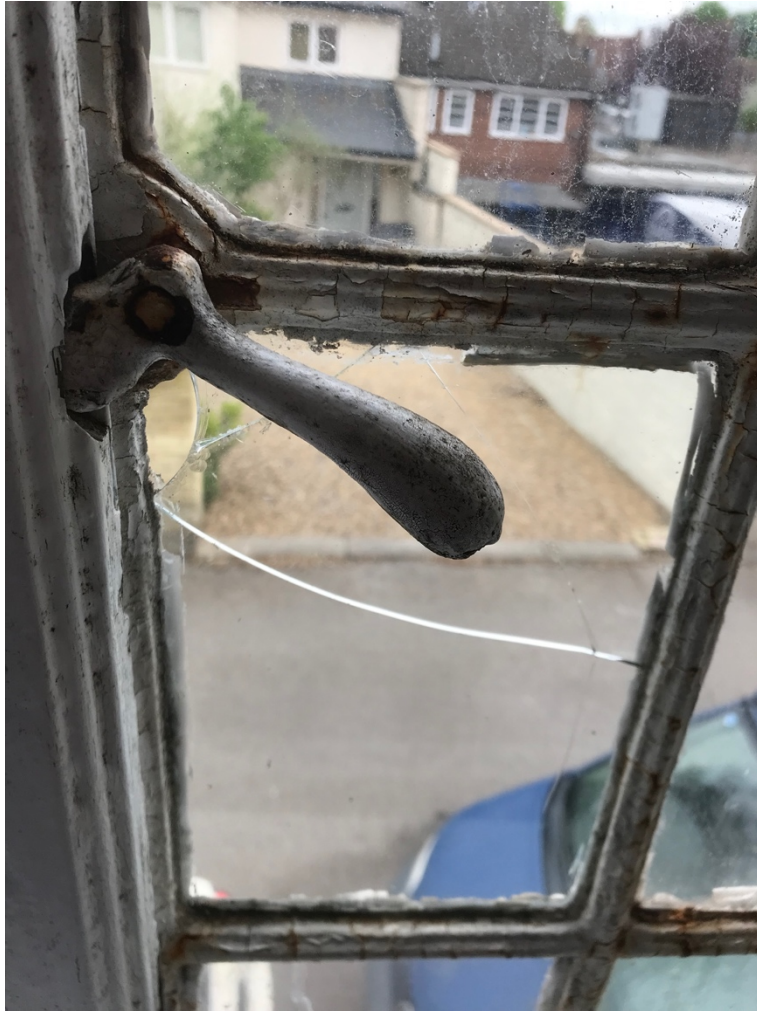
Picture 14: First floor double casement bathroom, cracked pane

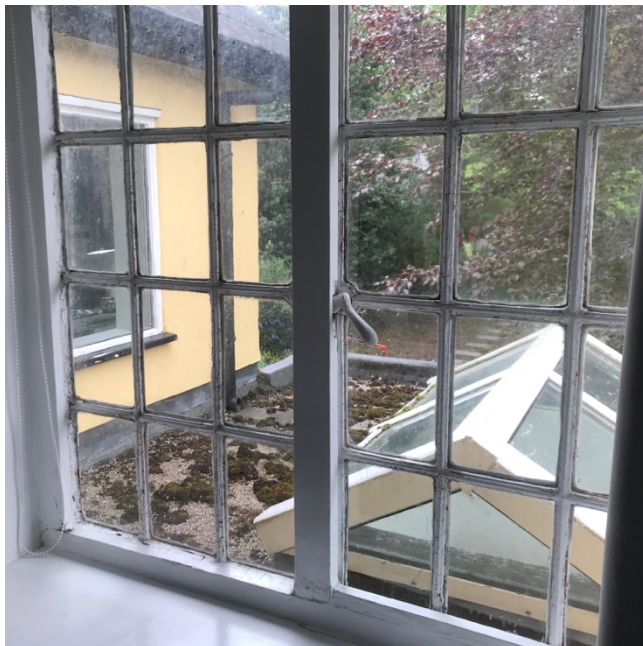
Picture 15: First floor double casement window rear bedroom

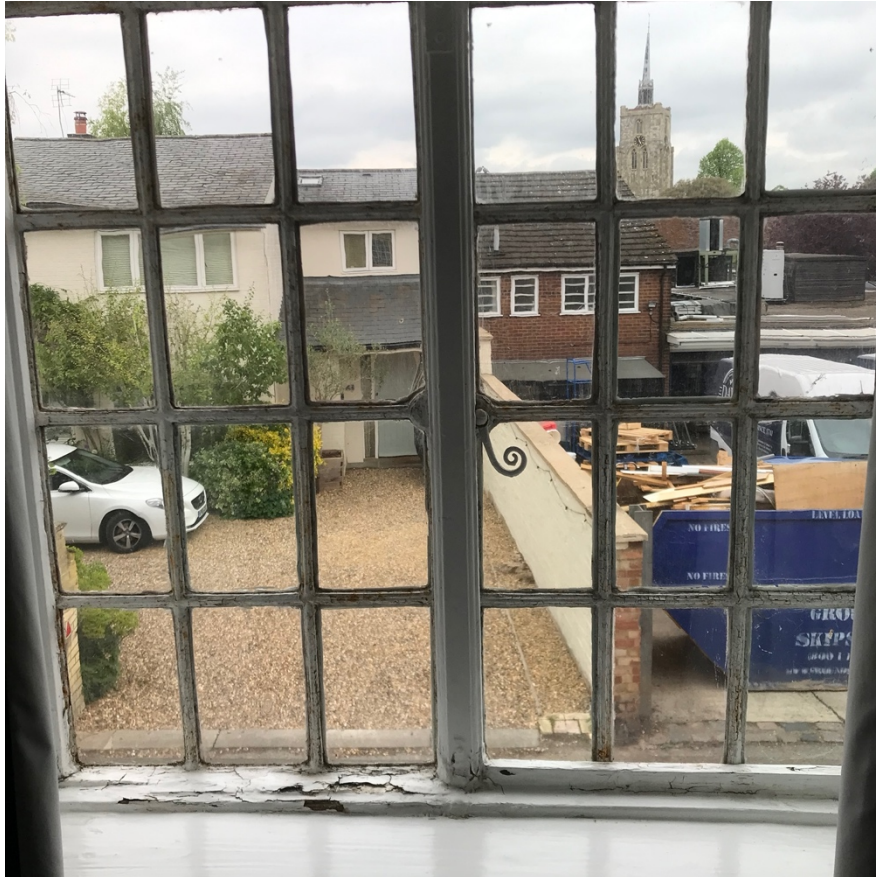
Picture 16: First floor double casement front bedroom

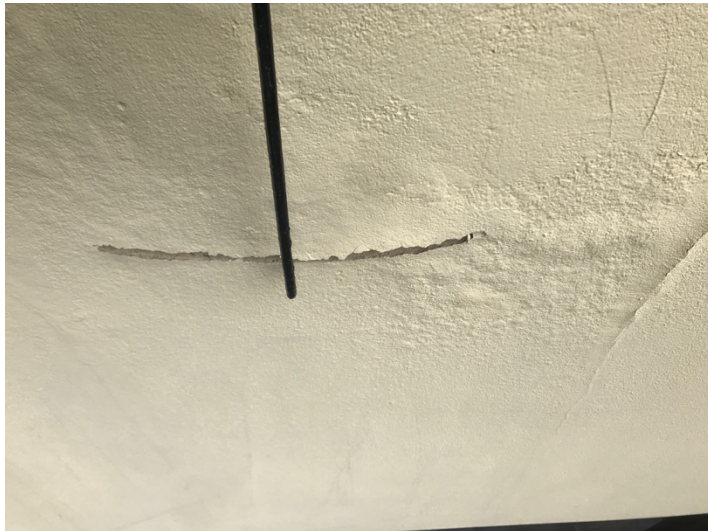
Picture 17: First floor main bedroom double casement, window hook causing damage to render

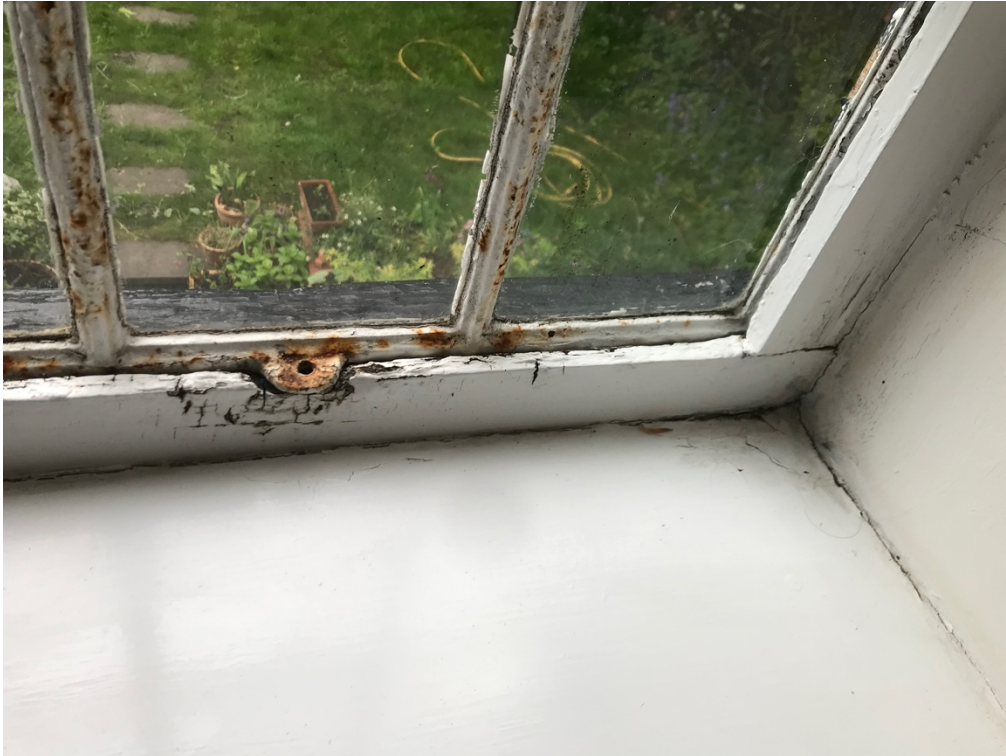
Picture 18: First floor main bedroom double casement cracking and rot in timber frame

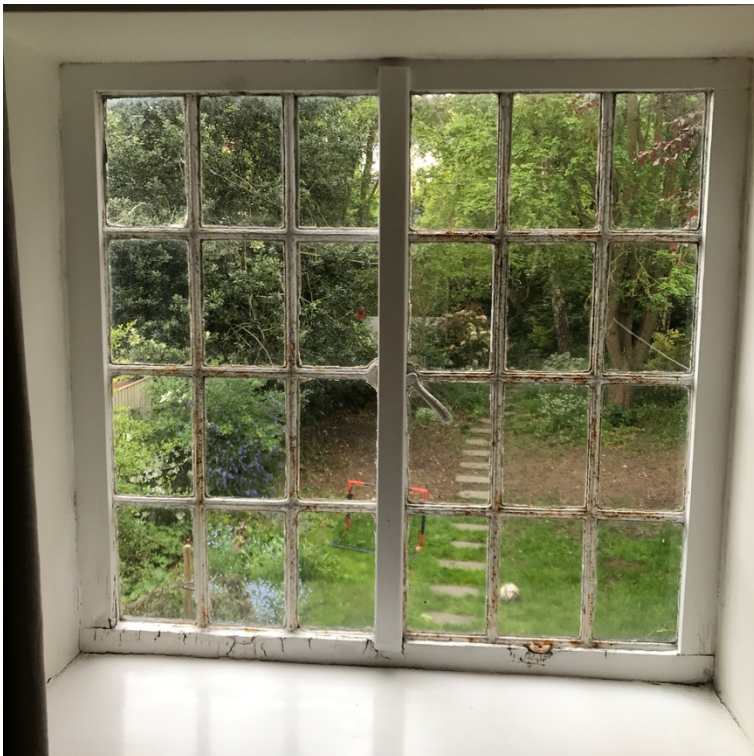
Picture 19: First floor main bedroom double casement, internal
