## Arboricultural Impact Assessment Regarding Safety Liabilities and Potential Insurance Issues

**No. 5 Pirton Close, Hitchin, Herts SG5 2BU**

| REPORT DATE: | 16 <sup>th</sup> September 2024 |

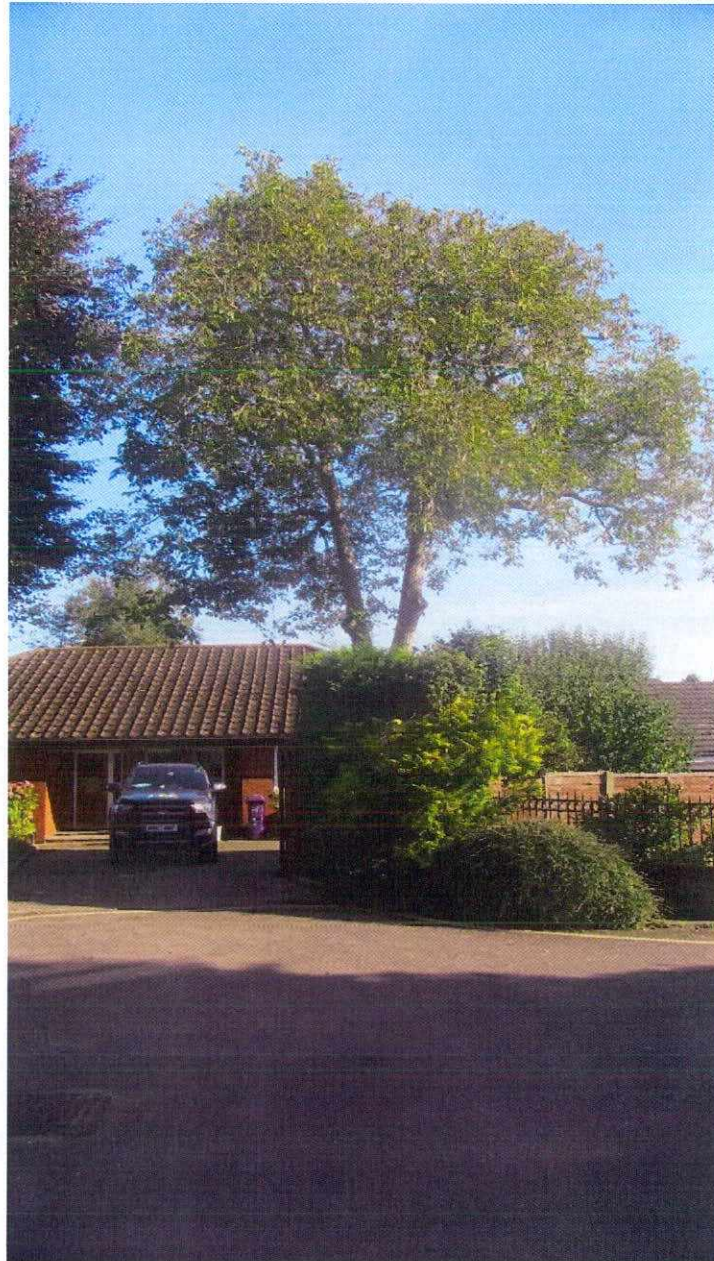
5.2.1 Tree 1, the common walnut is a tree of moderate-water-demand. It is located within its TZI of the bungalow front elevation but is currently only around half its likely ultimate size. Therefore, any contemporary adverse tree root/building interaction is improbable. This tree presents as being in somewhat poor condition but this is the way with walnut. It is minorly structurally compromised by two decaying branch removal wounds on the lower trunk but is not likely to fail due to this effect.

**PHOTOGRAPH NO. 1 – T1 – Common walnut viewed from the south**

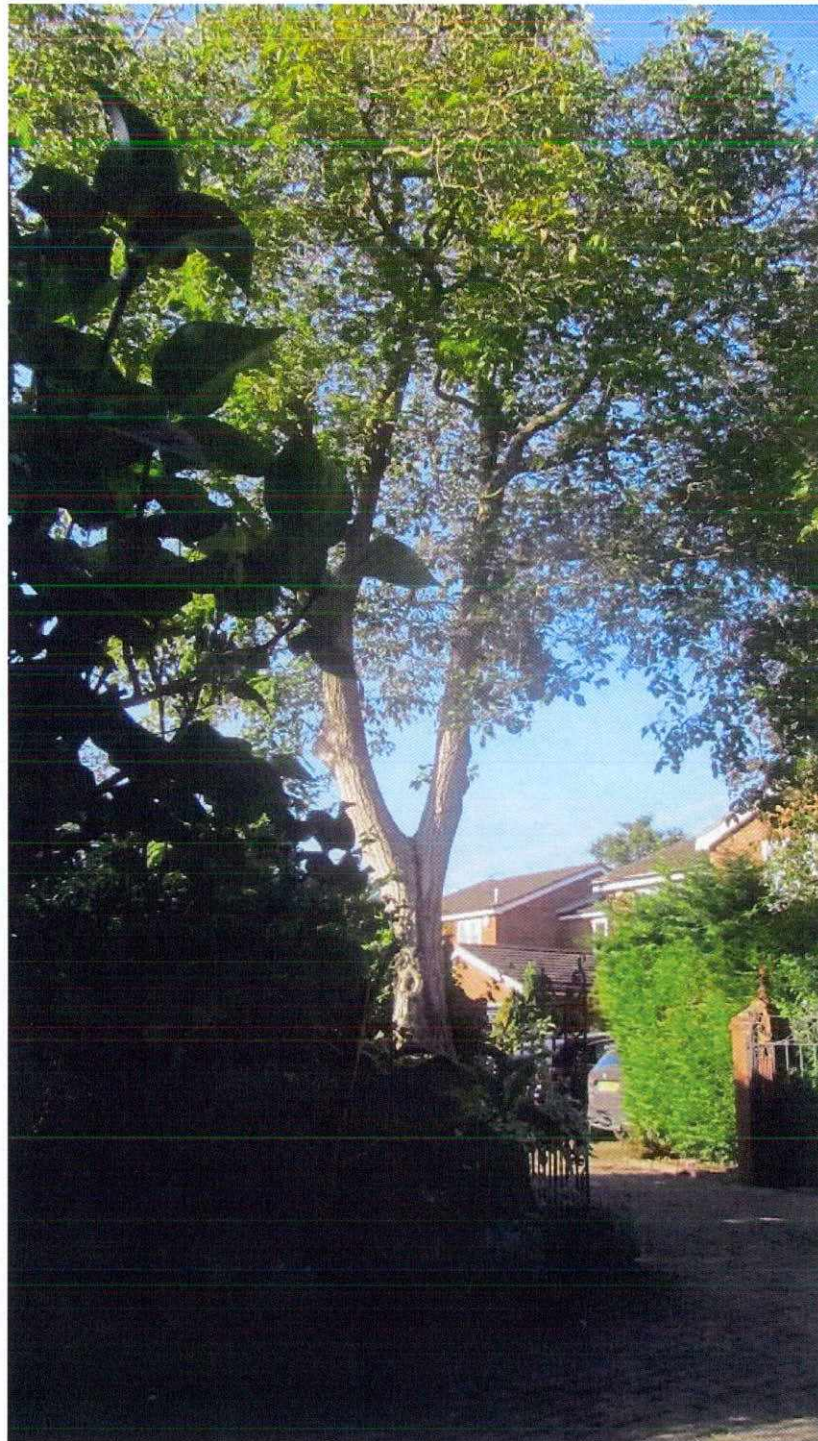
**PHOTOGRAPH NO. 2 – T1 – Common walnut viewed from the northeast**

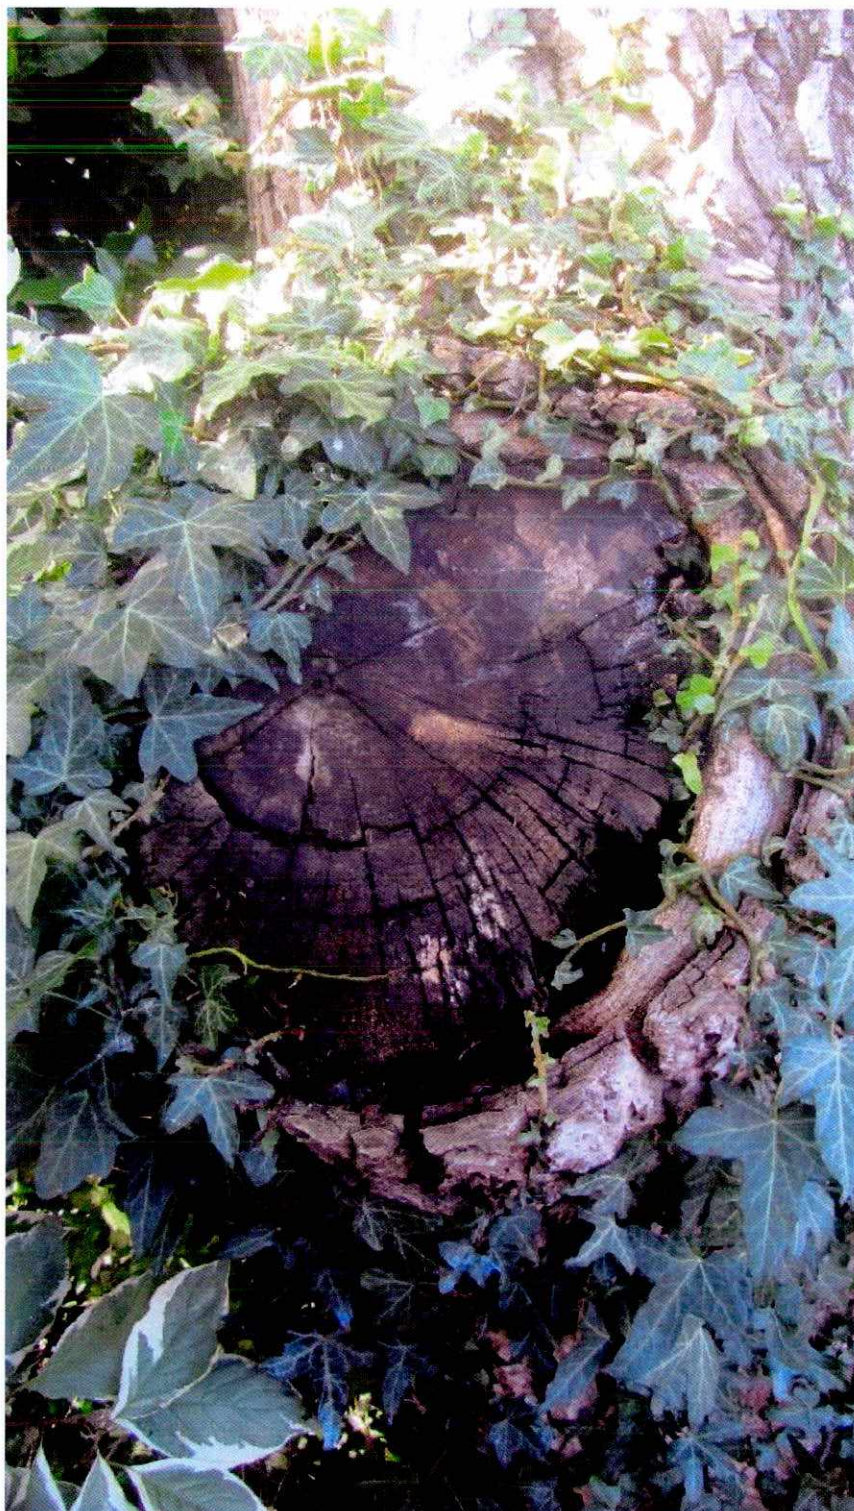
**PHOTOGRAPH NO. 3 – Decaying branch removal wound on the north side of  
T1**

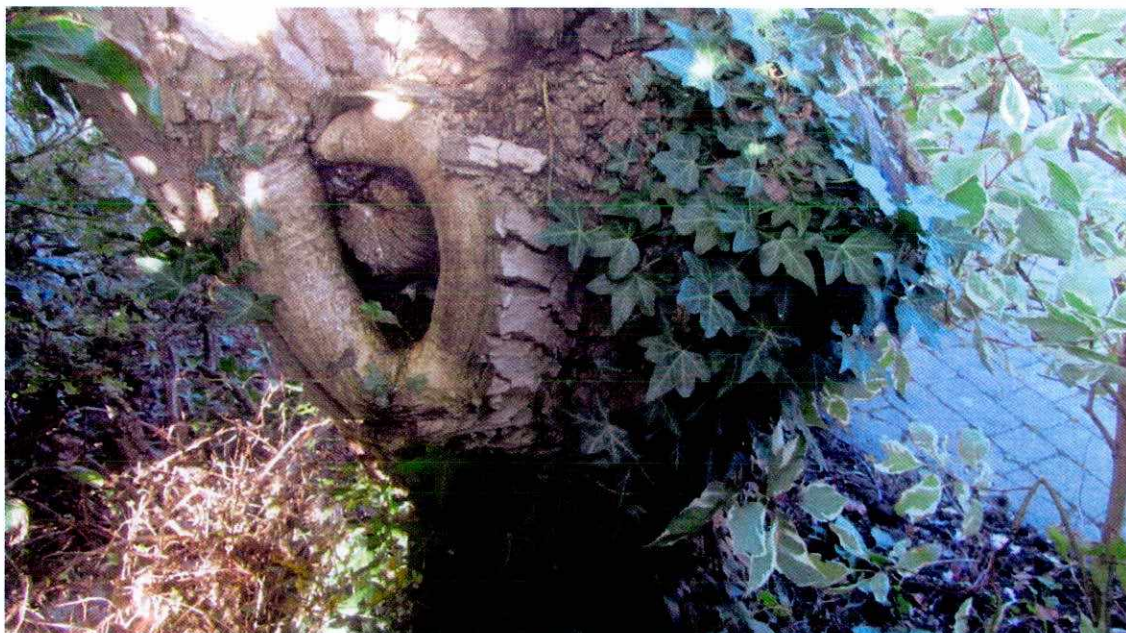
**PHOTOGRAPH NO. 4 – Decaying branch removal wood on the eastern side of  
T1**

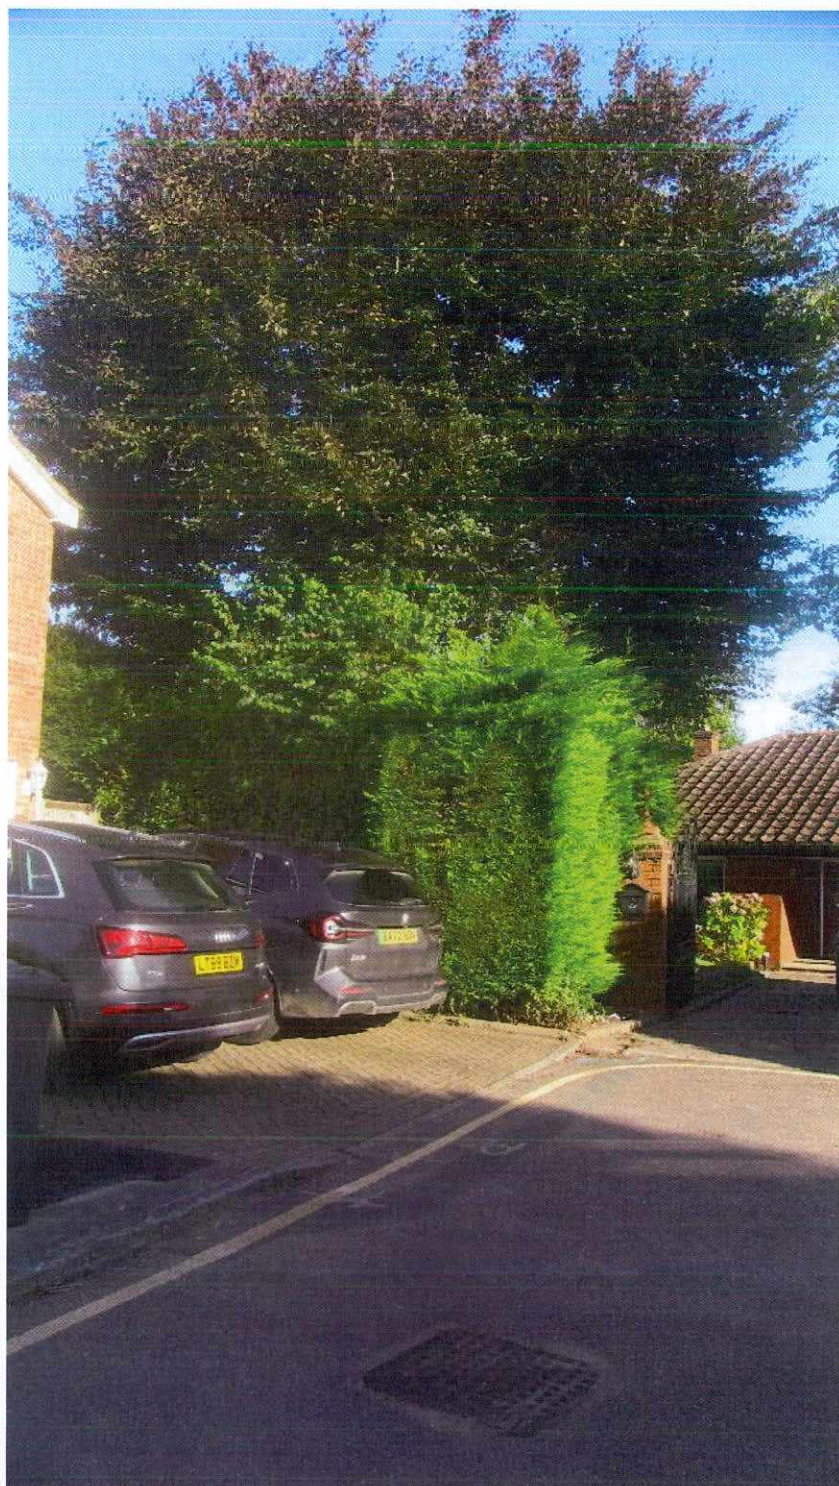
5.2.2 The second tree inspected, T2 – beech is the most significant on this site. It is of mature age class and likely around 100 years of age. The trunk and scaffold branch structure are sound with no real external signs of decay – other than some squirrel gnawing damage around the outer edge of a northern-side scaffold branch removal wound. Tree vigour and vitality are high, this being primarily evidenced by the foliar condition and density (see Photographs 5 & 6, Appendix 1) and secondarily by the rate and completeness of wound-wood growth which has, in most cases, completely occluded the wounds where branches have been pruned-off to 'lift' the canopy.

**PHOTOGRAPH NO. 5 – T2 – Common (European) beech viewed from the south**

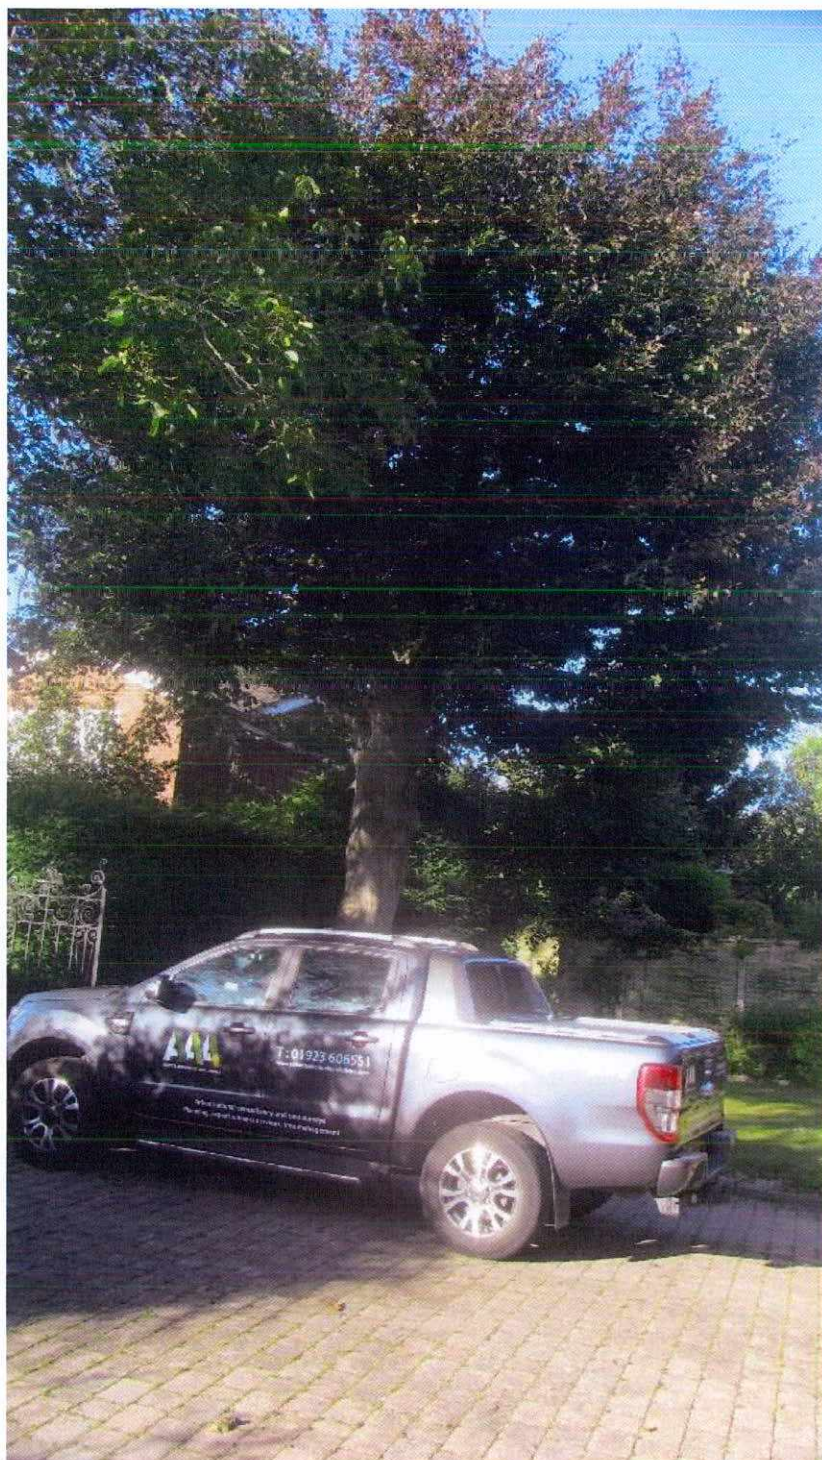
**PHOTOGRAPH NO. 6 – T2 – Beech viewed from the northeast**

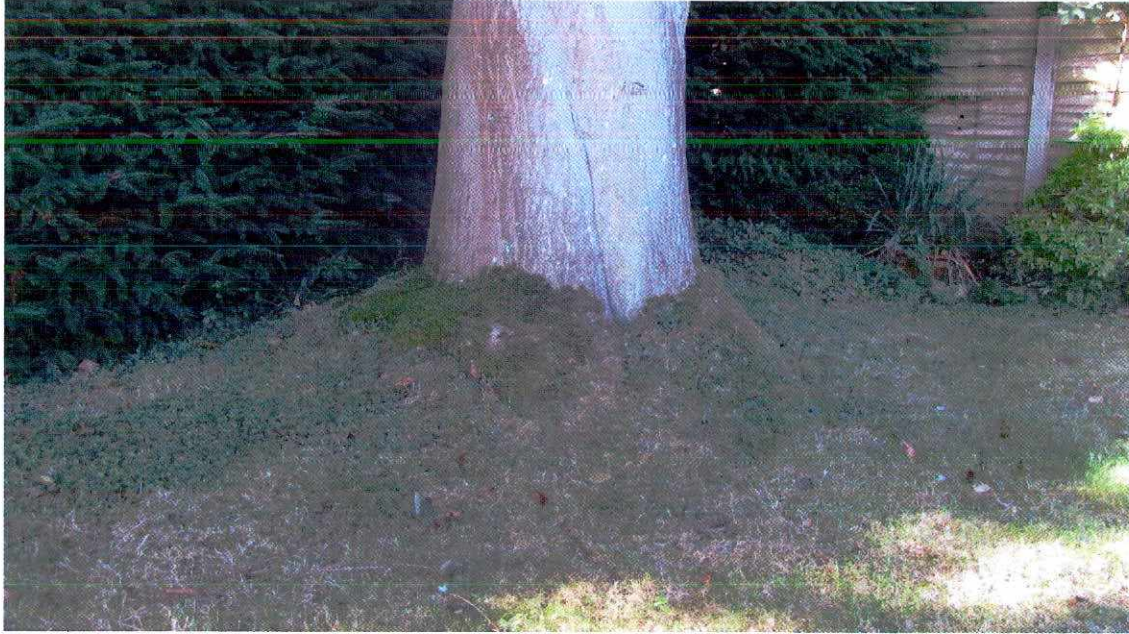
**PHOTOGRAPH NO. 7 – North side of the base of T2**

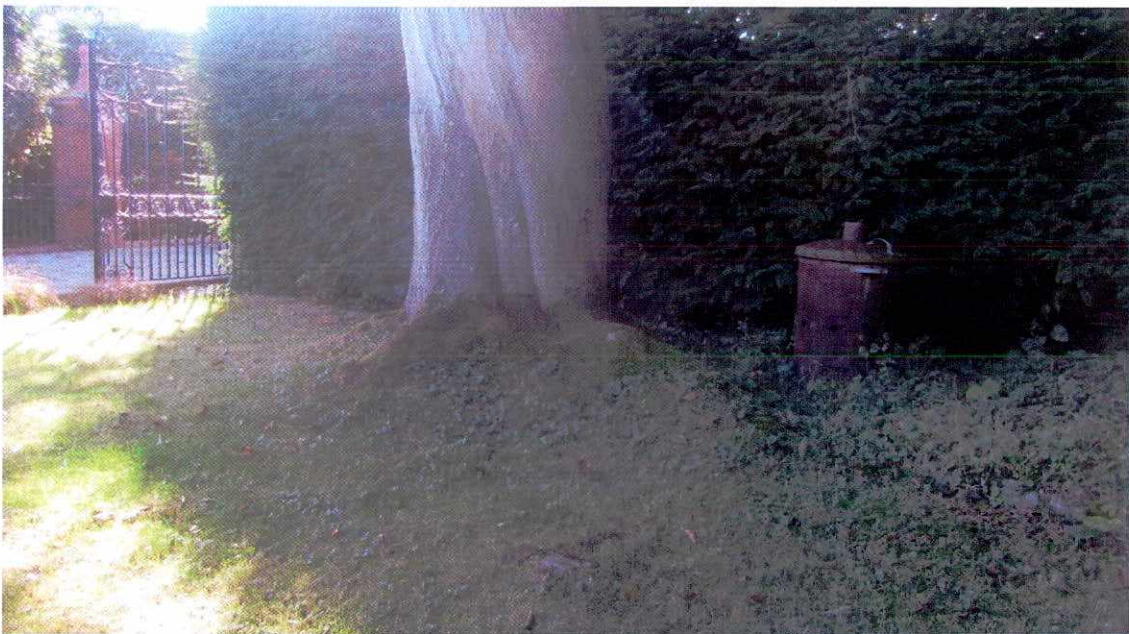
**PHOTOGRAPH NO. 8 – Northwest side of the base of T2**

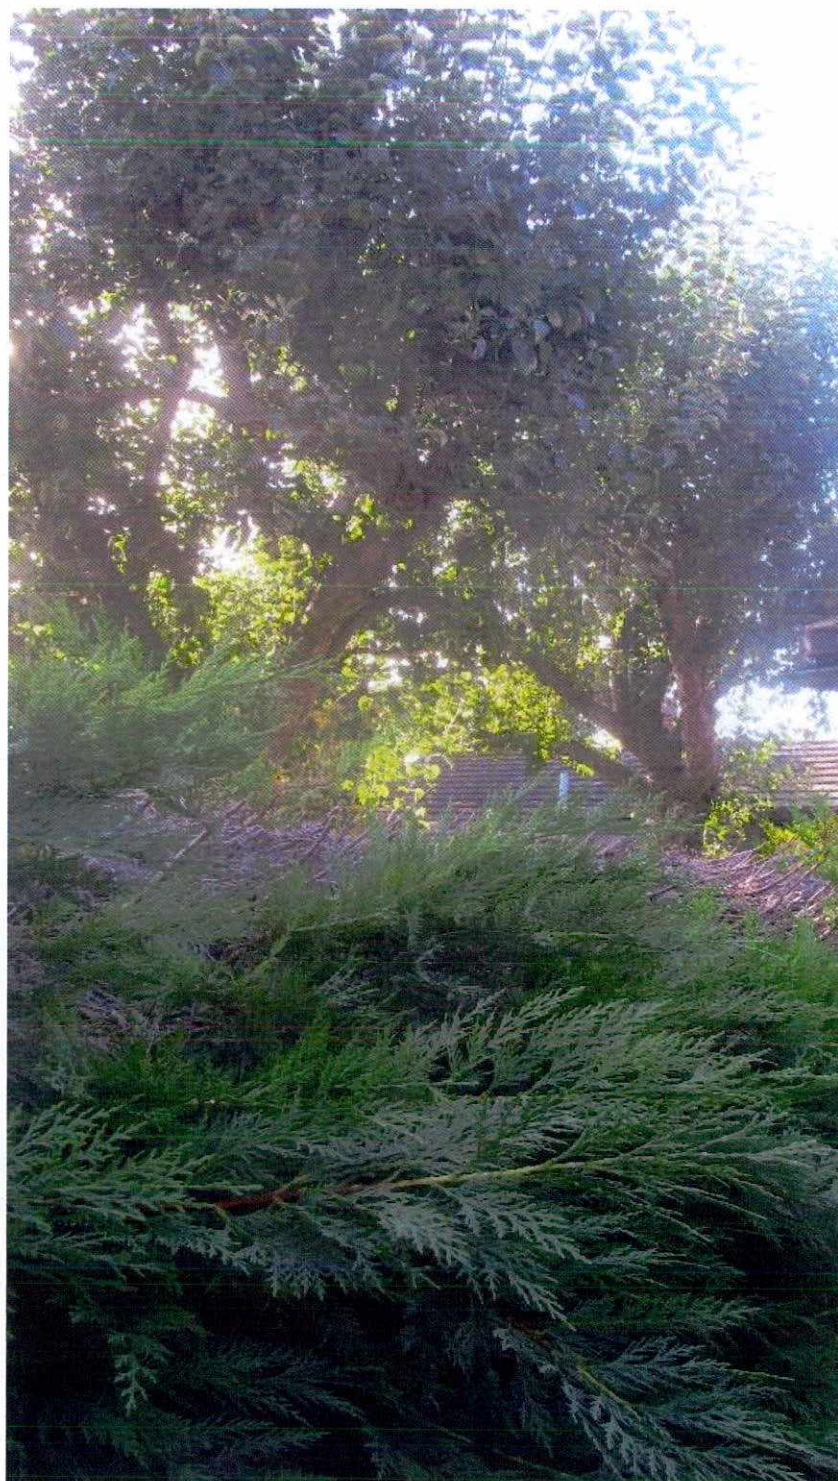
**PHOTOGRAPH NO. 9 – T3 & T4 # – third-party owned apple trees**

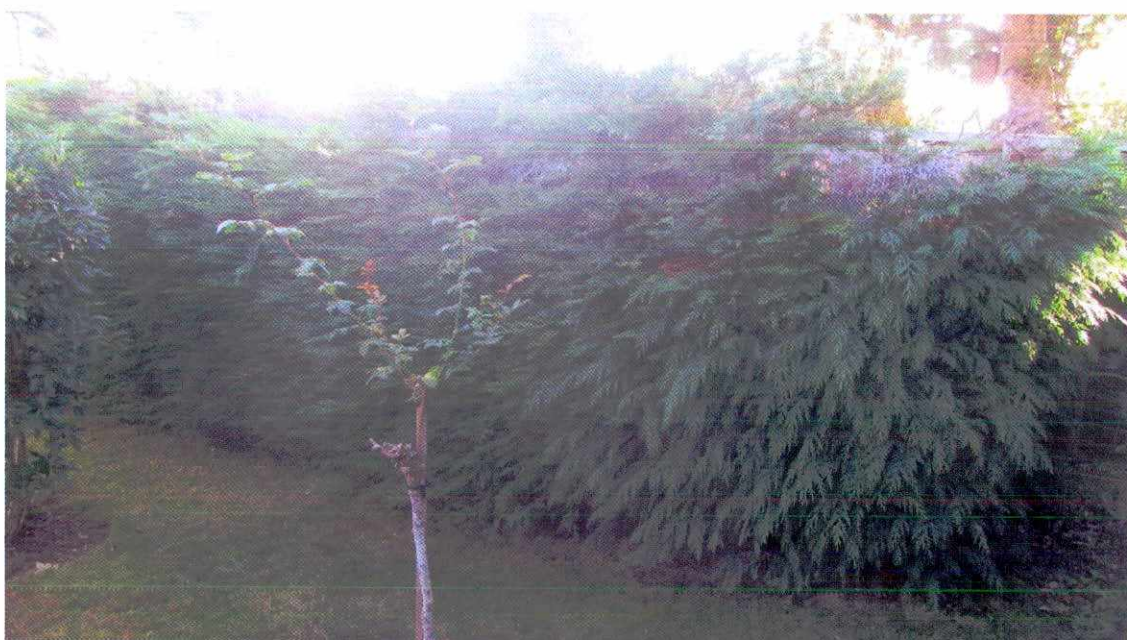
**PHOTOGRAPH NO. 10 – G1 – Leyland cypress hedge**

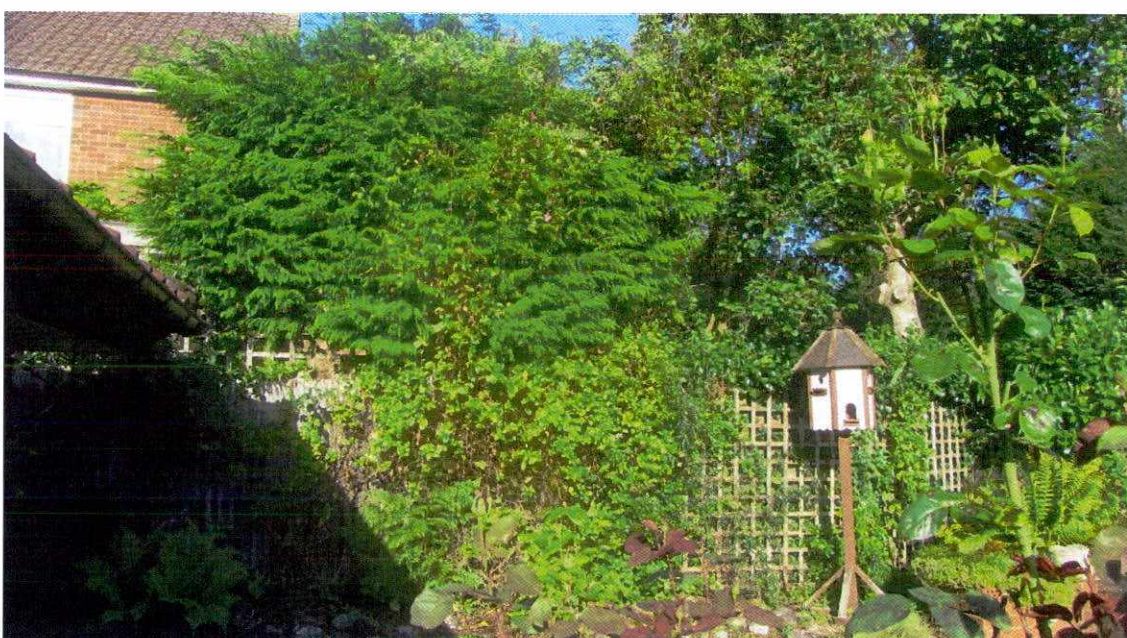
**PHOTOGRAPH NO. 11 – T5 # – third-party owned Lawson cypress**
