TREE SAFETY & CONDITION SURVEY

LETCHWORTH POLICE STATION

Hertfordshire Constabulary | Tree Safety & Condition Survey 2026

| Report reference | AGR/MWGM/LPS/S+C/2026-01 |

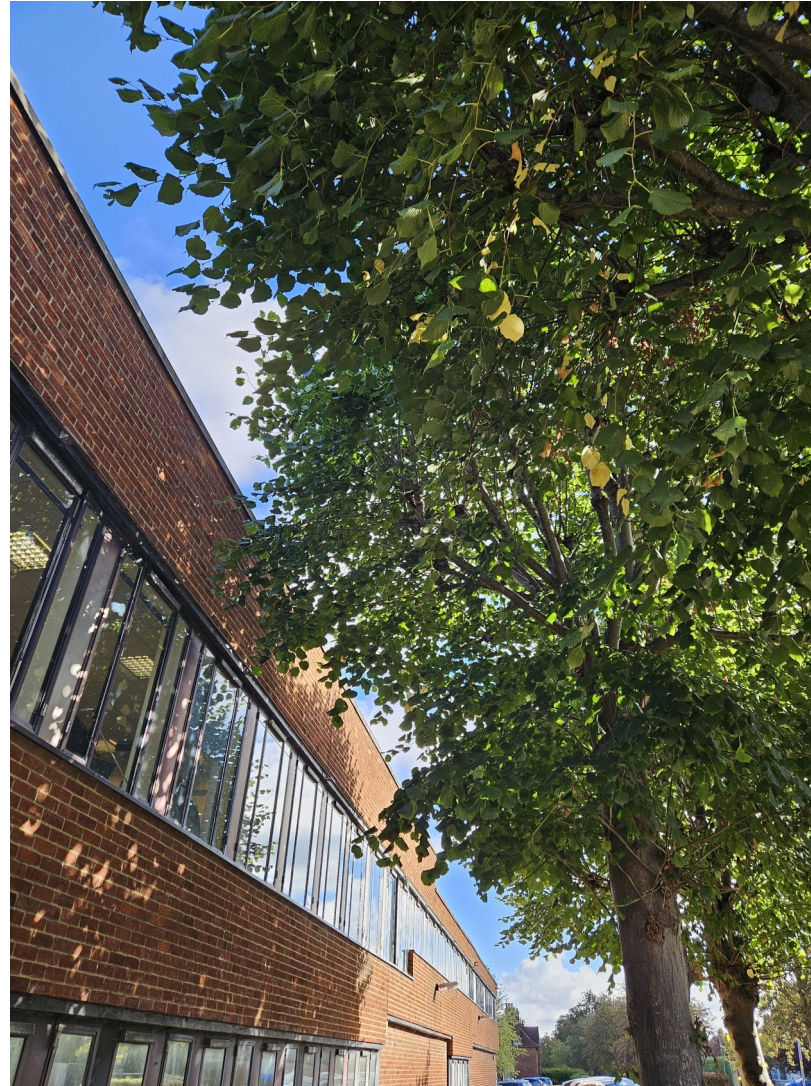
- T008 - Lime x3: repollard back to historic pollard points. Timescale: 1 Year; due 11 September 2027. The group is adjacent to the building and encroaches towards it; no significant defects were noted at the survey.

| Ref | Species / structure | Dimensions | Life stage / expectancy | Condition | Observations / target context | Recommendation | Priority / timescale |
|---|---|---|---|---|---|---|---|
| T008 | Lime x3<br>(Tilia sp.)<br>Group - 3 trees | H 5 m<br>Crown r 3 m | Mature<br>Life exp.: NR | Good | Group of three regularly pruned lime trees.<br>Encroaching on adjacent building. No significant defects noted. | Repollard back to historic pollard points. | P3 / WORK / 1 Year |

T008 - Lime x3 adjacent to the police-station building. Group encroaches toward the building; no significant defects noted. Repollard back to historic pollard points within 1 year.

| Priority | Ref. | Type | Recommendation | Timescale | Due date |
|---|---|---|---|---|---|
| P3 | T008 | WORK | Repollard back to historic pollard points. | 1 Year | 11-Sep-2027 |
