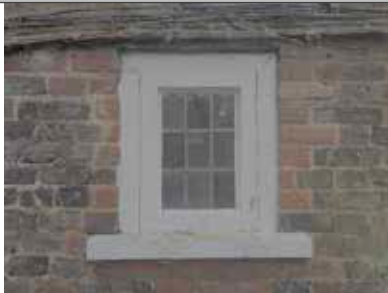
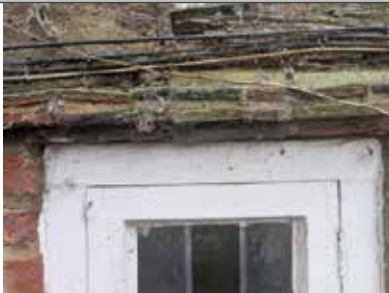
| Reference | Location | Style | Age | Condition | Significance | Internal | | | External | Detail | | Special Features | Glazing Type | Proposed Works |
|---|---|---|---|---|---|---|--|---|---|---|---|---|---|---|
| WG-07 | Flat 06 Bathroom External | Leaded light, casement window. Painted frame. | | 4 | Moderate | Moderate | | | | | | Side hung opening light. Masonry detail at head. Projected sill. | Single. | Replace with dark hardwood windows to match existing proportions and appearance. Detailed design, profiles, glazing specification and glazing bar details to be submitted to and approved by the Local Planning Authority prior to installation. |

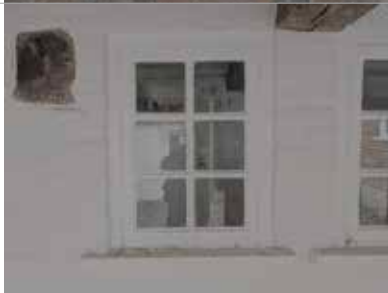
| Reference | Location | Style | Age | Condition | Significance | Internal | | | External | Detail | | Special Features | Glazing Type | Proposed Works |
|---|---|---|---|---|---|---|--|---|---|---|---|---|---|---|
| WG-08 | Flat 06 Corridor Courtyard | Glazing bars, casement window. | | 4 | Moderate. | Harmful | | | | | | Side hung opening light. Projected sill. | Single. | Replace with dark hardwood windows to match existing proportions and appearance. Detailed design, profiles, glazing specification and glazing bar details to be submitted to and approved by the Local Planning Authority prior to installation. |

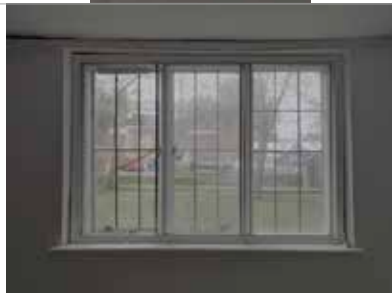
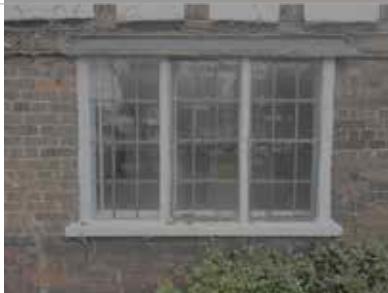
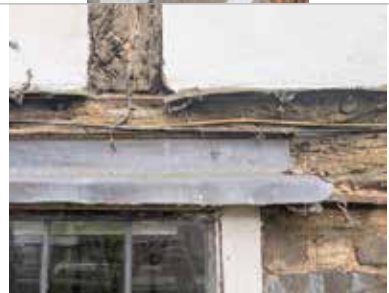
| Reference | Location | Style | Age | Condition | Significance | Internal | | | External | Detail | | Special Features | Glazing Type | Proposed Works |
|---|---|---|---|---|---|---|--|---|---|---|---|---|---|---|
| WG-09 | Flat 06 Liv/Kit External | Three leaded vertical lights, casement window. Painted frame. | | 2 | Poor. Worn lead flashing. Areas of frame in poor condition. | Considerable | | | | | | Two side hung opening lights. One fixed light. Original timber structure at head. Projected sill. | Single. Sliding secondary glaze panels internal. Green tinted panes. | Retain and repair existing window and historic leaded glazing. Treat timber damage and dry out moisture. Introduce slimline secondary glazing internally. Strip white paint subject to timber condition. Code 5 Lead Works. |

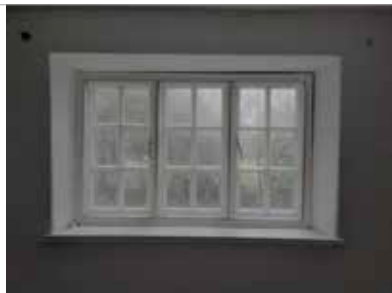
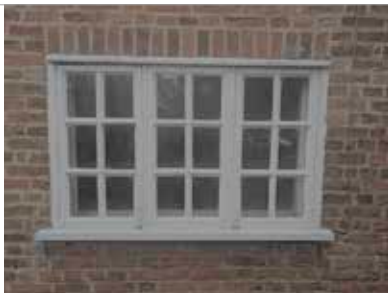
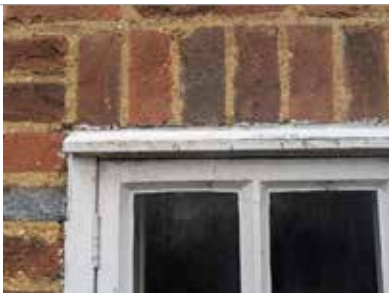
| Reference | Location | Style | Age | Condition | Significance | Internal | | | External | Detail | | Special Features | Glazing Type | Proposed Works |
|---|---|---|---|---|---|---|--|---|---|---|---|---|---|---|
| WG-10 | Flat 05 Liv/Bed External | Three vertical lights with glazing bars, casement window. | | 4 | Moderate. Areas of frame in poor condition. | Low | | | | | | Side hung casement windows. Two side hung opening lights. Fixed centre light. Projected sill. | Single. Side hung secondary glazing panels internal. | Replace with dark hardwood windows to match existing proportions and appearance. Detailed design, profiles, glazing specification and glazing bar details to be submitted to and approved by the Local Planning Authority prior to installation. |

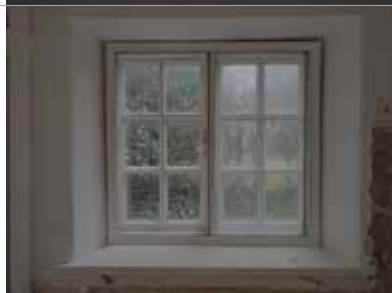
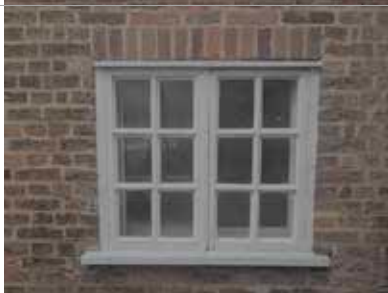
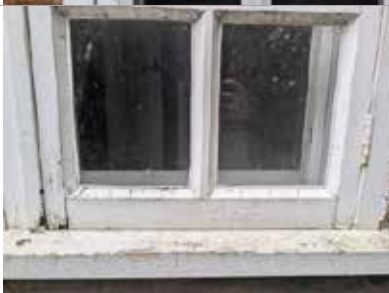
| Reference | Location | Style | Age | Condition | Significance | Internal | | | External | Detail | | Special Features | Glazing Type | Proposed Works |
|---|---|---|---|---|---|---|--|---|---|---|---|---|---|---|
| WG-11 | Flat 05 Kitchen External | Two vertical lights with glazing bars, casement window. Painted frame. | | 4 | Moderate. Areas of frame in poor condition. | Low | | | | | | One side hung opening light, one fixed light. Projected sill. | Single. Side hung secondary glazing panels internal. | Replace with dark hardwood windows to match existing proportions and appearance. Detailed design, profiles, glazing specification and glazing bar details to be submitted to and approved by the Local Planning Authority prior to installation. |

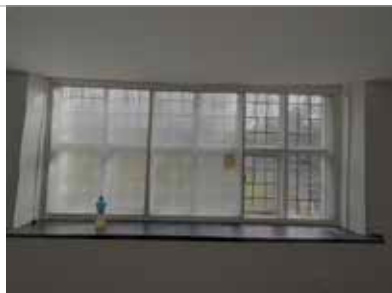
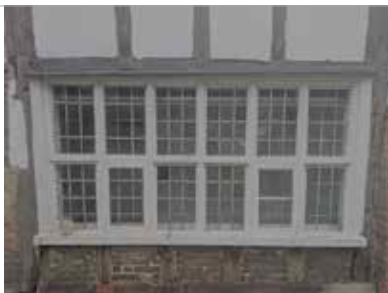
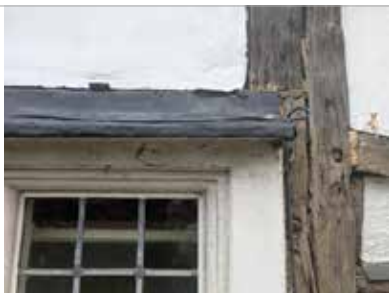
| Reference | Location | Style | Age | Condition | Significance | Internal | | | External | Detail | | Special Features | Glazing Type | Proposed Works |
|---|---|---|---|---|---|---|--|---|---|---|---|---|---|---|
| WG-12 | Flat 04 Liv/Bed External | Twelve leaded vertical lights across two rows, casement window. Painted frame. | | 2 | Poor. Worn lead flashing. | Exceptional | | | | | | Multiple side hung opening lights. Projected sill. | Single. Sliding secondary glazing panels internal. Green tinted panes. | Retain and repair existing window and historic leaded glazing. Treat timber damage and dry out moisture. Introduce slimline secondary glazing internally. Strip white paint subject to timber condition.. Code 5 Lead Works. Reinstate leading in pane with glazing bar. |

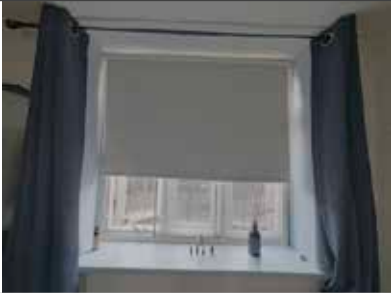
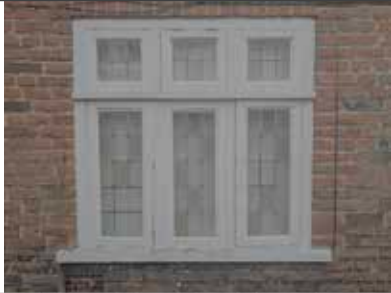
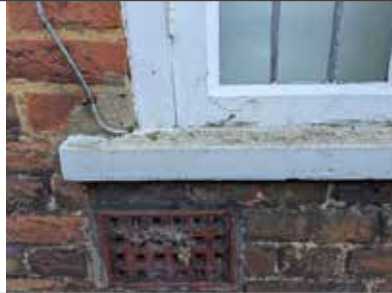
| Reference | Location | Style | Age | Condition | Significance | Internal | External | Detail | Special Features | Glazing Type | Proposed Works |
|---|---|---|---|---|---|---|---|---|---|---|---|
| WG-19 | Flat 02 Liv/Kit/Bed<br>External | Six leaded lights<br>across two rows,<br>casement window.<br>Painted frame. | | 3 Moderate. | Considerable | | | | Two side hung and<br>one top hung<br>opening lights. | Single. Green and<br>pink tinted panes. | Replace with dark<br>hardwood windows to<br>match existing<br>proportions and<br>appearance. Detailed<br>design, profiles, glazing<br>specification and<br>glazing bar details to<br>be submitted to and<br>approved by the Local<br>Planning Authority prior<br>to installation. |

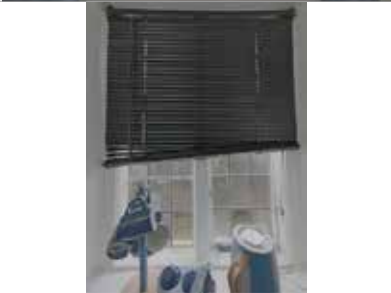
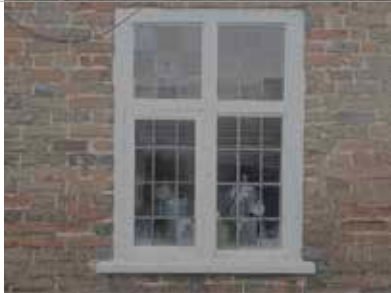
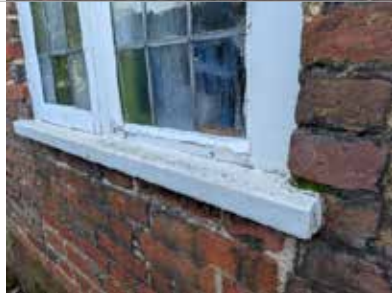
| Reference | Location | Style | Age | Condition | Significance | Internal | External | Detail | Special Features | Glazing Type | Proposed Works |
|---|---|---|---|---|---|---|---|---|---|---|---|
| WG-20 | Flat 02 Liv/Kit/Bed<br>External | Four leaded lights,<br>casement window.<br>Painted frame. | | 3 Moderate. | Considerable | | | | One side hung<br>opening light, rest<br>fixed. | Single. Green and<br>orange tinted<br>panes. | Retain and repair<br>existing window and<br>historic leaded glazing.<br>Treat timber damage<br>and dry out moisture.<br>Introduce slimline<br>secondary glazing<br>internally. Strip white<br>paint subject to timber<br>condition. |

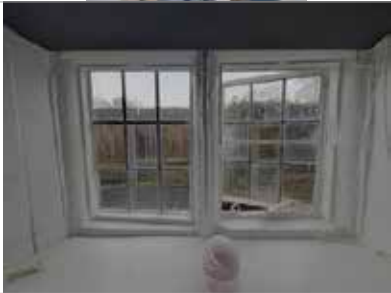
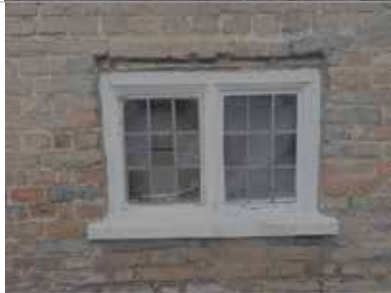
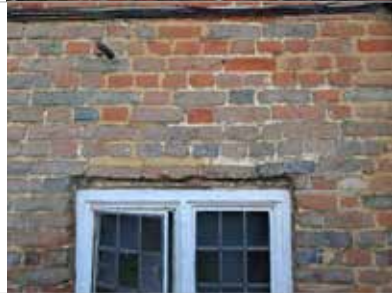
| Reference | Location | Style | Age | Condition | Significance | Internal | External | Detail | Special Features | Glazing Type | Proposed Works |
|---|---|---|---|---|---|---|---|---|---|---|---|
| WG-21 | Flat 02 Bathroom<br>External | Two leaded lights.<br>Painted frame. | | 3 Poor. Window head<br>collapsing. | Moderate | | | | Leaded lights. One<br>side hung opening<br>light, one fixed<br>light. Projected sill. | Single. Green and<br>orange tinted<br>panes. | Retain and repair<br>existing window and<br>historic leaded glazing.<br>Treat timber damage<br>and dry out moisture.<br>Introduce slimline<br>secondary glazing<br>internally. Strip white<br>paint subject to timber<br>condition. Lintel works<br>as per structural<br>engineer's<br>specification. |

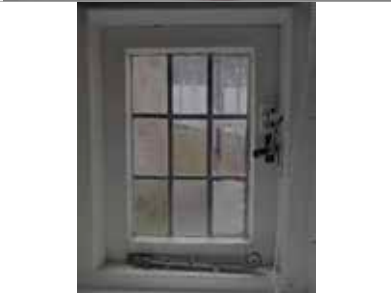
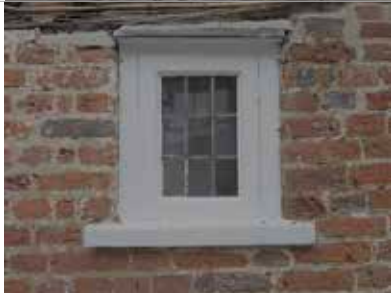
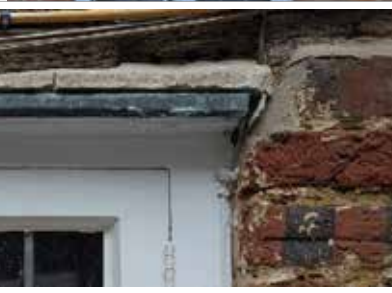
| Reference | Location | Style | Age | Condition | Significance | Internal | External | Detail | Special Features | Glazing Type | Proposed Works |
|---|---|---|---|---|---|---|---|---|---|---|---|
| WG-22 | Flat 02 Lobby<br>Courtyard | Leaded light,<br>casement window.<br>Painted frame. | | 3 Moderate. | Considerable | | | | Side hung opening.<br>Projected sill. | Single. | Retain and repair<br>existing window and<br>historic leaded glazing.<br>Treat timber damage<br>and dry out moisture.<br>Introduce slimline<br>secondary glazing<br>internally. Strip white<br>paint subject to timber<br>condition.. Code 5<br>leadworks. |

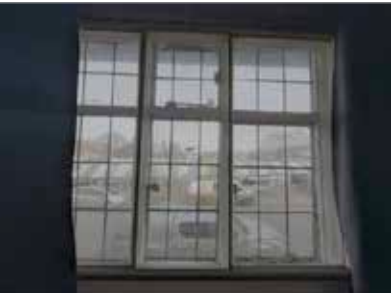
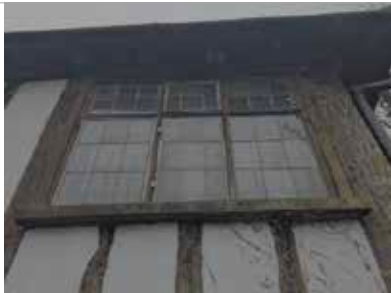
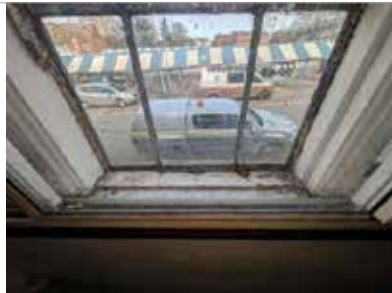
| Reference | Location | Style | Age | Condition | Significance | Internal | External | Detail | Special Features | Glazing Type | Proposed Works |
|---|---|---|---|---|---|---|---|---|---|---|---|
| WF-01 | Flat 07 Liv/Bed<br>External | Six leaded lights<br>across two rows,<br>casement window.<br>Original hardwood<br>frame. | | 3 Very poor | Considerable | | | | Leaded lights. Two<br>side hung opening<br>light, one fixed<br>light. | Single. | Retain and repair<br>existing window and<br>historic leaded glazing.<br>Treat timber damage<br>and dry out moisture.<br>Introduce slimline<br>secondary glazing<br>internally. Strip internal<br>white paint subject to<br>timber condition. |

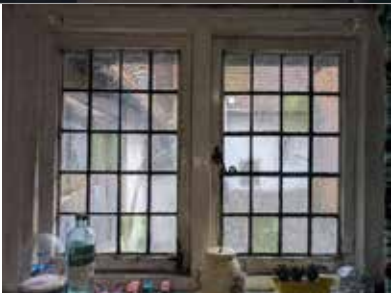
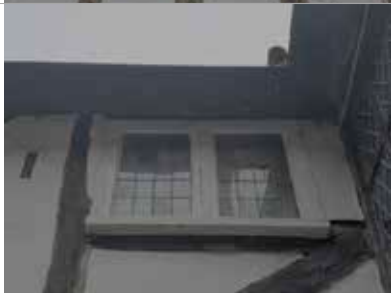
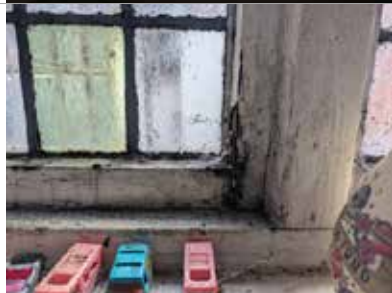
| Reference | Location | Style | Age | Condition | Significance | Internal | External | Detail | Special Features | Glazing Type | Proposed Works |
|---|---|---|---|---|---|---|---|---|---|---|---|
| WF-02 | Flat 07 Kitchen<br>Courtyard | Two leaded lights,<br>casement window.<br>Painted frame. | | 3 Very poor | Considerable | | | | Leaded lights. One<br>side hung opening<br>light, one fixed<br>light. Projected sill. | Single. Side hung<br>casement opening. | Replace with dark<br>hardwood windows to<br>match existing<br>proportions and<br>appearance. Detailed<br>design, profiles, glazing<br>specification and<br>glazing bar details to<br>be submitted to and<br>approved by the Local<br>Planning Authority prior<br>to installation. |

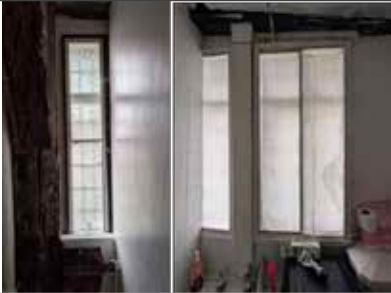
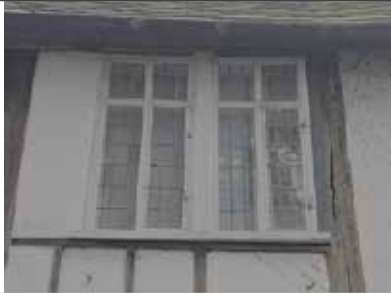
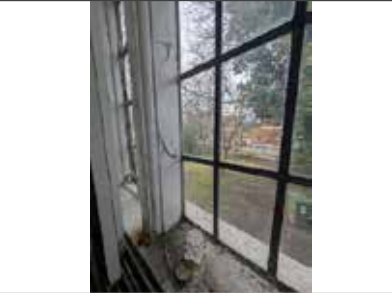
| Reference | Location | Style | Age | Condition | Significance | Internal | External | Detail | Special Features | Glazing Type | Proposed Works |
|---|---|---|---|---|---|---|---|---|---|---|---|
| WF-03 | Flat 07 Bathroom<br>External | Eight leaded lights across two rows, casement window. Painted frame. | | 3 Poor. Obstructed by imposed internal wall. | Considerable | | | | Leaded lights. Two side hung opening light, two fixed lights. | Single. Frosted sliding secondary glazing panels internal. Side hung casement openings. | Replace with dark hardwood windows to match existing proportions and appearance. Detailed design, profiles, glazing specification and glazing bar details to be submitted to and approved by the Local Planning Authority prior to installation. |

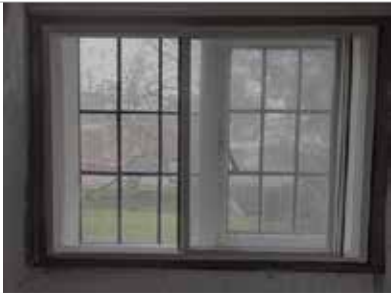
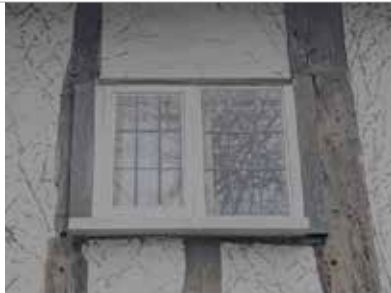
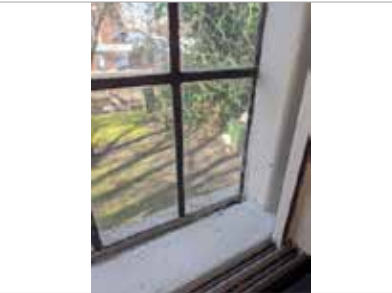
| Reference | Location | Style | Age | Condition | Significance | Internal | External | Detail | Special Features | Glazing Type | Proposed Works |
|---|---|---|---|---|---|---|---|---|---|---|---|
| WF-04 | Flat 12 Cupboard<br>External | Two leaded lights. Painted frame with irregular repairs (mismatched timber detailing) | | 3 Moderate | Considerable | | | | One side hung opening light, one fixed light. | Single. Sliding secondary glazing panels internal. | Replace with dark hardwood windows to match existing proportions and appearance. Detailed design, profiles, glazing specification and glazing bar details to be submitted to and approved by the Local Planning Authority prior to installation. |

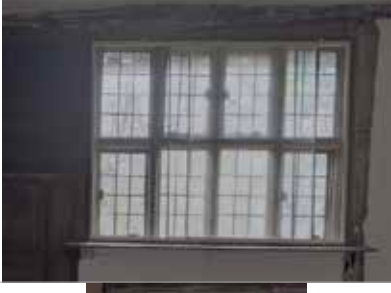
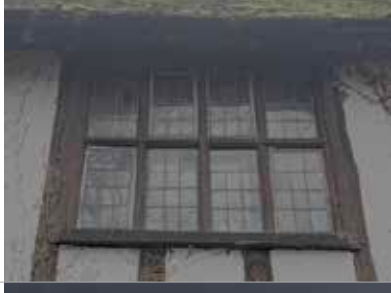
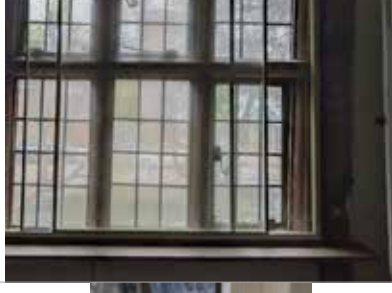
| Reference | Location | Style | Age | Condition | Significance | Internal | External | Detail | Special Features | Glazing Type | Proposed Works |
|---|---|---|---|---|---|---|---|---|---|---|---|
| WF-05 | Flat 12 Liv/Bed<br>External | Eight leaded vertical lights across two rows, casement window. Original hardwood frames. | | 3 Good | Considerable | | | | Multiple side hung opening lights. Original timber structure framing opening. | Single. Sliding secondary glazing panels internal. | Retain and repair existing window and historic leaded glazing. Treat timber damage and dry out moisture. Introduce slimline secondary glazing internally. |

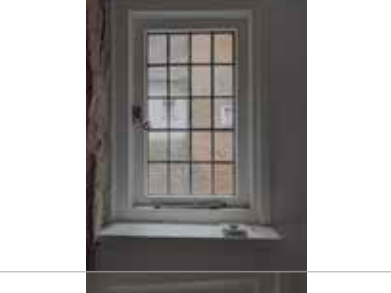
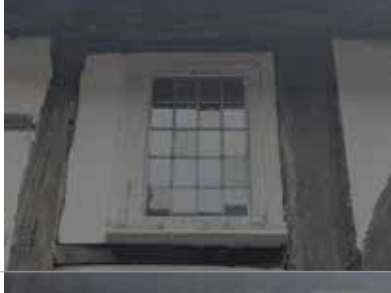
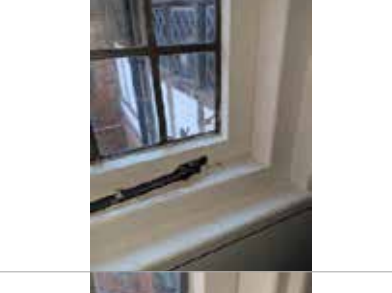
| Reference | Location | Style | Age | Condition | Significance | Internal | External | Detail | Special Features | Glazing Type | Proposed Works |
|---|---|---|---|---|---|---|---|---|---|---|---|
| WF-06 | Flat 12 Kitchen<br>Courtyard | Leaded light, casement window. Painted frame. | | 4 Good | Considerable | | | | Side hung opening light. Original timber structure partially framing opening. | Single. Green and orange tinted panes. | Retain and repair existing window and historic leaded glazing. Treat timber damage and dry out moisture. Introduce slimline secondary glazing internally. Strip white paint subject to timber condition. |

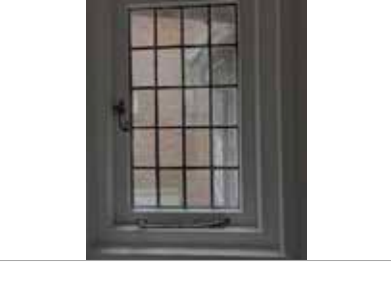
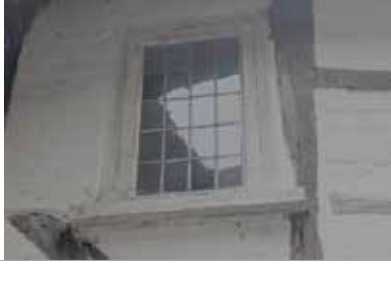
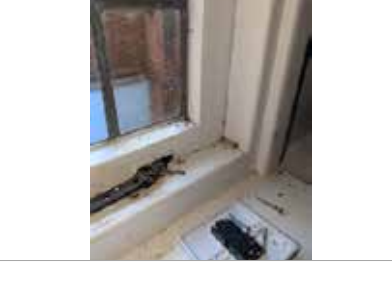
| Reference | Location | Style | Age | Condition | Significance | Internal | External | Detail | Special Features | Glazing Type | Proposed Works |
|---|---|---|---|---|---|---|---|---|---|---|---|
| WF-07 | Flat 12 Liv/Bed<br>Courtyard | Leaded light, casement window. Painted frame. | | 4 Good | Considerable | | | | Side hung opening light. Projected sill. | Single. | Retain and repair existing window and historic leaded glazing. Treat timber damage and dry out moisture. Introduce slimline secondary glazing internally. Strip white paint subject to timber condition. |

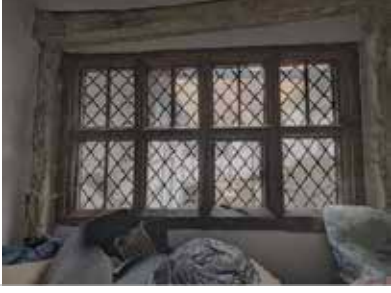
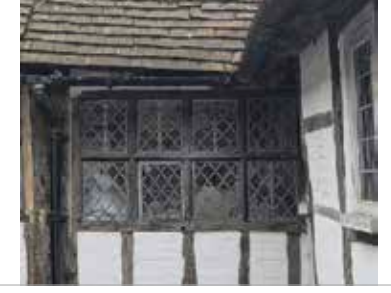
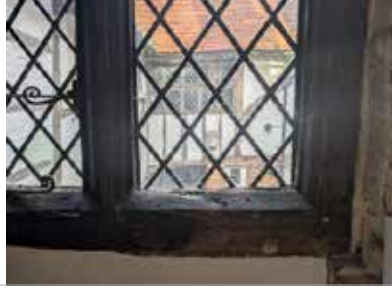
| Reference | Location | Style | Age | Condition | Significance | Internal | External | Detail | Special Features | Glazing Type | Proposed Works |
|---|---|---|---|---|---|---|---|---|---|---|---|
| WF-08 | Stairwell 03<br>Courtyard | Eight diamond leaded lights, casement window. Original hardwood frame and glass. | | 1 Good | Exceptional | | | | Multiple side hung opening lights. Original timber structure framing opening. | Single. | Sensitive cleaning. |

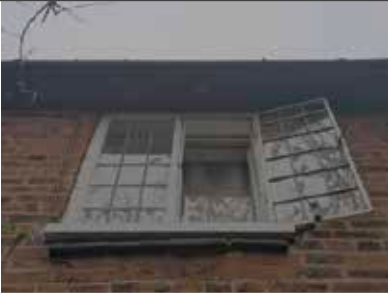
| Reference | Location | Style | Age | Condition | Significance | Internal | | External | Detail | | Special Features | Glazing Type | Proposed Works |
|---|---|---|---|---|---|---|---|---|---|---|---|---|---|
| WF-09 | Flat 11 Liv/Bed<br>External | Two leaded lights, casement window. Painted frame. | | 3 Moderate | Considerable | | | | | | Side hung opening light. Projected sill. | Single. | Retain and repair existing window and historic leaded glazing. Treat timber damage and dry out moisture. Introduce slimline secondary glazing internally. Strip white paint subject to timber condition. |

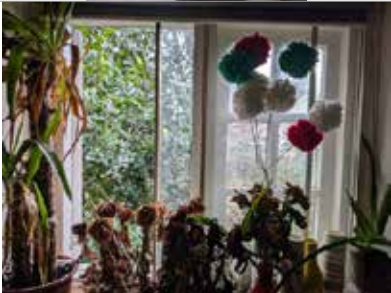
| Reference | Location | Style | Age | Condition | Significance | Internal | | External | Detail | | Special Features | Glazing Type | Proposed Works |
|---|---|---|---|---|---|---|---|---|---|---|---|---|---|
| WF-10 | Flat 11 Kitchen<br>External | Two vertical lights with glazing bars, casement window. Painted frame. | | 5 Poor | Low | | | | | | Side hung opening light. Projected sill. | Single. | Replace with dark hardwood windows to match existing proportions and appearance. Detailed design, profiles, glazing specification and glazing bar details to be submitted to and approved by the Local Planning Authority prior to installation. |

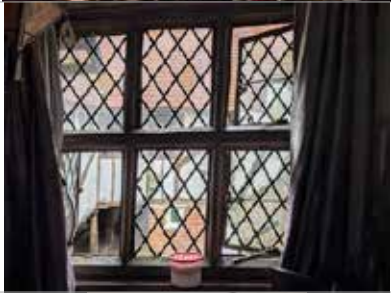
| Reference | Location | Style | Age | Condition | Significance | Internal | | External | Detail | | Special Features | Glazing Type | Proposed Works |
|---|---|---|---|---|---|---|---|---|---|---|---|---|---|
| WF-11 | Flat 11 Liv/Bed<br>Courtyard | Six diamond leaded lights, casement window. Original hardwood frame and glass with some repairs to frame. | | 1 Moderate | Exceptional | | | | | | Side hung casement openings. Original timber structure framing opening. | Single. | Retain and repair existing window and historic leaded glazing. Treat timber damage and dry out moisture. Introduce slimline secondary glazing internally. |

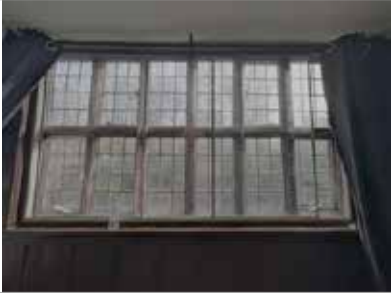
| Reference | Location | Style | Age | Condition | Significance | Internal | | External | Detail | | Special Features | Glazing Type | Proposed Works |
|---|---|---|---|---|---|---|---|---|---|---|---|---|---|
| WF-13 | Flat 10 Liv/Bed<br>External | Two rows of six leaded lights, casement window. Original hardwood frame. | | 2 Good | Exceptional | | | | | | Side hung casement openings. Original timber structure framing opening. | Single. Sliding secondary glazing panels internal. | Retain and repair existing window and historic leaded glazing. Treat timber damage and dry out moisture. Introduce slimline secondary glazing internally. |

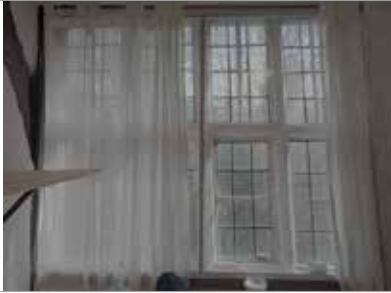
| Reference | Location | Style | Age | Condition | Significance | Internal | | External | Detail | | Special Features | Glazing Type | Proposed Works |
|---|---|---|---|---|---|---|---|---|---|---|---|---|---|
| WF-14 | Flat 10 Kitchen<br>External | Two rows of four leaded lights, casement window. Original hardwood frame with some repairs. | | 2 Poor | Exceptional | | | | | | Side hung casement openings. Original timber structure framing opening with repairs. | Single. Sliding secondary glazing panels internal. | Retain and repair existing window and historic leaded glazing. Treat timber damage and dry out moisture. Introduce slimline secondary glazing internally. Strip internal white paint subject to timber condition. |

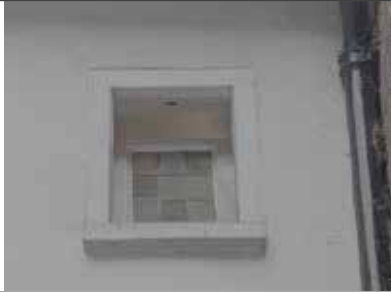
| Reference | Location | Style | Age | Condition | Significance | Internal | | External | Detail | | Special Features | Glazing Type | Proposed Works |
|---|---|---|---|---|---|---|---|---|---|---|---|---|---|
| WF-15 | Flat 10 Bathroom Courtyard | Leaded light, pivot window. | | 4 Poor in areas. | Moderate | | | | | | Horizontal pivot opening. | Single. Tinted panes. | Replace with dark hardwood windows to match existing proportions and appearance. Detailed design, profiles, glazing specification and glazing bar details to be submitted to and approved by the Local Planning Authority prior to installation. |

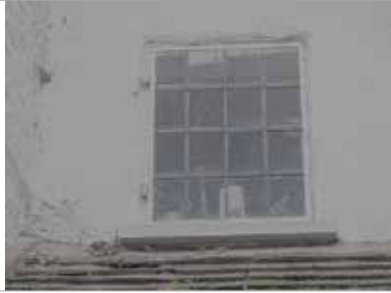
| Reference | Location | Style | Age | Condition | Significance | Internal | | External | Detail | | Special Features | Glazing Type | Proposed Works |
|---|---|---|---|---|---|---|---|---|---|---|---|---|---|
| WF-16 | Stairwell 02 Courtyard | Leaded light, casement window. Painted frame. | | 3 Moderate. | Considerable | | | | | | Side hung opening light. Projected sill. | Single. | Clean. |

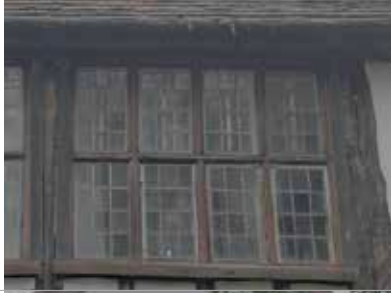
| Reference | Location | Style | Age | Condition | Significance | Internal | | External | Detail | | Special Features | Glazing Type | Proposed Works |
|---|---|---|---|---|---|---|---|---|---|---|---|---|---|
| WF-17 | Flat 09 Kitchen External | Two rows of four leaded lights, casement window. Original hardwood frame with some repairs. | | 2 Moderate | Exceptional | | | | | | Side hung casement openings. Original timber structure framing opening with repairs. | Single. Sliding secondary glazing panels internal. | Retain and repair existing window and historic leaded glazing. Treat timber damage and dry out moisture. Introduce slimline secondary glazing internally. Strip internal white paint subject to timber condition. |

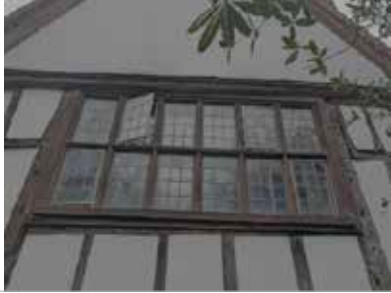
| Reference | Location | Style | Age | Condition | Significance | Internal | | External | Detail | | Special Features | Glazing Type | Proposed Works |
|---|---|---|---|---|---|---|---|---|---|---|---|---|---|
| WF-18 | Flat 09 Liv/Bed External | Two rows of six leaded lights, casement window. Original hardwood frame. | | 2 Good | Exceptional | | | | | | Side hung casement openings. Original timber structure framing opening with repairs. | Single. Sliding secondary glazing panels internal. | Retain and repair existing window and historic leaded glazing. Treat timber damage and dry out moisture. Introduce slimline secondary glazing internally. |

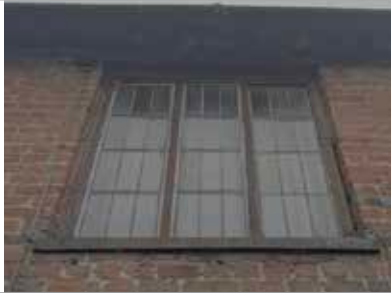
| Reference | Location | Style | Age | Condition | Significance | Internal | | External | Detail | | Special Features | Glazing Type | Proposed Works |
|---|---|---|---|---|---|---|---|---|---|---|---|---|---|
| WF-19 | Flat 08 Liv/Bed External | Three vertical leaded lights, casement window. Original outer hardwood frames. | | 2 Poor | High | | | | | | Side hung casement openings. | Single. Green tinted panes. | Retain and repair existing window and historic leaded glazing. Treat timber damage and dry out moisture. Introduce slimline secondary glazing internally. Strip internal white paint subject to timber condition. |

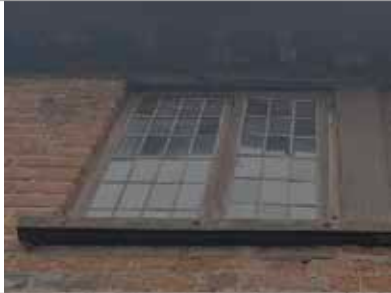
| Reference | Location | Style | Age | Condition | Significance | Internal | | External | Detail | | Special Features | Glazing Type | Proposed Works |
|---|---|---|---|---|---|---|---|---|---|---|---|---|---|
| WF-20 | Flat 08 Liv/Bed External | Two vertical leaded lights, casement window. Original outer hardwood frame. | | 2 Poor | Considerable | | | | | | Side hung casement openings. Projected sill. | Single. Green tinted panes. | Retain and repair existing window and historic leaded glazing. Treat timber damage and dry out moisture. Introduce slimline secondary glazing internally. Strip internal white paint subject to timber condition. |

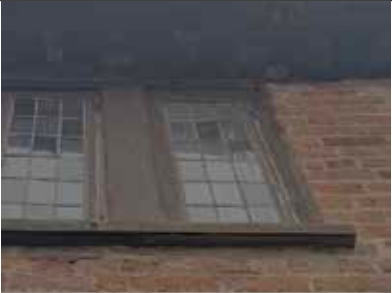
| Reference | Location | Style | Age | Condition | Significance | Internal | | External | Detail | Special Features | Glazing Type | Proposed Works |
|---|---|---|---|---|---|---|---|---|---|---|---|---|
| WF-21 | Flat 08 Liv/Bed External | Two vertical leaded lights, casement window. Original outer hardwood frame. | | 2 Poor | Considerable | | | | | Side hung casement openings. Projected sill. | Single. Green and orange tinted panes. | Retain and repair existing window and historic leaded glazing. Treat timber damage and dry out moisture. Introduce slimline secondary glazing internally. Strip internal white paint subject to timber condition. |

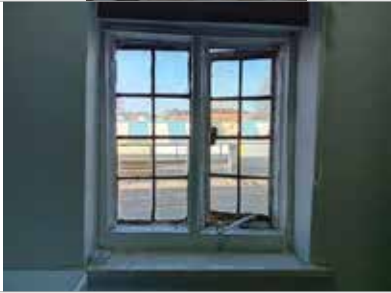
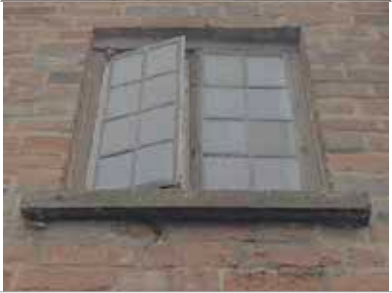
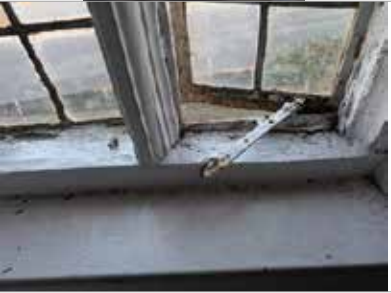
| Reference | Location | Style | Age | Condition | Significance | Internal | | External | Detail | Special Features | Glazing Type | Proposed Works |
|---|---|---|---|---|---|---|---|---|---|---|---|---|
| WF-22 | Flat 08 Bathroom External | Two vertical leaded lights, casement window. Original outer hardwood frame. | | 2 Very poor | Moderate | | | | | Side hung casement openings. Projected sill. | Single Orange tinted panes. | Retain and repair existing window and historic leaded glazing. Treat timber damage and dry out moisture. Introduce slimline secondary glazing internally. Strip internal white paint subject to timber condition. |

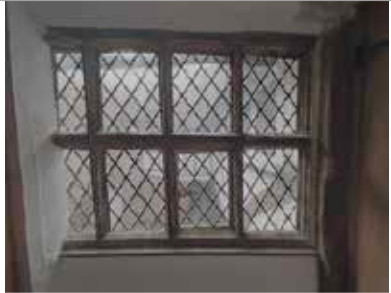
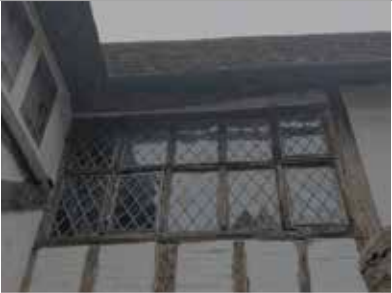
| Reference | Location | Style | Age | Condition | Significance | Internal | | External | Detail | Special Features | Glazing Type | Proposed Works |
|---|---|---|---|---|---|---|---|---|---|---|---|---|
| WF-23 | Stairwell 01 Courtyard | Two rows of five vertical, diamond leaded lights, casement window. Original hardwood frame and glass. | | 1 Good | Exceptional | | | | | Side hung openings. | Single. | Sensitive repairs and removal of partition wall. |

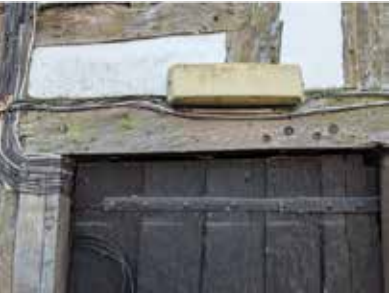
| Reference | Location | Style | Age | Condition | Significance | Internal | | External | Detail | Special Features | Glazing Type | Proposed Works |
|---|---|---|---|---|---|---|---|---|---|---|---|---|
| DG-01 | First entrance door | | | 2 Moderate | Considerable | | | | | | | Retain, remove fixtures. Add subtle bronze up down lighting features outside the door frame. |

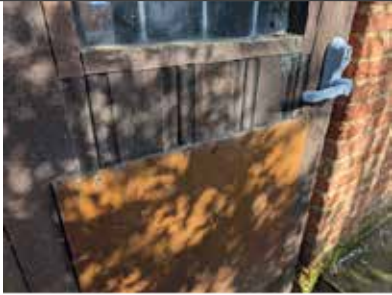
| Reference | Location | Style | Age | Condition | Significance | Internal | External | Detail | Special Features | Glazing Type | Proposed Works |
|---|---|---|---|---|---|---|---|---|---|---|---|
| DG-03 | Back entrance door | | 5 | Very poor | Low | | | | | | Replace |
