## Ground Investigation Report

Proposed Commercial Development

Baldock Industrial Estate

May 2025

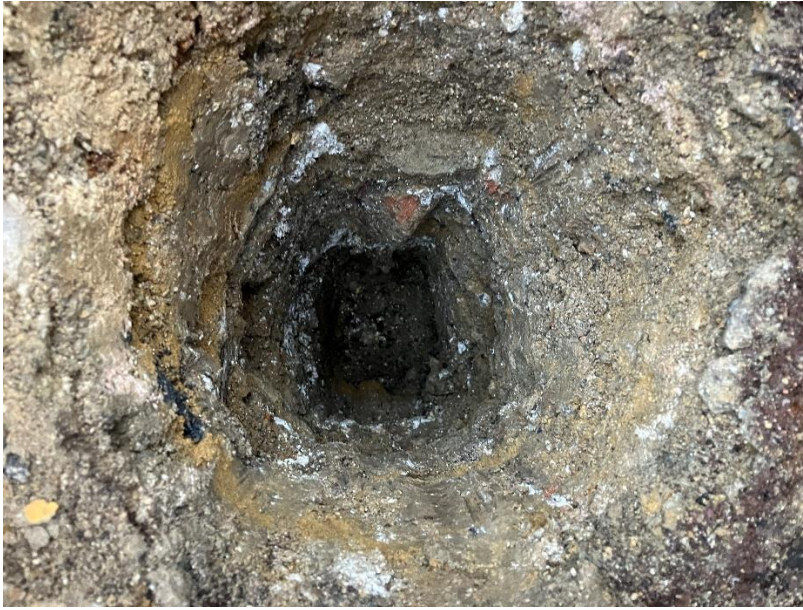
- 6.2.3 In the west (vicinity of BH04), Made Ground extended to 1.5m depth. Surfacing asphalt extended onto a coarse gravel subbase, and a buried concrete layer (0.15m thick) was present below this. Underlying Made Ground again comprised an assortment of gravelly sands and clays. A slight hydrocarbon odour was recorded from 0.85m depth in TP02, but was not identified in BH02.

*Figure 6-A: Made Ground within the inspection pit at BH02.*

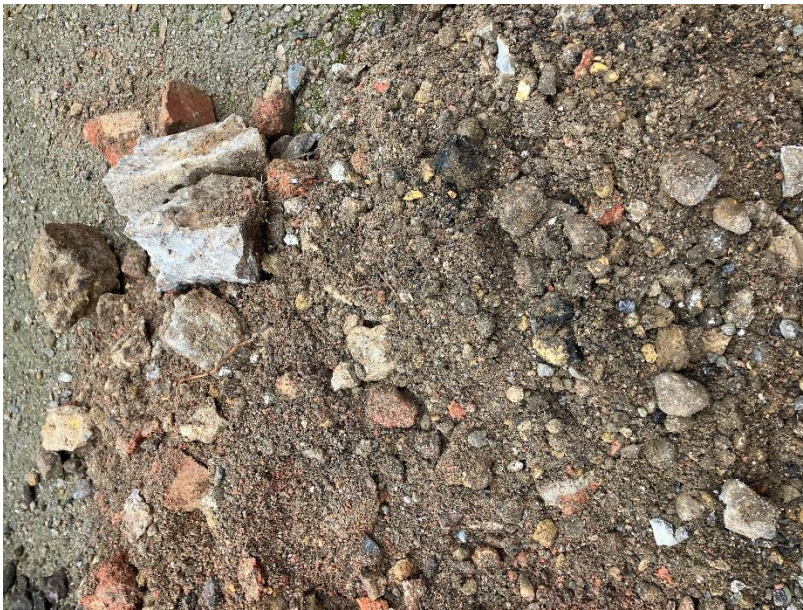
*Figure 6-B: Made Ground excavated from TP01.*

| Exploratory hole ID | Depth of observation (m bgl) | Stratum | Description |
|---|---|---|---|
| TP01 | 0.05 - 0.35 | Made Ground | Suspected asbestos containing material, (fragment of cement board), observed in Made Ground. |

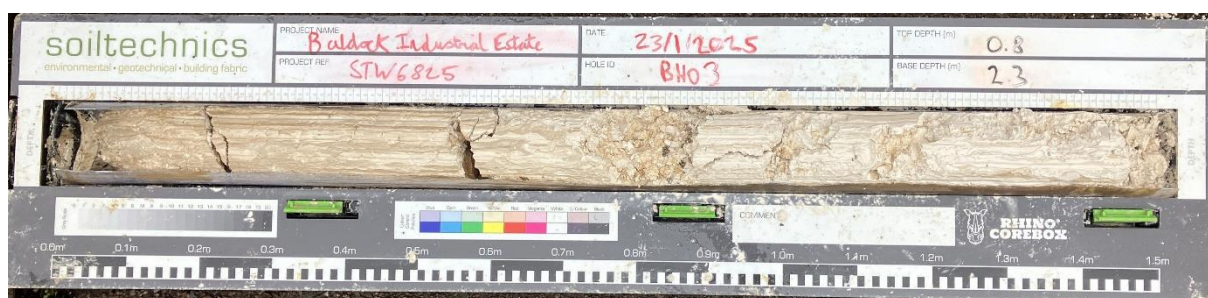
- 6.3.1 Chalk was encountered in all exploratory hole locations, underlying the Made Ground. Structureless chalk composed of brown to off-white sandy clayey gravel with low to medium content was encountered to depths between 1.9m and 2.9m, after which the chalk became more competent. At depth the Chalk was weak, low density, cream to off-white with occasional black specs. Fractures appeared very closely to closely spaced. The base of the chalk was not proven with the maximum depth achieved being 19m.
- 6.3.2 Photographs of the chalk encountered are presented below.

Figure 6-C: Structureless chalk encountered in BH03.

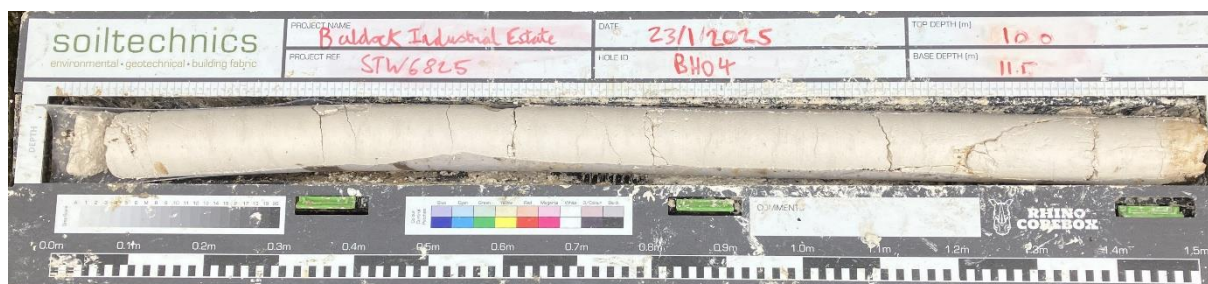
Figure 6-D: Structured chalk encountered in BH04.
