# **CAMBRIDGE ASBESTOS REMOVAL LTD**

**R & D for Asbestos containing materials at**

Science Block  
Temple Dinsley  
School Lane  
Preston, Hitchin  
Hertfordshire, SG4 7RT

REFERENCE; ECB/5341

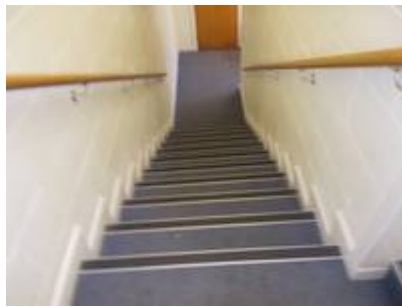
Location Ref: V01

Area/ Floor/ Room/ Product: Main: All Levels: Staircase: Stair nosing

Non asbestos vinyl staircase nosings.

No Action Required

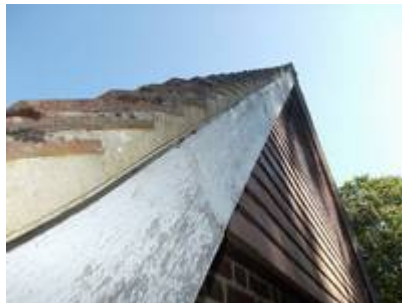
Location Ref: 1

Area/ Floor/ Room/ Product: Main: Ground floor: External: Boarding

Non asbestos board roof tile  
undercloaking.

No Action Required
