**EXISTING WINDOWS 1, 2, 3, 4 & 5**

Address.  
18, Horn Hill  
Whitwell  
Herts.  
SG4 8AS

Ref No.  
A 02

Title.  
Existing  
Windows 1, 2,  
3, 4 & 5

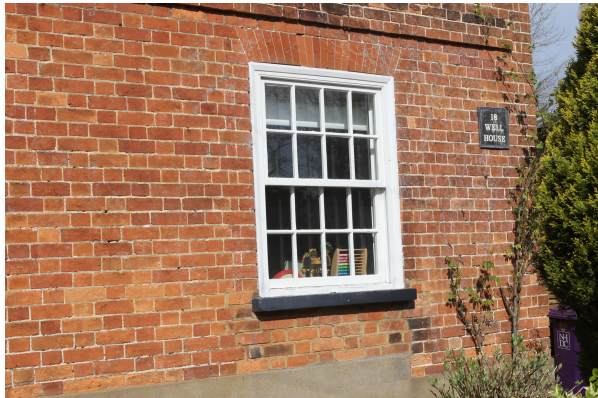
Window 1.  
Front elevation.  
Ground floor, right hand side.

This timber single glazed sash window is a relatively recent replacement. When compared to the same window at No 22 Horn Hill this window has been replaced as it is four courses of brickwork shorter. Non original bricks with sand and cement mortar, rather than traditional lime mortar, has been used to infill below this window. The window itself has been brought forward level with the face of the brickwork - probably to allow secondary glazing to be fitted neatly internally. It would appear that apart from the bottom courses of brickwork being altered the reveals and brick lintel are original.

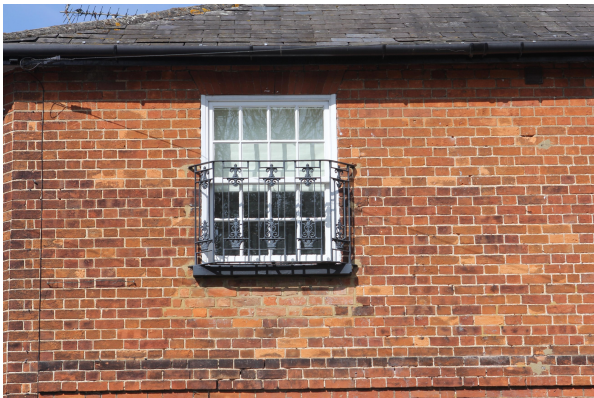
Window 4.  
Front Elevation.  
First floor left hand side.

This timber single glazed sash window is a relatively recent replacement. When compared to the same window at No 22 Horn Hill this window has been replaced as this window is four courses of brickwork shorter. Non original bricks with sand and cement mortar, rather than traditional lime mortar has been used to infill below this window and the window itself has been brought forward level with the face of the brickwork - probably to allow secondary glazing to be fitted neatly internally. It would appear that apart from the bottom courses of brickwork being altered the reveals and brick lintel are original. The cast iron canted railing appears to be original however it has been repositioned from it's original location.

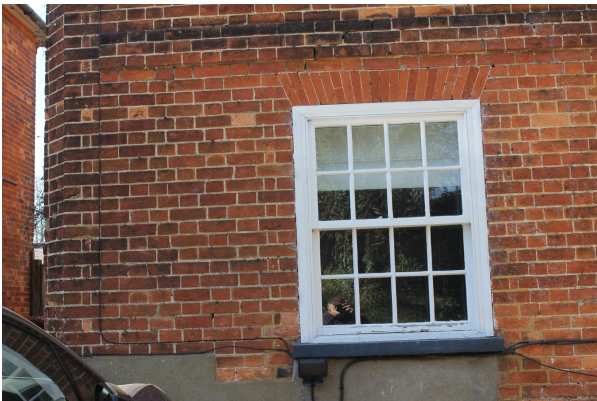
Window 2.  
Front elevation.  
Ground floor, left hand side.

This timber single glazed sash window is a relatively recent replacement. When compared to the same window at No 22 Horn Hill this window has been replaced as this window is four courses of brickwork shorter. Non original bricks with sand and cement mortar, rather than traditional lime mortar has been used to infill below this window and the window itself has been brought forward to the face of the brickwork - probably to allow secondary glazing to be fitted neatly internally. It would appear that apart from the bottom courses of brickwork being altered the reveals and brick lintel are original.

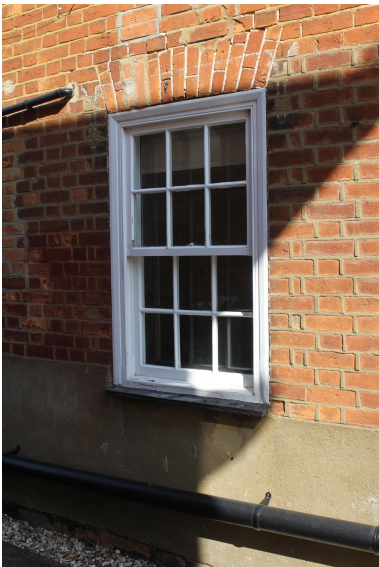
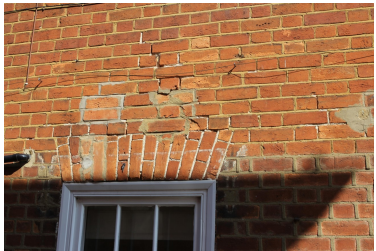
Window 5.  
Side elevation.  
Ground floor

This timber single glazed sash window is a relatively recent replacement. It may have replaced a historic door with brickwork infilled below but this is not certain. There is no stone sill, simply a modern tile sill. This window has been brought forward with architrave style beading to infill between the window and the brickwork. It is likely that the brick lintel above is not the original. The pointing adjacent this window is generally modern sand and cement, rather than traditional lime mortar. The brickwork immediately above the window appears to have dropped slightly with cracks opening in the mortar joints above

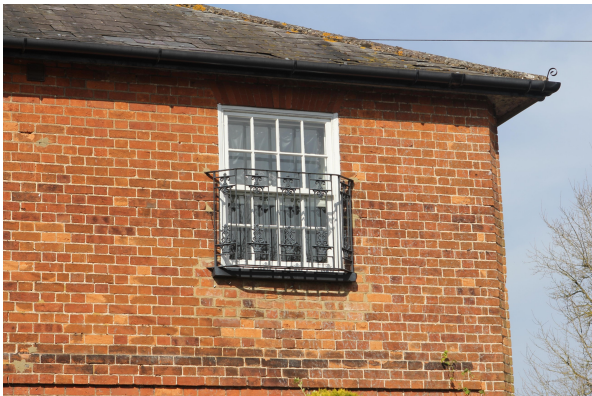
Window 3.  
Front Elevation.  
First floor right hand side.

This timber single glazed sash window is a relatively recent replacement. When compared to the same window at No 22 Horn Hill this window has been replaced as this window is four courses of brickwork shorter. Non original bricks with sand and cement mortar, rather than traditional lime mortar has been used to infill below this window and the window itself has been brought forward level to the face of the brickwork - probably to allow secondary glazing to be fitted neatly internally. It would appear that apart from the bottom courses of brickwork being altered the reveals and brick lintel are original. The cast iron railing appears to be the original however it has been repositioned from it's original location.
