# Site: **Orchard House** – Arboricultural Report

**Report Title:** TCR/888 98 Norton Road Letchworth Arboricultural Report 2025

**Version:** V1.0  
**Issue Date:** July 2025  
**Report Ref:** TCR/888

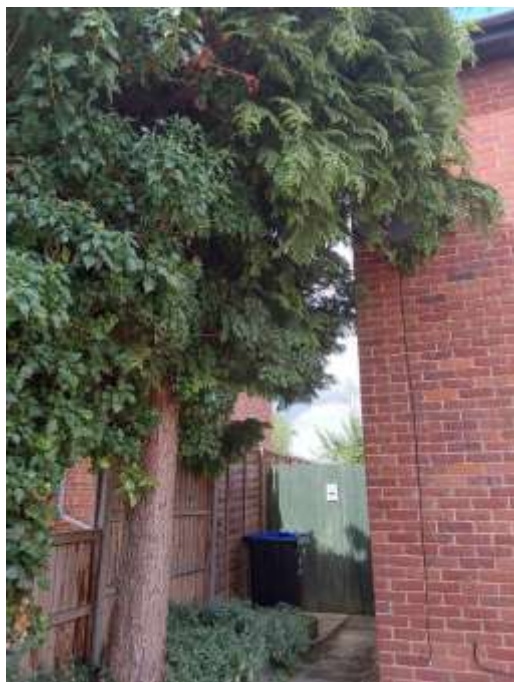
**Plate 1:** T001 and its proximity to the building.

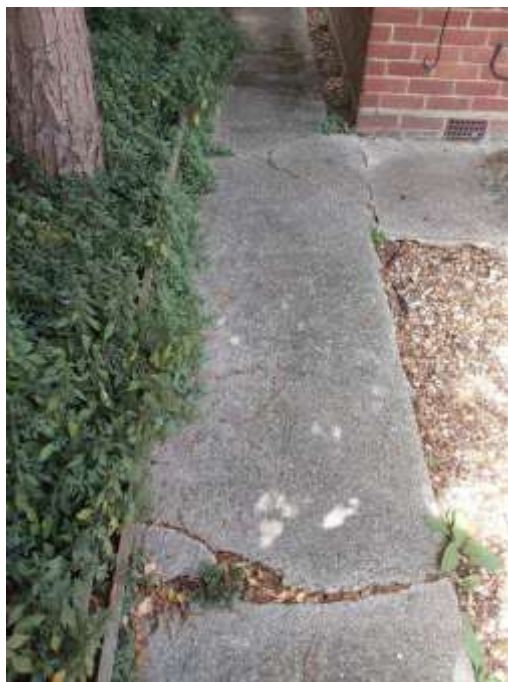
**Plate 2:** Direct damage caused by secondary root expansion of T001.

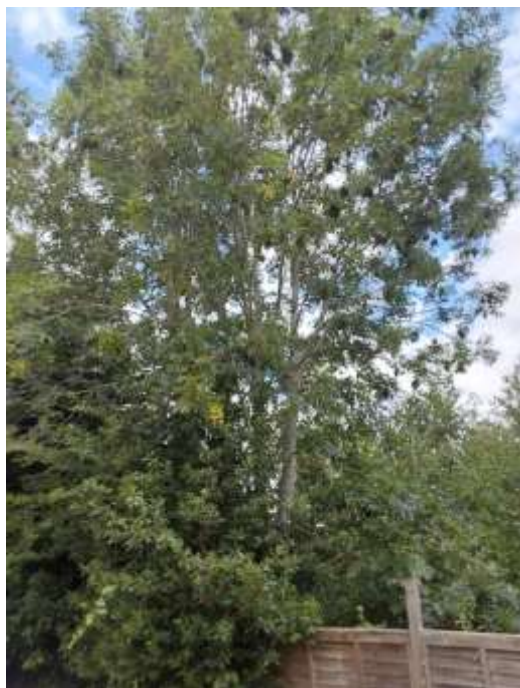
**Plate 3:** T003 and its current crown condition (good).

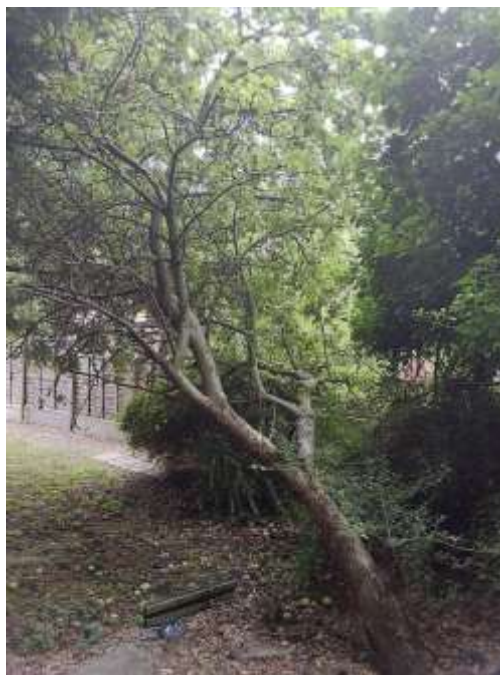
**Plate 4:** T005 showing a lean deemed to be of low significance currently.
