Arboricultural Recommendations Excerpt:

Carried out by: Adam Richards of Valley Provincial Limited

Date: 23<sup>rd</sup> March 2026

Site address: Hitchin Rd, Gosmore, St Ippolyts, Hitchin SG4 7QH

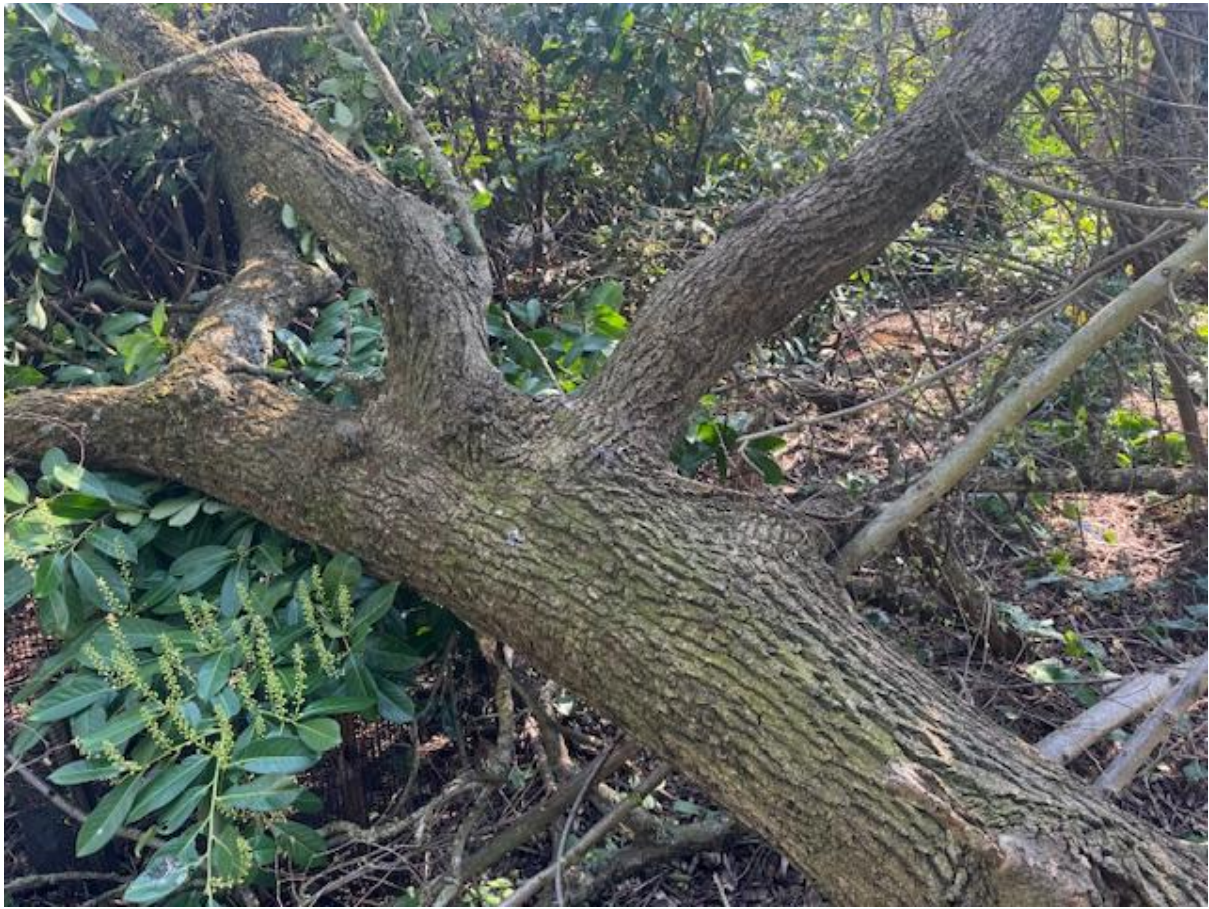
| Tree no. | Species | Work specification | Reason for works |
|---|---|---|---|
| T1 | Oak | Sectionally dismantle down to ground level | Tree has recently lost a large limb, which narrowly missed a neighbouring property. Severe decay to base and in trunk. Cavity to base of tree extended almost all the way across the diameter of the trunk when probed, and up to the recently lost scaffold limb. High risk of catastrophic failure. Close proximity to path, neighbouring property and road to rear of care home |

T1 – Oak – Failed scaffold limb

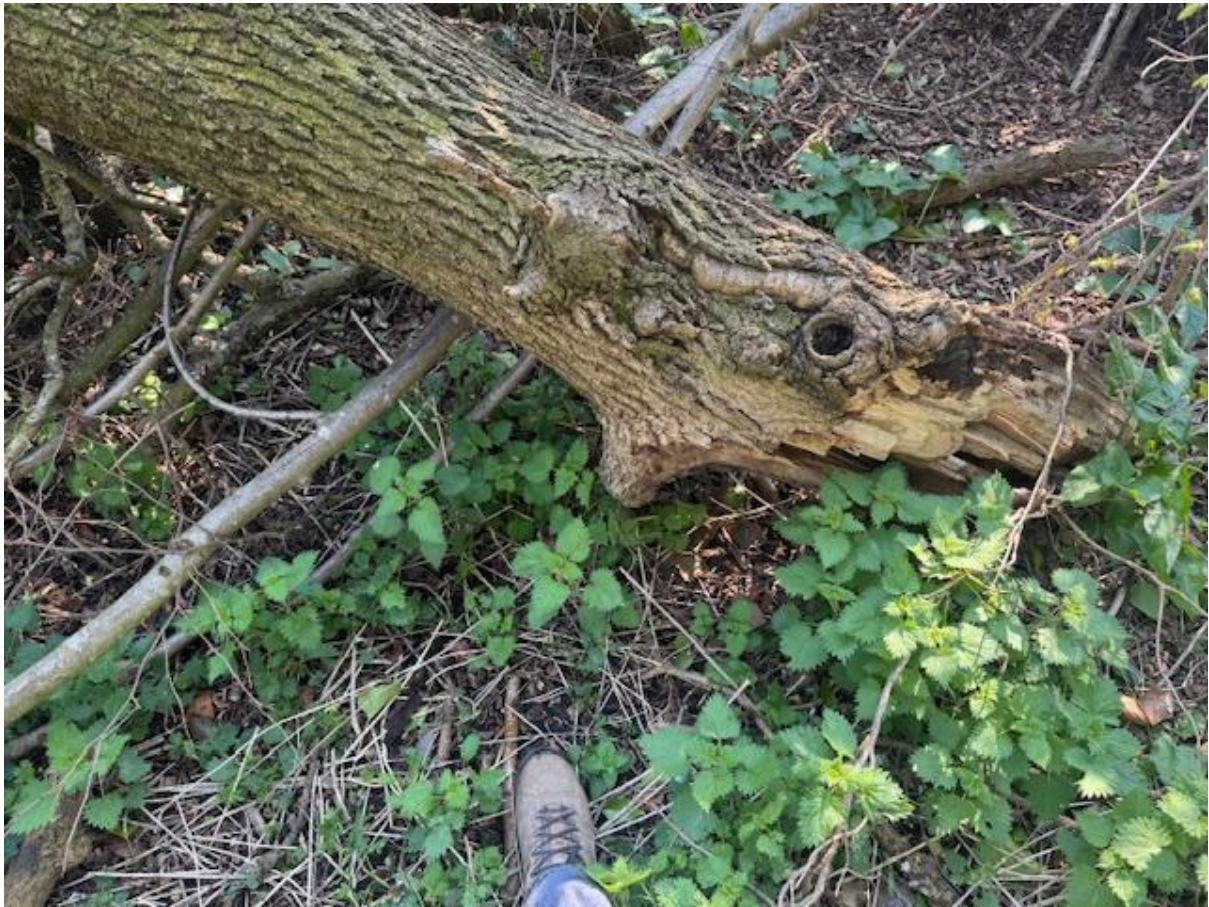
T1 – Oak – Failed scaffold limb

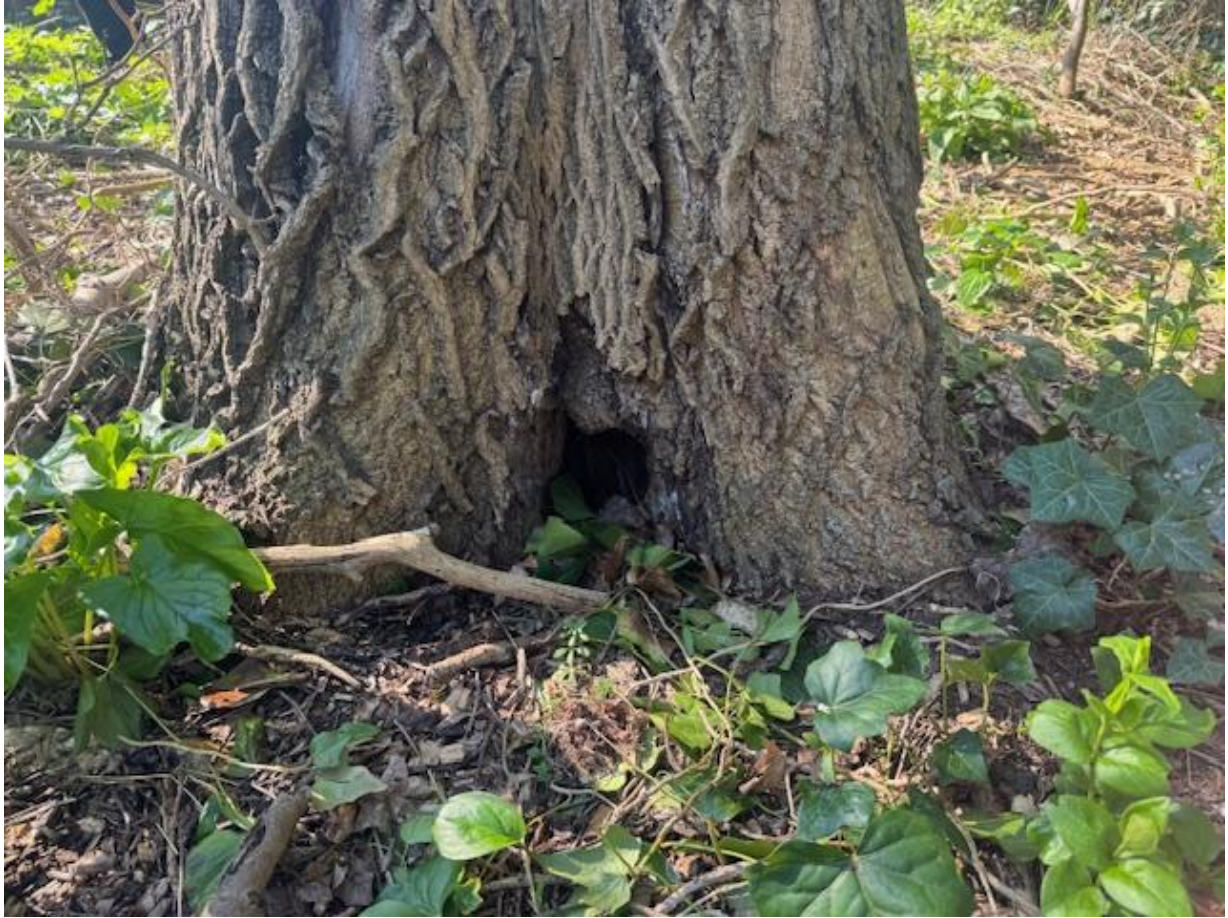
T1 – Oak – Extensive cavity to base which extends almost across entire diameter of stem

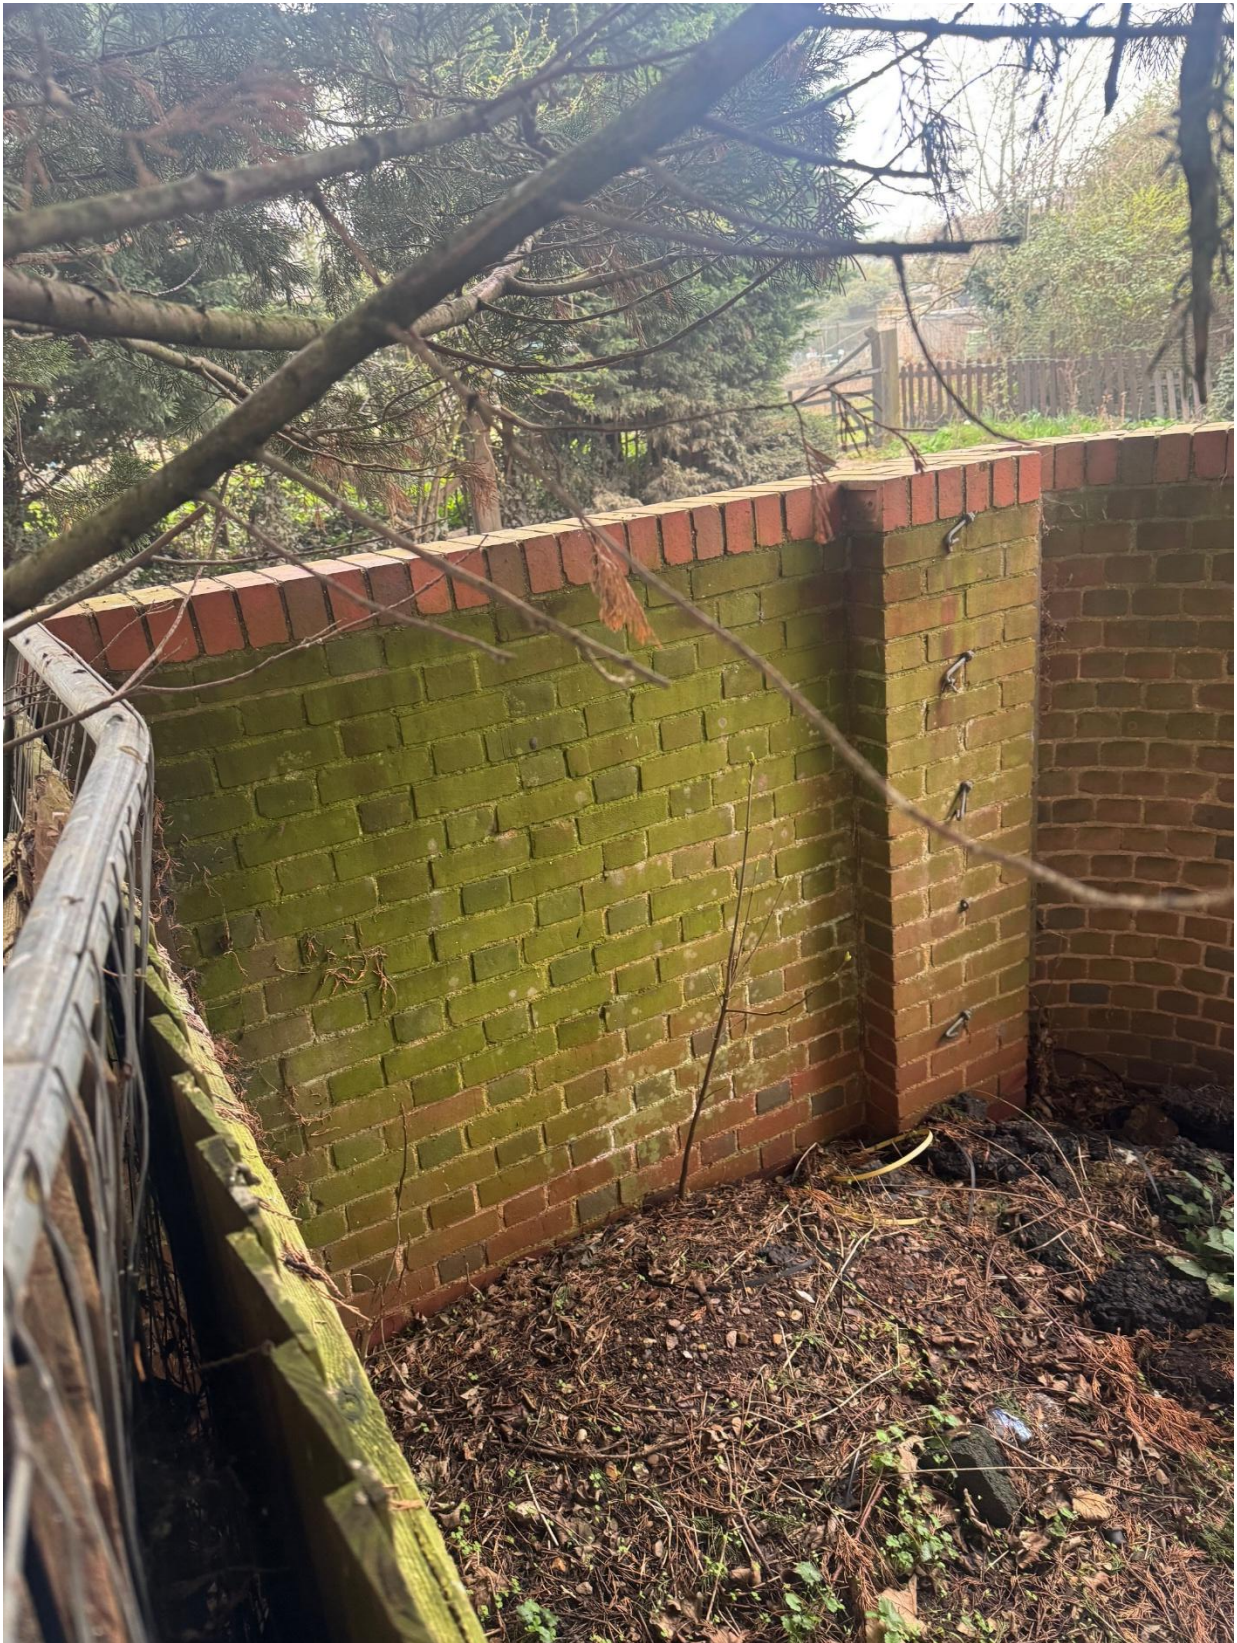
| Tree no. | Species | Work specification | Reason for works |
|---|---|---|---|
| G1 | Leyland cypress group | Sectionally dismantle down to ground level | Trees are in fair/poor condition. Some of the trees have poorly formed, defective v-shaped unions, which are at risk of failing. Some bifurcating stems have already failed due to defective unions. Close proximity to neighbouring driveway and road to rear of care home. It is advised that the trees are removed as they will continually require height reduction to lessen the likelihood of failure. Trees are also at high risk of causing structural damage to boundary wall |

G1 – Wall in close proximity to Leyland cypress group

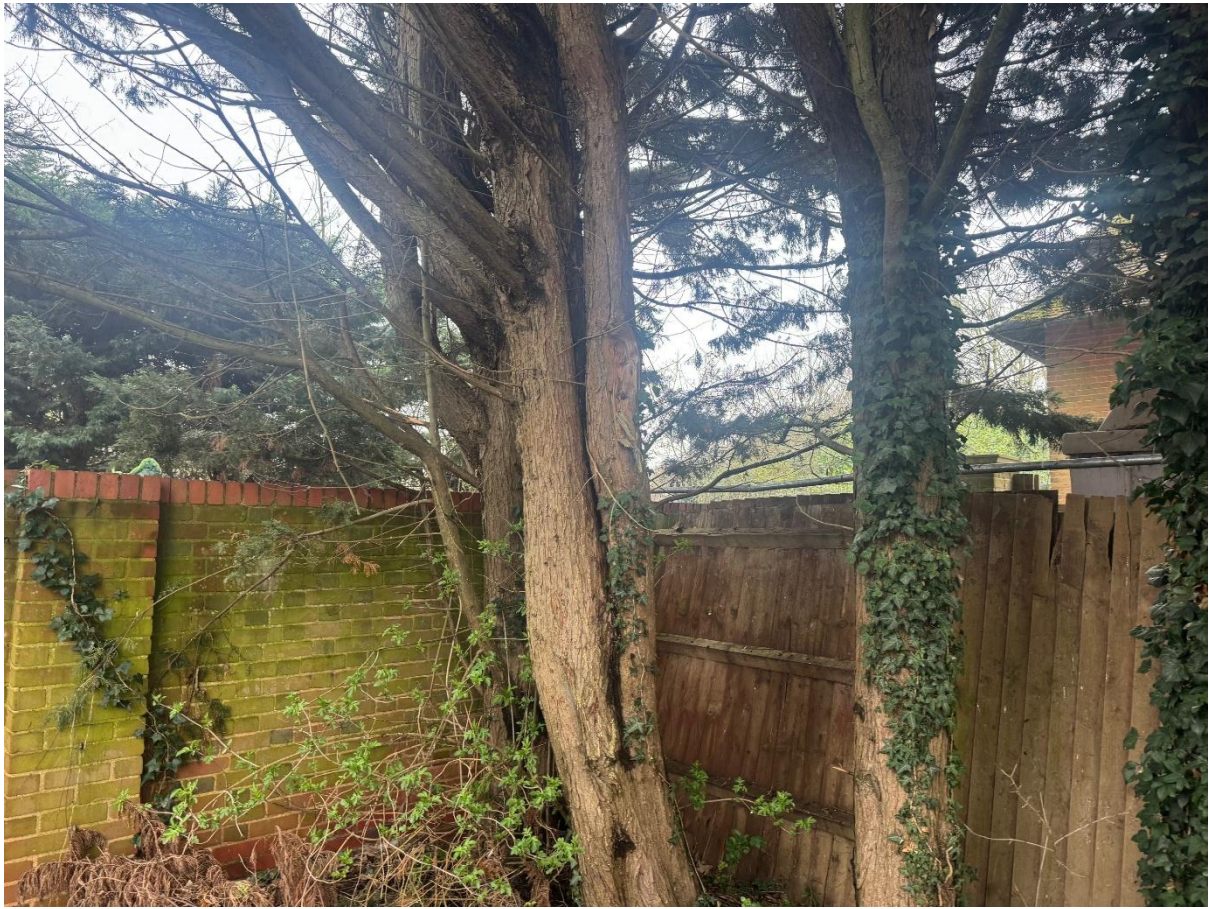
G1 – Leyland cypress group – Defective unions

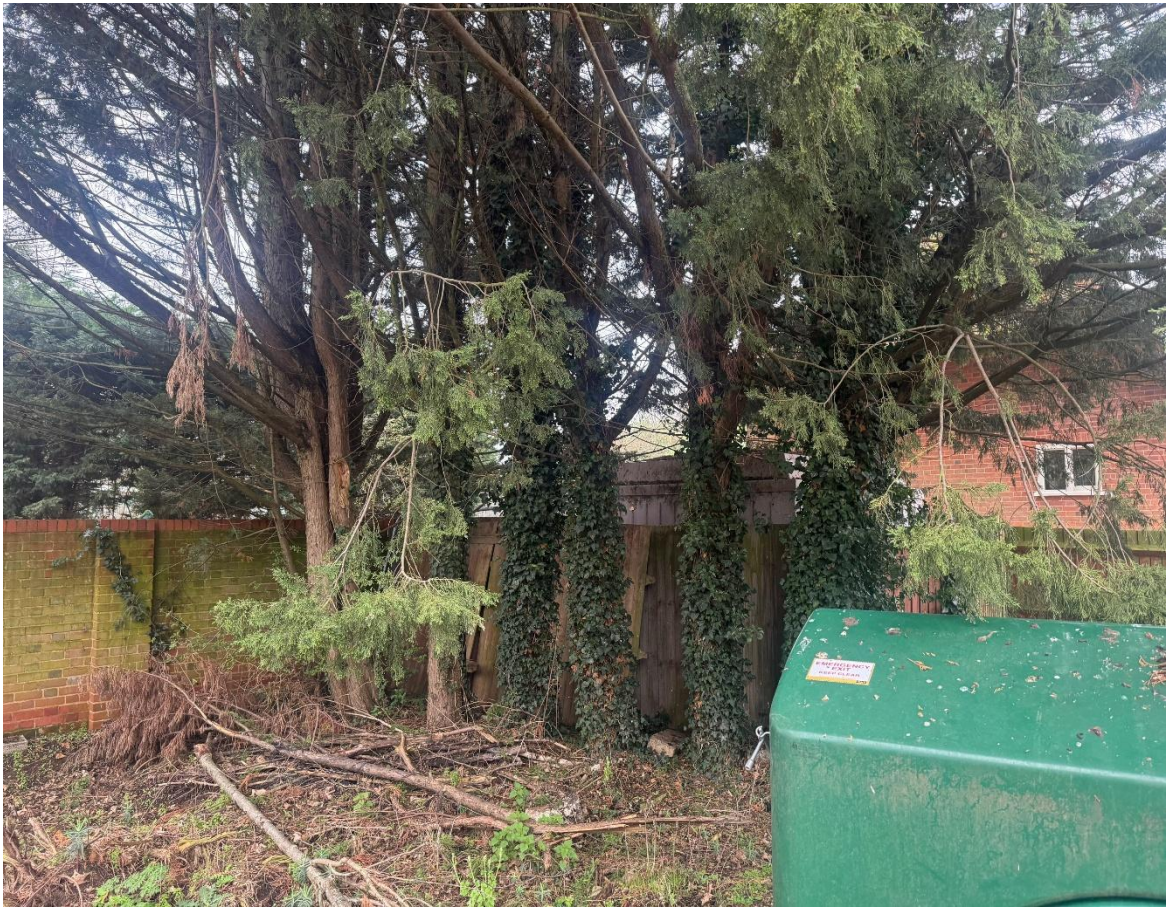
G1 – Leyland cypress group – Defective unions
