**PHASE 2 ENVIRONMENTAL INVESTIGATION**  
**of a site at**  
**ASHWELL ROAD, BYGRAVE, BALDOCK,**  
**HERTFORDSHIRE**  
**for**  
**RICHARD YOUNG**

**Project No 3236**  
**Report ref: 3236-P2E-1**  
**Issued: 05 May 2026**  
**Revision:**

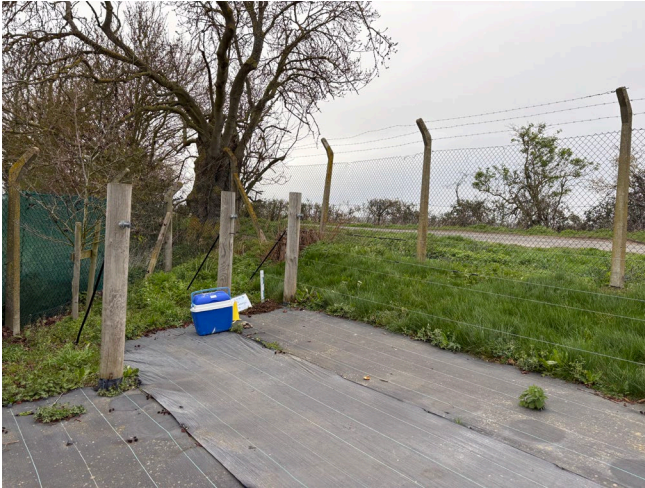
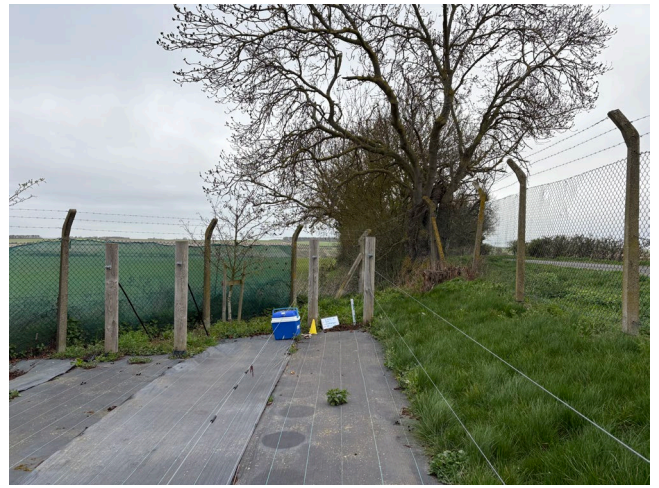
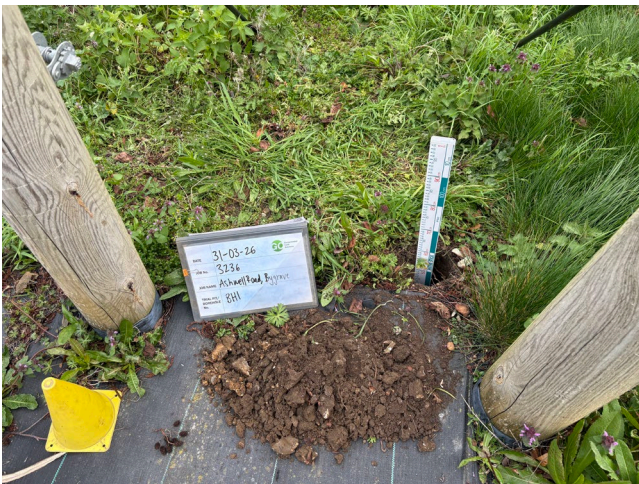
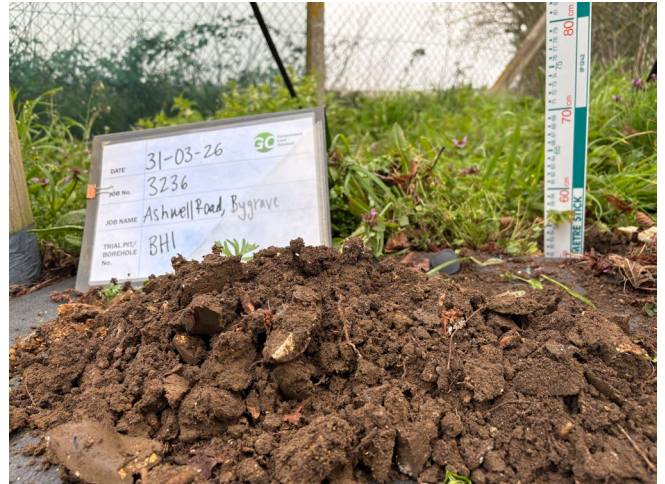
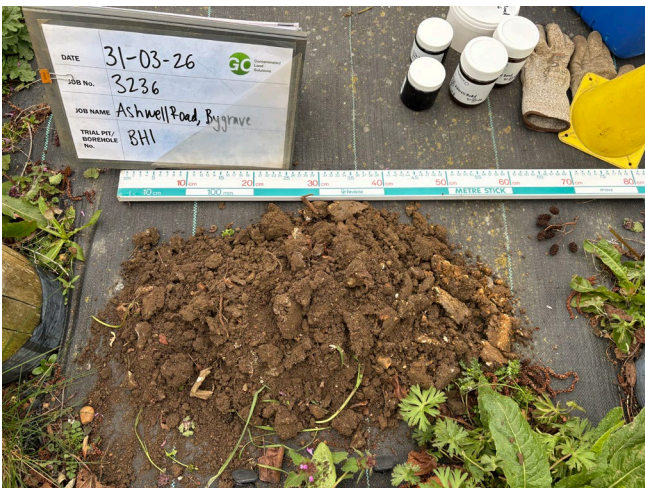
## BH 1

| <b>Project</b> | <b>Ashwell Road, Bygrave, Baldock</b> | | | | <b>Project No.</b> | <b>3236</b> | |
|---|---|---|---|---|---|---|---|
| Remarks: Groundwater not noted during excavations. No visual or olfactory evidence of contamination noted. | | | | | | | |

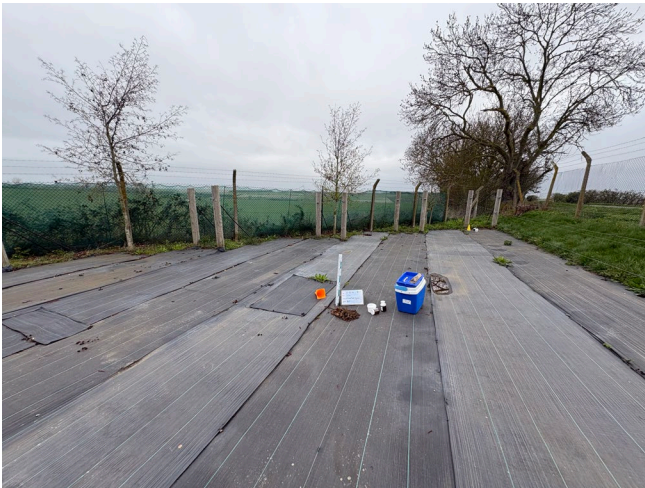
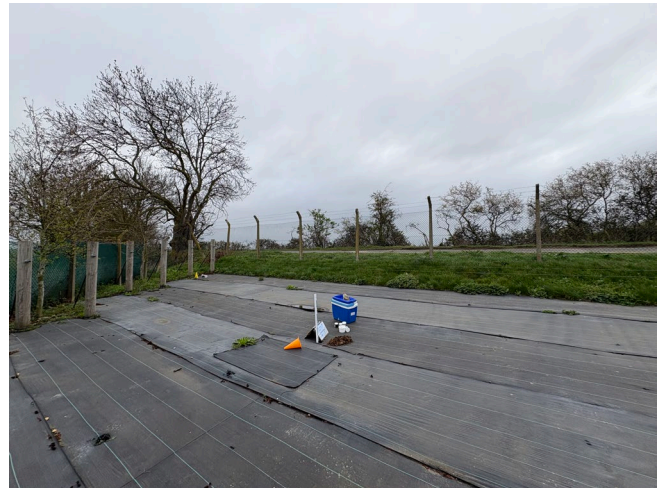
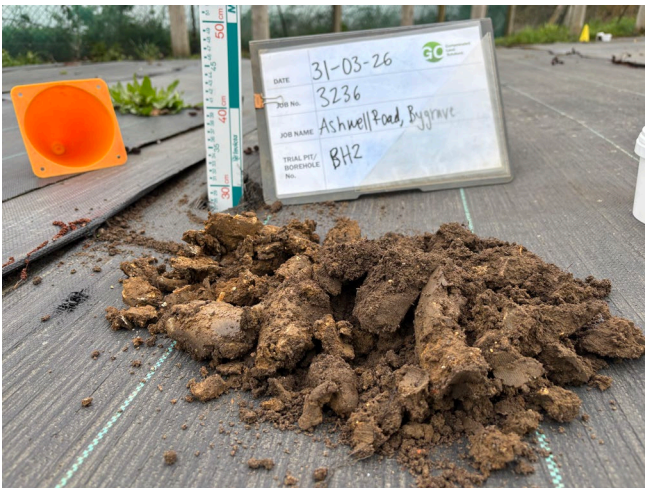
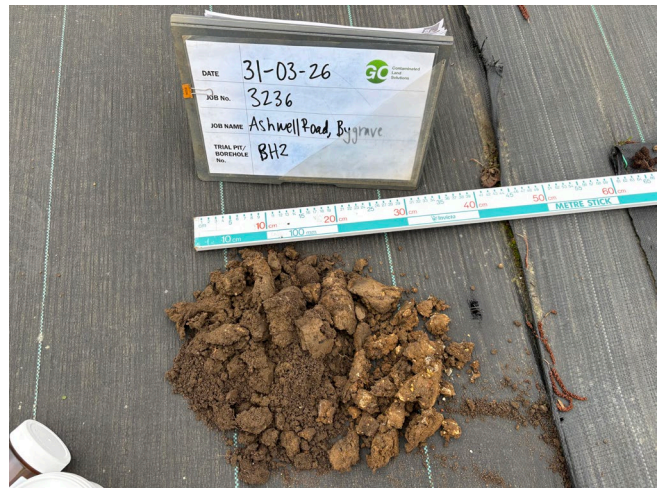
## BH 2

| Remarks: Groundwater not noted during excavations. No visual or olfactory evidence of contamination noted. | | | | | | |
