## Asbestos Inspection Report

### Bulk Sample Survey

Land off of Icknield Way  
Letchworth  
SG6 4AD

Project No: G-14484  
Report Issue: 1  
Date: Feb 2024

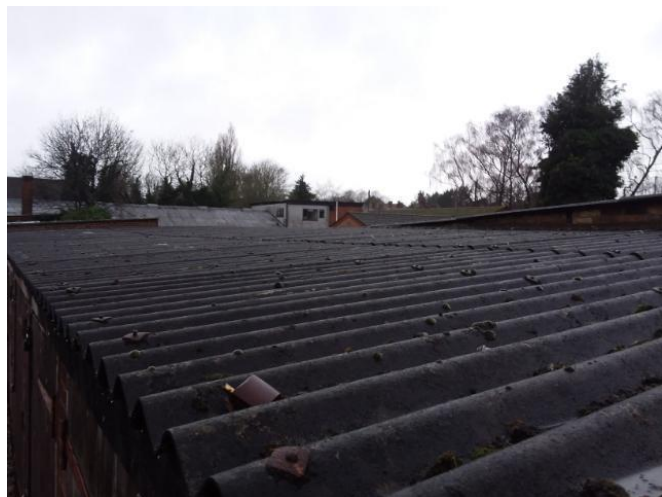
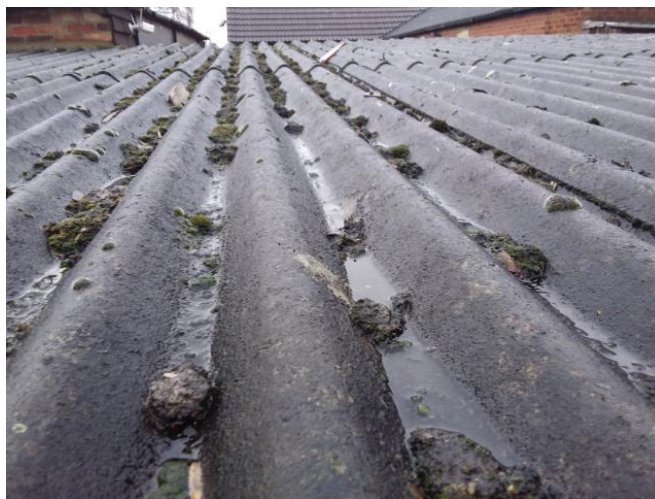
| Sample Ref: | S001/425662 | Survey Type: | Bulk Sample |

| Area: | Block 1 | Product Type: | Asbestos reinforced composites etc. 1 |
| Floor: | External | Damage: | Low damage 1 |
| Product: | Roof sheets | Asbestos Type: | Chrysotile 1 |
| Quantity: | 160m <sup>2</sup> | Material Assessment: | Very Low Risk 4 |

Comments: Corrugated cement roof sheets

Action: Remove following HSE guidelines

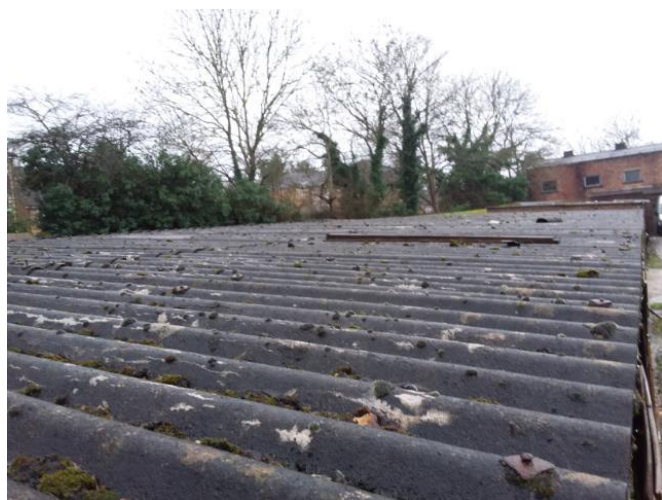
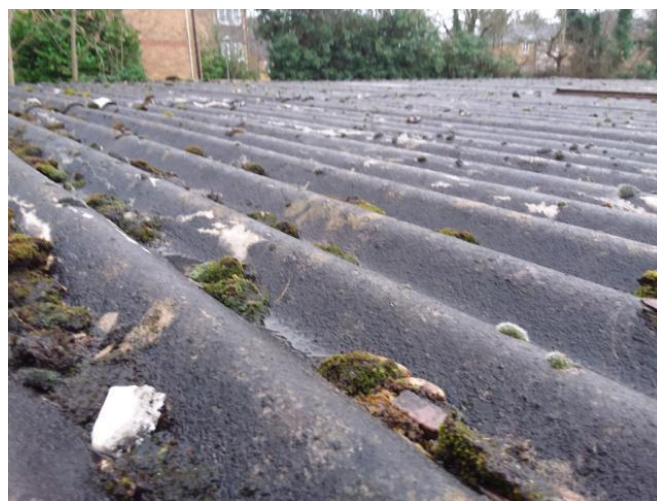
| Sample Ref: | As S001/425662/1 | Survey Type: | Bulk Sample |

| Area: | Block 2 | Product Type: | Asbestos reinforced composites etc. 1 |
| Floor: | External | Damage: | Low damage 1 |
| Quantity: | 160m <sup>2</sup> | Material Assessment: | Very Low Risk 4 |

Comments: Corrugated cement roof sheets

Action: Remove following HSE guidelines

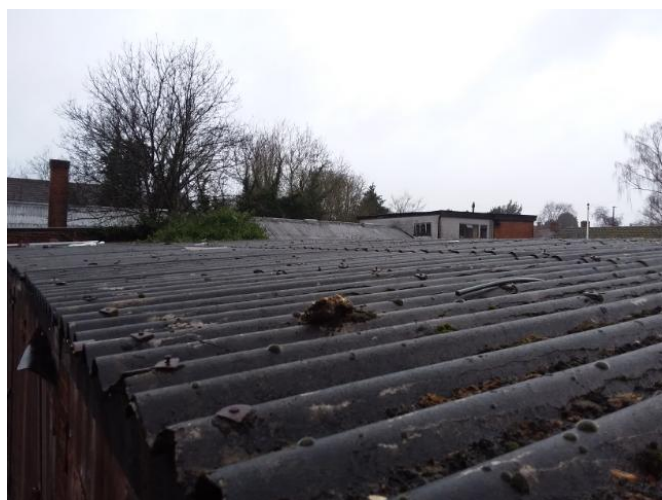
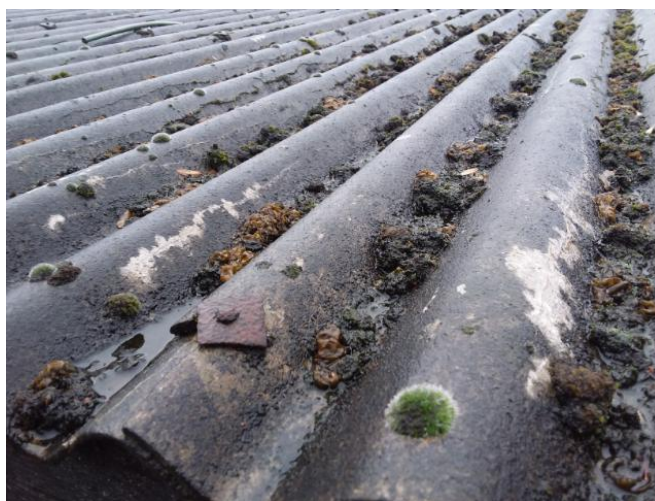
| Sample Ref: | As S001/425662/2 | Survey Type: | Bulk Sample |

| Area: | Block 3 | Product Type: | Asbestos reinforced composites etc. 1 |
| Floor: | External | Damage: | Low damage 1 |
| Quantity: | 95m <sup>2</sup> | Material Assessment: | Very Low Risk 4 |

Comments: Corrugated cement roof sheets

Action: Remove following HSE guidelines

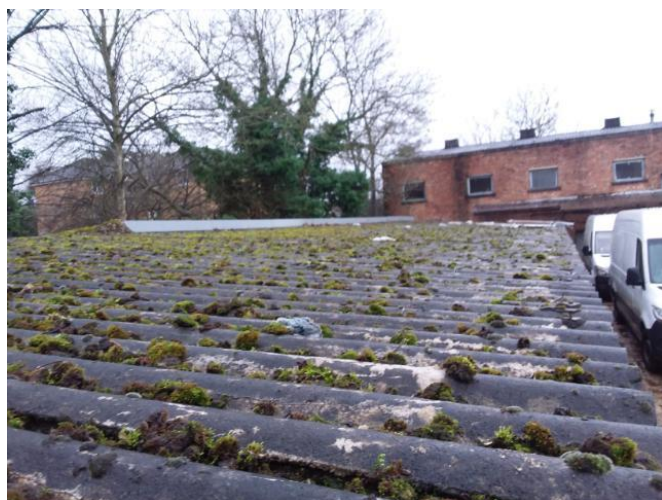
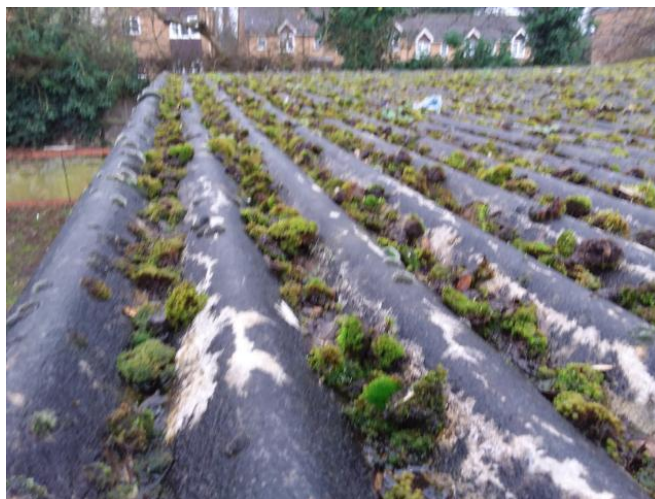
| Sample Ref: | As S001/425662/3 | Survey Type: | Bulk Sample |

| Area: | Block 4 | Product Type: | Asbestos reinforced composites etc. 1 |
| Floor: | External | Damage: | Low damage 1 |
| Quantity: | 140m <sup>2</sup> | Material Assessment: | Very Low Risk 4 |

Comments: Corrugated cement roof sheets

Action: Remove following HSE guidelines

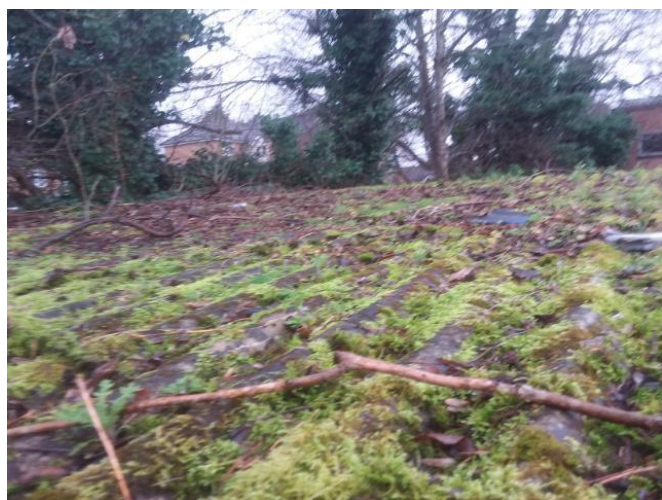
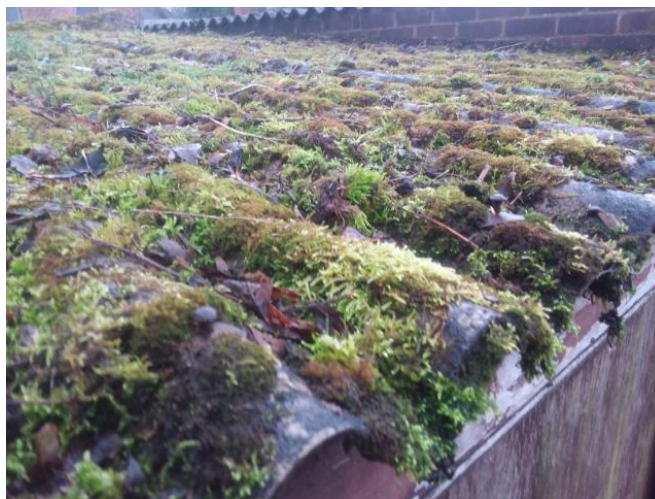
| Sample Ref: | As S001/425662/4 | Survey Type: | Bulk Sample |

| Area: | Block 5 | Product Type: | Asbestos reinforced composites etc. 1 |
| Floor: | External | Damage: | Low damage 1 |
| Quantity: | 40m <sup>2</sup> | Material Assessment: | Very Low Risk 4 |

Comments: Corrugated cement roof sheets

Action: Remove following HSE guidelines

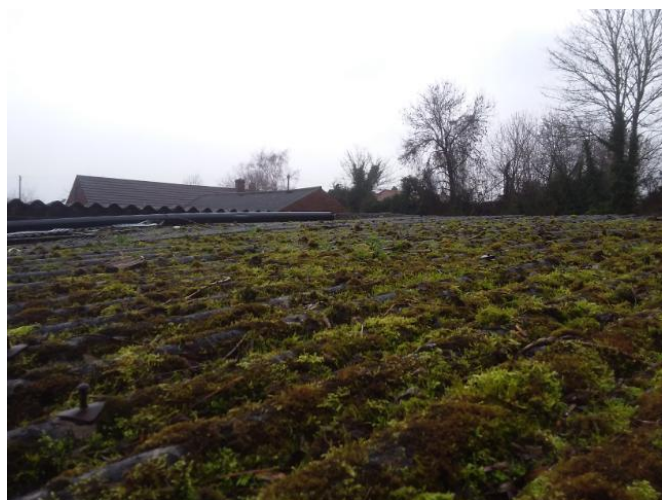
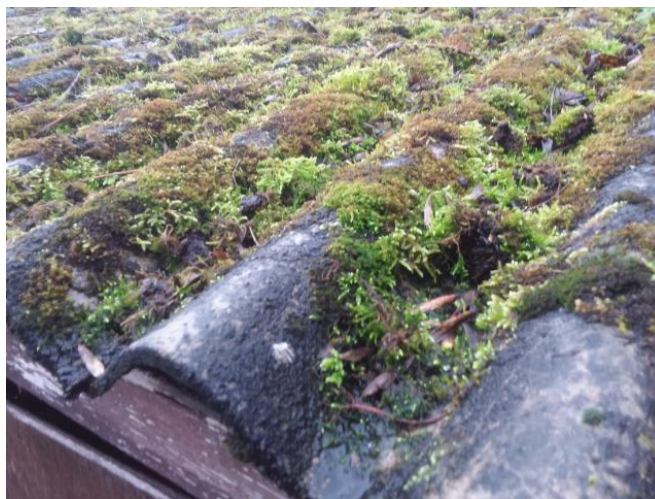
| Sample Ref: | As S001/425662/5 | Survey Type: | Bulk Sample |

| Area: | Block 6 | Product Type: | Asbestos reinforced composites etc. 1 |
| Floor: | External | Damage: | Low damage 1 |
| Quantity: | 28m <sup>2</sup> | Material Assessment: | Very Low Risk 4 |

Comments: Corrugated cement roof sheets

Action: Remove following HSE guidelines

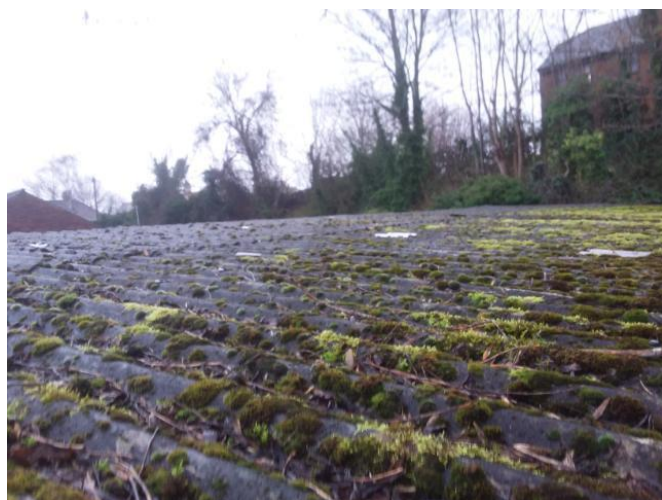
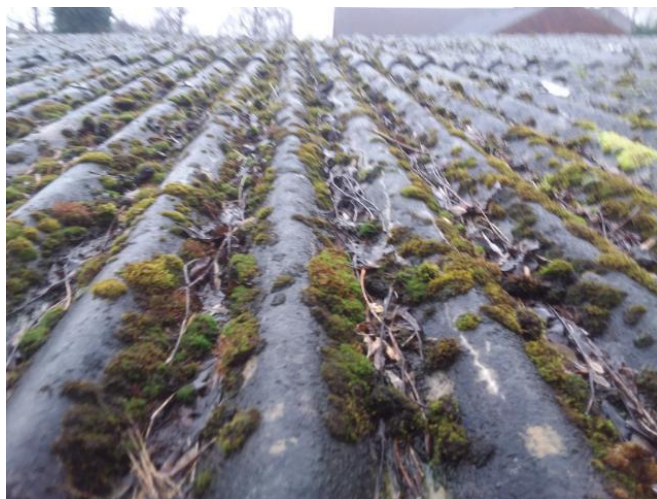
| Sample Ref: | As S001/425662/6 | Survey Type: | Bulk Sample |

| Area: | Block 7 | Product Type: | Asbestos reinforced composites etc. 1 |
| Floor: | External | Damage: | Low damage 1 |
| Quantity: | 110m <sup>2</sup> | Material Assessment: | Very Low Risk 4 |

Comments: Corrugated cement roof sheets

Action: Remove following HSE guidelines

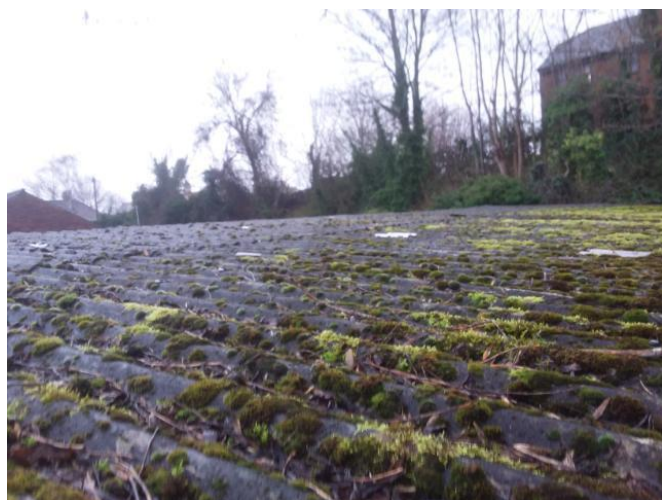
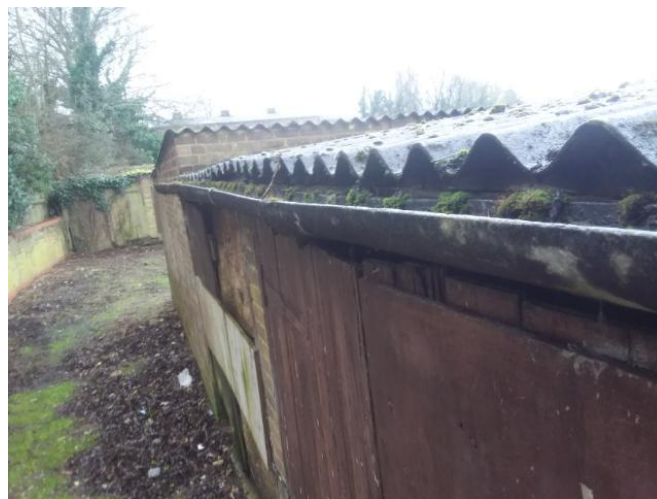
| Sample Ref: | As S001/425662/7 | Survey Type: | Bulk Sample |

| Product: | Guttering | Asbestos Type: | Chrysotile 1 |
| Quantity: | 5lm | Material Assessment: | Very Low Risk 4 |

Comments: Cement guttering

Action: Remove following HSE guidelines

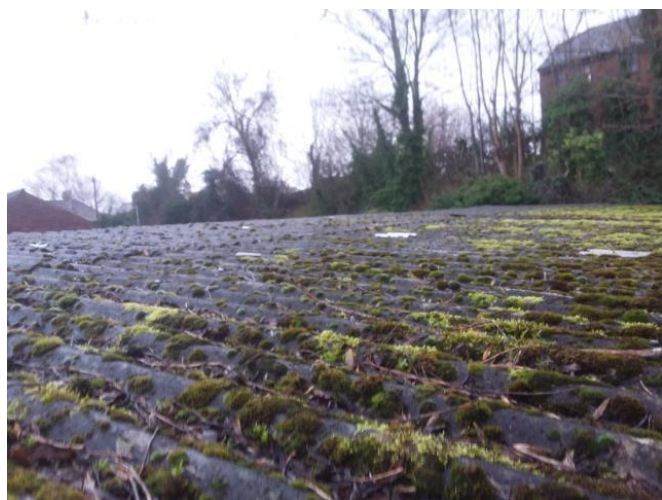
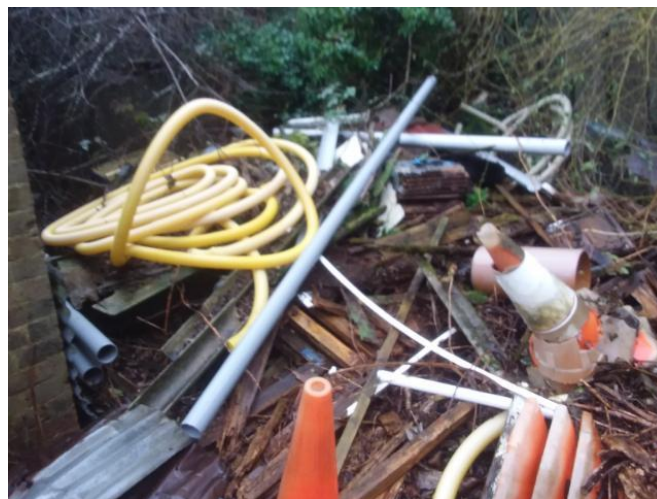
| Sample Ref: | As S001/425662/8 | Survey Type: | Bulk Sample |

| Floor: | External | Damage: | Visible asbestos debris 3 |
| Product: | Debris | Asbestos Type: | Chrysotile 1 |
| Quantity: | Not quantified | Material Assessment: | Low Risk 6 |

Cement debris to side of block 7 - appears to be remainder of guttering to block 7 (approx 15 lm) and broken asbestos cement sheets

Action: Remove following HSE guidelines
