## LIMETREE HOUSE

Group 4 - 6 x Ash trees

GROUP DETAILS - 4

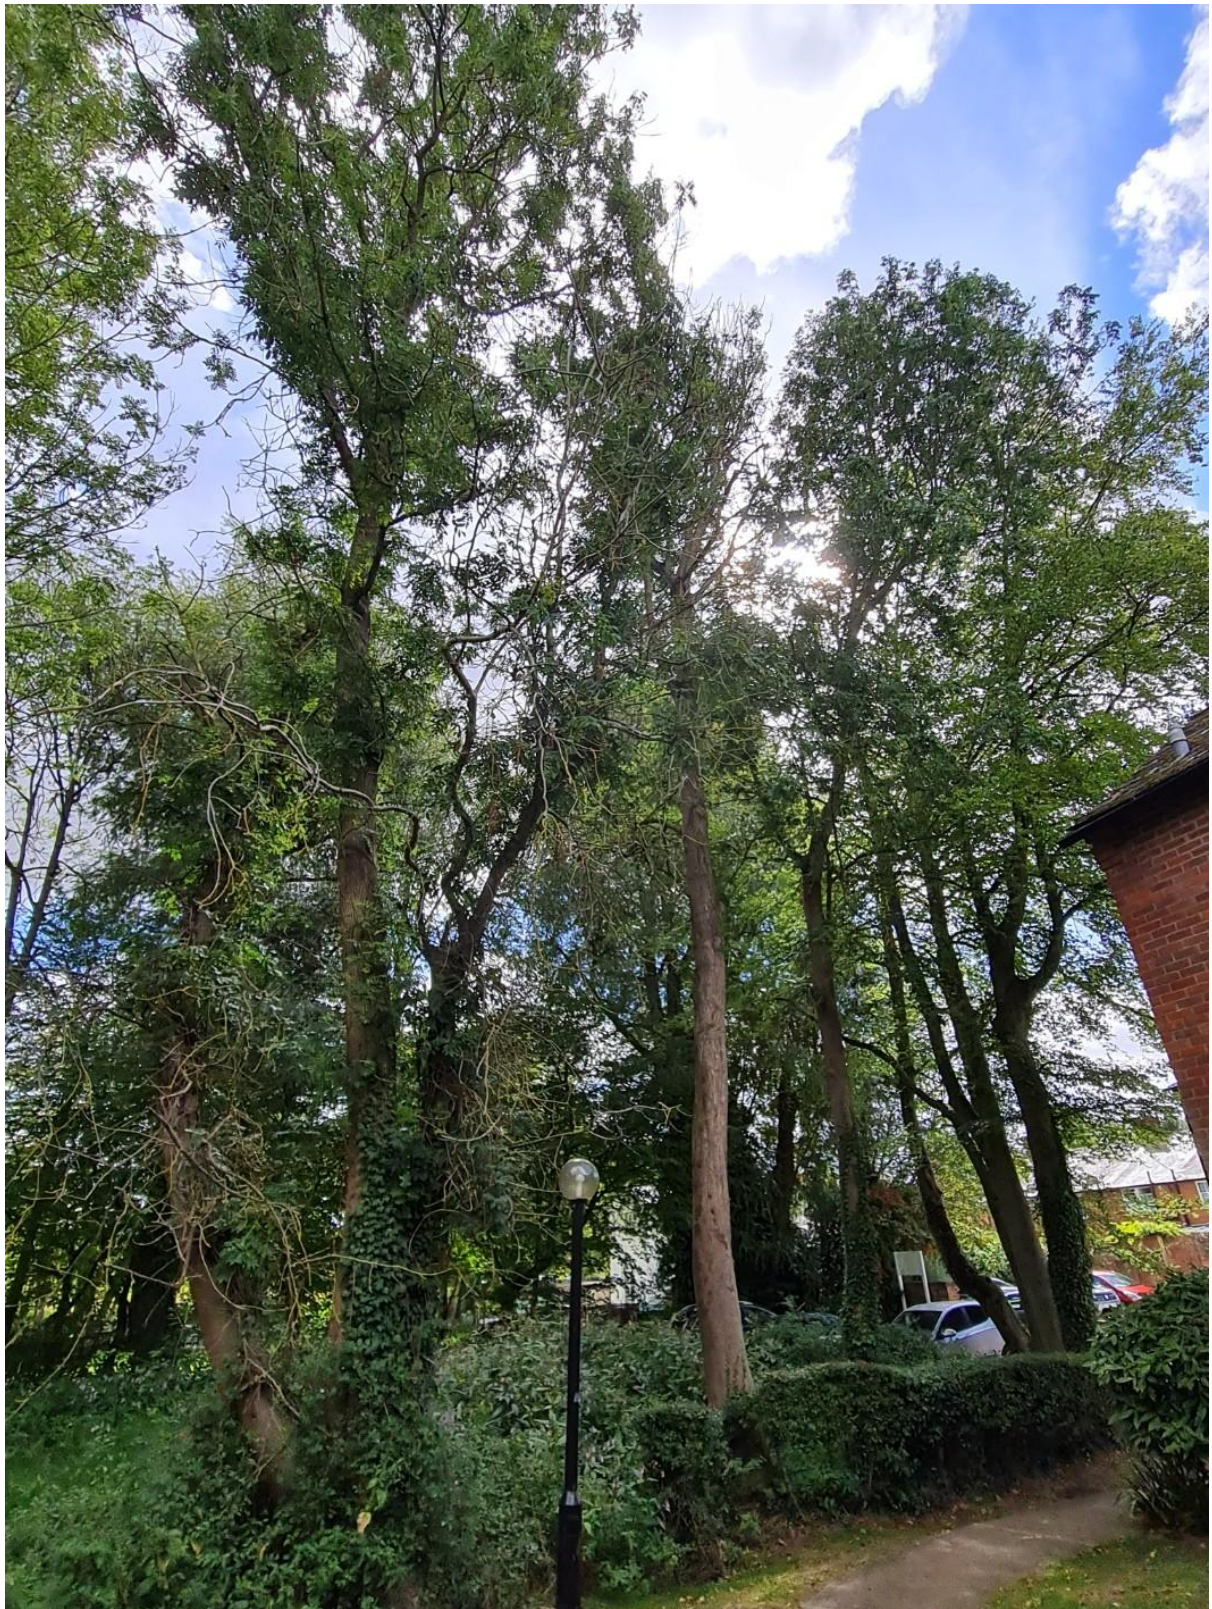
| VTA | BS5837 | OBSERVATIONS | MISC | BBVJV | WORK RECORDS | HISTORY |
|---|---|---|---|---|---|---|
| Observations Comments | | | Scattered group of trees in similar condition. Branch dieback symptomatic of Ash Dieback, Stage 1. Further dieback and tree death foreseeable. | | | |
| Crown Observations | | | Crown Dieback, Previously Reduced | | | |
| Crown Diseases | | | Ash Die Back (Hymenoscyphus fraxineus.) | | | |
| Ash Dieback Survey | | | Level 1: 0% - 25% | | | |

Works required - **Fell Process and Remove x6 Ash Trees to ground level**

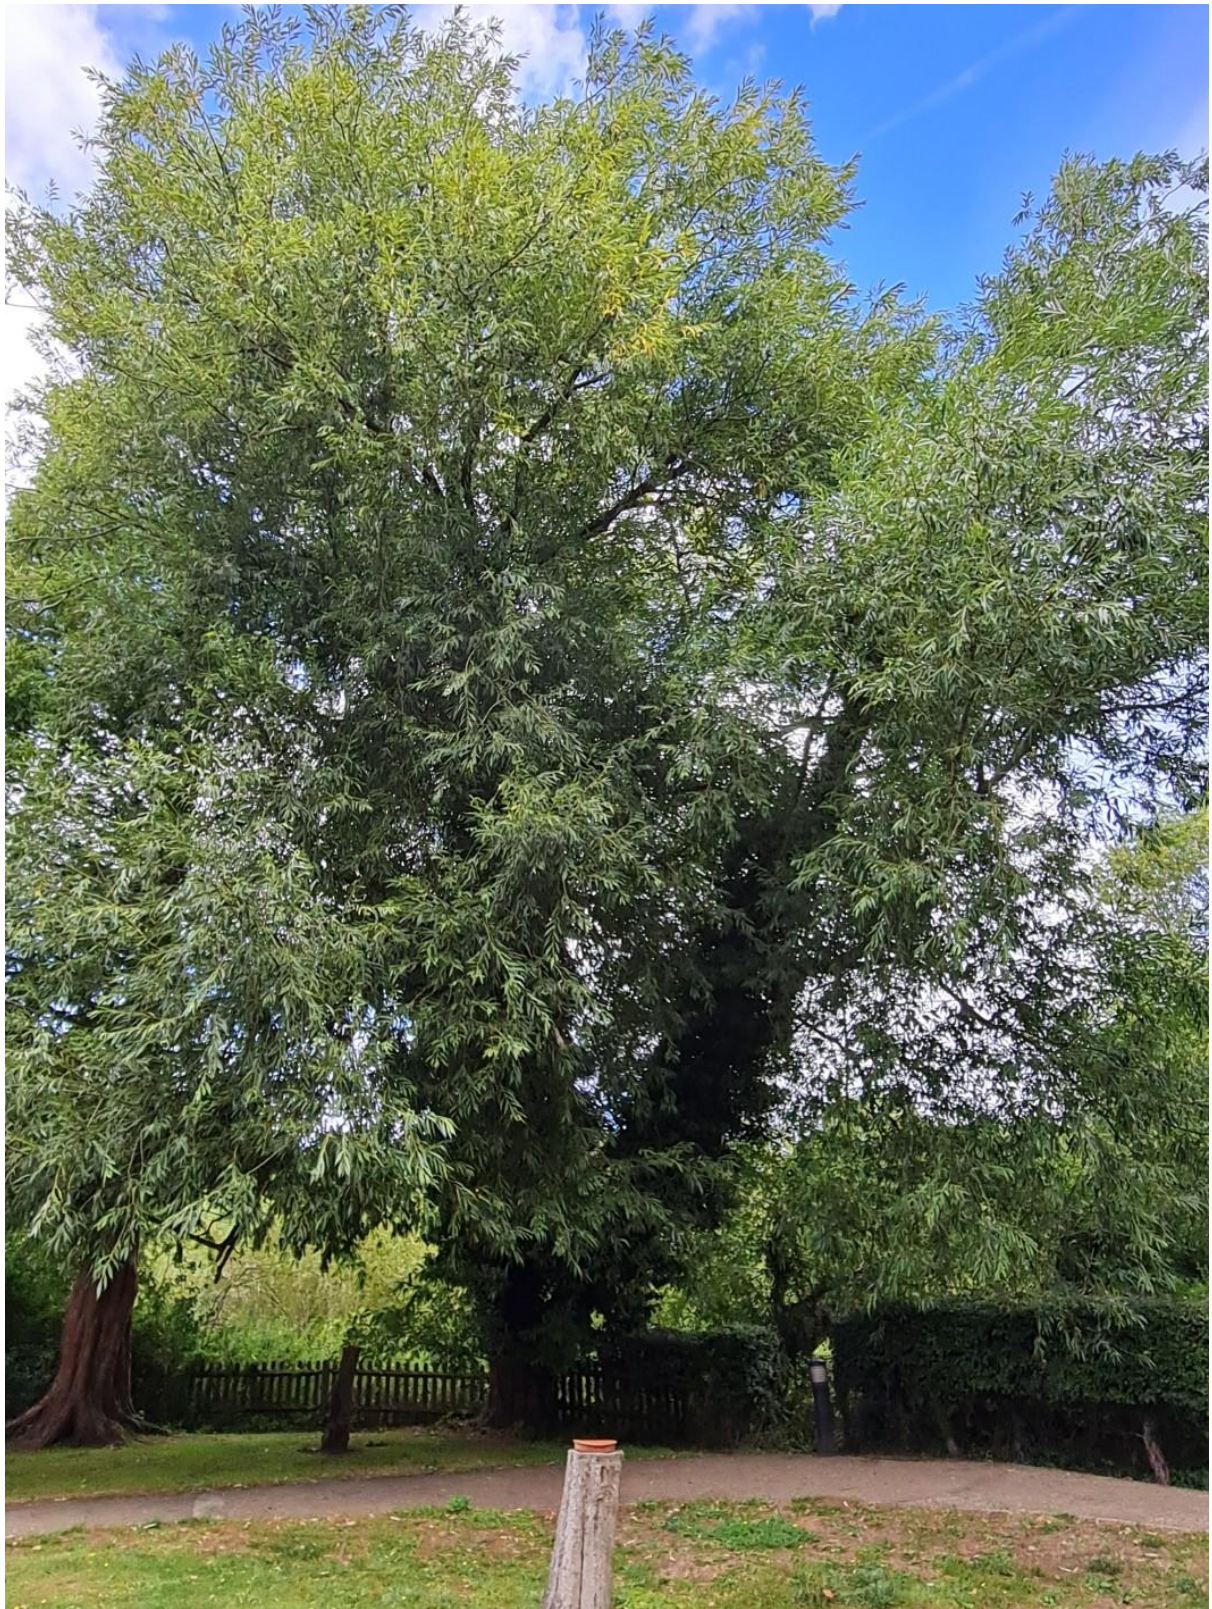
Tree 4- Crack Willow

Low branches overhanging path.

Ivy Covered Stem

Low Branches

Works required: **Raise Crack Willow to 4meters**

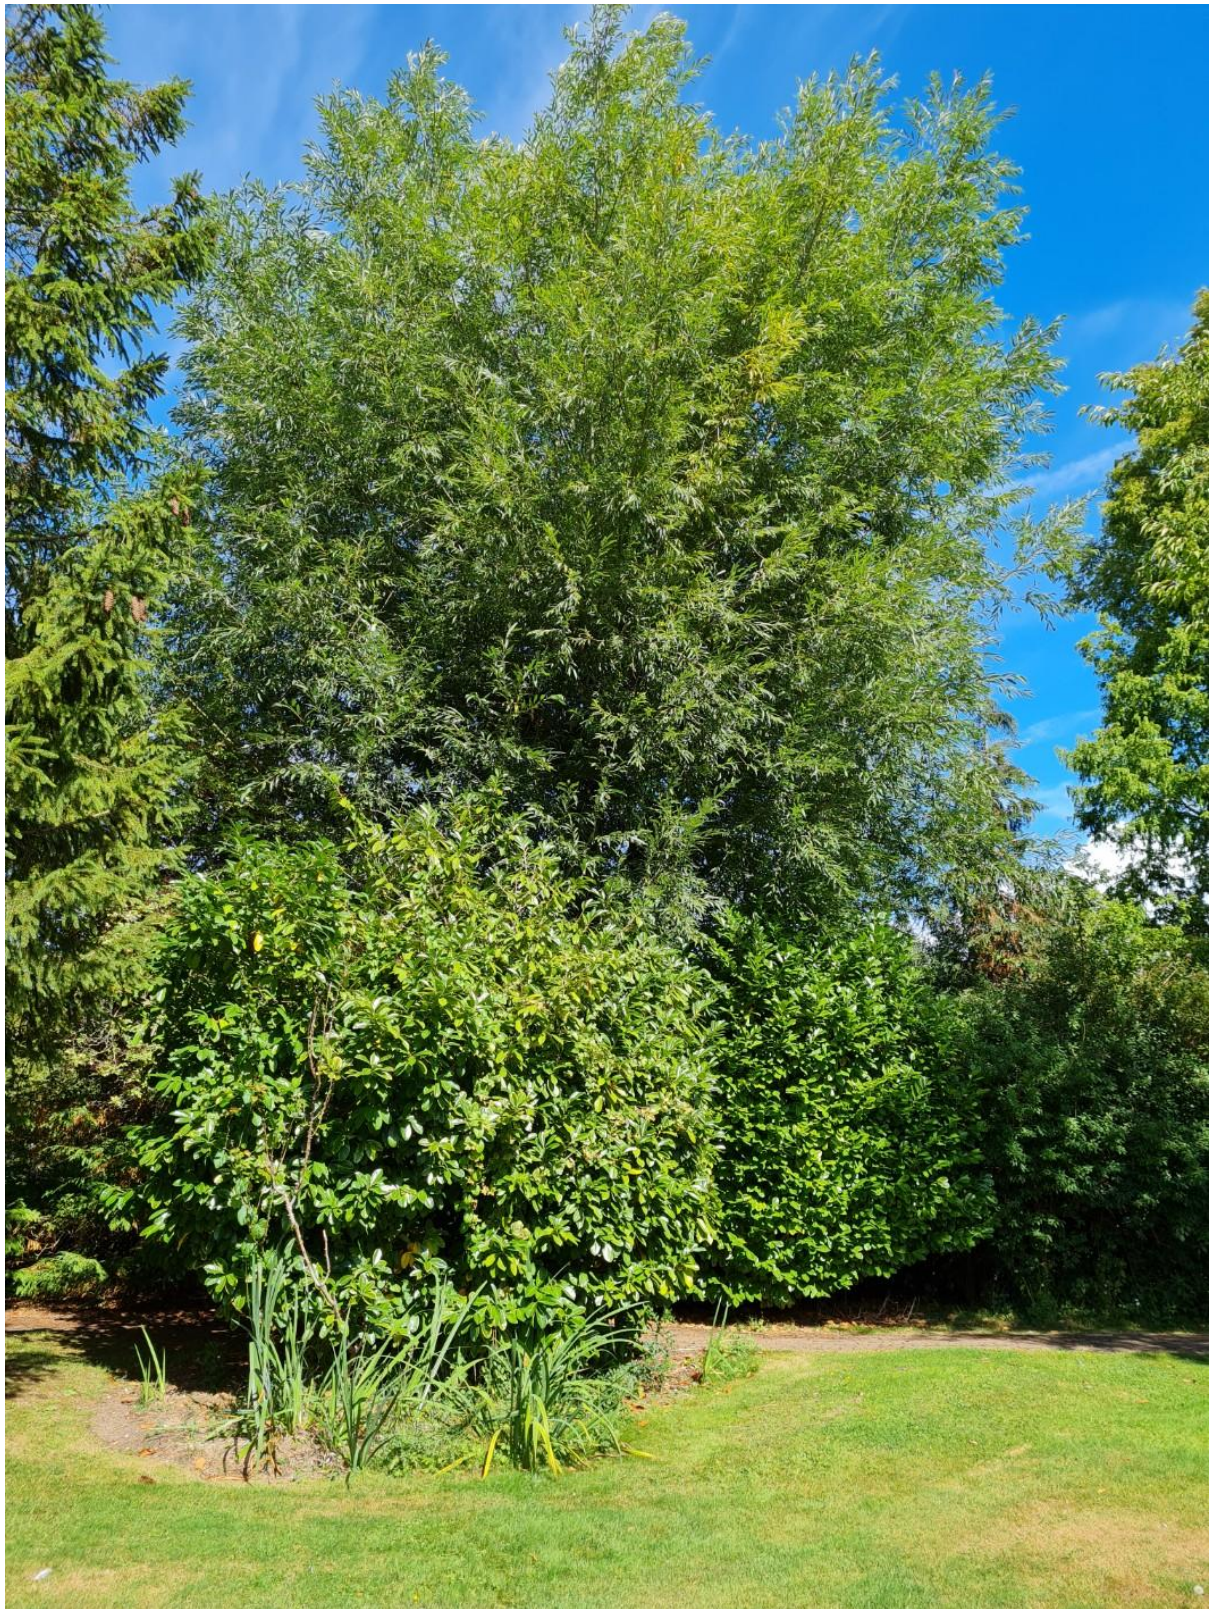
Tree 7- Crack Willow

Leaning stem, compensatory growth. Previously pollarded, regrowth reaching size where significant loading stresses on attachment points.

Previously Pollarded

Works required: **Re Pollard** note: **observational comments on loading stress**

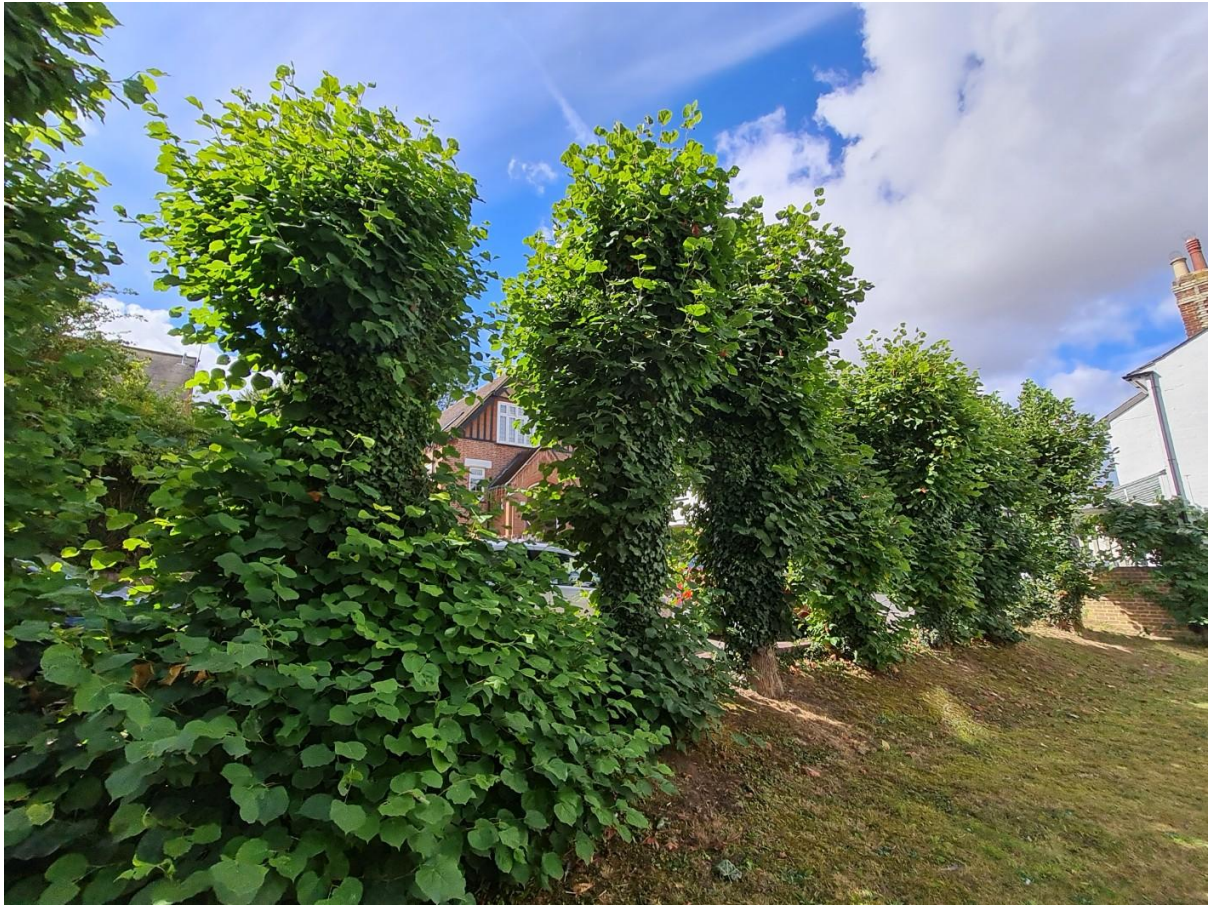
Group 1 – 8 x Lime trees

| Observations Comments | Line of pollards. |
| Trunk Observations | Prolific Epicormic/Basal Growth |
| Crown Observations | Previously Pollarded |

Works required – re-pollard (prolific epicormic and basal growth)
