Waterman Tree Co.

**No. 02004**

**Date 24/10/25**

## **TREE REPORT**

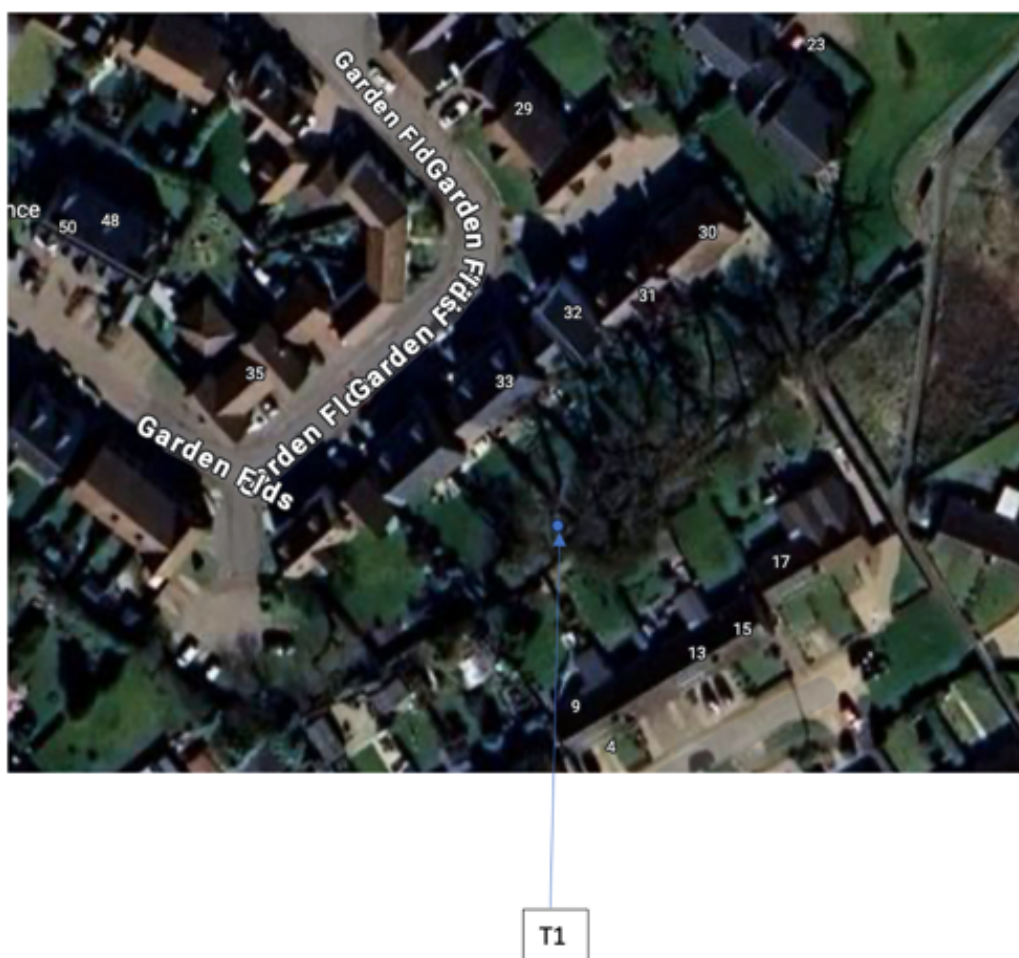
Figure 1

T1 is a mature English oak (*Quercus robur*) situated within the rear garden of the property, approximately 10 metres from the rear elevation of the house (see Figure 1). The tree stands at an estimated height of 18 metres and is an established feature of the site. A detailed visual inspection was carried out from ground level, incorporating percussion testing using a nylon mallet to assess suspected areas of internal decay and dysfunction.

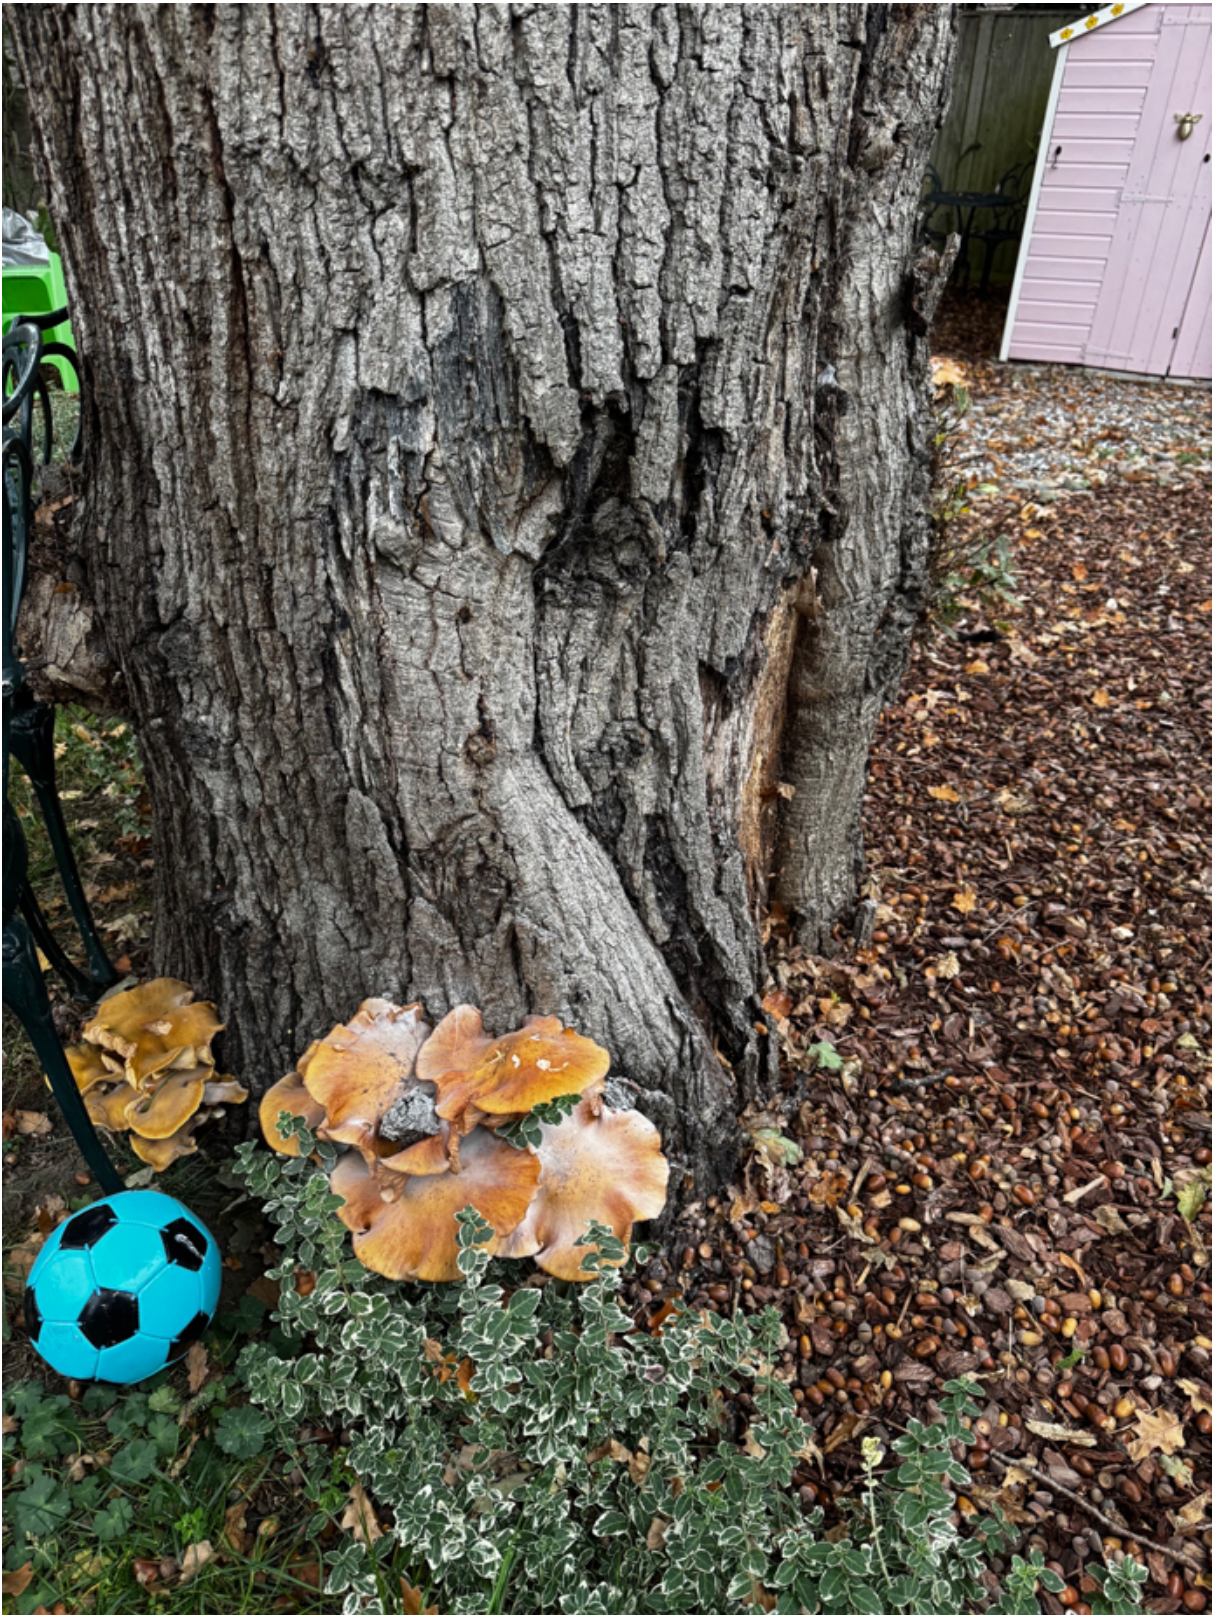
Figure 2

Significant decay is present at the base of the main stem, most notably on the north-west aspect, where a large area of degraded tissue measuring approximately 300 mm in width and 1.2 metres in vertical extent was observed. The area produces a distinctly hollow resonance under percussion testing, confirming extensive internal decay.

In addition, honey fungus (*Armillaria* spp.) was observed fruiting from the decayed tissue on this same aspect (Figure 2). The presence of *Armillaria* indicates active fungal colonisation of the basal wood and root plate, a serious condition associated with progressive structural

degradation and potential root death. The fungus is capable of attacking the cambium and sapwood, leading to extensive loss of structural integrity and eventual mechanical failure.

Following removal, it is recommended that the stump and surrounding soil be excavated and disposed of appropriately to reduce the spread of *Armillaria* to adjacent vegetation.

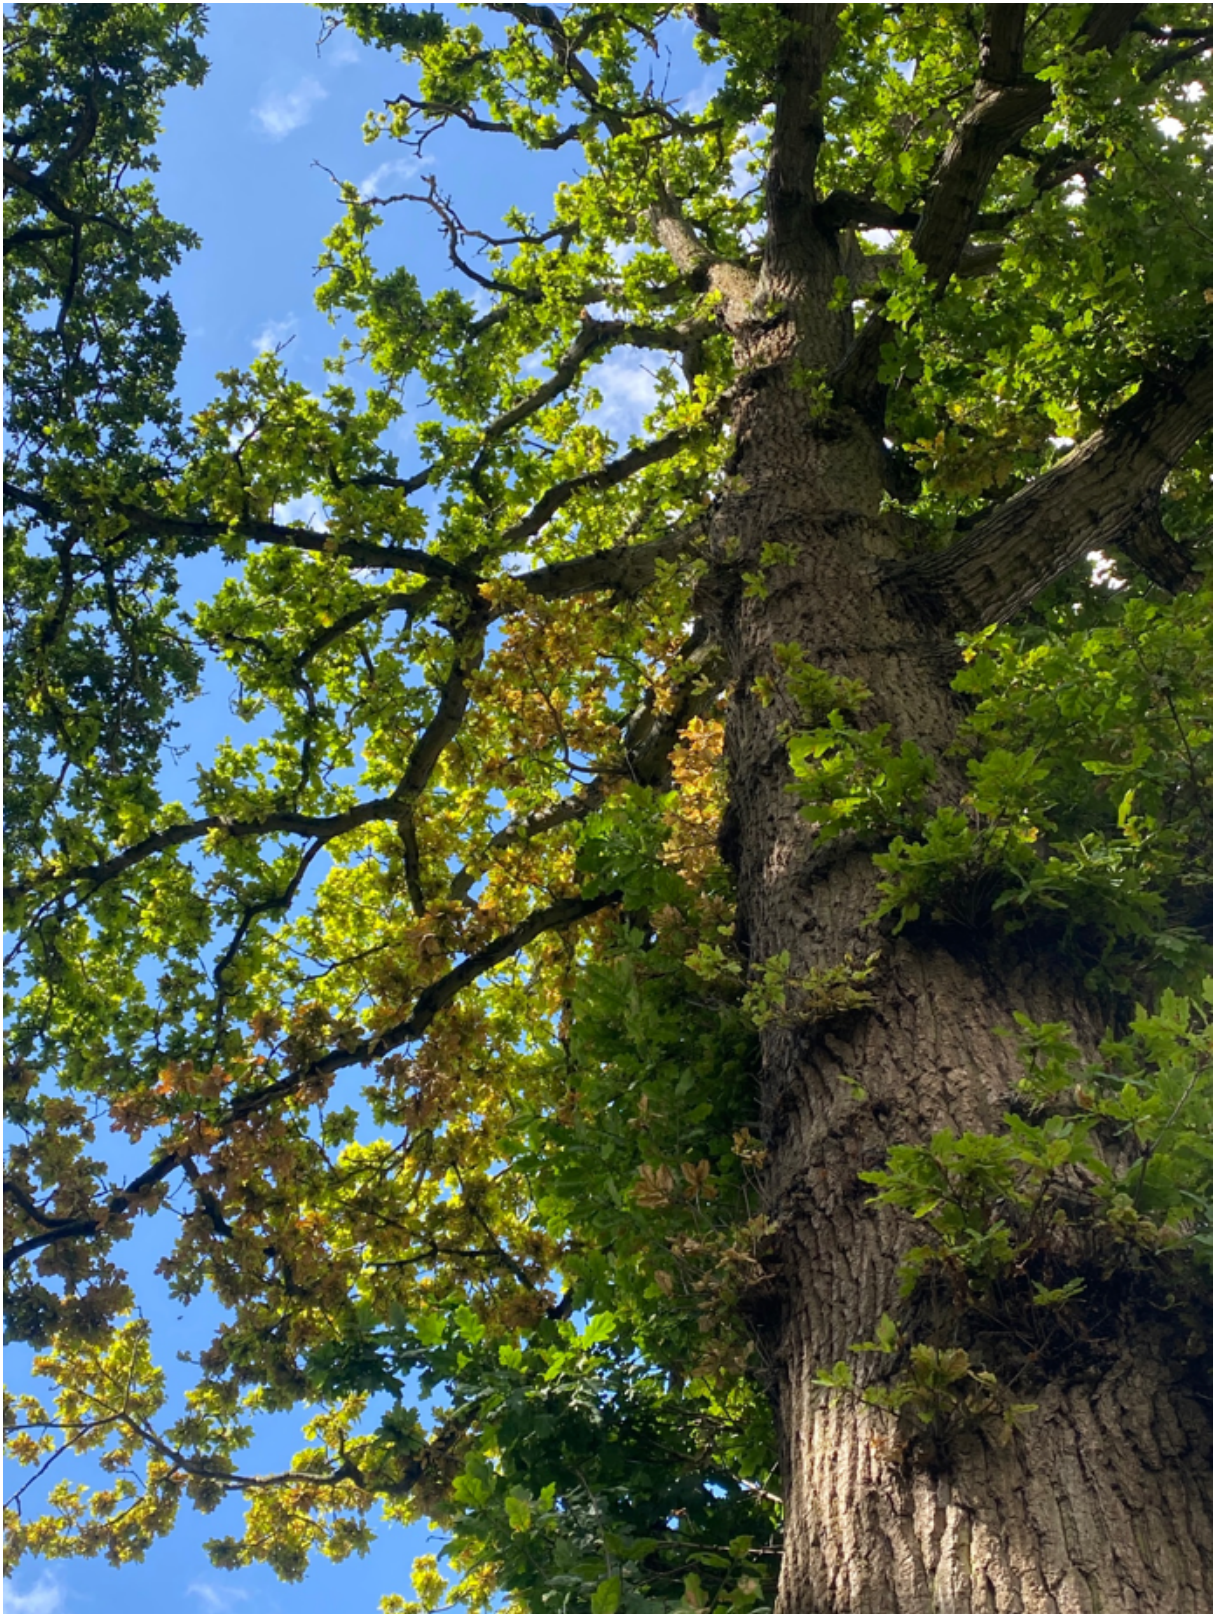
Figure 3

The tree has been subject to extensive historic crown lifting and limb removal, believed to have taken place approximately three years ago. Large pruning wounds are visible throughout the lower crown, and substantial epicormic growth has developed in response.

While the upper canopy currently retains a reasonable leaf density (Figure 3), the tree exhibits reduced lower crown mass damping, thereby increasing wind leverage forces acting upon the decayed basal stem. In combination with basal and root decay, this markedly elevates the risk of mechanical failure under adverse weather conditions.

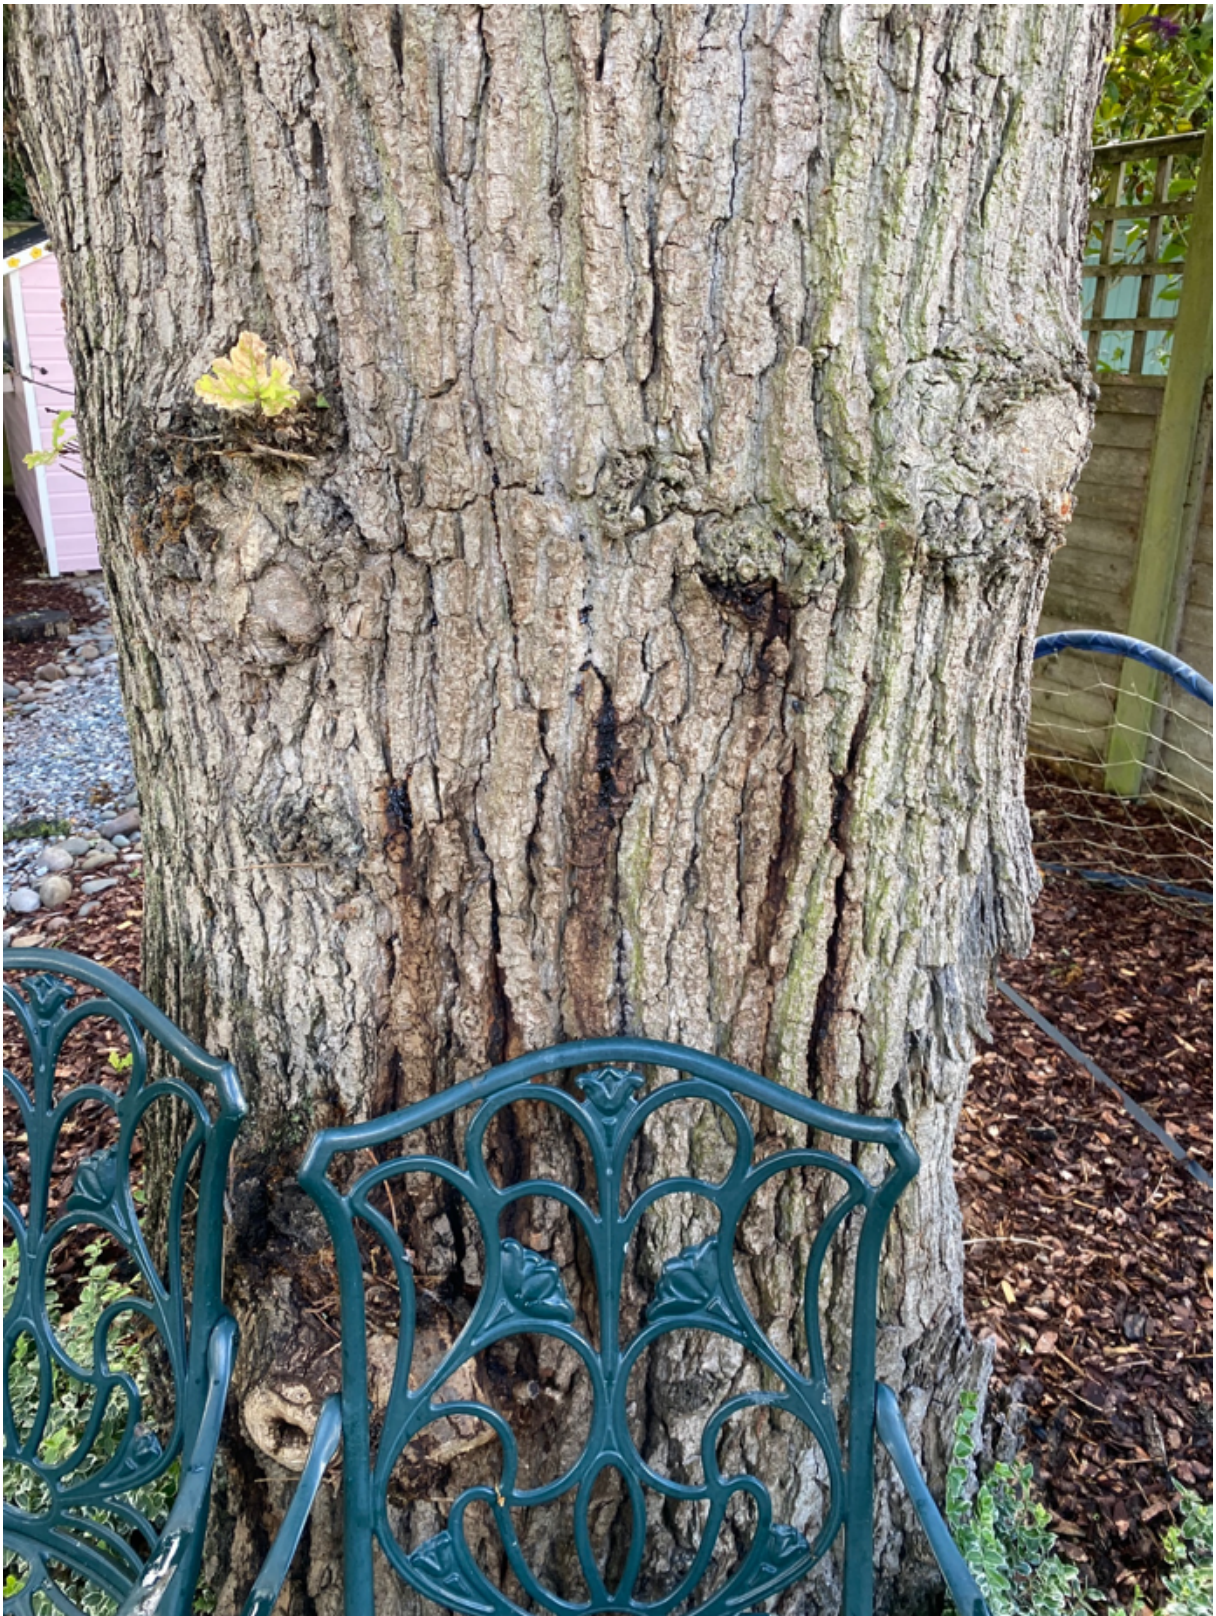
Figure 4

A black, tar-like exudate was noted on the northern side of the main stem, approximately 2 metres above ground level (see Figure 4). This may indicate Phytophthora bleeding canker infection. While unconfirmed, this additional pathogen presence further suggests a decline in overall tree health and vitality.
