## Preliminary Bat Roosting Assessment Report

### Offley Place, Kings Walden Road

March 2025

Maydencroft Limited was appointed to carry out a **Preliminary Bat Roosting Assessment (PBRA)** of the buildings at Offley Place, Kings Walden Road, Great Offley, Hitchin, SG5 3DX. The survey was conducted in preparation for the installation of solar panels on the roofs of the cottage, old stable, boiler room, and ballroom. No internal cabling will be installed.

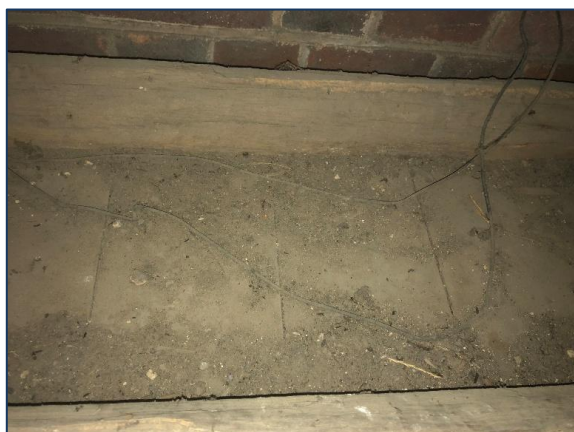
droppings scattered around the floorboards around the loft hatch, most appeared old but a few were fresh and dark confirming the loft space as an active roost.

*Figure 4. Bat droppings found adjacent to the open loft hatch, within the old stable.*

The preliminary bat roosting assessment confirmed building 1 as a roost and identified that building 2 has **high suitability for roosting bats**. Therefore, in line with the *Bat Conservation Trust – Bat Survey Guidelines for Professional Ecologists*, three dusk emergence or dawn re-entry will be required between May and August to be confident in a positive result for bat presence and characterise the bat roost in building 1 and confirm or negate bat presence in building 2 and accurately characterise the roost if present.

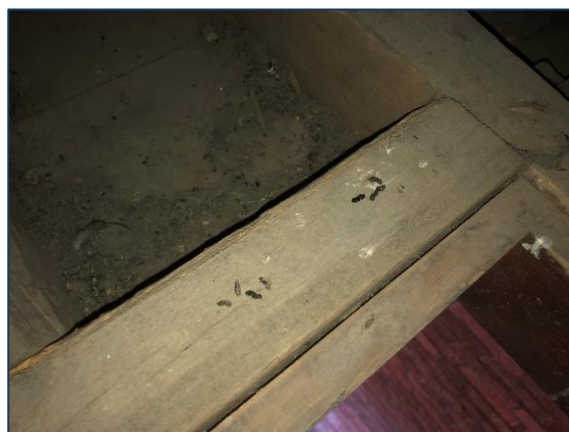
*Figure 5. Birds nest immediately adjacent to open hatch.*

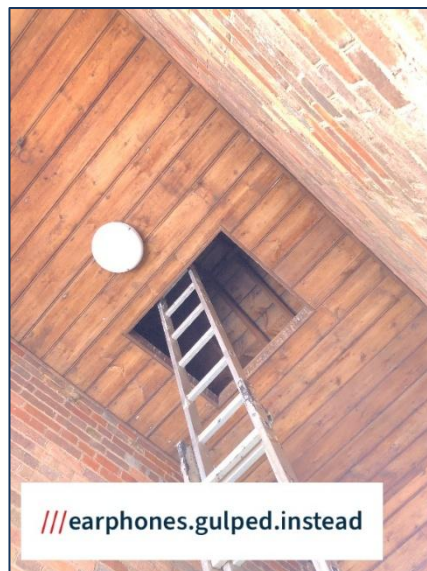
Figure 9. open loft hatch into loft space.

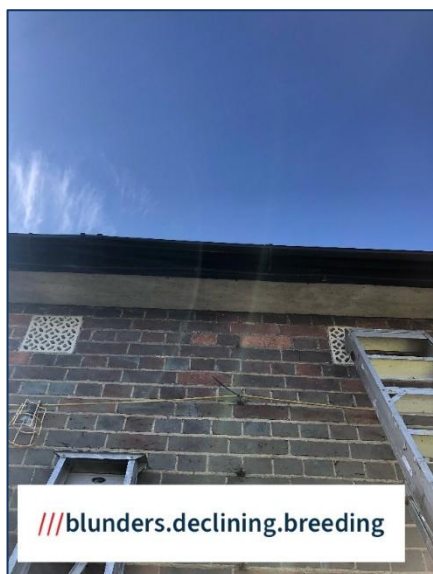
Figure 10. Gap in soffit on the east side of the old stable and boiler room stretching 13m (to ///risk.poetry.validated ) with a width of 1-3.5cm.

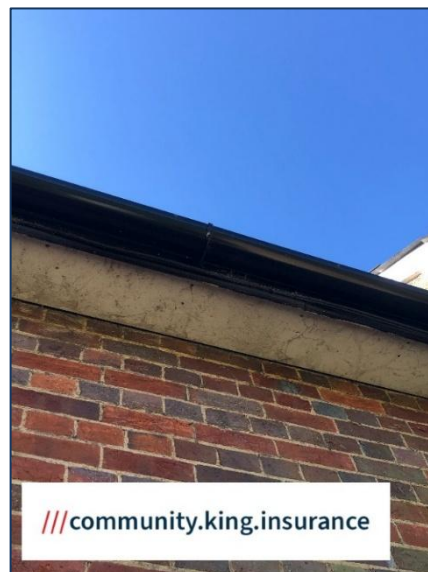
*Figure 12. Gap in soffit on the east side of the old Stable and boiler Room stretching 8m (from ///risk.poetry.validated) with a width of 1-3.5cm*

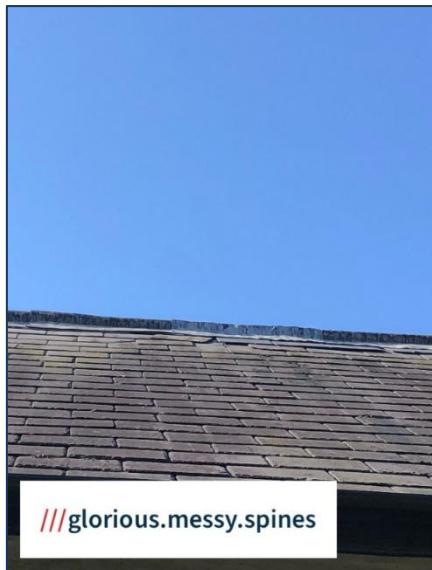
*Figure 13. Lifted and slipped tiles on the east side of the roof apex of the old stable.*

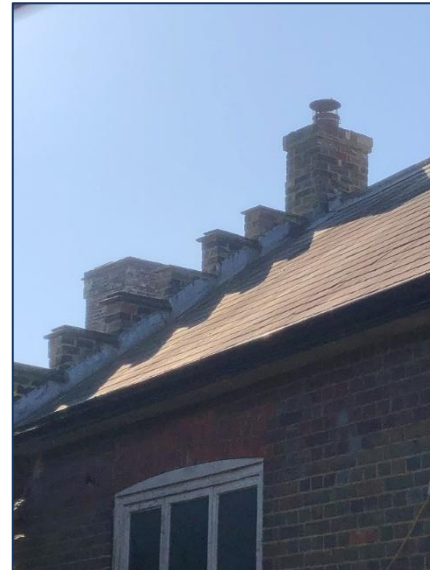
*Figure 14. Lifted lead flashing upon cottage roof.*

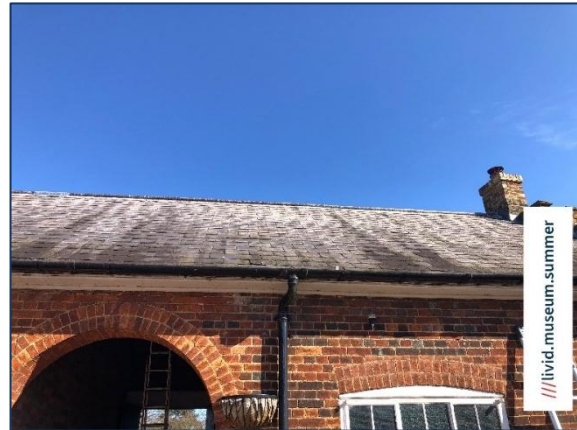
Figure 16. Multiple raised tiles along full length.

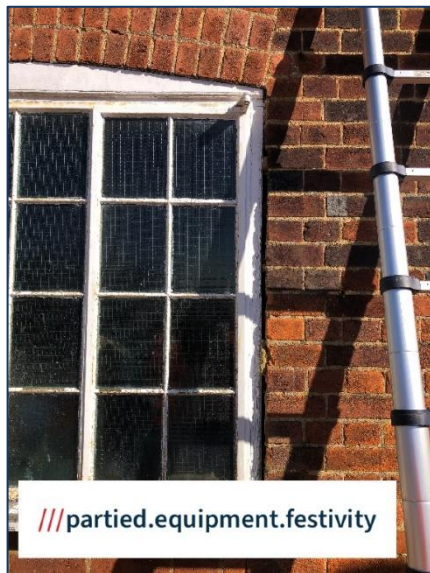
Figure 17. Missing mortar adjacent to window pane.

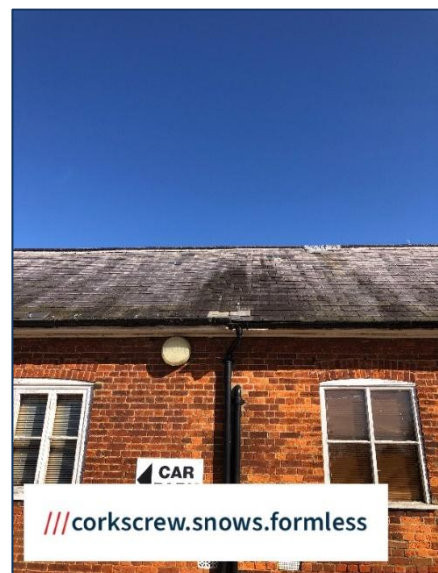
Figure 18. Slipped and missing tiles.

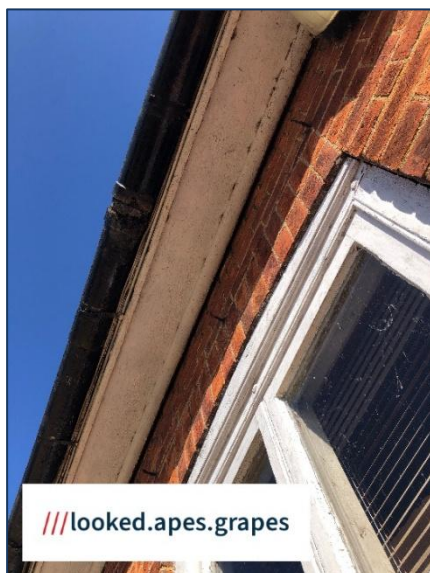
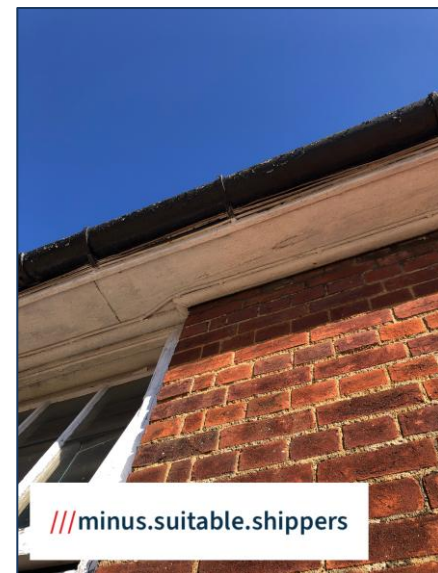
Figure 19a and b. Gap in soffit stretching approx. 10m, width undulates from 0cm to 3cm.

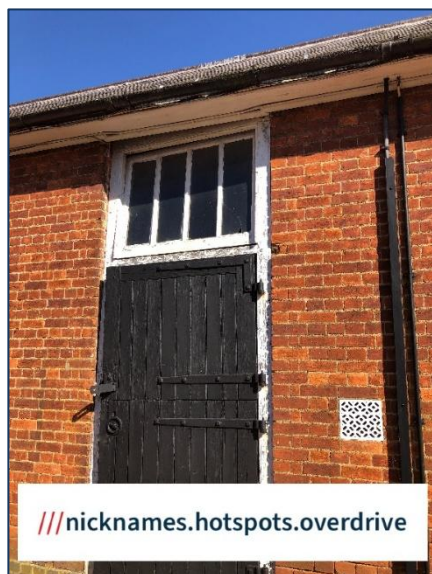
Figure 20. One of three windows stuck open, leaving crevice between frame and sill. Hole in soffit also present above window.

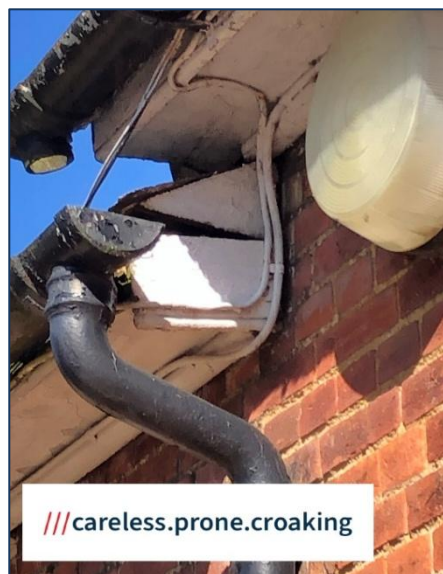
Figure 21. Gap opening into soffit.

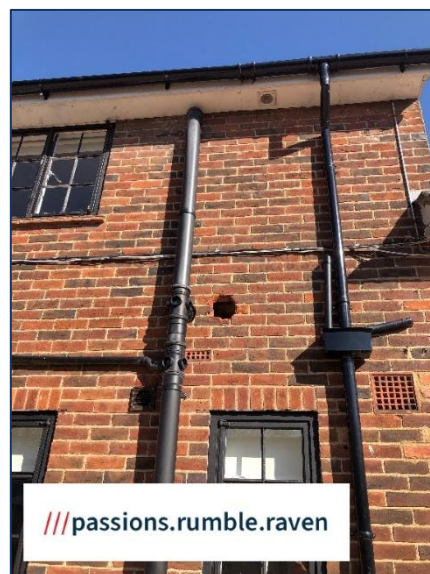
Figure 26. Hole in brickwork leading into a cavity wall.

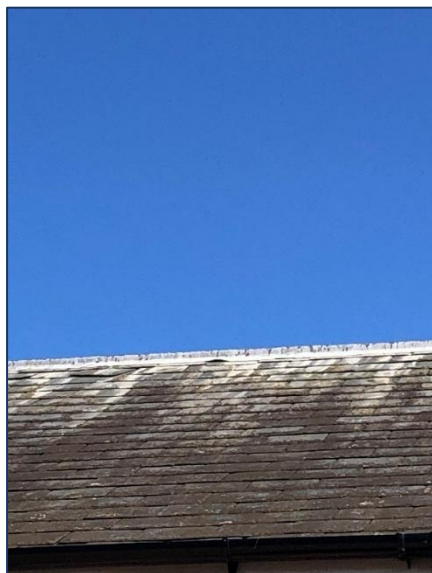
Figure 28. Lifted lead flashing

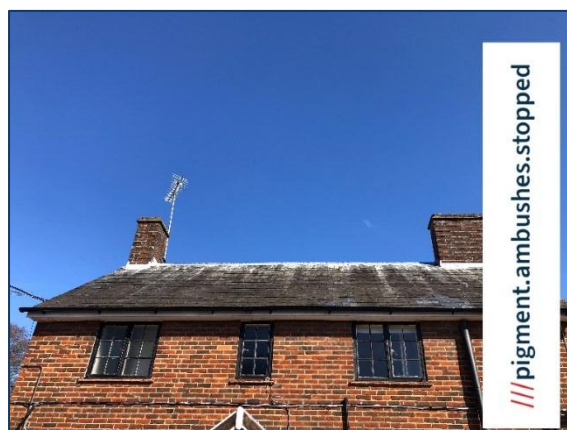
Figure 27. Lifted tiles across entire roof

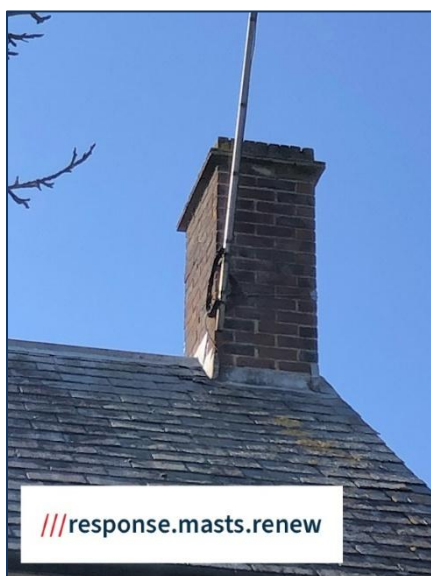
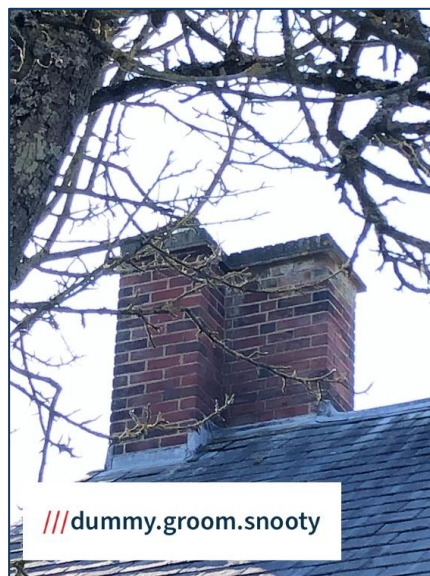
Figure 30. Slipped tiles around chimneys, providing crevices.

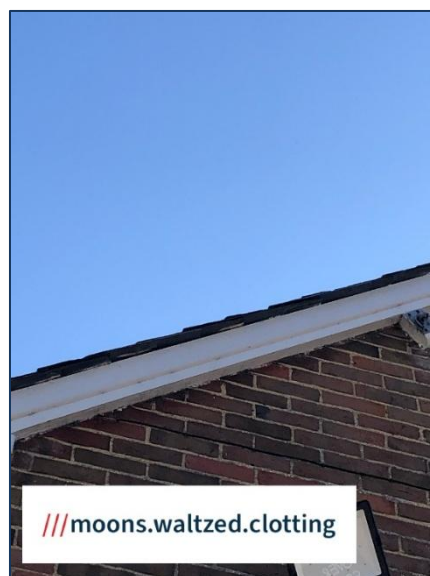
Figure 32. Small gaps between soffit and tiles, widest approx. 3cm.

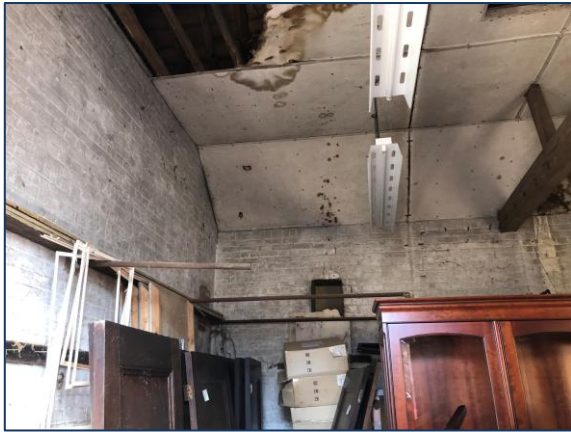
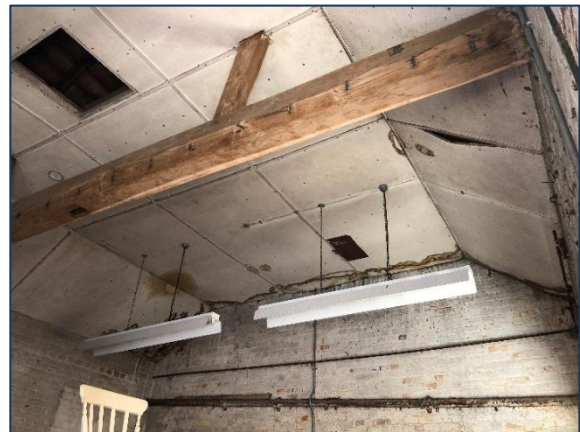
*Figure 35a and b. The old stable's deteriorated ceiling.*

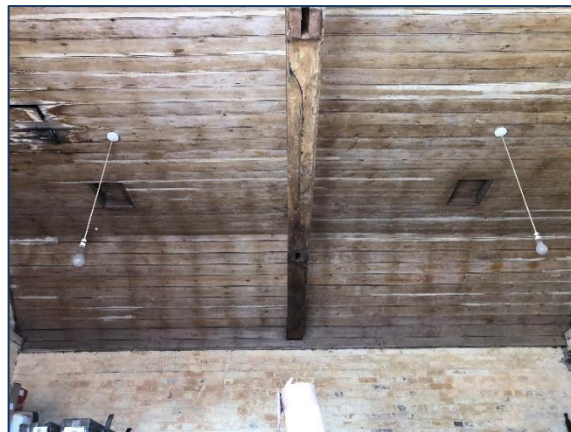
*Figure 36. The rotten, wooden ceiling boards of the old stable.*
