### **Arboricultural Health and Safety Survey**

**CAS/2024/140**

**Site  
Saint Marys Church, Rushden, SG9 0SG.**

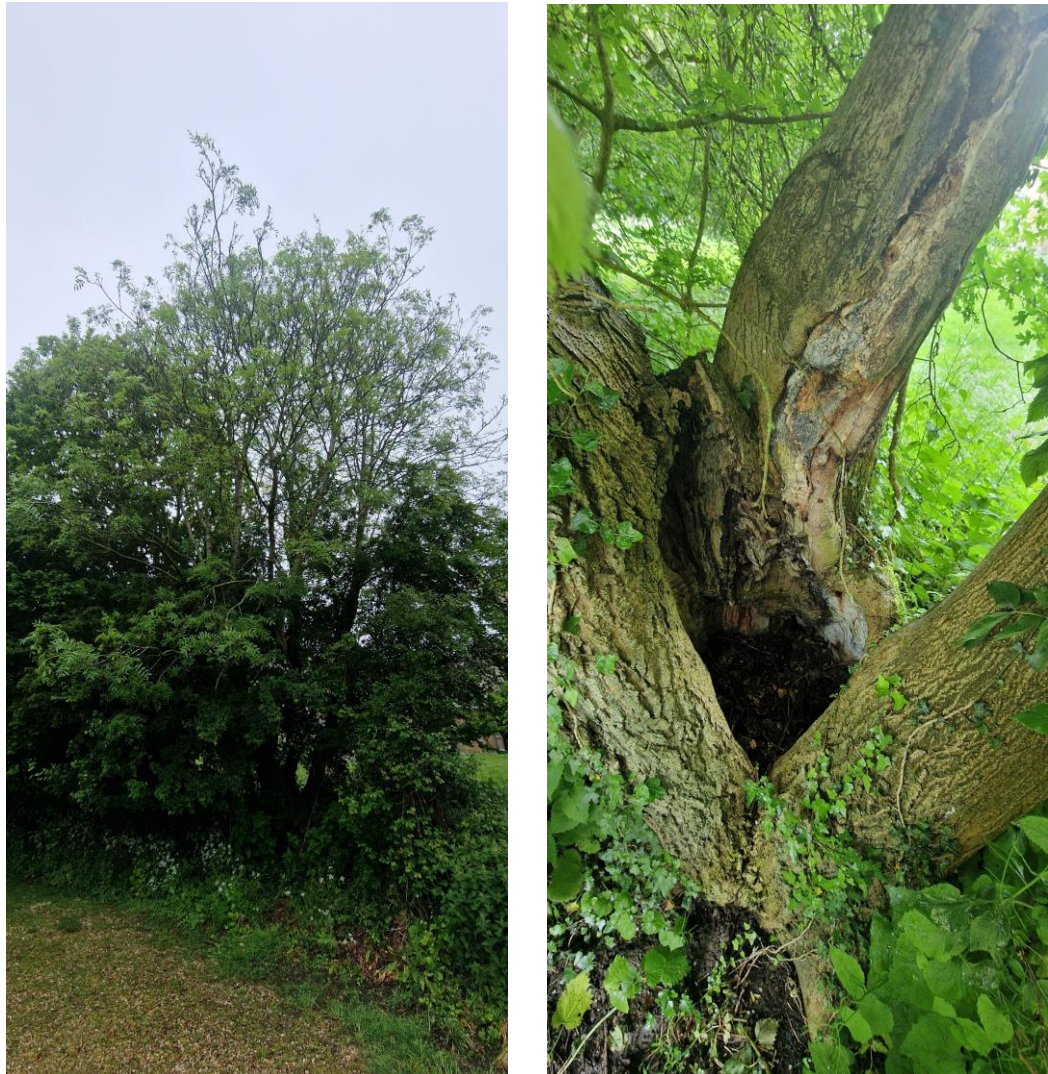
- 2.2.7 Tree numbered T02 Ash (*Fraxinus excelsior*) has been historically coppiced (cut down to a stump and allowed to regenerate naturally). Upon inspection significant

decay was noted in the coppice stool. Therefore, a recommendation has been made for a significant reduction to the trees canopy (50%) to minimize sail effect in windy conditions and the associated pressures on lower structural elements of the tree.

T02 Ash (viewed from car park) & Coppice stool

| Ref. | Species | Description | Measurements | Survey Notes | Overall Condition | Recommendations |
|---|---|---|---|---|---|---|
| T02 | Ash<br>(Fraxinus sp.) | Owned by the estate.<br>Target # - car park.<br>Target # - footpath. | Height (m): 17<br>Crown Radius (m): 7.5<br>DBH (cm): 35<br>Stems: 3<br>Life Stage: Over Mature<br>Life Exp.: 10+ Years | Tree is historic coppice with stool area decayed and hollowed out. Investigation with metal probe revealed decay to at least 60cm | Poor | Crown reduce by 50 % to minimise sail effect and associated pressures on lower structural elements of tree<br>Timescale: 16-Nov-2024 (6 Months) |

| Ref. | Species | Description | Measurements | Recommendations | Priority / Timescale |
|---|---|---|---|---|---|
| T02 | Ash<br>(Fraxinus sp.) | Owned by the estate.<br>Target # - car park.<br>Target # - footpath. | Height (m): 17<br>Crown Radius (m): 7.5<br>DBH (cm): 35<br>Stems: 3<br>Life Stage: Over Mature<br>Life Exp.: 10+ Years | Crown reduce by 50 % to minimise sail effect and associated pressures on lower structural elements of tree | 16-Nov-2024<br>(6 Months) |
