**Tree Survey and Arboricultural Impact Assessment  
In Accordance with BS 5837:2012**

| Project No<br><b>11056</b> | <b>Land at Roundwood, Back Lane, Graveley, Hertfordshire, SG1 6GB</b> | | |
| Client: | | Croudace Homes | |
| Date of Report: | 05/12/2024 | Revision: | Original |

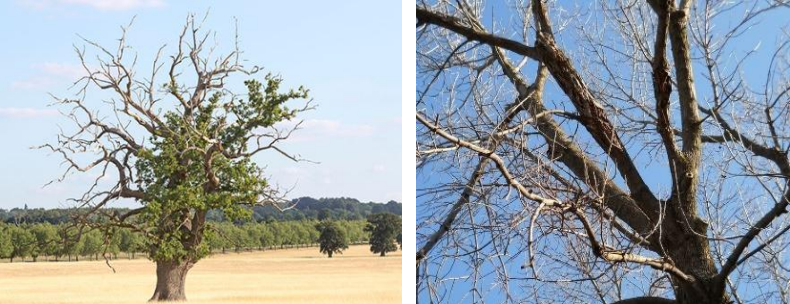
| <b>Symptoms/damage type and cause:</b> | This relates to dead branches in the crown of the tree. In the majority of cases, this is caused by the natural ageing process of the tree or shading due to its close proximity to neighbouring trees. However, in some situations, it may be related to fungal, bacterial or viral infection. |
| <b>Consequence:</b> | Depending upon the location and mass of dead wood removal of the affected tissue may be necessary to prevent harm to persons or property as the wood will become unstable as it decays and in some circumstances is likely to fall from the tree with little or no warning. |

| <b>Control:</b> | Detailed monitoring should be undertaken on those trees showing signs of excessive deadwood production to identify the underlying cause. |

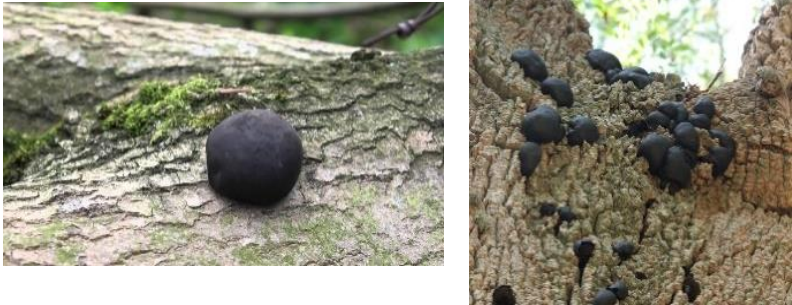
| <b>Name: <i>Daldinia concentrica</i> (Cramp Balls syn. King Alfred's Cakes)</b> | |

| <b>Symptoms/damage type and cause:</b> | This fungus is common and widespread on Ash trees but can also be found on Beech, Lime and Horse Chestnut. It is saprophytic in nature, only colonising wood that is already dead. |
| <b>Consequence:</b> | Its presence indicates areas of deadwood and may cause such wood to fall, but it is otherwise not regarded as a significant condition in itself. |

| <b>Control:</b> | Removal of affected tissues by tree surgery is necessary where affected parts of the tree have the potential to cause harm in the event of their structural failure. |

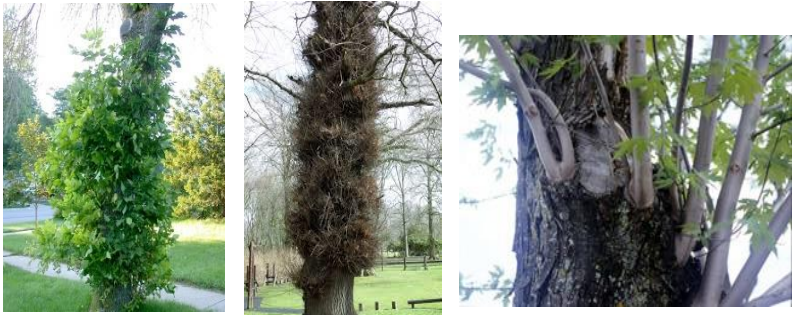
| <b>Name: Epicormic growth</b> | |

| <b>Symptoms/damage type and cause:</b> | This is the production of numerous shoots on the main stem and branches of the tree. They are produced by the bursting into life of otherwise dormant buds. It is commonly associated with elevated levels of stress on the tree. |
| <b>Consequence:</b> | Whilst epicormic growth is usually symptomatic of an issue elsewhere within the tree, heavy proliferation can cause the trees resources to become depleted or may mask significant structural weaknesses within the framework of the tree. |

| <b>Control:</b> | Pruning off epicormic growth may be necessary to improve the visual amenity of the tree or prevent the development of a hazard or obstruction. No direct means of prevention are available other than therapeutic measures to alleviate stresses on the tree. |

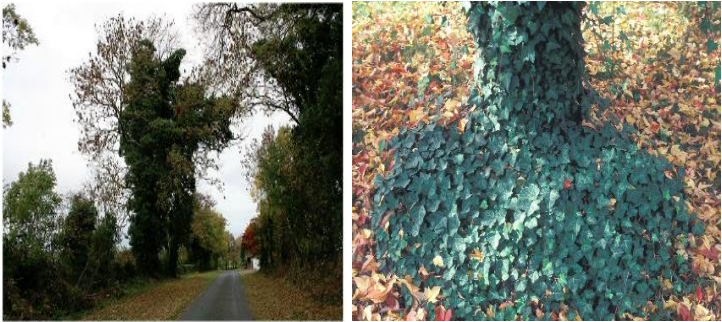
| <b>Symptoms/damage type and cause:</b> | Ivy may grow to varying degrees on all areas of a tree from the base to the upper crown. It is possible that in doing so it will out-compete the host tree for available light thereby suppressing the host. |

| <b>Control:</b> | Ivy should only be removed if absolutely necessary because it provides abundant cover to wildlife and then by severing twice close to the ground and removing a length of stem thereby causing the gradual dying away of the aerial parts of the plant providing extended benefit to wildlife whilst relieving the pressure on the tree. |
