# TREE CONDITION REPORT

## No. 15 The Chilterns, Hitchin, Herts SG4 9PP

| <b>AAAL REF:</b> | <b>SAL/KMA/10488</b> |
| <b>REPORT DATE:</b> | <b>27<sup>th</sup> October 2020</b> |

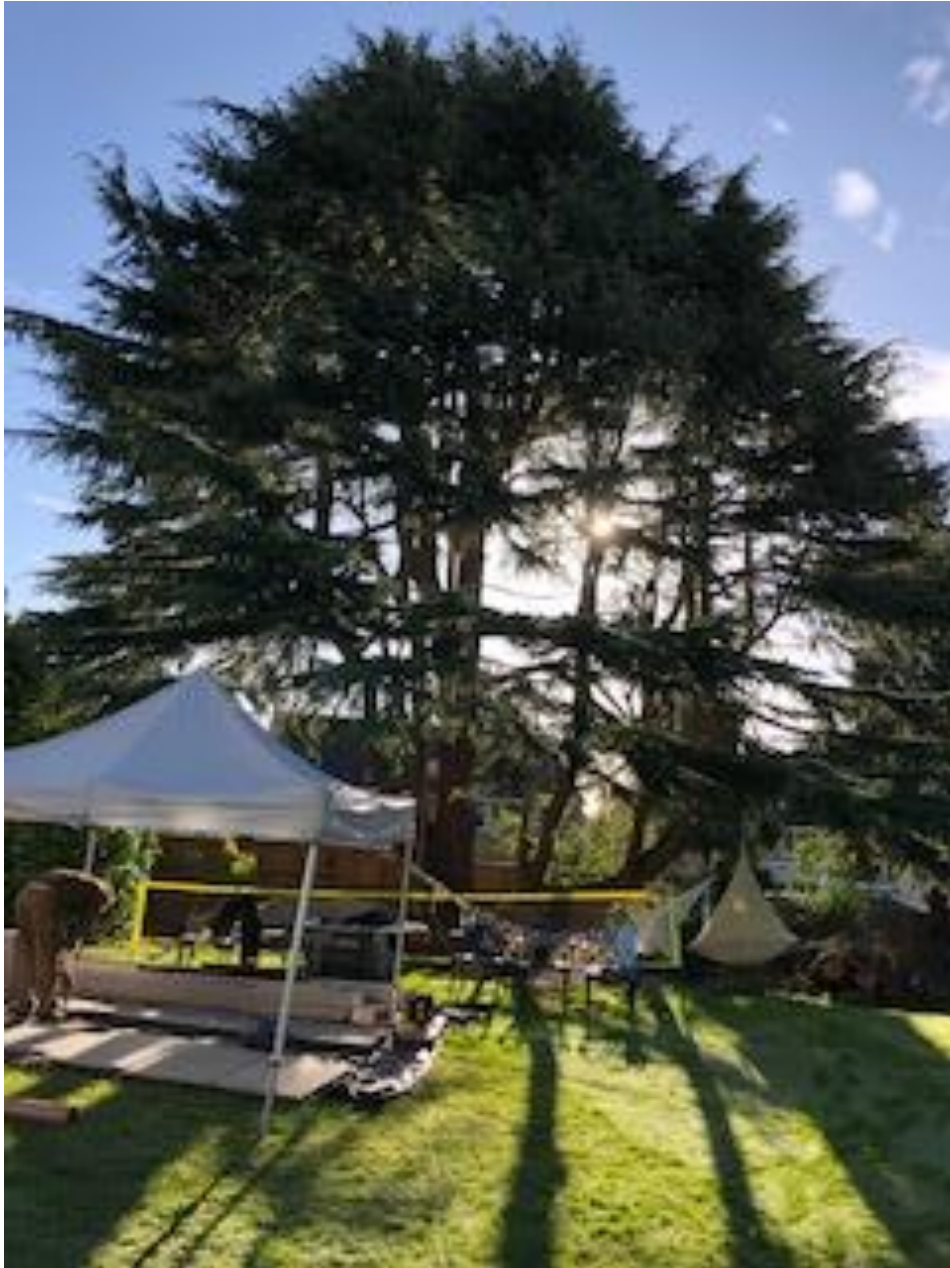
**2.1 Inspection of trees on site:** I inspected only one tree on this site. The tree is a Himalayan cedar which is growing close to the northeastern rear garden boundary (see photographs 1 & 2, Appendix 1 at the back of this report). Tree details are summarised in the tabulation below:

**PHOTOGRAPH NO. 1 - T1 – CEDAR VIEWED FROM THE NORTH**

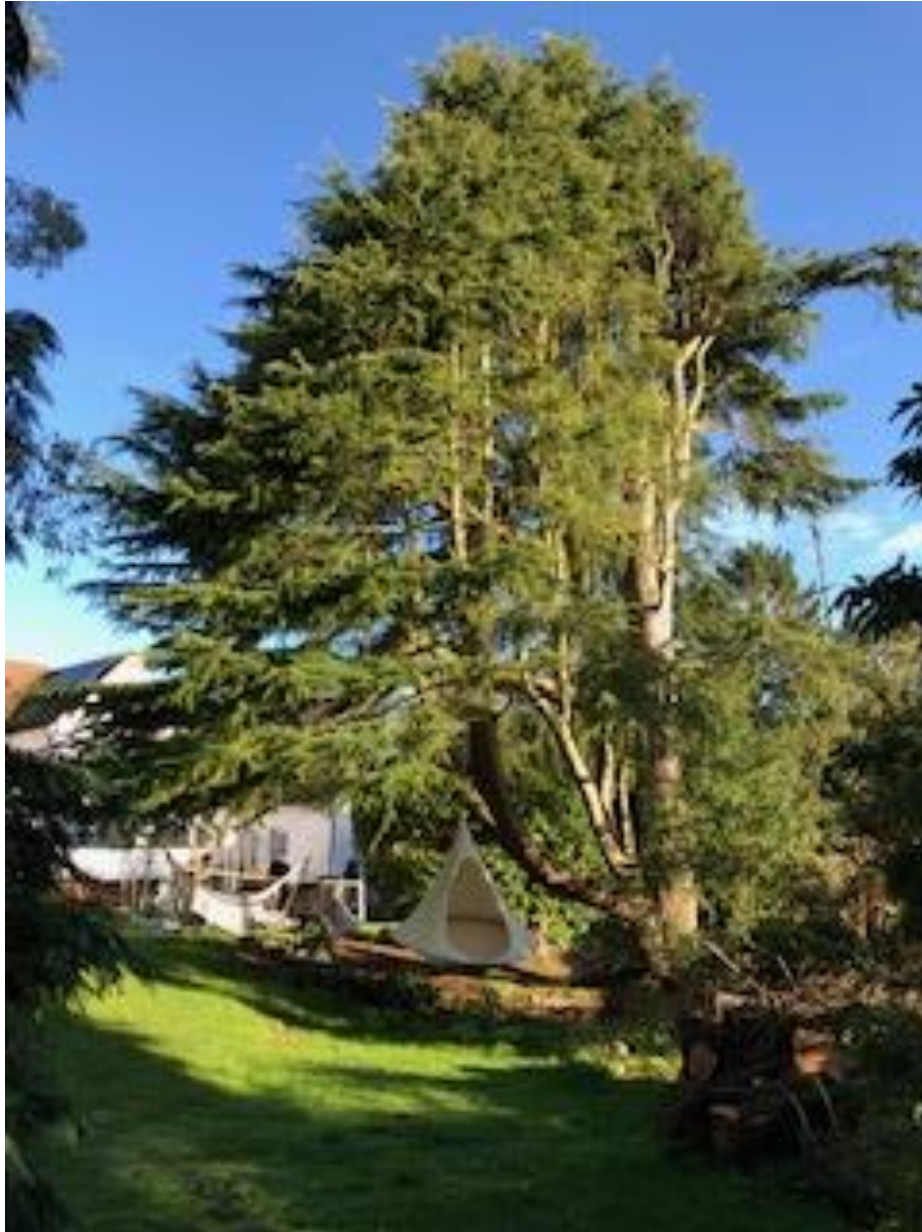
- 3.3 Four large scaffold branches grow out toward the western side (see photograph 2, Appendix 1 at the back of this report). Unusually these have produced a number of apically growing shoots on their upper surfaces and the branch ends have adopted an upward growth form two thirds of their length from the trunk. The overall form is now a crowded and untidy tangle comprised of a cohort of apically orientated branches/rival leaders.

- 3.5 Due to a significant section of the tree crown having broken out the remaining tree is now heavily disposed to the west and more vulnerable to wind induced 'torsional twisting' and possible structural failure (see photograph 2, Appendix 1 at the back of this report). Pruning can be prescribed to address this but will need to be considered and specific.

**PHOTOGRAPH NO. 2 - T1 – CEDAR VIEWED FROM THE SOUTH**

6.1 T1 - Himalayan cedar - reduce apical and lateral branch extremities by around 2m, this should prove sufficient to reduce end weight, 'lever-arm' effect and pre-disposition to failure. Although the proliferation of upright-growing competing leaders presents as a tangle I consider that it would be unwise to remove any individual stem completely. It is better that they remain together as they contribute to a 'wind damping' effect which will reduce the risk of future failures. Even branches 'clashing together' help in this effect. The previous pruning/breakout point should be reduced to around 300 mm above the lateral branch located below the failure point, this will effectively remove two lateral branches that would fail in the near future.

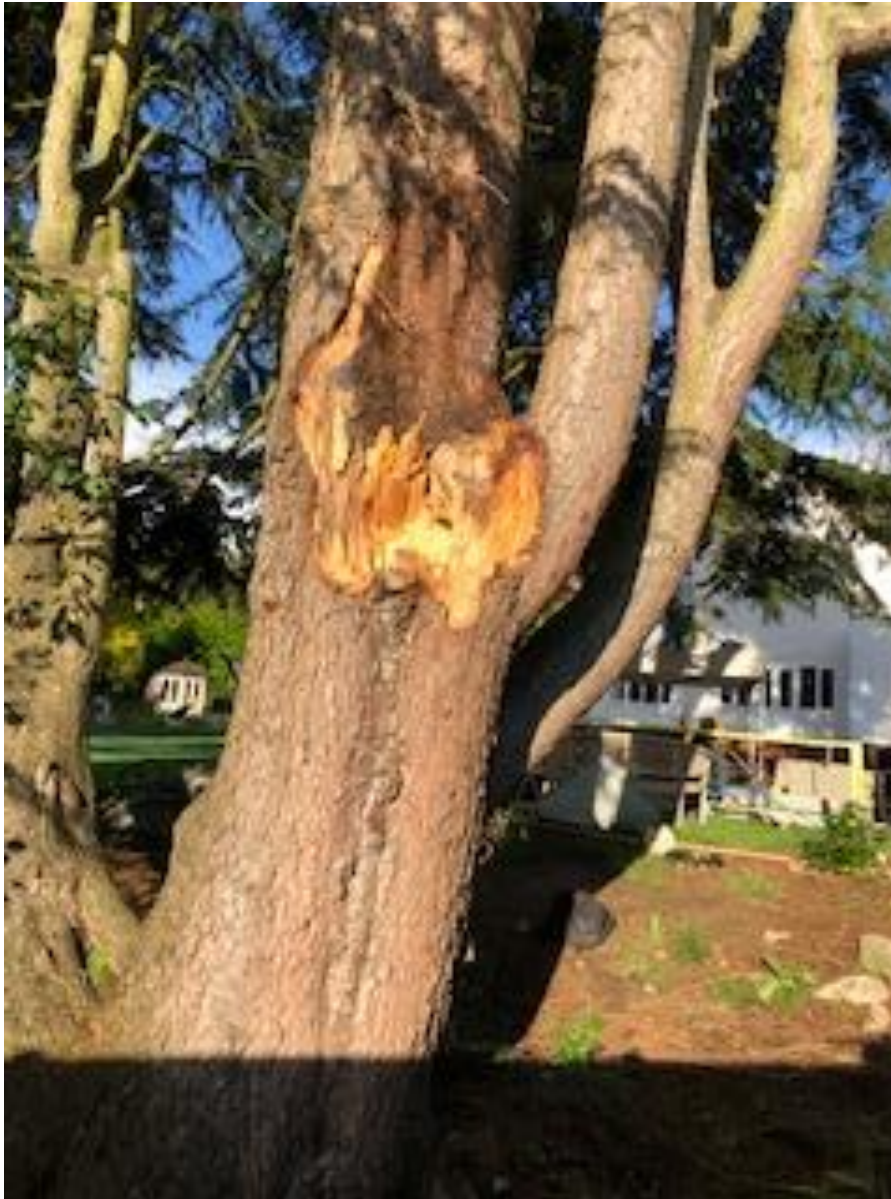
**PHOTOGRAPH NO. 3 – BRANCH BREAKOUT POINT ON NORTHWESTERN SIDE**

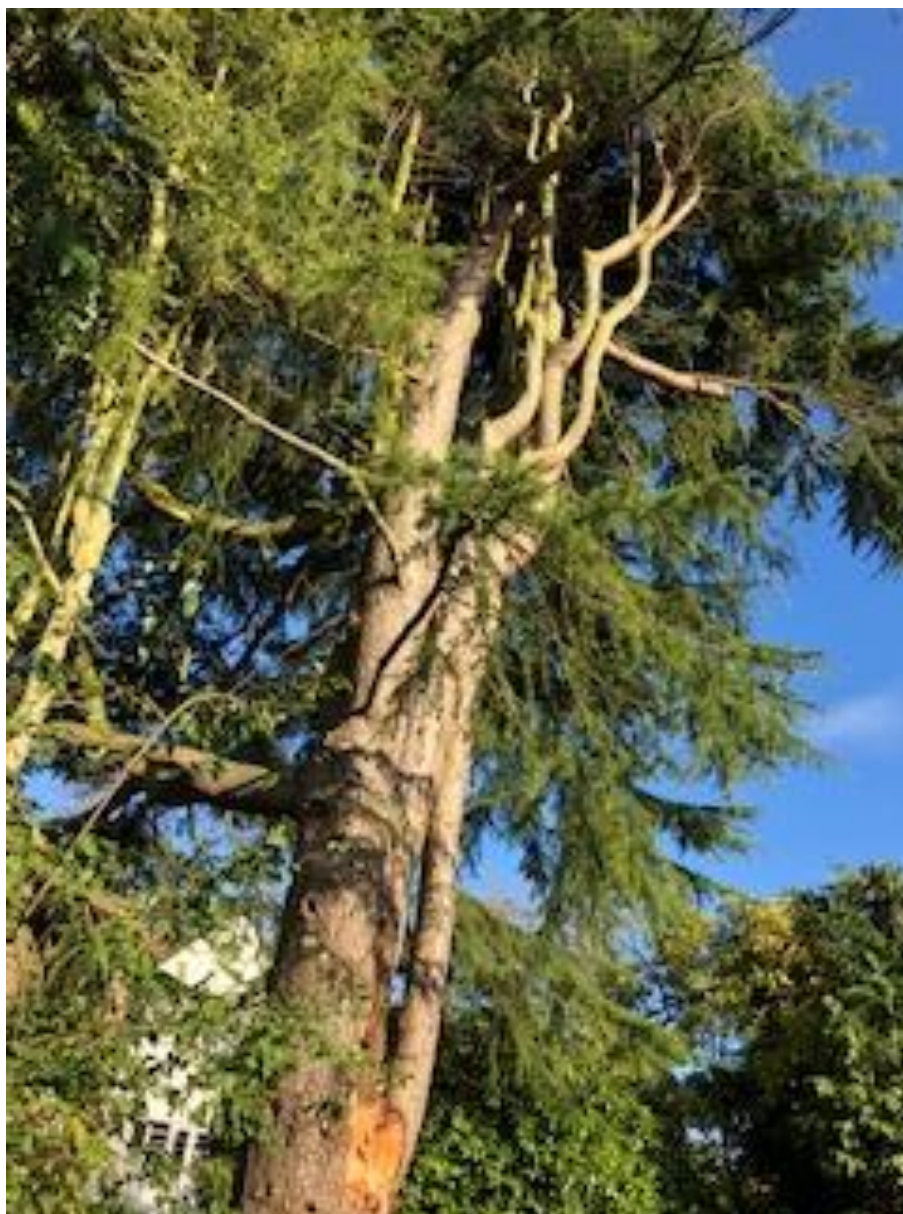
- 3.2 This tree is of mature age class being within the middle one-third of its probable life expectancy. It is of significant size having an estimated height of 22 m and a measured trunk diameter of 860 mm. Overall form is poor and it seems that has been so since the tree was planted. Most trees grow with a single trunk and smaller diameter lateral branches. In this way they are structurally sound with a low propensity for branch break. Form of this cedar tree is that of a single trunk of 860 mm diameter with a rival leader of 520 mm diameter (measured at 1 m above ground level), arising from ground level on the southwest side (see photograph 1, Appendix 1 at the back of this report). The rival leader that failed was of 530 mm diameter (at around 3 m above ground level) and arose on the northeast side of the tree (see photographs 3, 4, 5 & 6, Appendix 1 at the back of this report). A further rival leader arises from the same point and has grown up through the tree crown entwining and conflicting with the upper tree parts at higher level (see photographs 3, 4, 5 & 6, Appendix 1 at the back of this report). One more significant rival leader arises at 4 m above ground level on the southern side of the tree with a tight, fused branch union which extends for around 1.5 m before separating and fusing again about 600 mm further up (see photographs 4, 5 & 6, Appendix 1 at the back of this report).

**PHOTOGRAPH NO. 4 - TRUNK SCAFFOLD BRANCHES AND CROWN SEEN FROM THE EASTERN SIDE**

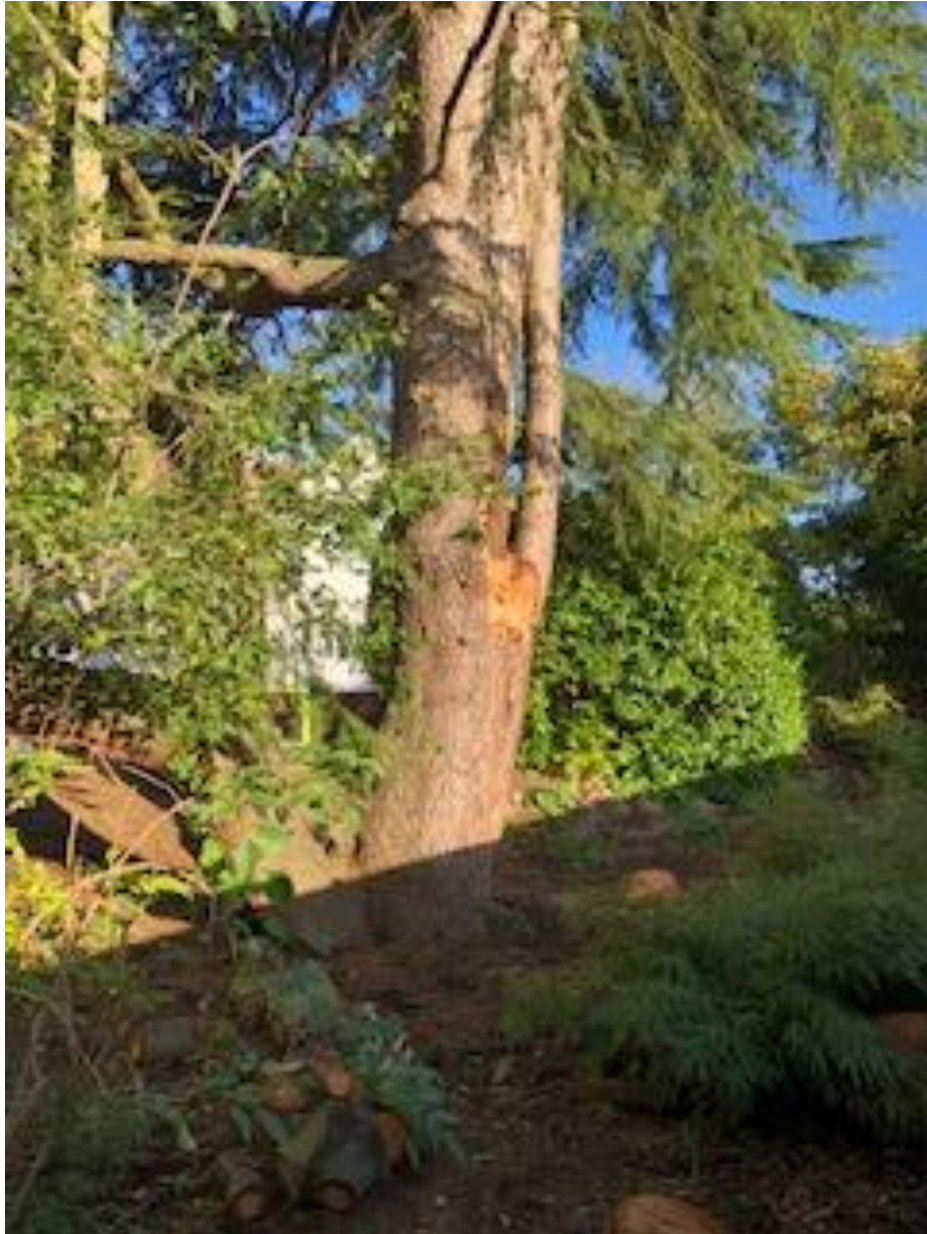
**PHOTOGRAPH NO. 5 - SCAFFOLD BRANCHES SHOWING 'FUSED' RIVAL LEADER**

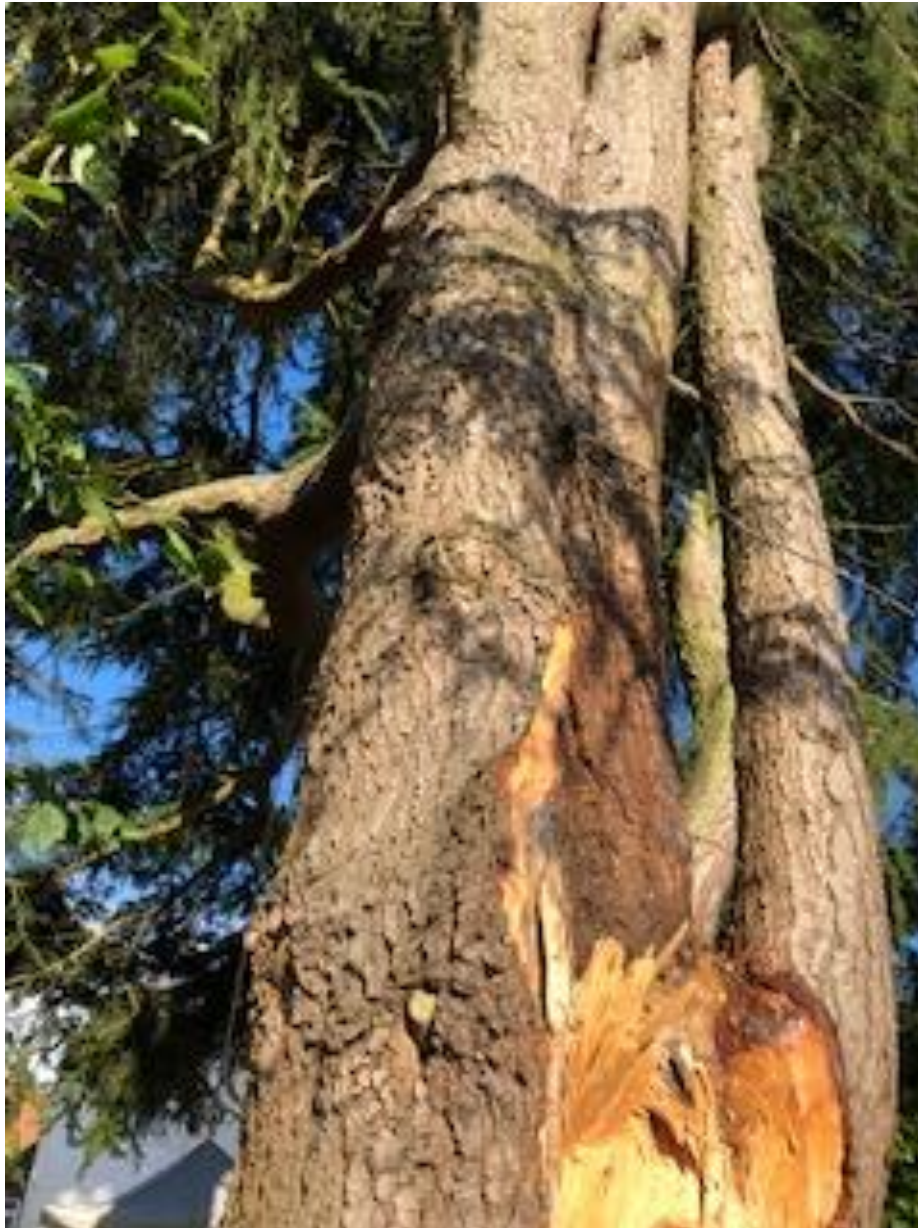
**PHOTOGRAPH NO. 6 - CROWN BREAKOUT POINT SHOWING 'FUSED' RIVAL LEADER AND  
NORTHERLY ENTWINED RIVAL LEADER**

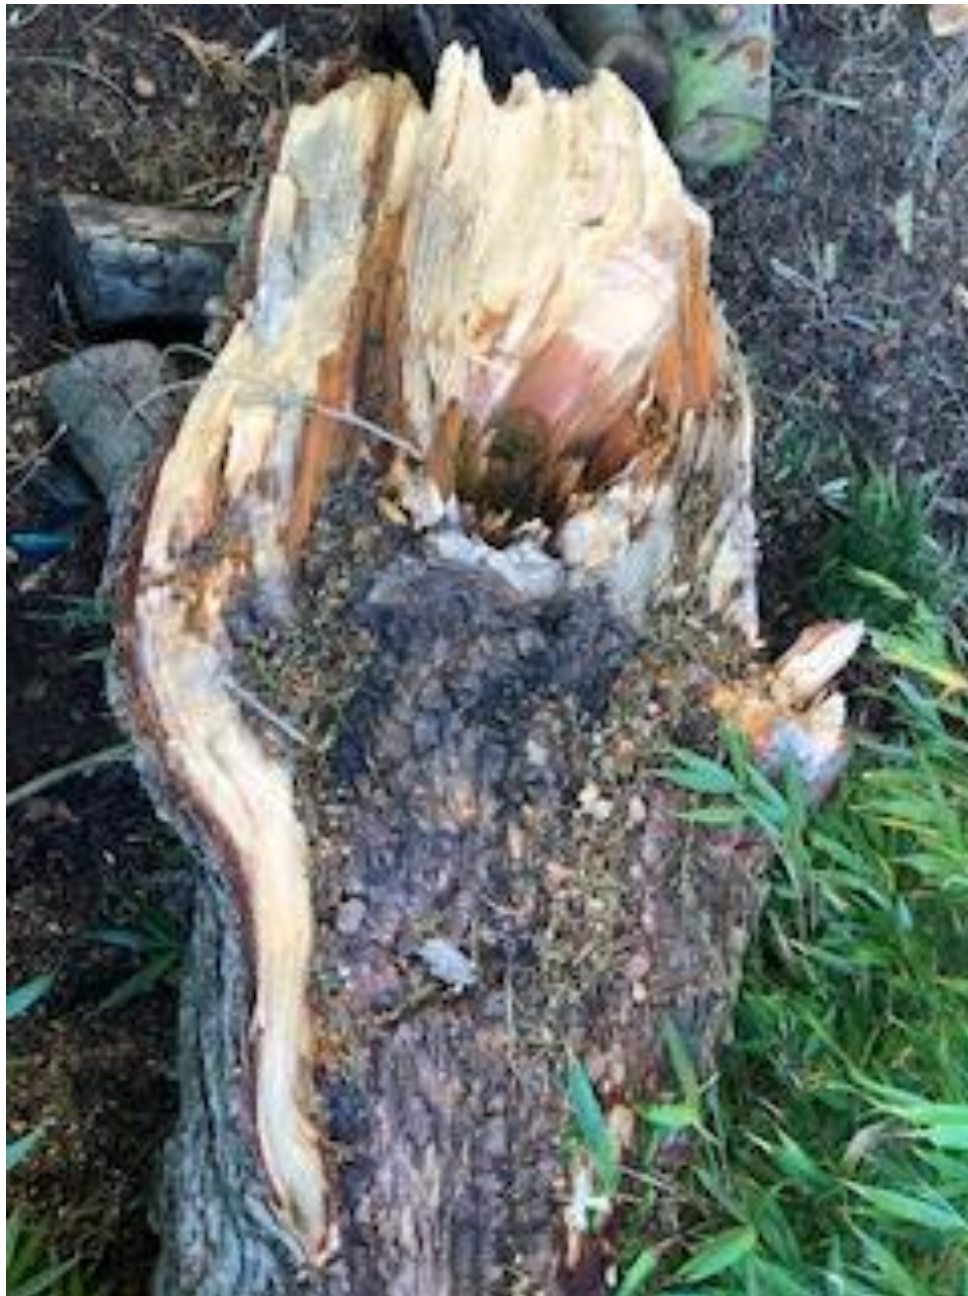
**PHOTOGRAPH NO. 8 - 'STUB END' OF THE FAILED SECTION**
