# Condition Report

The Holt Farm, Kimpton, Hitchin. SG4 8HG.

| Issue date: | 2 <sup>nd</sup> September 2025 |

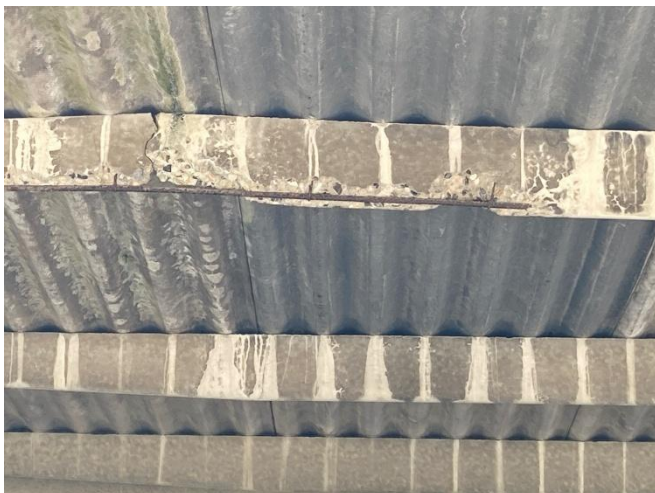
The damage to the concrete is due in part to physical impact and in part to the roof leaking and water ingress causing the steel reinforcement within the purlins to rust, expand and damage the surrounding concrete.

Many of the purlins have cracked and are in danger of collapse.

Barn 12 has a precast reinforced concrete frame and has profiled asbestos cement sheets to the roof and elevation. The concrete structural frame is significantly damaged in sections and parts of the metal reinforcement are exposed and badly corroded, causing the surrounding concrete to become cracked and displaced. The concrete panels are cracked and damaged and several are very loose creating a safety hazard. The frame and the cladding is in general poor order and requires taking down and replacing.

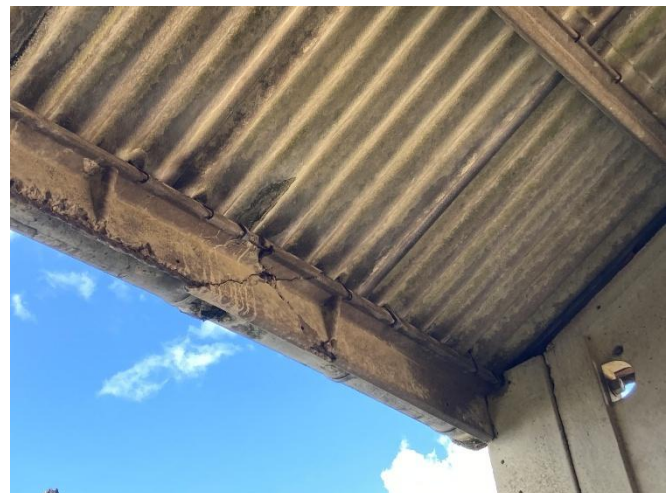
Some sections of the concrete are loose and could fall.

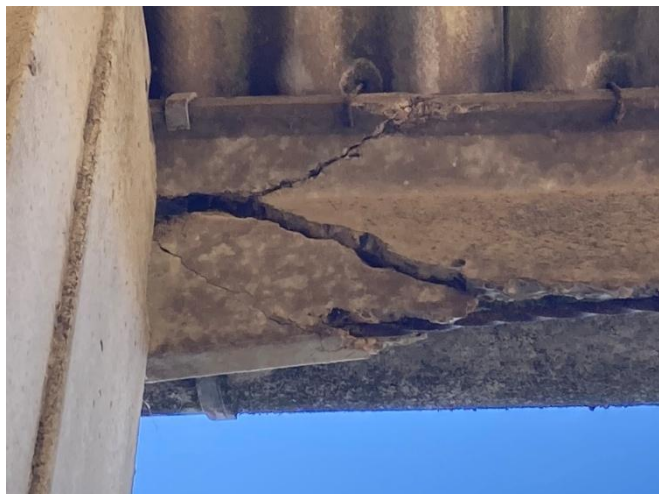
**The concrete purlins have cracked and could collapse.**

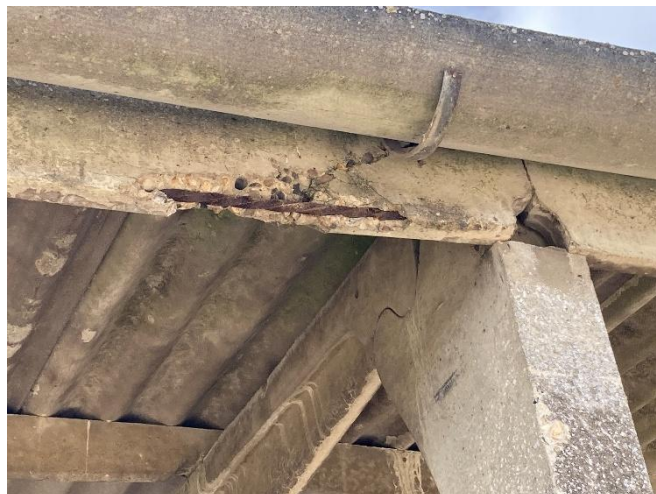
**The reinforcement has corroded in sections, causing the surrounding concrete to become displaced.**

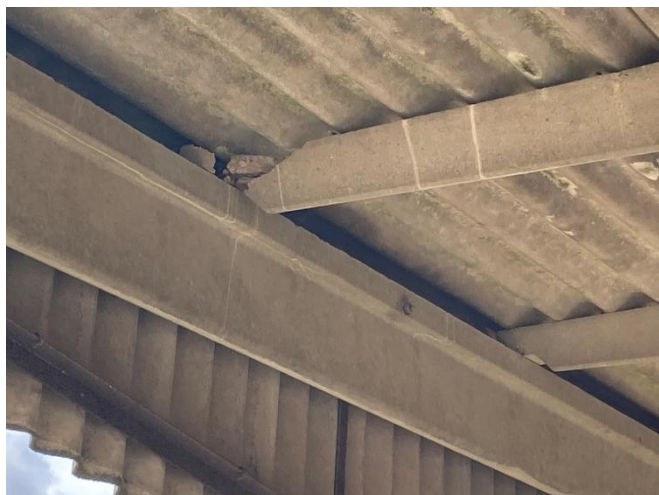
**Some purlins are damaged where they bear on the beams.**

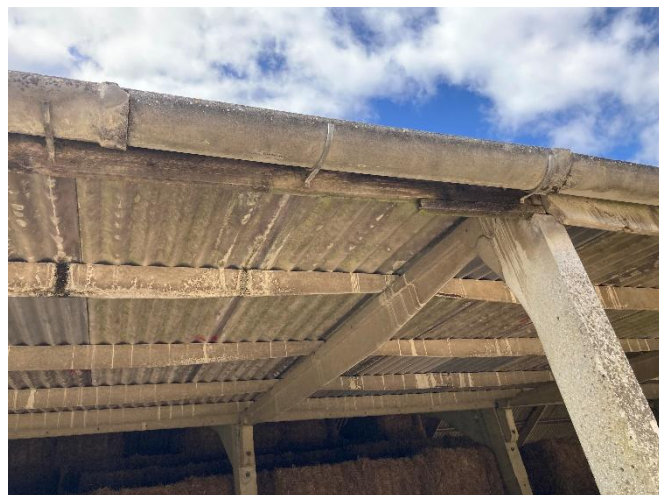
**One damaged concrete purlin has been replaced in a basic manner with a timber purlin.**

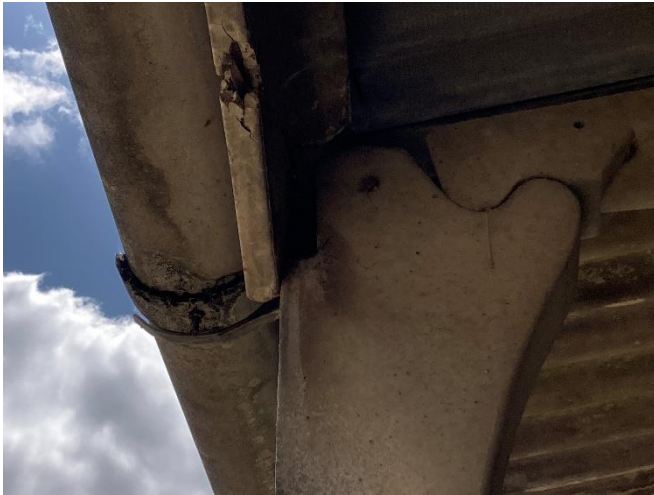
Some purlins have moved from their original bearing position and are at risk of falling.

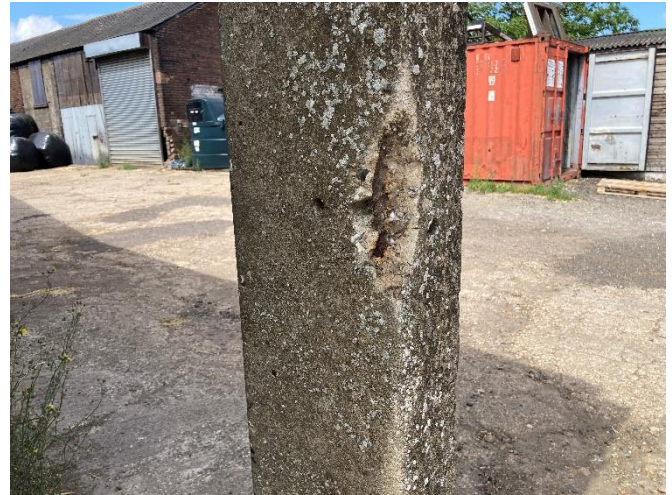
The concrete posts have localised areas of corroded reinforcement and cracking.

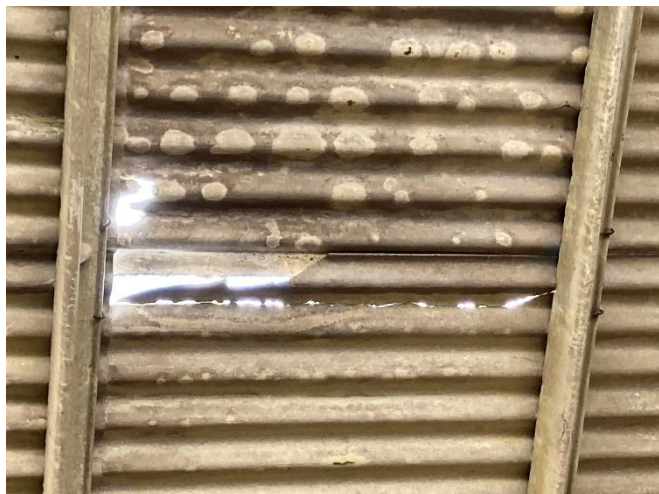
Some of the cement roof sheets are damaged, creating a safety risk and allowing water to ingress into the building.

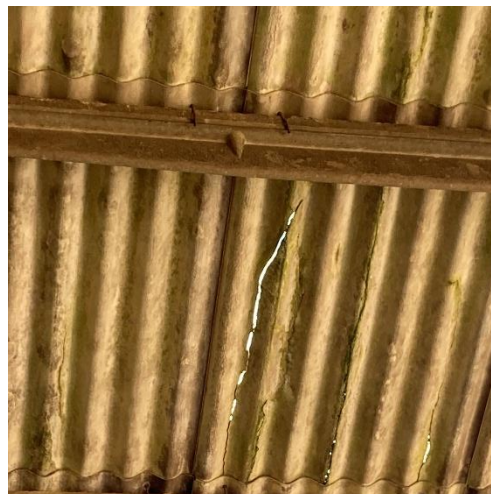
The roof cladding is cracked in sections.

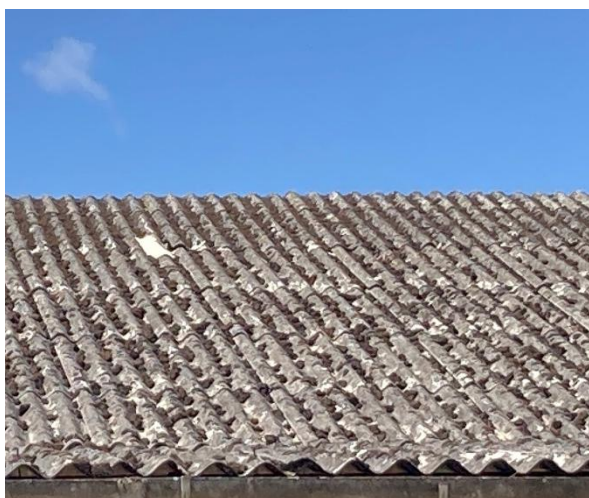
The roof has been patched repaired to a basic standard in sections. Repairing roof sheets that contain asbestos creates safety issues.

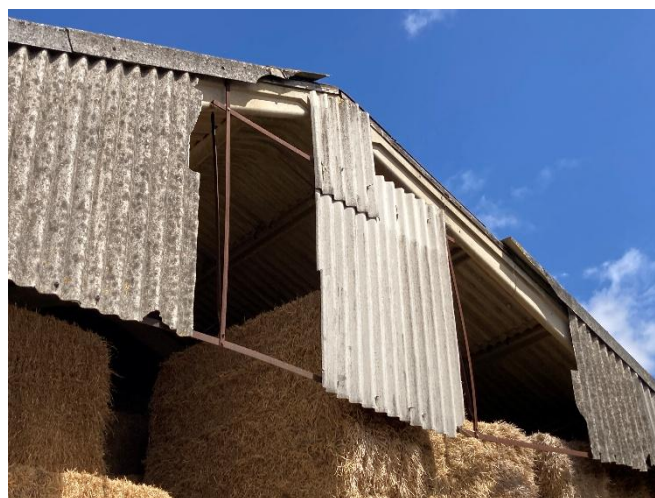
The cladding to the south gable end of the duo pitched roof is in poor condition and in danger of collapse.

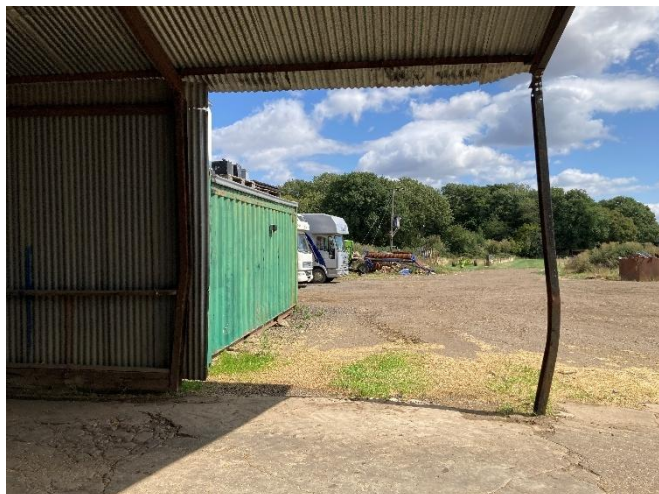
On the east side of the barn, the frame is impact damaged and the horizontal metal cladding frame missing.

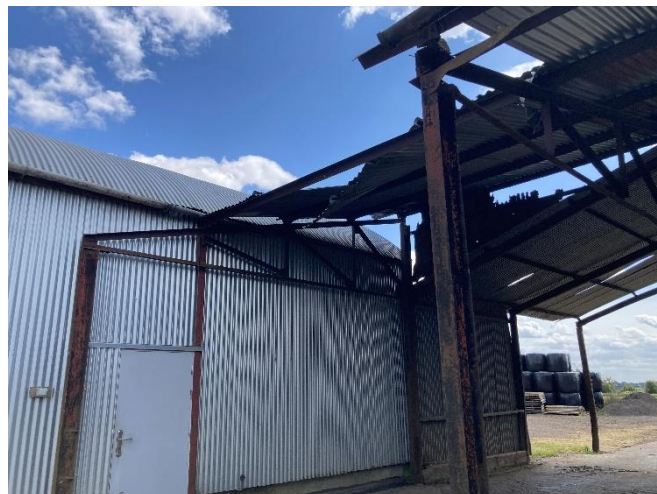
At the east side of the northern edge of the barn, a number of the roof purlins are missing.

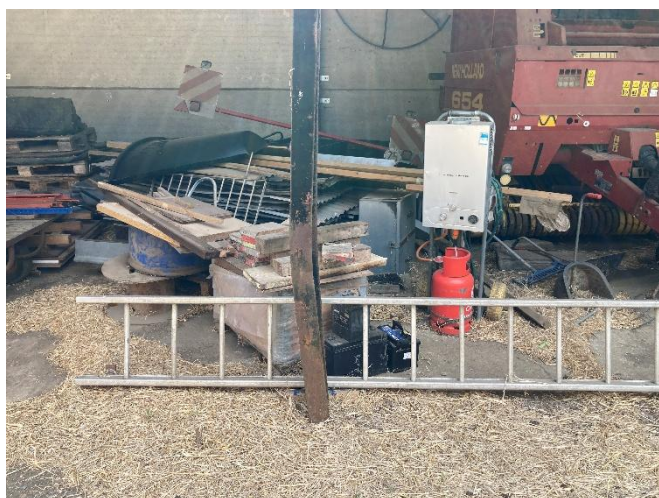
To the western section of the northern edge of the barn, one of the columns is impact damaged and bent.

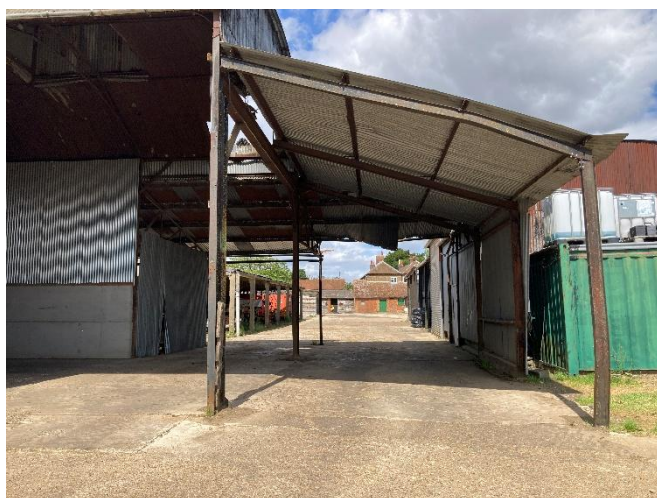
The diagonal steel beam at the east end of the southern perimeter of the barn is impact damaged.

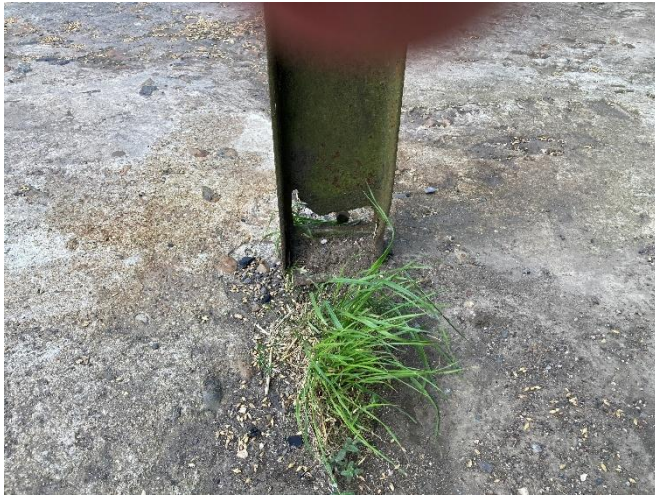
On the east side of the north elevation, the steel is badly corroded at ground level.

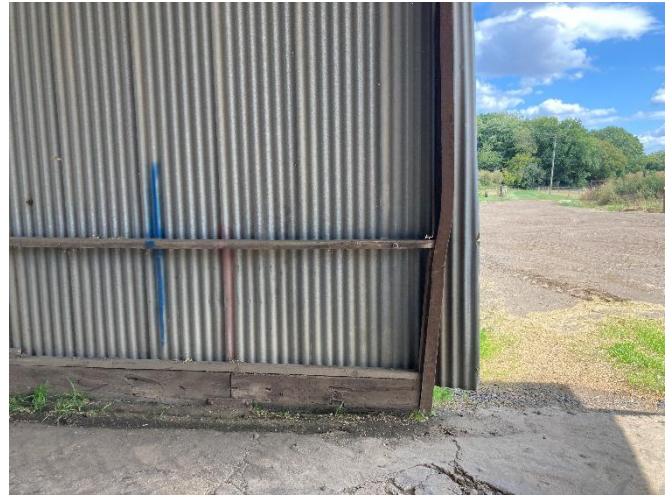
To the east side of the building, the central beam is impact damaged and bent.

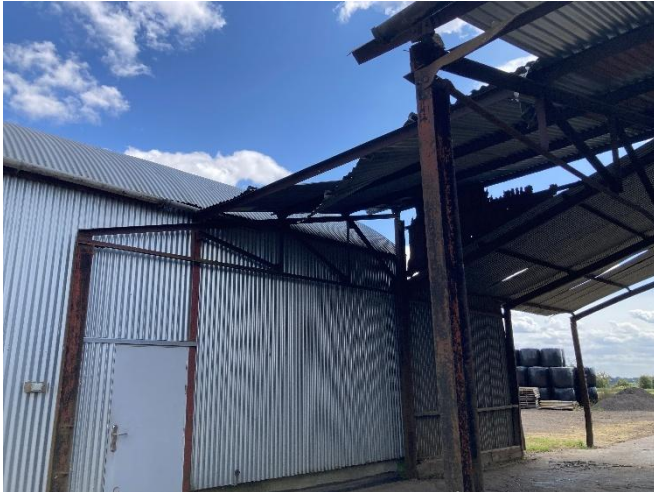
To the north east corner, the sheets are missing or very loose creating a significant safety risk. Several panels were blowing in the wind.

The condition of the panels also means the building is no longer wind and weathertight. The panels are in a serious state of disrepair and require stripping in their entirety and replacing.

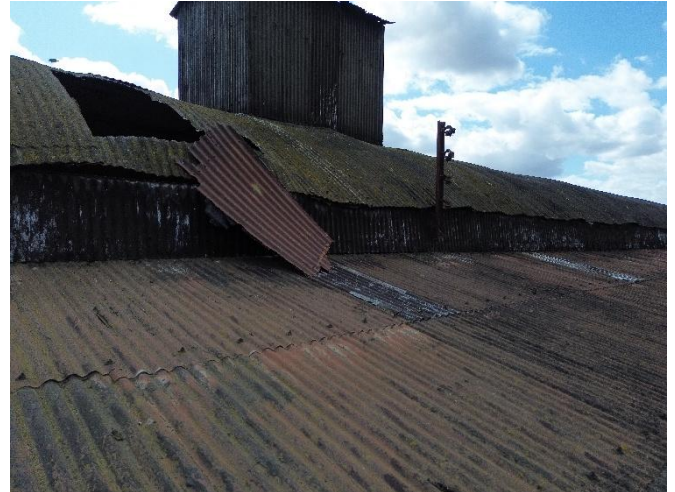
To the north east corner one roof sheet has fallen away and is only secured in one corner.

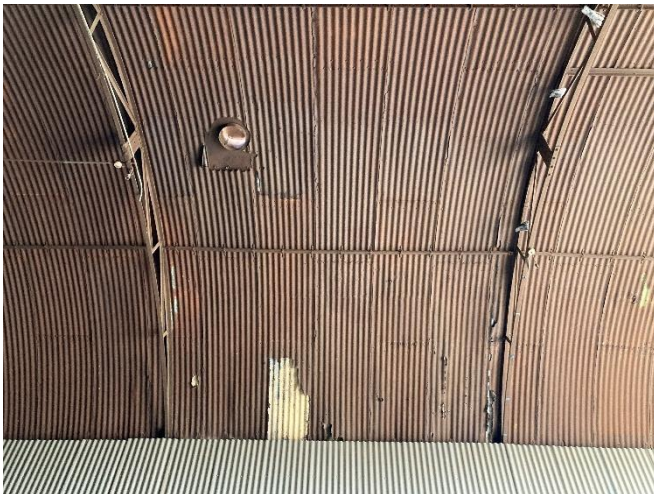
To the majority of the barn, the underside of the curved roof sheets are corroded, reducing the strength of the sheets.

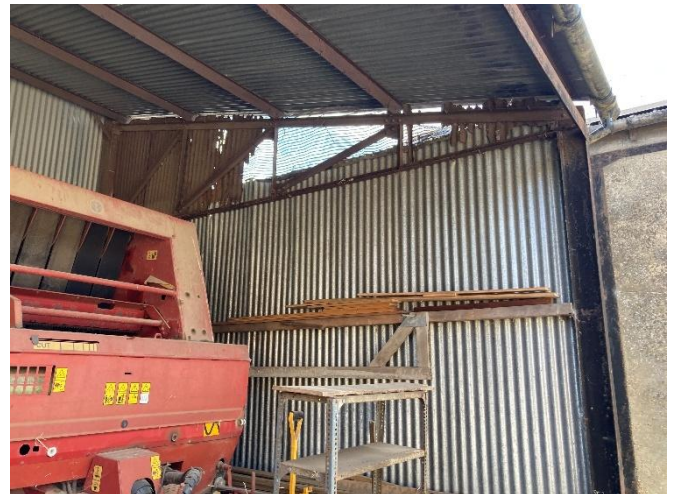
At the west end of the building, the high level metal sheeting is very badly rusted and a safety risk.

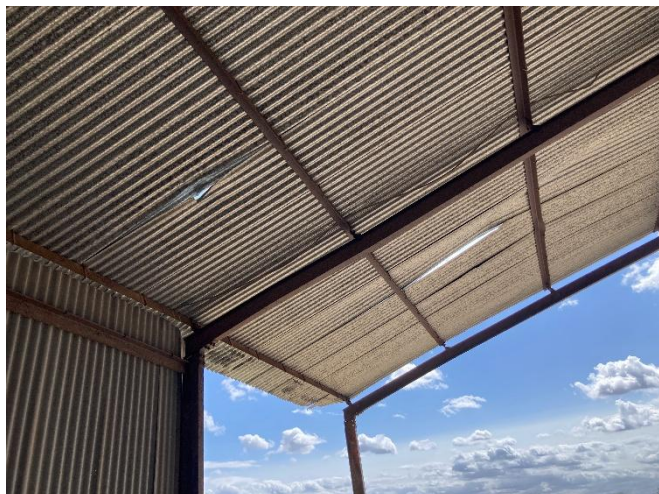
To the south bay on the east side, the metal roof sheets are impact damaged and daylight is visible between the sheets.

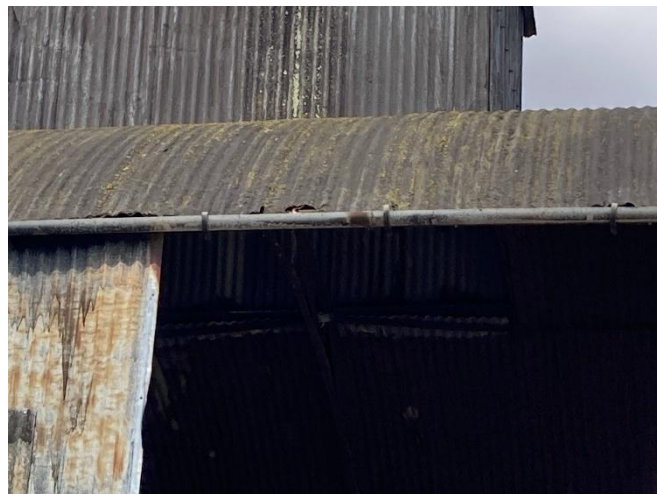
To the southern edge of the roof at the east end, the roof sheets are badly corroded and have partly broken away.

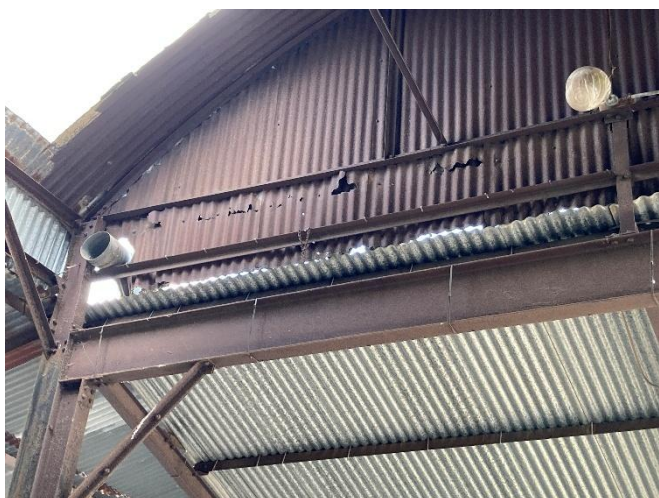
Vertical sheets in the barn, are badly corroded and have holes present in the sheets.

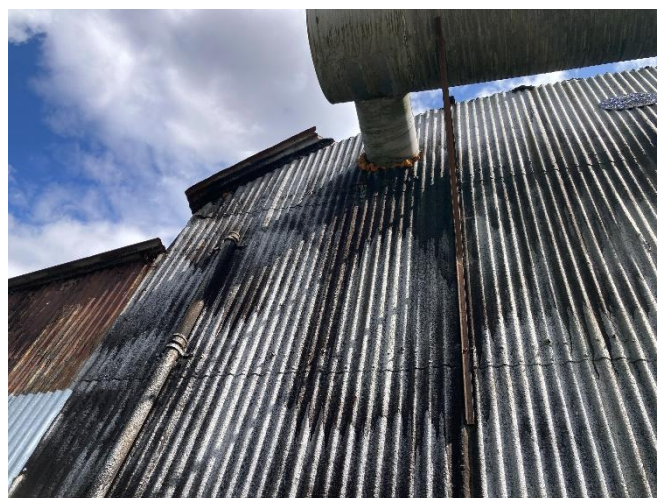
At the west end of the barn, the roof sheets do not extend over the wall cladding, creating a void through which water can enter.
