Structural Appraisal Of Removal Of Roof Covering

Existing Corner & Threshing Timber Barns

Highover Farm  
Highover Way  
Hitchin  
Herts  
SG4 0RQ

Project 7219

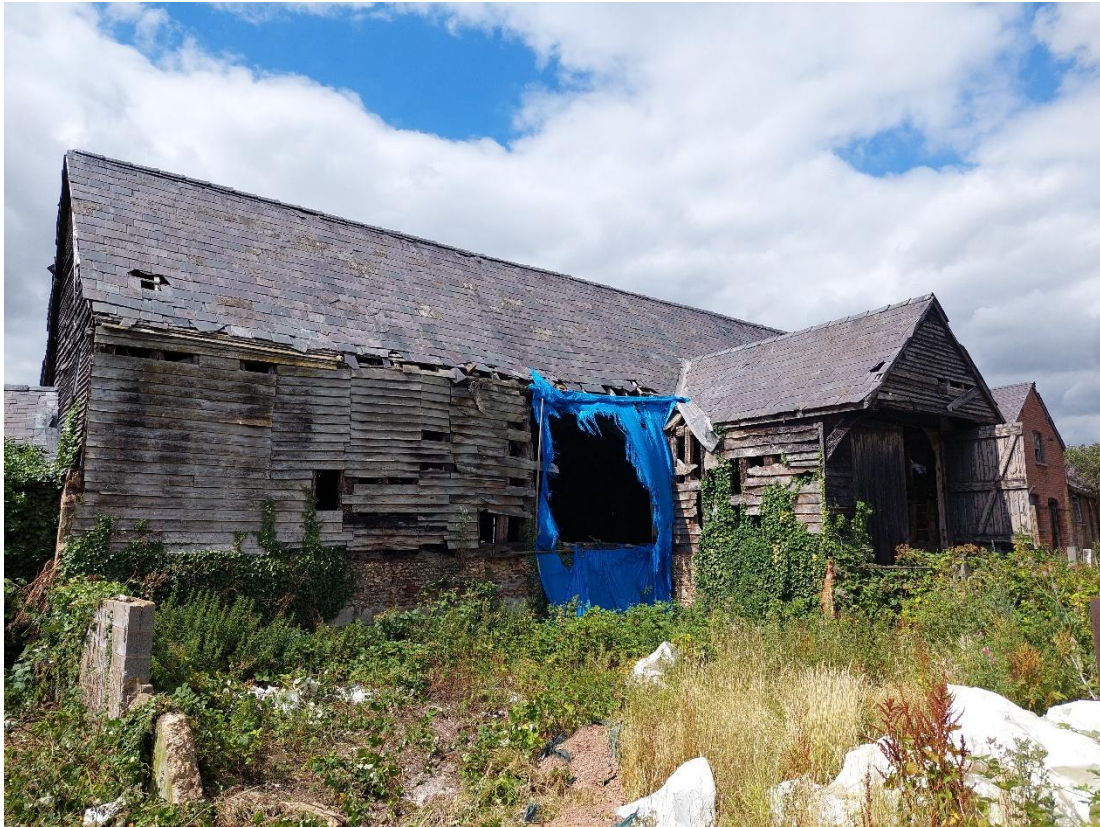
There is a general sway of the whole building towards the farm central courtyard.

*Figure 1 - Threshing Barn Front Elevation*

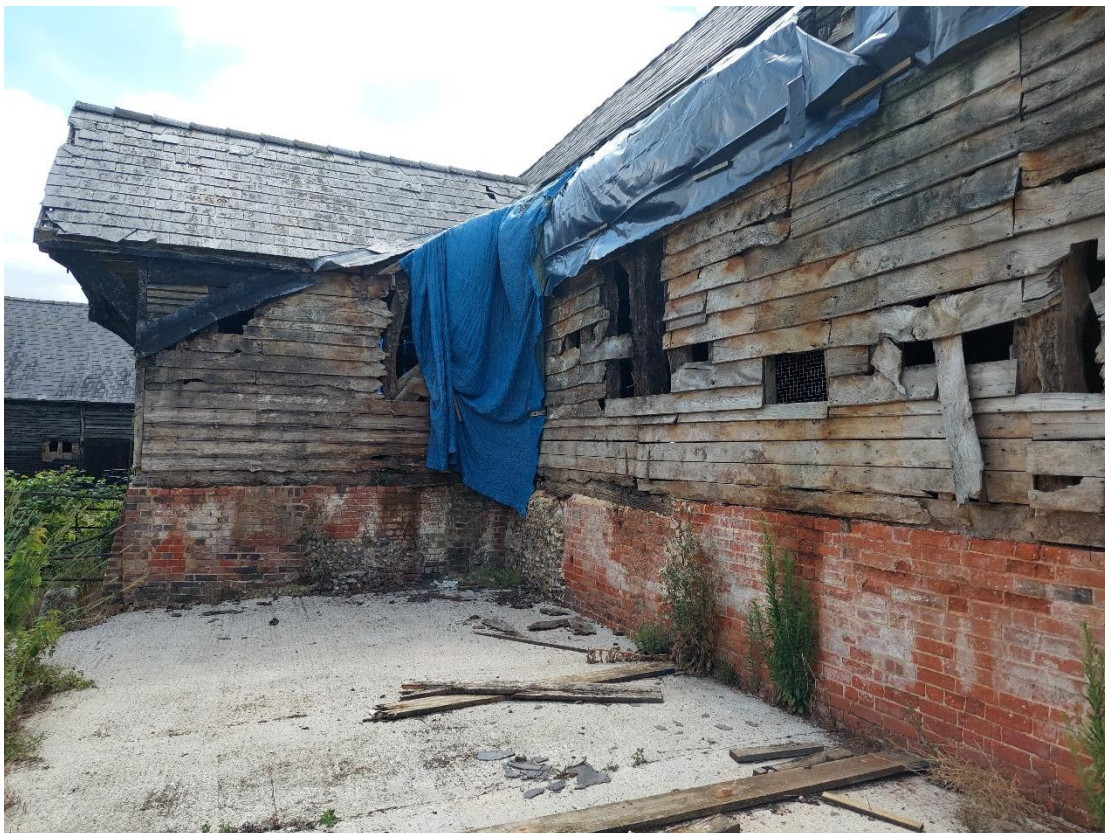
*Figure 2 - Threshing Barn Front Elevation*

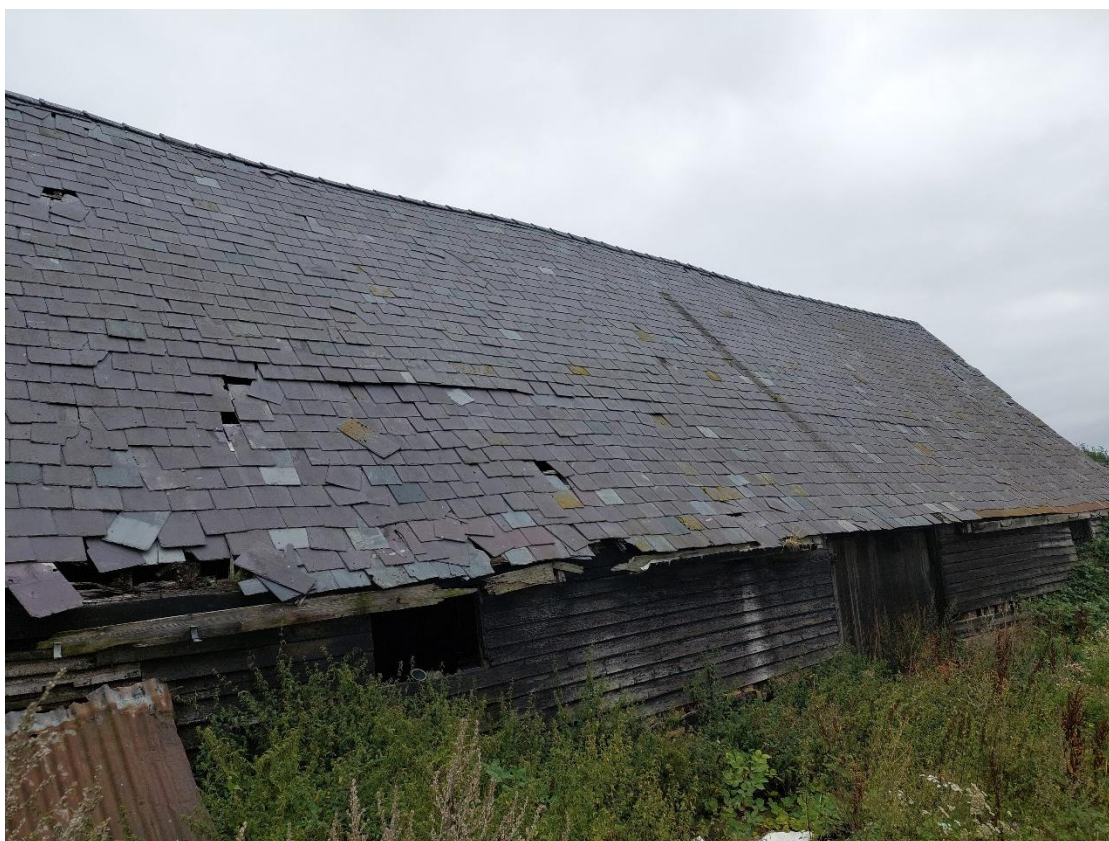
The trusses carry oak purlins, in turn supporting hand cut rafters. There is no sarking board or felting between the rafters and slate battens. There are numerous holes in the roof covering and missing boards to the side walls.

*Figure 3 -Threshing Barn Rear Roof Slope*

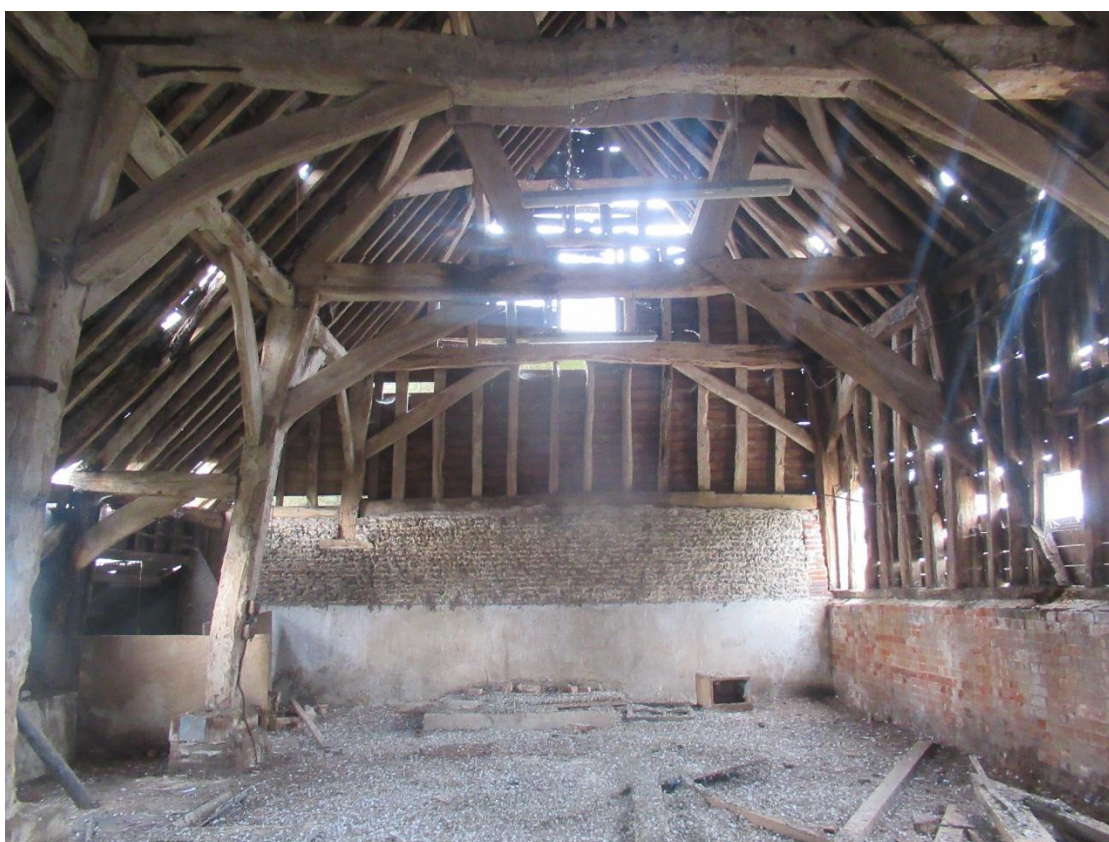
The Heritage Consulting report recommends limited replacement of rotten timbers and further survey of others. The principal structural members are all in surprisingly good condition.

*Figure 4 - Threshing Barn Internal*

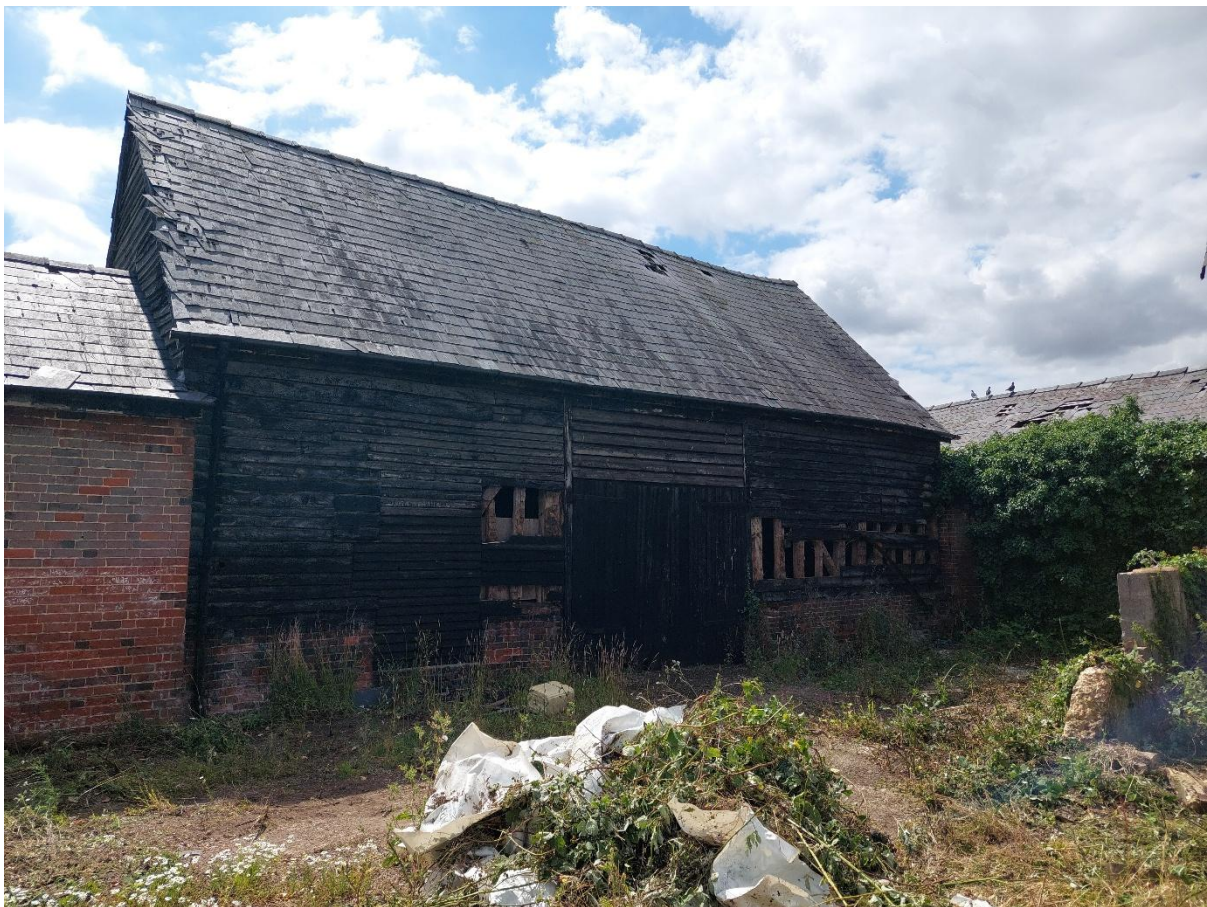
There are numerous holes in the roof where tiles have slipped slightly or fallen entirely. The left hand verge has numerous tiles at risk of falling

*Figure 5 - Unit 2 Front Elevation*

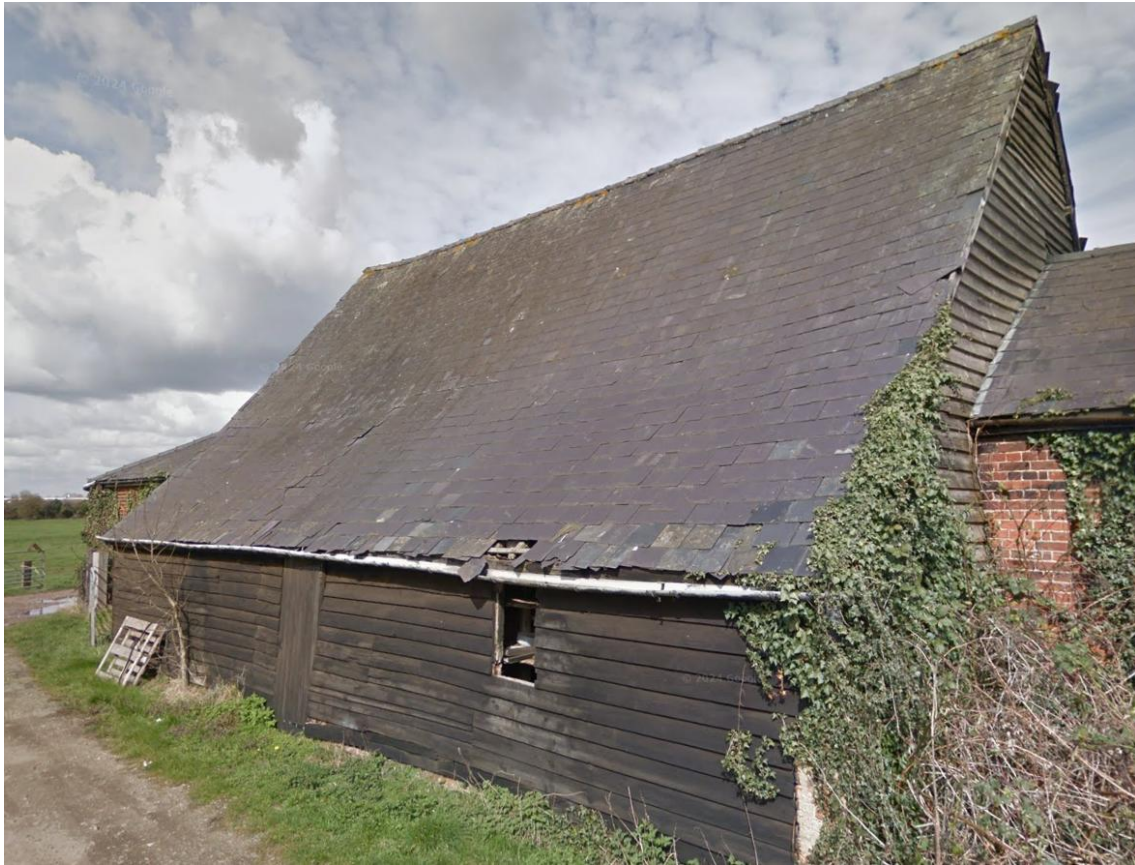
*Figure 6 - Unit 2 Rear Roof Slope*

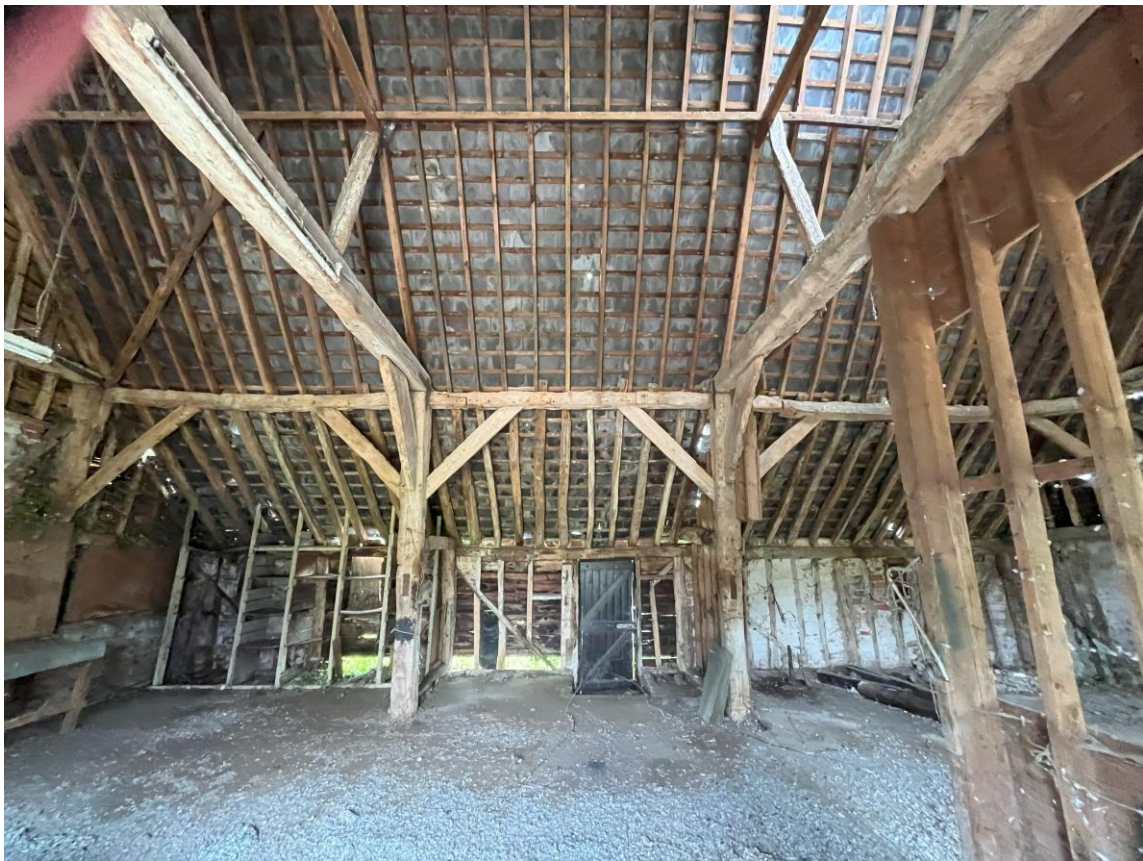
STA Ltd have carried out a walkover survey of the barn, the principal members are in good condition, there will be local replacement or splicing of rafters and wall plates where water ingress has led to rot, and also to some elevational studs where cladding boards have become displaced and missing.

*Figure 7 - Unit 2 Interior*
