## 299 - The Biggin

Condition Survey

02/26: Planning Issue

**Michael Collins Architects**

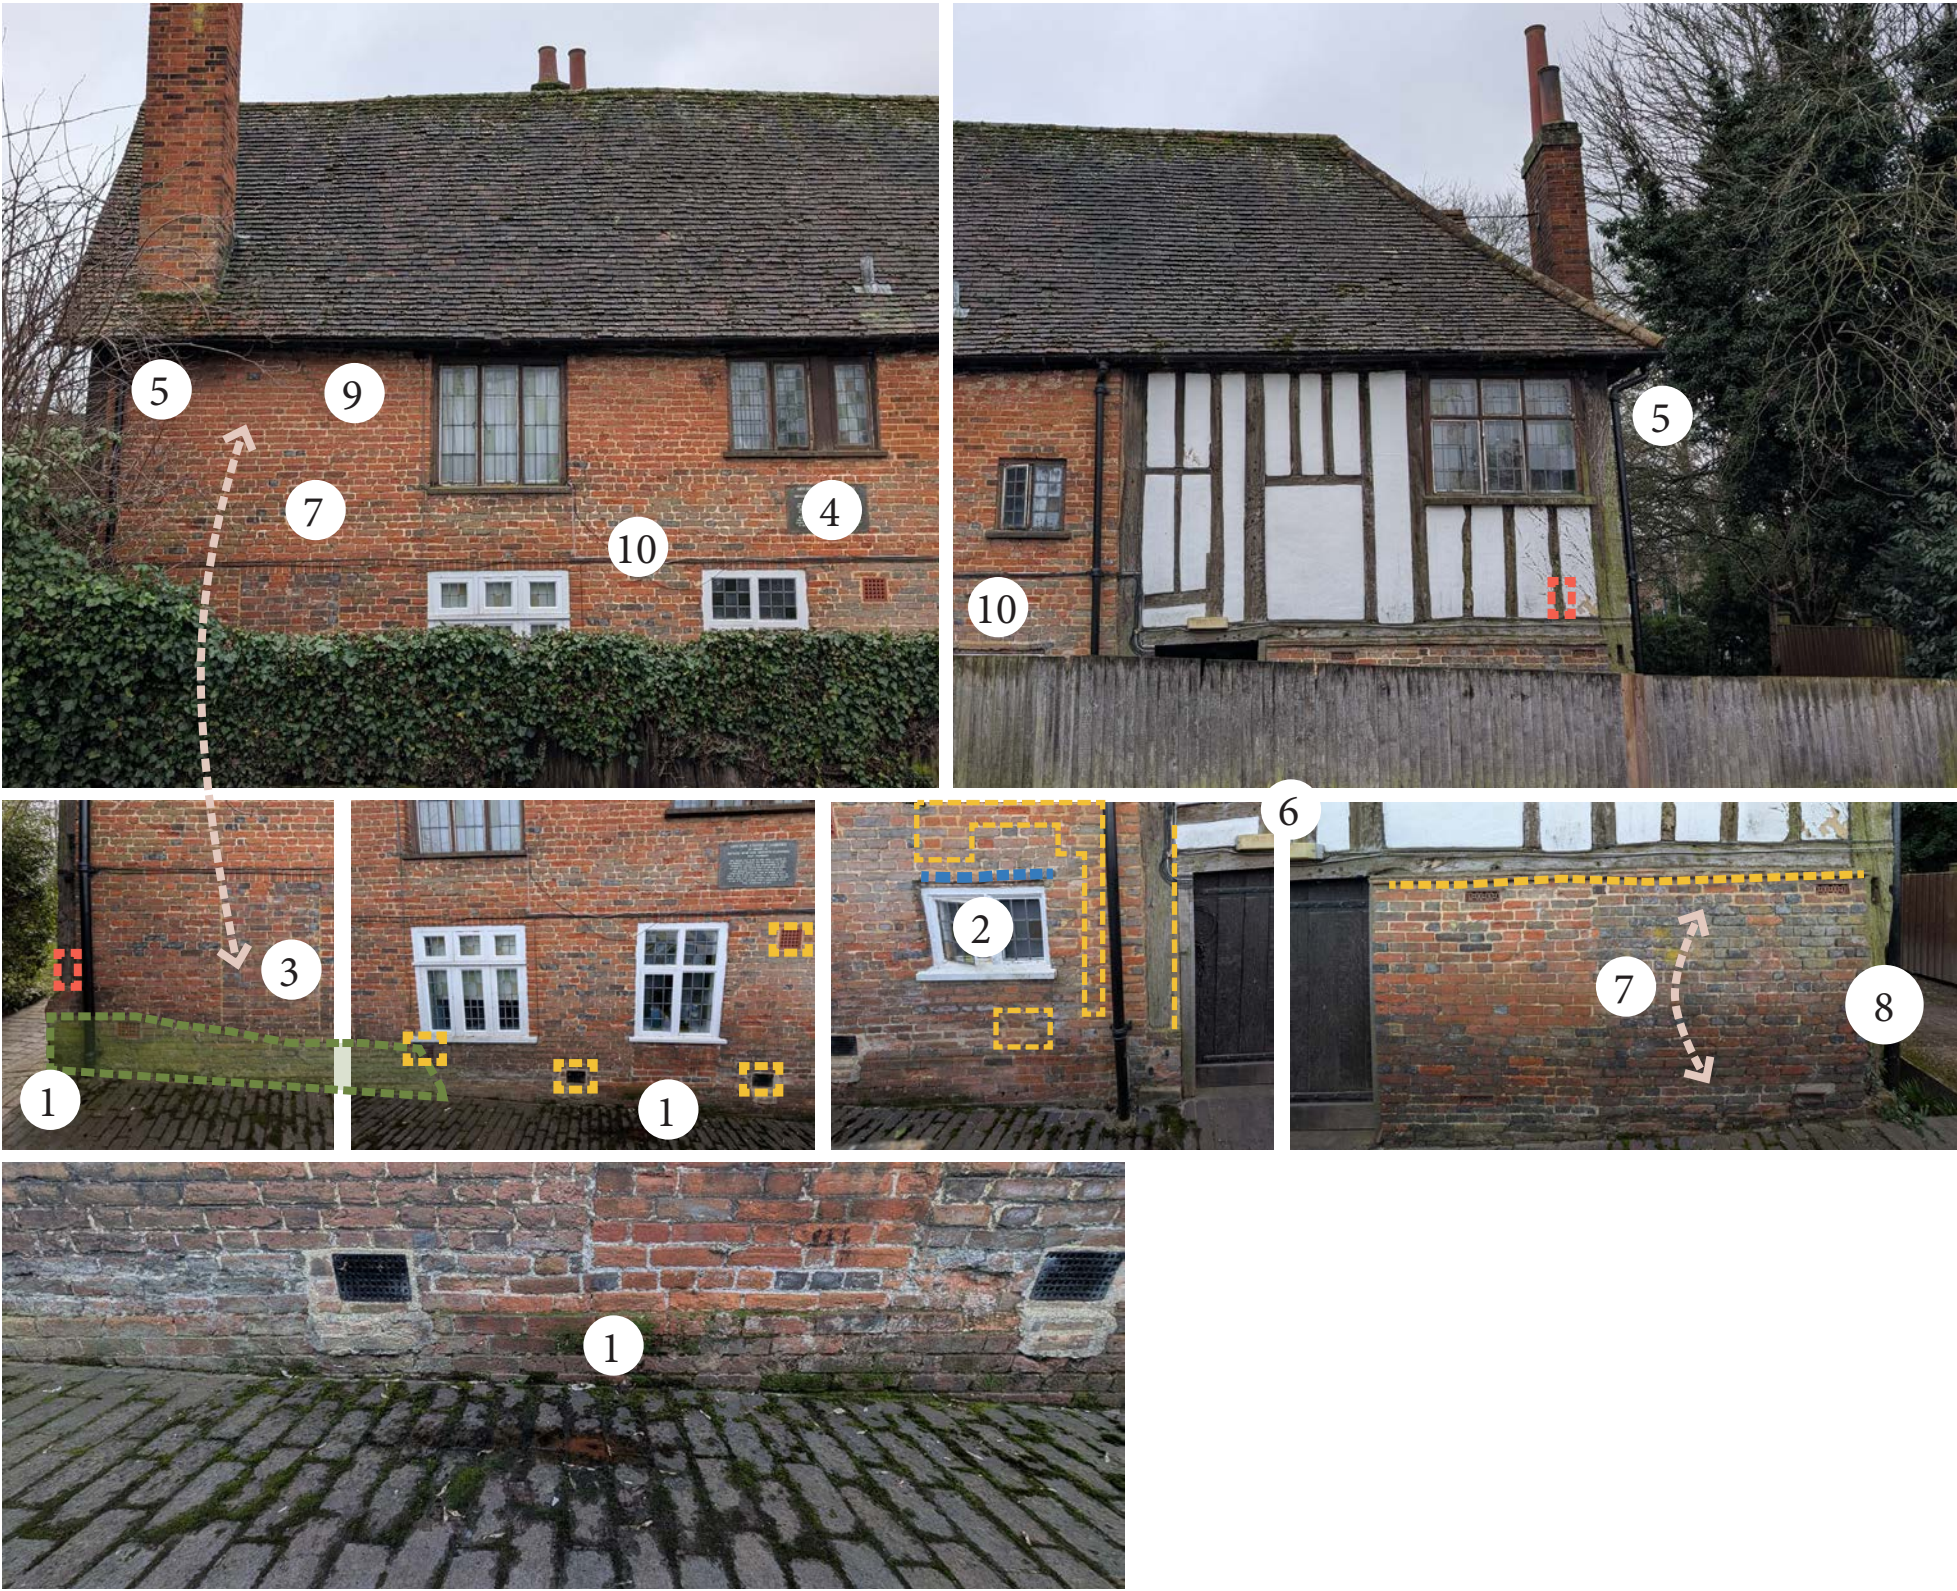
### Street Elevation, North Facing

- 1. Surface water drainage issues. Damp build up.
- 2. Collapsing window head
- 3. Previous window opening infilled with brick
- 4. Hitchin United Charities plaque

- 5. Existing cast iron rainwater goods. Poor to fair condition. Replacement and isolated repair required following detailed survey
- 6. Light fitting above door in very poor condition. Not inkeeping with historic fabric. New bronze fittings proposed.

- 7. Flush pointed mixed bond masonry. Bowing evidence in part of the facade.
- 8. Post covered with moss and algae.
- 9. Historic crack, further inspection recommended to confirm that the crack is not progressive.

- 10. Brickwork in reasonable condition considering age. Several bricks de-faced generally due to natural softness of the hand-fired brick. Majority of mortar is lime mortar with some areas of cementitious mortar. Further survey and schedule required to determine what particular bricks require replacement. All cement mortar to be repointed as per structural survey.

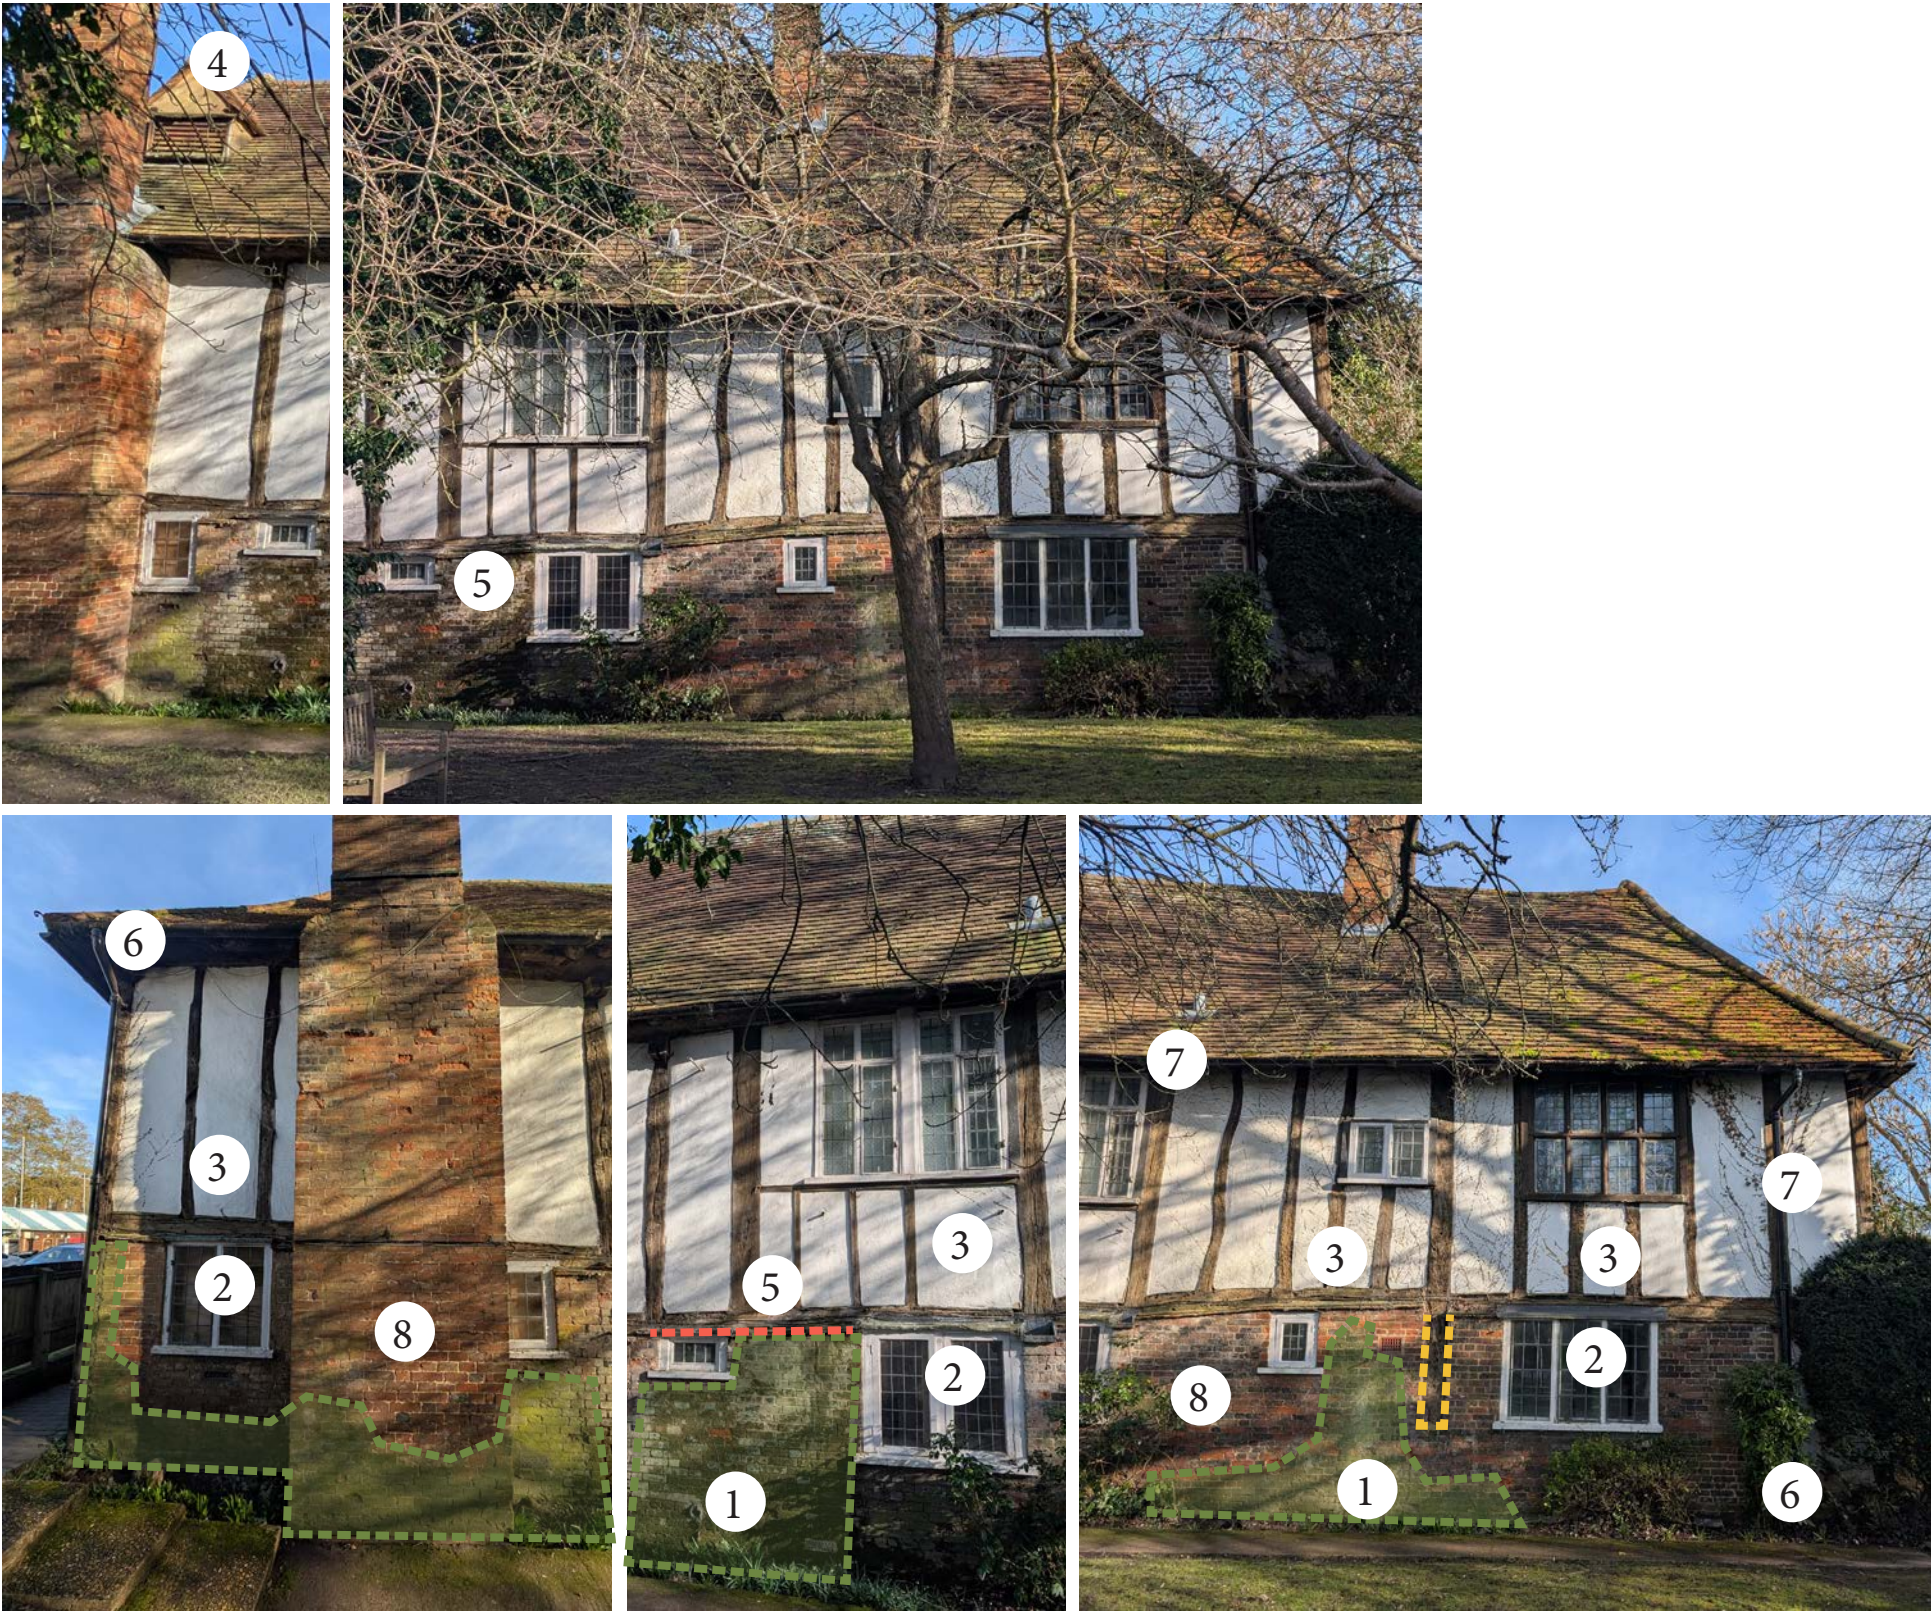
### Elevation, West Facing

1. Surface water drainage issues, flower bed unlikely to drain water quickly but is considered an improvement on hard standings on other elevations.
2. Window lead flashing works required

3. Cementitious with roofing felt detail, trapping moisture in the facade. Paint likely unbreatheable encouraging decay.
4. Louvered dormer to attic
5. Base of plate is very damp. Some decay to timbers but may be salvaged.

6. Clear vegetation to determine condition of existing gully outlet to ascertain remedial works. Rot in base of stud above concrete skirt.
7. Existing cast iron rainwater goods. Poor condition. Replacement and isolated repair required following detailed survey

8. Brickwork in reasonable condition considering age. Several bricks de-faced generally due to natural softness of the hand-fired brick. Majority of mortar is lime mortar with some areas of cementitious mortar. Further survey and schedule required to determine what particular bricks require replacement. All cement mortar to be repointed as per structural survey.

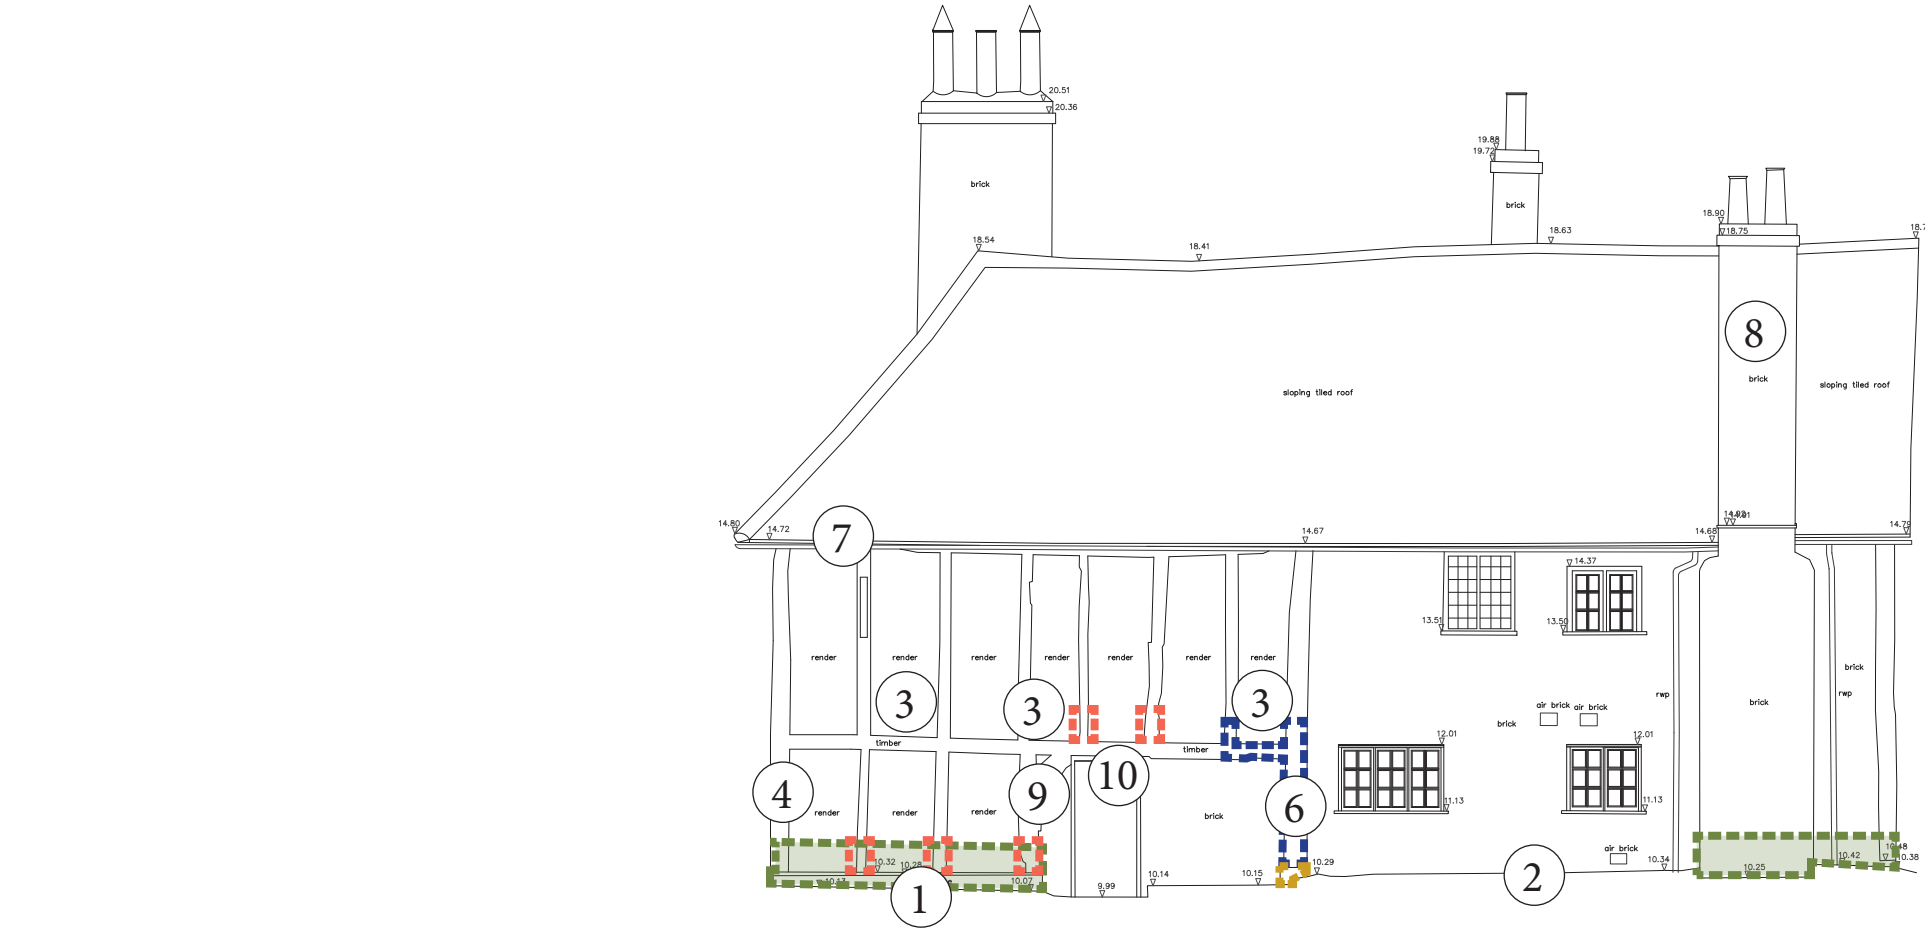
### Back Elevation, South Facing

1. Surface water drainage issues, rotting posts above. Concrete plinth trapping moisture.
2. Surface drainage water issues. Damp build up.
3. Cement with roofing felt detail, trapping moisture. Unbreathable paint encouraging decay.

4. Planting obstructing survey, likely causing damp build up. Planting to be removed.
5. Windows WG-10, WG-11 and WF-10 with glazing bars to be replaced with hardwood frames and rectangular leading as per window schedule.

6. Timber sounds hollow, further structural investigation needed
7. Existing cast iron rainwater goods. Poor to fair condition. Replacement and isolated repair

8. Chimney tied back to roof
9. Original post and haunch, severely decayed but high historical value.
10. Decay at top of plate and base of stud
11. Back entrance door damaged and lower half bordered up. To be replaced with secure door more inkeeping with historic fabric.

12. Brickwork in reasonable condition considering age. Several bricks de-faced generally due to natural softness of the hand-fired brick. Majority of mortar is lime mortar with some areas of cementitious mortar. Further survey and schedule required to determine what particular bricks require replacement.

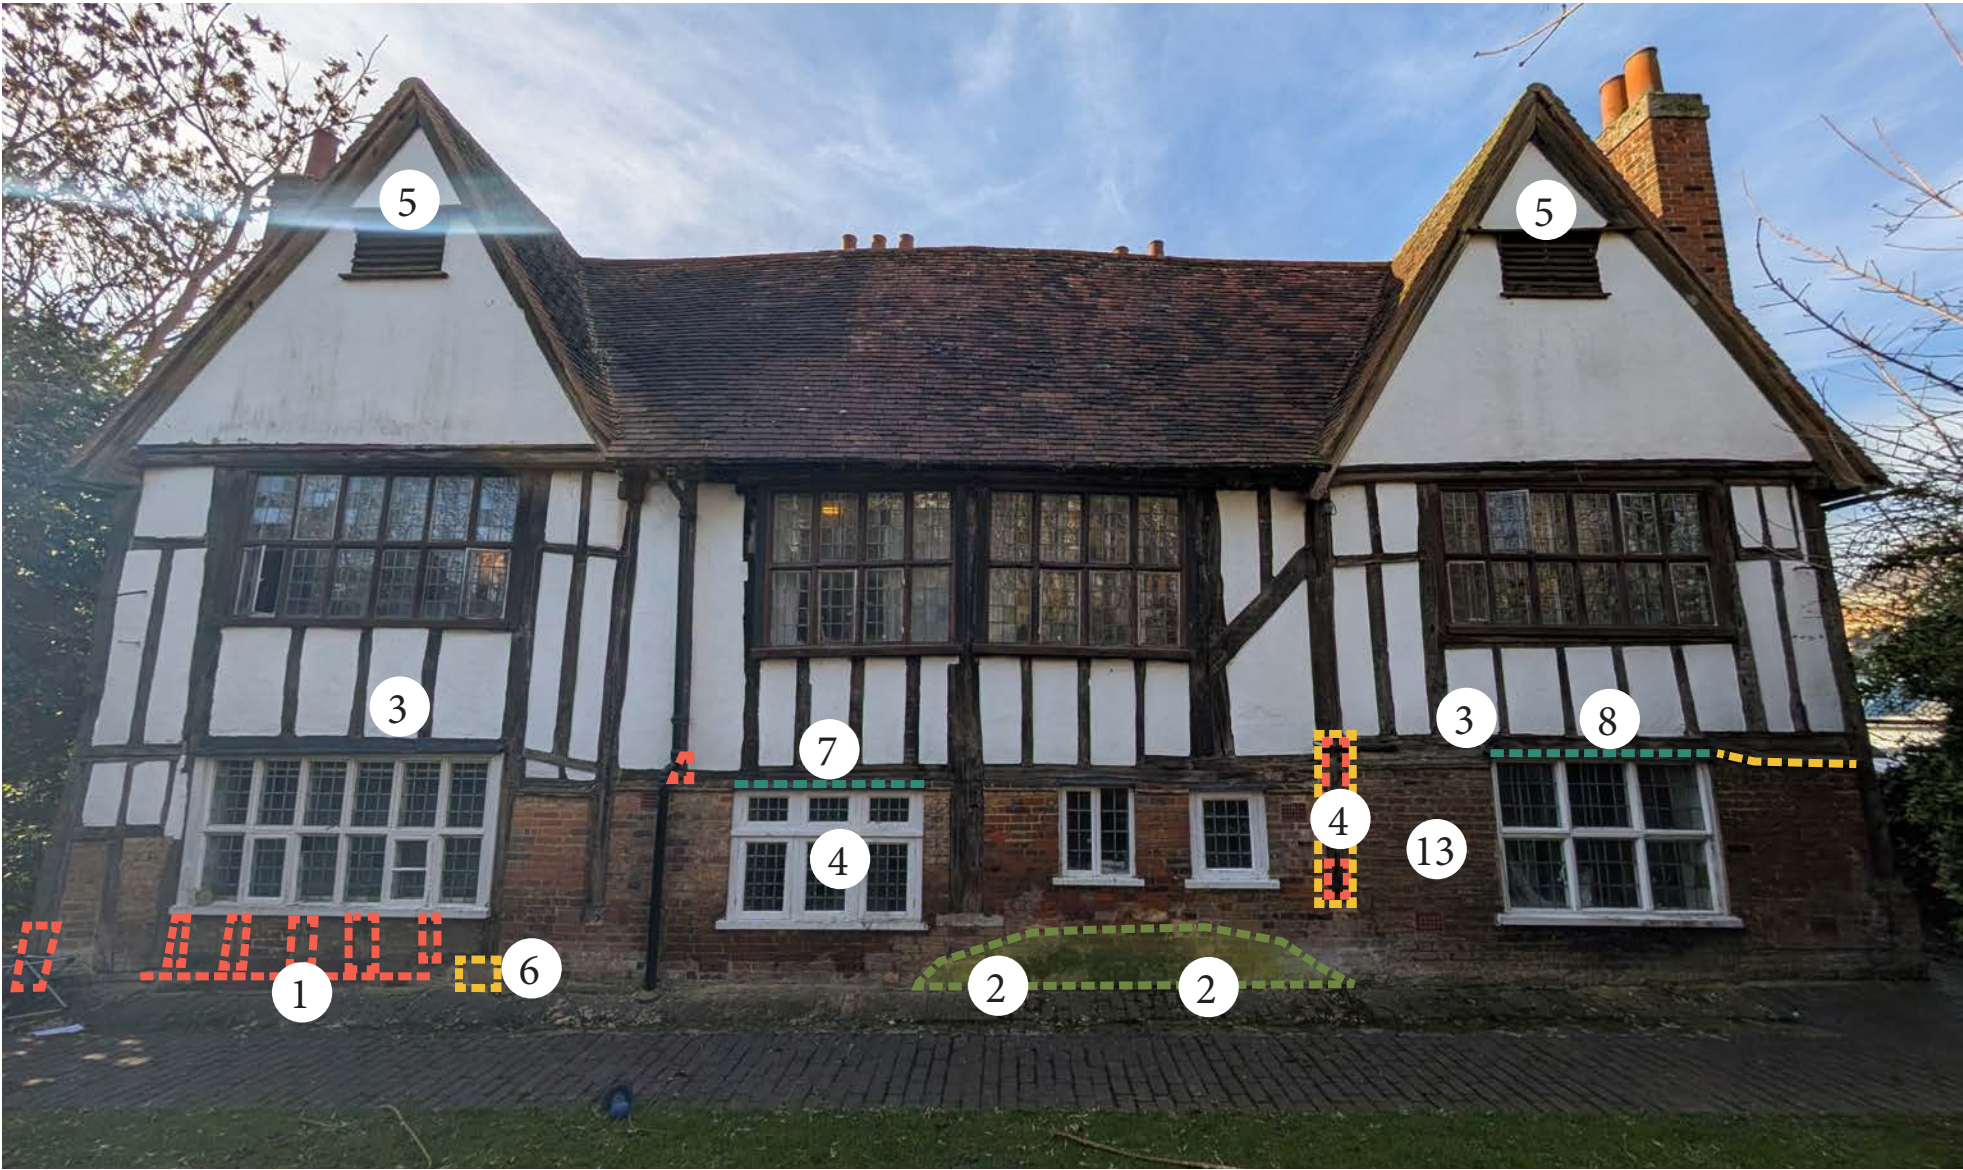
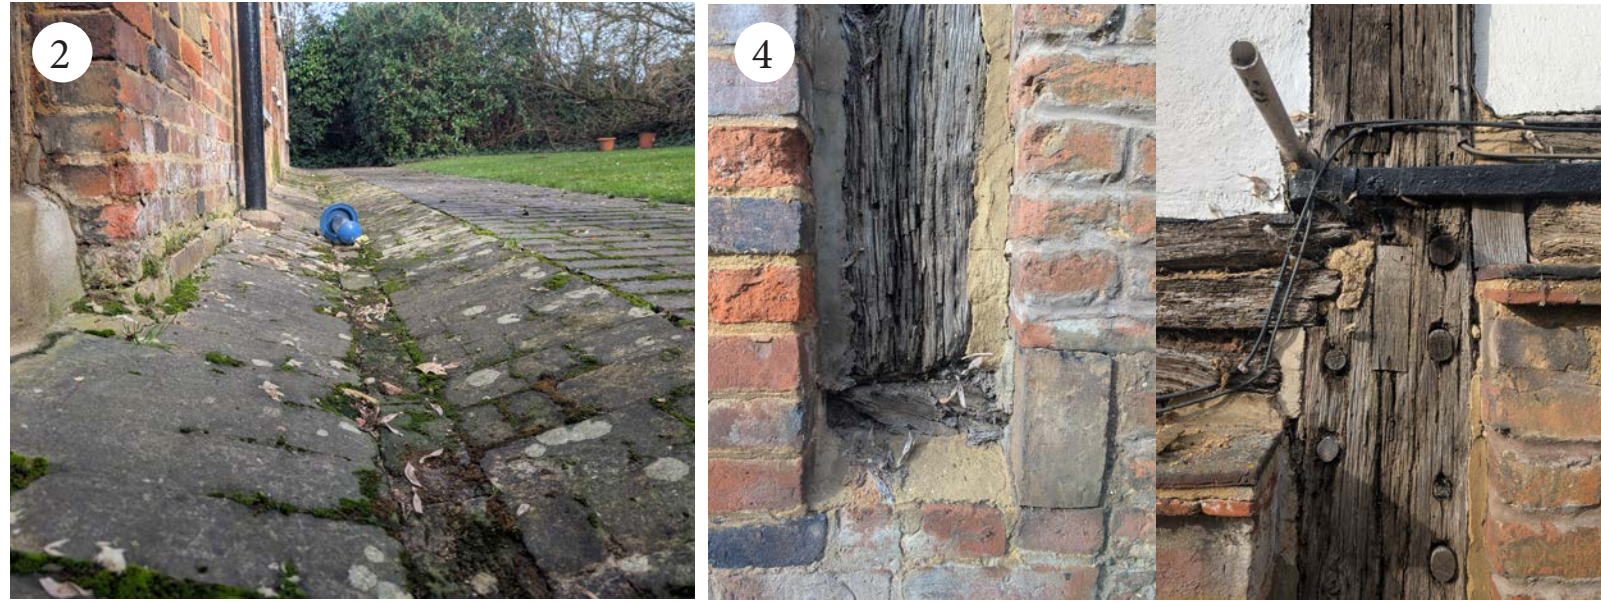
Elevation, East Facing

- 1. Surface water drainage issues. Rotting post above. Cement detail trapping moisture.
- 2. Surface drainage water issues with drainage channel. Damp build up.
- 3. Cementitious with roofing felt detail, trapping moisture in the facade. Paint likely unbreathable encouraging decay.
- 4. Localised rot in post base with cement full around
- 5. Louvres in dormer to attic
- 6. Cement at base but timber condition is adequate
- 7. Timber lintel over window is a replacement and does not bear load on left hand side, the lintel therefore leans on the window for support on the left.
- 8. Timber lintel over window is a replacement and does not bear load at either end, the lintel therefore leans on the window for support.

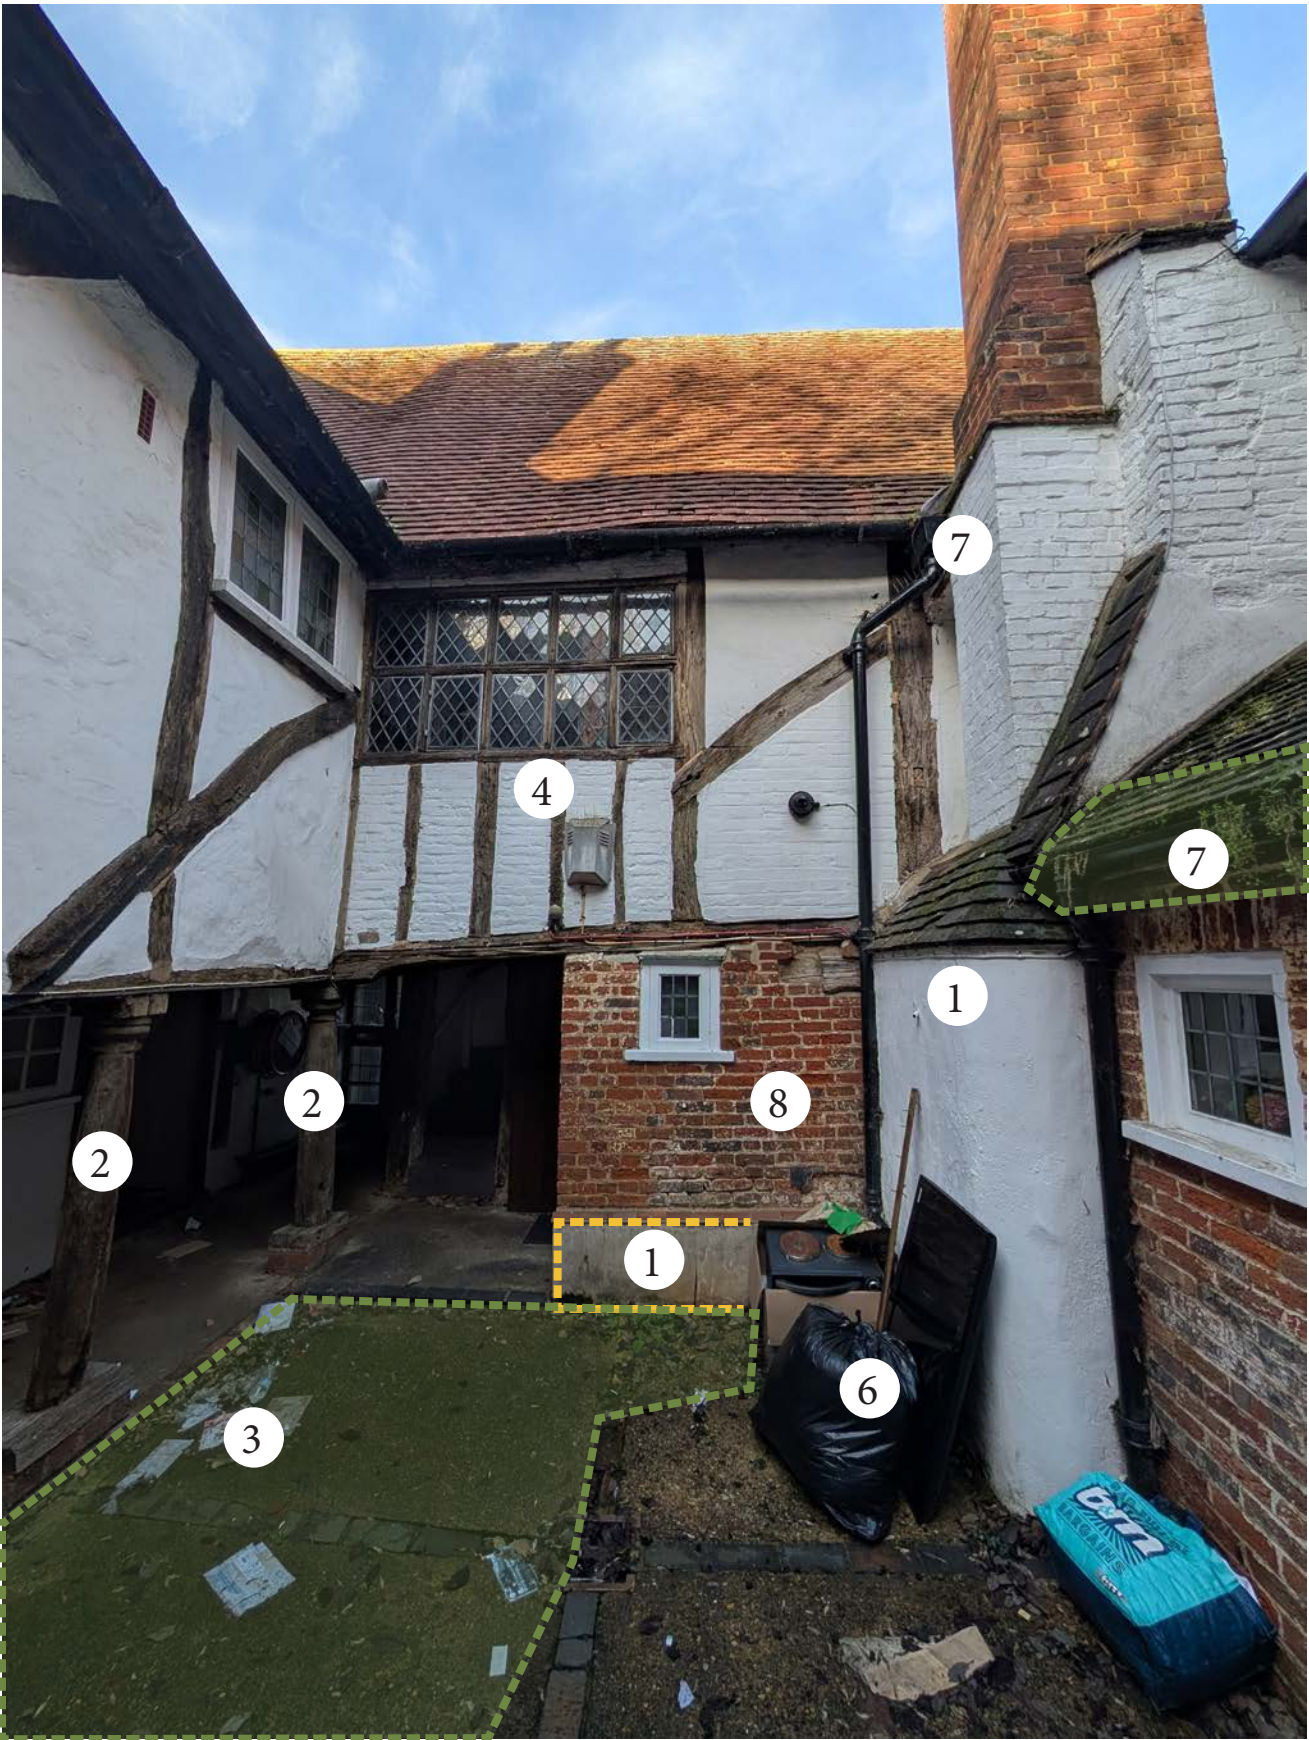
### Courtyard Elevation, South Facing

1. Surface drainage water issues due to concrete plinth. Damp build up. Removal of plinth and introduction of french drain.
2. Highly significant historic timbers in a Tuscan style form a cloister. Sound structural condition despite weathered appearance.

7. Existing cast iron rainwater goods. Poor condition. Replacement and isolated repair required following detailed survey
8. Several bricks de-faced generally due to natural softness of the hand-fired brick. Majority of mortar is lime mortar with some areas of cementitious mortar. Further survey and schedule required to determine what particular bricks require replacement.

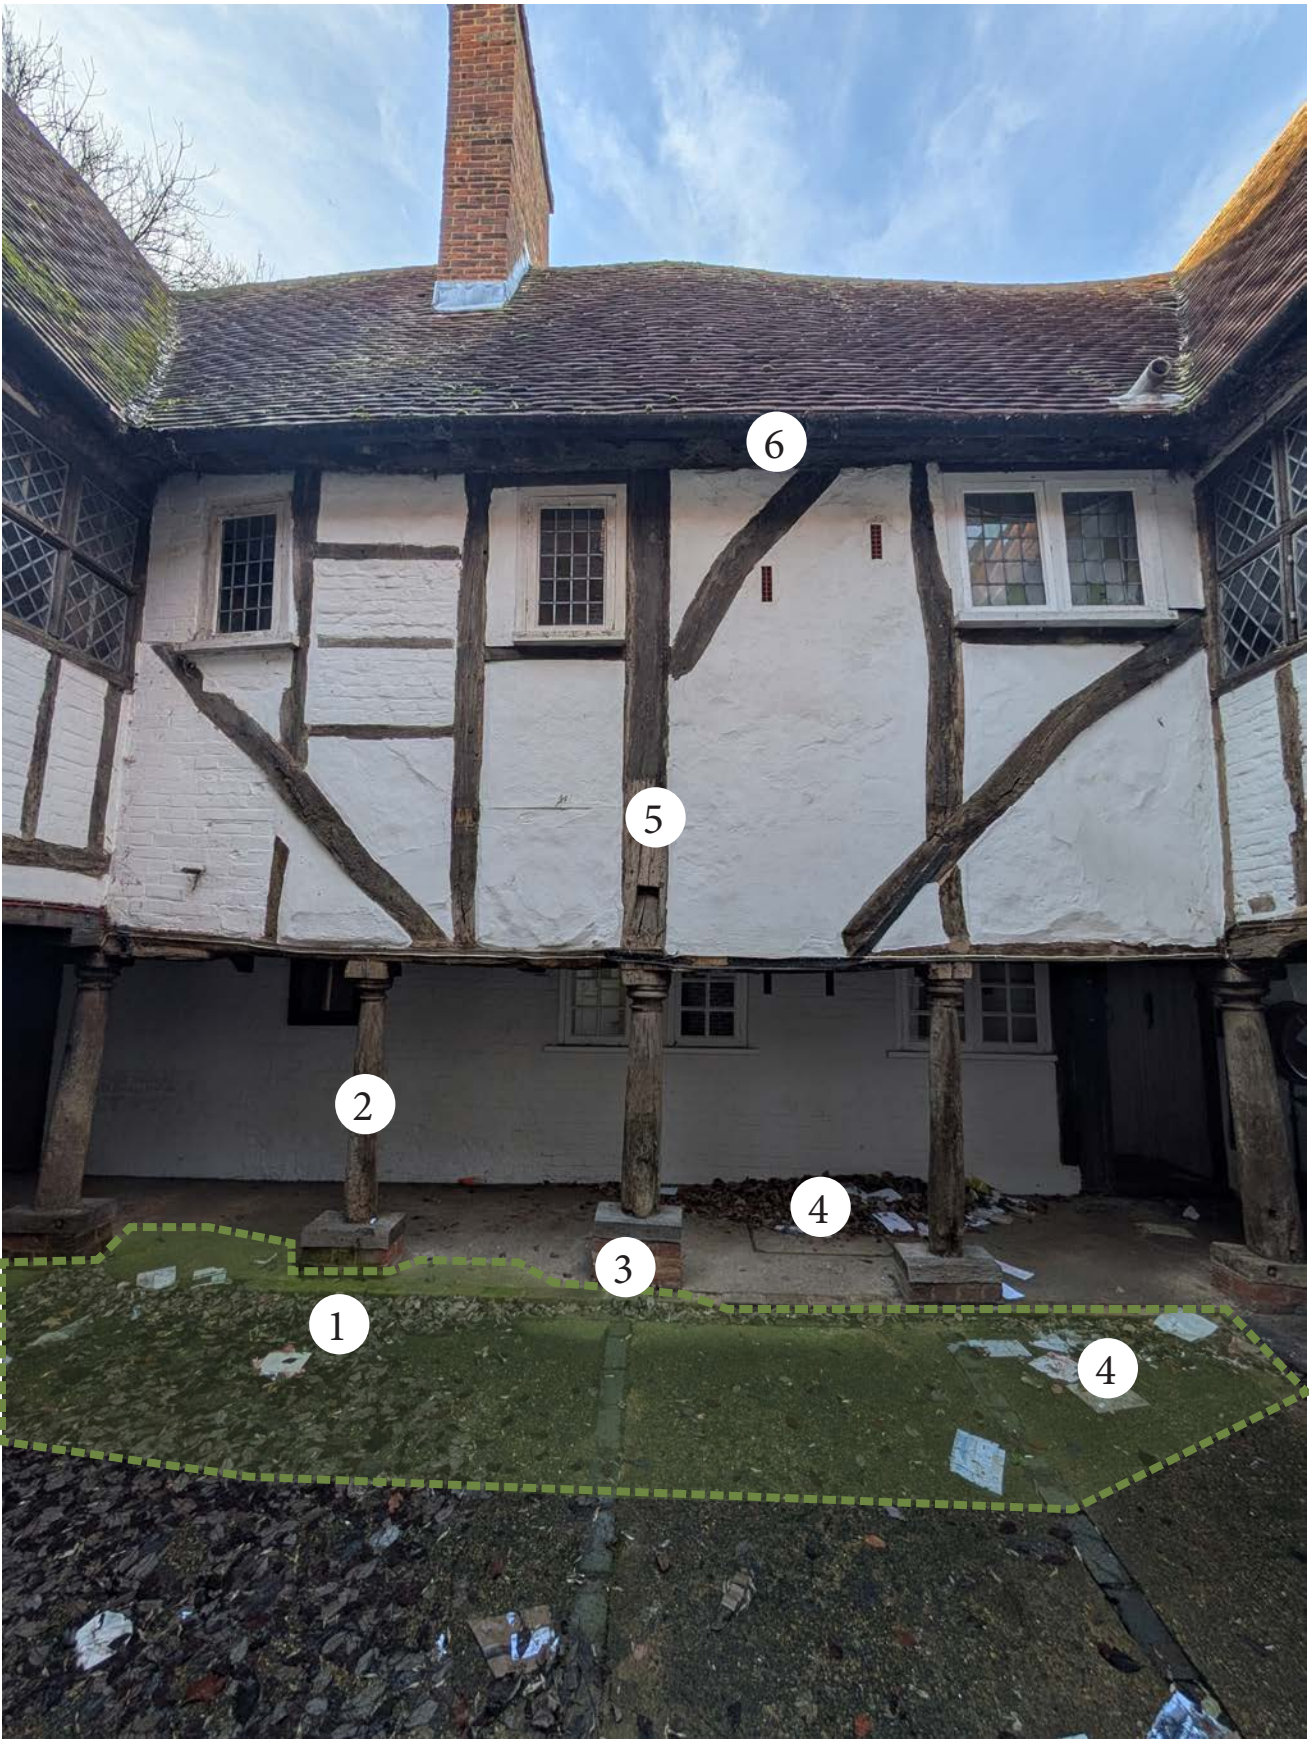
### Courtyard Elevation, East Facing

1. Surface drainage water issues due to exposed aggregate ground finish. Moss and algae growth. Removal of cement and introduction of permeable paving proposed.
2. Highly significant historic timbers in a Tuscan style form a cloister. Sound structural condition despite weathered appearance.
3. Tuscan style columns repaired and stabilised with oak bearing plates and timber filler sculpted into the head section in places. Structurally sound.
4. Post littered throughout courtyard. New post box required.
5. Historic raking cut into timber structure signifying a previous support placement, an early form of Acrow Prop as outlined in the structural survey.
6. Existing cast iron rainwater goods in poor condition. Replacement and isolated repair required following detailed survey

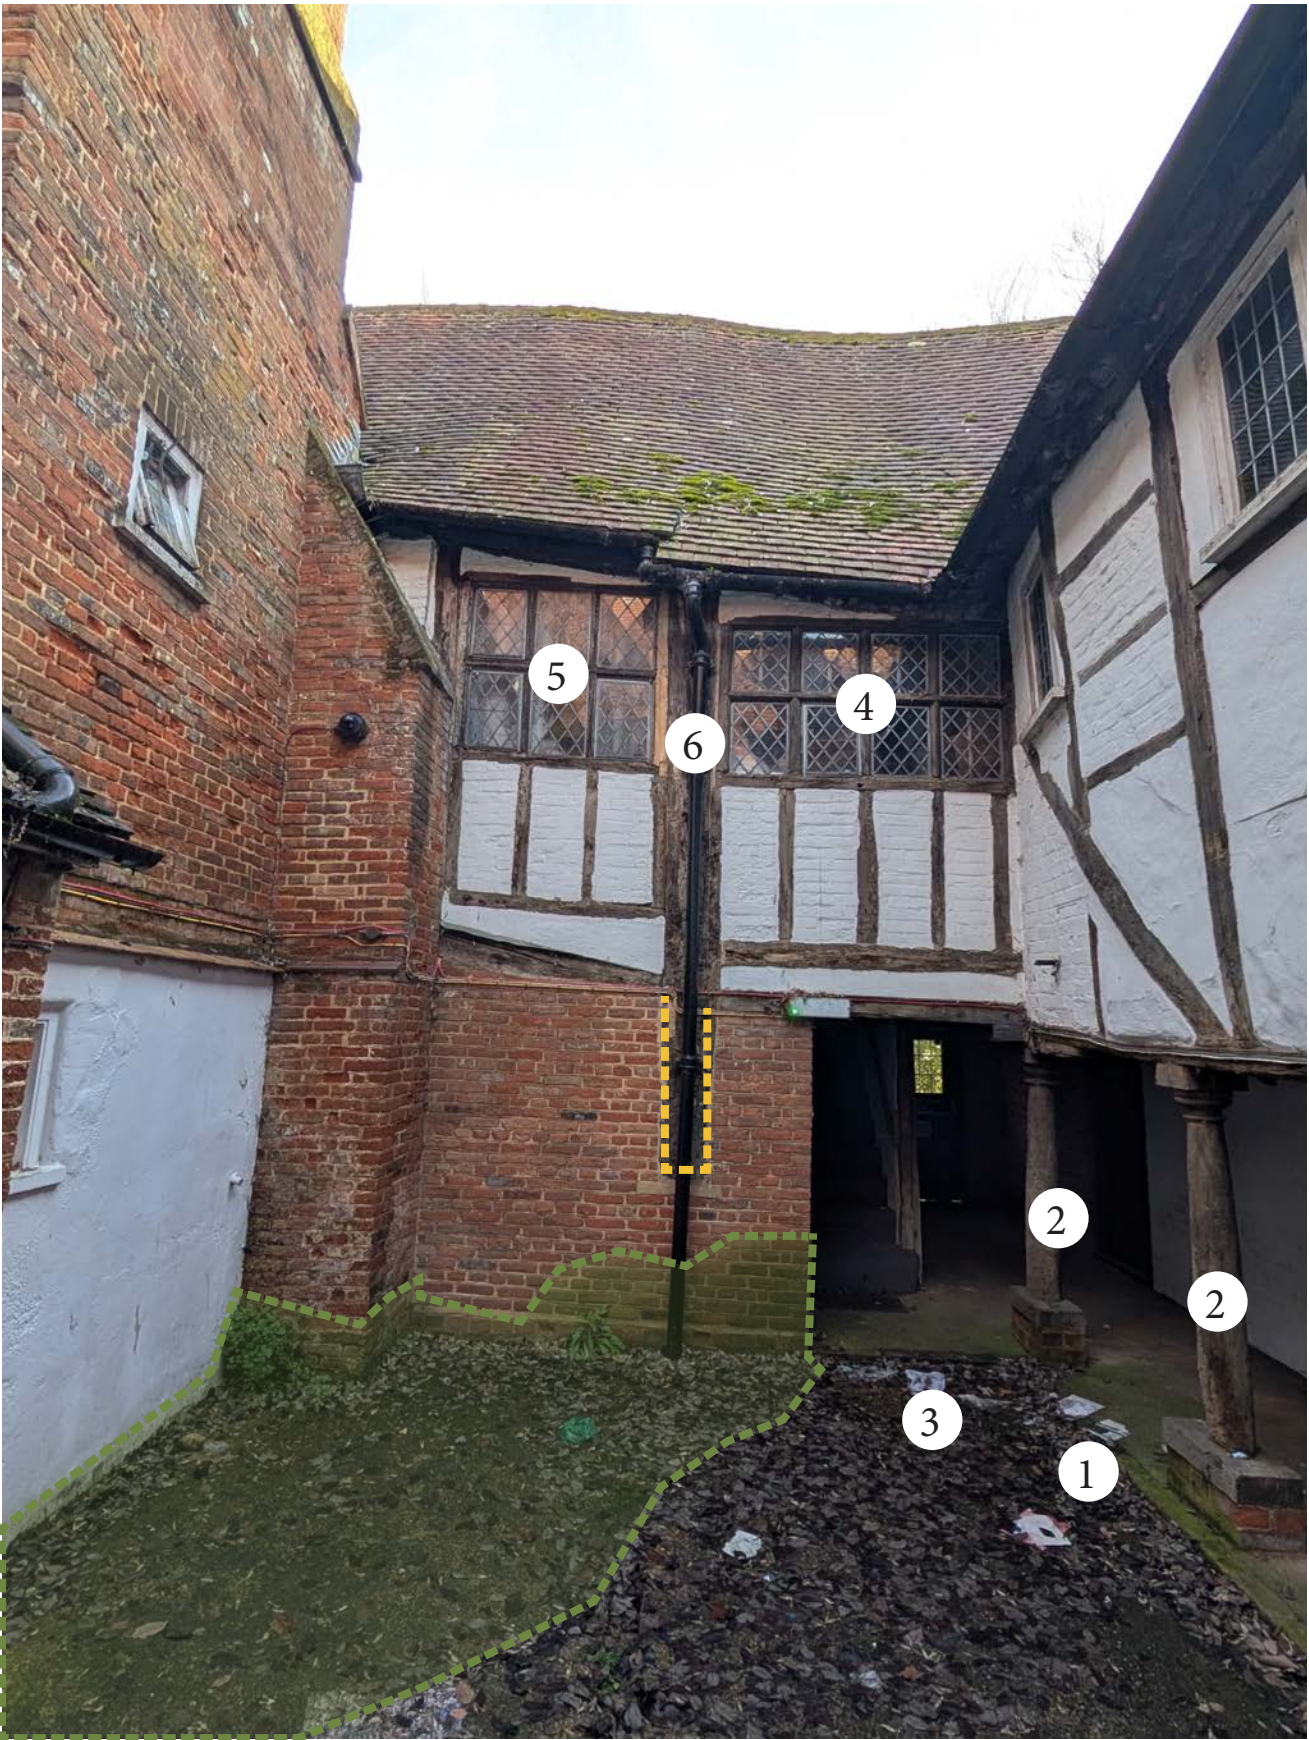
Courtyard Elevation, North Facing

- 1. Surface drainage water issues due to exposed aggregate ground finish. Moss and algae growth. Removal of cement and introduction of permeable paving proposed.
- 2. Highly significant historic timbers in sound structural condition despite weathered appearance.
- 3. Post littered throughout courtyard. New post box required.
- 4. WF-08 of exceptional historical significance, considered in good condition. Will remain onto an unheated space therefore proposed works to clean.
- 5. WF-11 of exceptional historical significance. Proposed repairs to introduce secondary glazing into Flat 11.
- 6. Existing cast iron rainwater goods. Poor. Replacement and isolated repair required following detailed survey

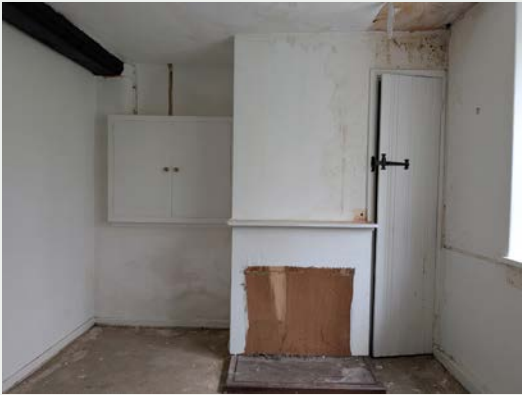
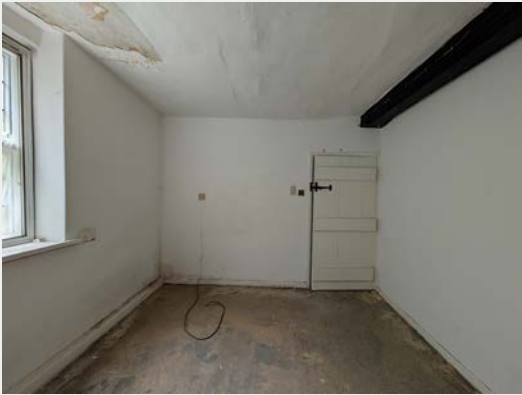
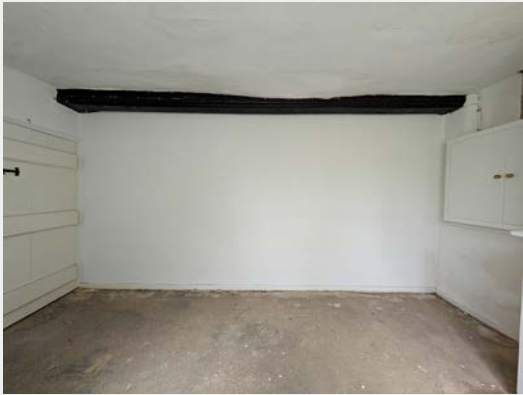
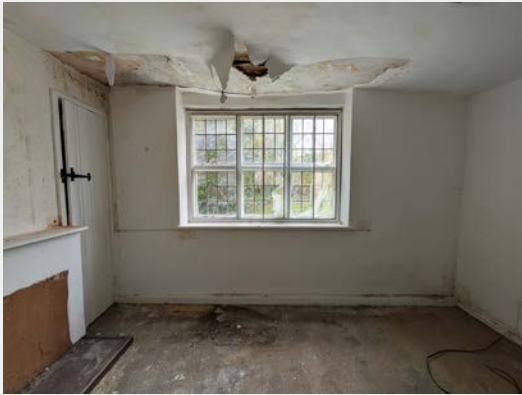
| | | | | | Description | Significance | Condition | Notes | Proposed Repairs |
|---|---|---|---|---|---|---|---|---|---|
| Living/Bedroom<br>WG-17<br>Historic timber beam<br>Meter cabinet position to be retained | | | | | Historical timber beam in ceiling adjacent to partition | High | Moderate | Historically painted black | Clean up and assess condition of timber |
| | | | | | Significant water damage to ceiling and cupboard adjacent to chimney breast | Moderate | Very poor | Possible structural damage to ceiling. Building fabric still damp | Strip back affected areas of ceiling and cupboard plaster to assess depth of damage and allow to dry out fully. Reinstate ceiling in the same style where possible. |
| | | | | | Historic timber beam and arched support. Cast iron services. | High | Poor | Glass door is not inkeeping with historic fabric | Replace modern door to kitchen. Storage cupboard removed. Service positions to be kept the same, existing pipe work network utilised where possible. Fittings and fixtures kept seperate from historic timber. |

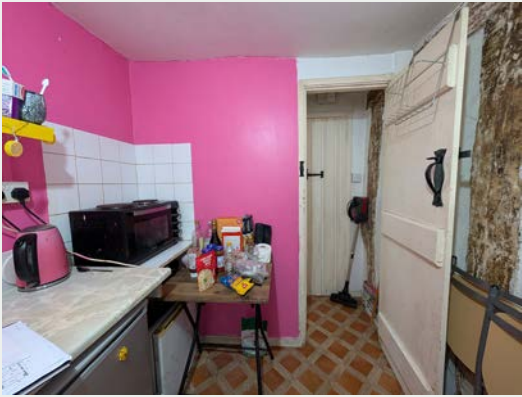
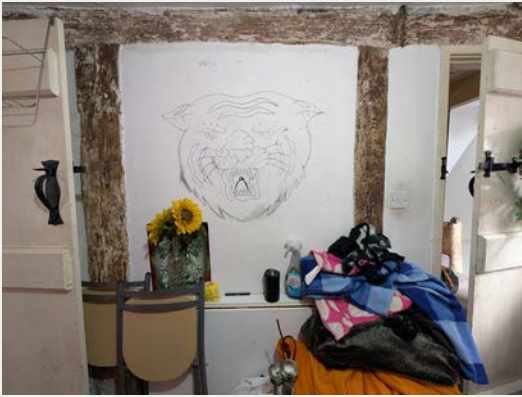
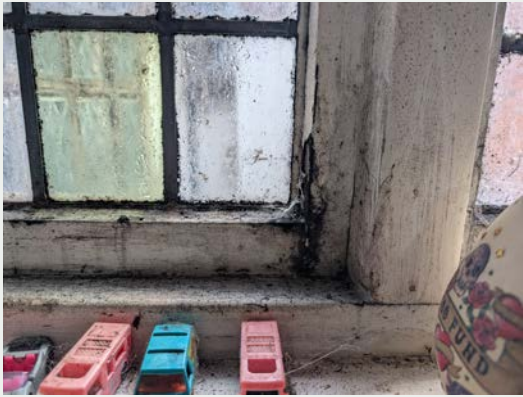
| | | | | Description | Significance | Condition | Notes | Proposed Repairs |
|---|---|---|---|---|---|---|---|---|
| Kitchen<br>WF-02<br>Room in very poor condition due to lack of ventilation and build up of condensation, damp, and mold | | | | | High | Very poor | Unpainted but weathered timbers | Timbers will be retained new fittings separate. Room will need to be unoccupied and dried out/ventilated. |

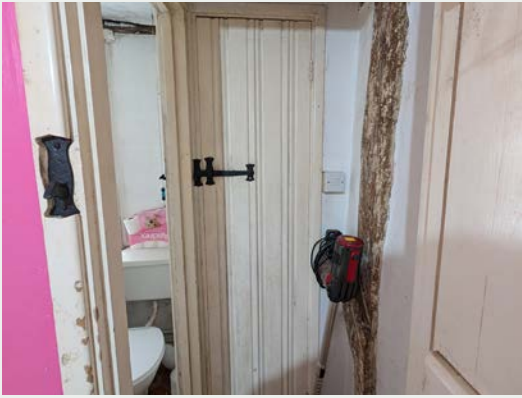
| | | | | Description | Significance | Condition | Notes | Proposed Repairs |
|---|---|---|---|---|---|---|---|---|
| Bathroom<br>WF-03 Room in very poor condition due to lack of ventilation and build up of condensation, damp, and mold | | | | | High | Very poor | Unpainted but weathered timbers | Timbers will be retained new fittings separate. Room will need to be unoccupied and dried out/ventilated. |
