299 - The Biggin: Window Schedule

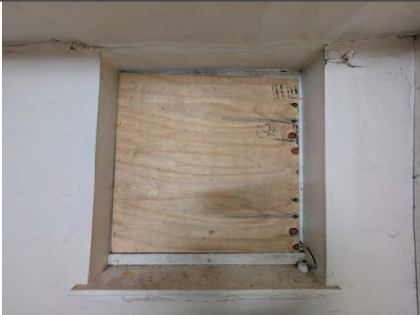
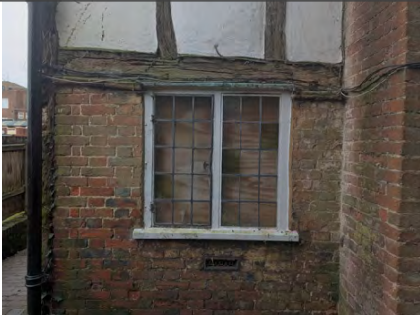
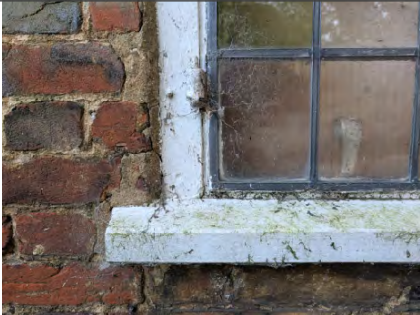
| Reference | Location | Style | Age | Condition | Significance | Internal | External | Detail | Special Features | Glazing Type | Proposed Works |
|---|---|---|---|---|---|---|---|---|---|---|---|
| WG-01 | Plant Room<br>External | Two vertical leaded lights, casement window. Painted frame. | | 3 Poor. Boarded up. Worn imposed lead flashing. Cement infill around frame. | Moderate | | | | Side hung opening lights. Original timber structure at head. Projected sill. | Single. | Replace with hardwood frame and rectangular leading to match existing. Code 5 Lead Works. |

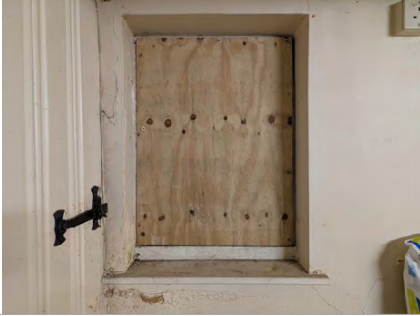
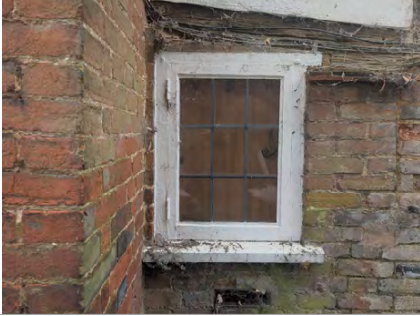
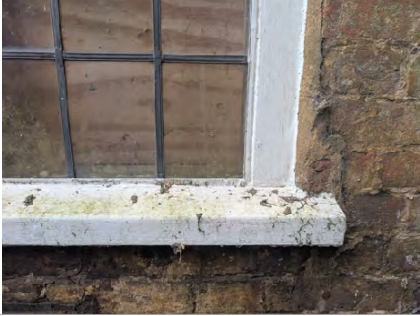
| Reference | Location | Style | Age | Condition | Significance | Internal | External | Detail | Special Features | Glazing Type | Proposed Works |
|---|---|---|---|---|---|---|---|---|---|---|---|
| WG-02 | Plant Room<br>External | Leaded light, casement window. Painted frame. | | 3 Very poor. Boarded up. Significant damp and rot. Cement infill around frame. | Moderate | | | | Side hung opening lights. Original timber structure at head. Projected sill. | Single. Three green tinted panes. | Replace with hardwood frame and rectangular leading to match existing. Code 5 Lead Works. |

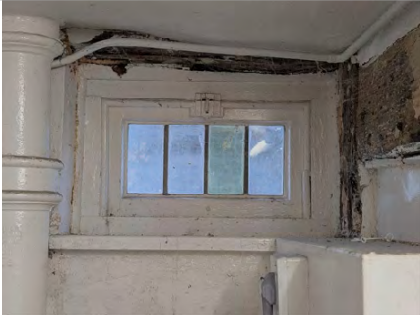
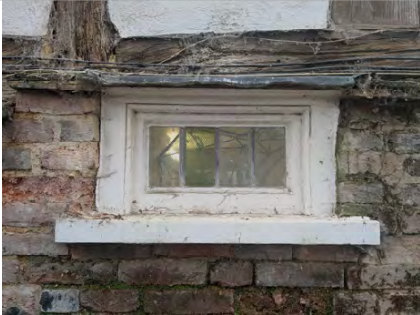
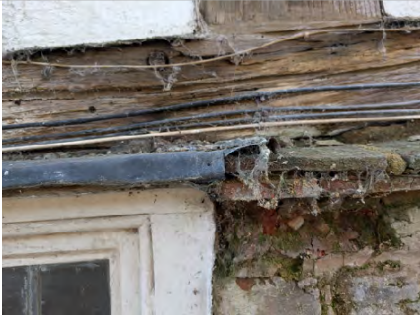
| Reference | Location | Style | Age | Condition | Significance | Internal | External | Detail | Special Features | Glazing Type | Proposed Works |
|---|---|---|---|---|---|---|---|---|---|---|---|
| WG-03 | Flat 06 Bedroom<br>External | Leaded light, casement window. Painted frame. | | 3 Poor. Worn lead flashing. | Moderate | | | | Inward tilt. Original timber structure at head. Projected sill. | Single. One green tinted pane. | Replace with hardwood frame and rectangular leading to match existing. Code 5 Lead Works. |

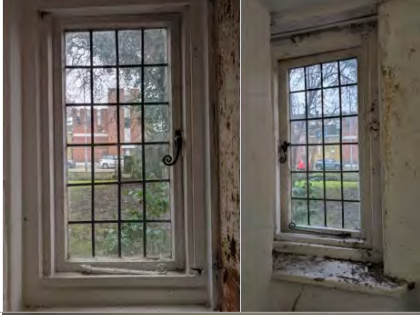
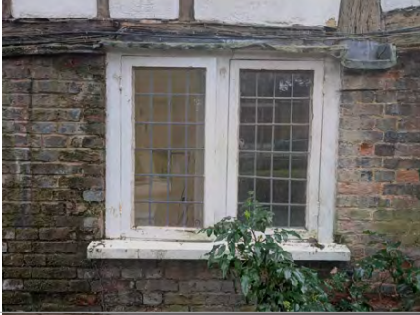
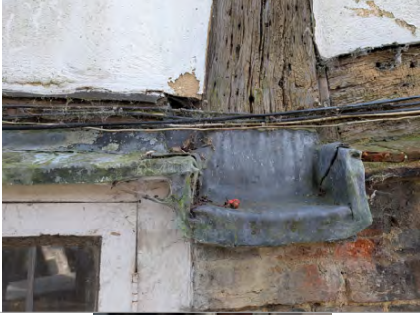
| Reference | Location | Style | Age | Condition | Significance | Internal | External | Detail | Special Features | Glazing Type | Proposed Works |
|---|---|---|---|---|---|---|---|---|---|---|---|
| WG-04 | Flat 06 Bedroom<br>External | Two vertical leaded lights, casement window. Painted frame. | | 4 Poor. Worn lead flashing. | Moderate | | | | Two side hung opening lights. Original timber structure at head. Projected sill. | Single. | Strip paint subject to timber condition. Remove partition wall. Add slimline secondary glazing. Code 5 Lead Works. |

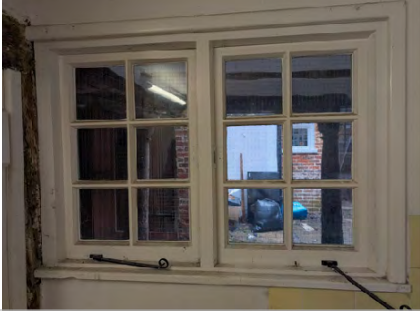
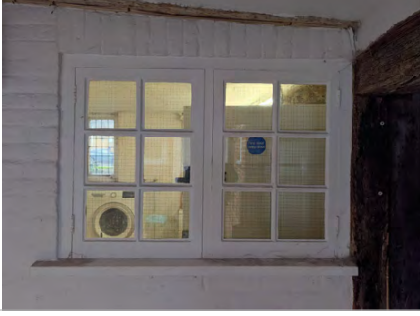
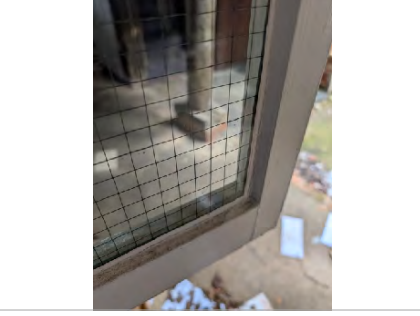
| Reference | Location | Style | Age | Condition | Significance | Internal | External | Detail | Special Features | Glazing Type | Proposed Works |
|---|---|---|---|---|---|---|---|---|---|---|---|
| WG-05 | Flat 06 Bedroom<br>Courtyard | Two vertical lights with glazing bars, casement window. Painted frame. | | 5 Moderate | Harmful | | | | Two side hung opening lights. Projected sill. | Single. | Replace with hardwood frame and rectangular leading |

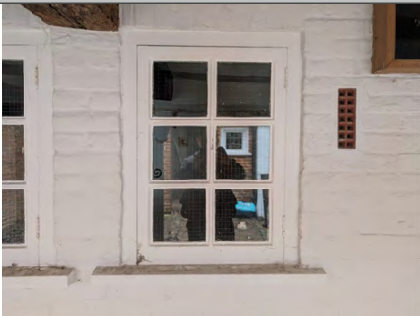
| Reference | Location | Style | Age | Condition | Significance | Internal | External | Detail | Special Features | Glazing Type | Proposed Works |
|---|---|---|---|---|---|---|---|---|---|---|---|
| WG-06 | Flat 06 Bedroom Courtyard | Glazing bars, casement window. Painted frame. | | 5 Moderate | Harmful | | | | Side hung opening light. Projected sill. | Single. | Replace with hardwood frame and rectangular leading |

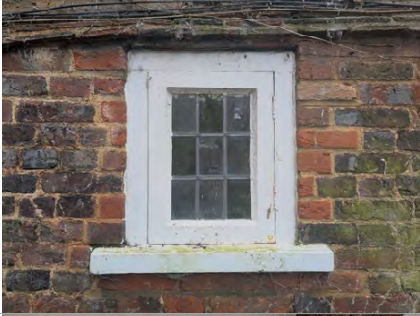
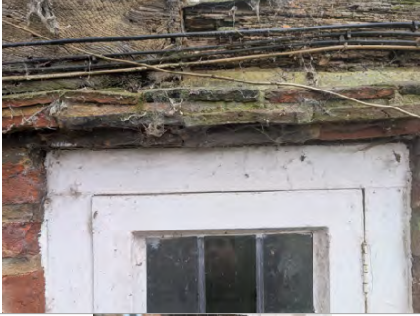
| Reference | Location | Style | Age | Condition | Significance | Internal | External | Detail | Special Features | Glazing Type | Proposed Works |
|---|---|---|---|---|---|---|---|---|---|---|---|
| WG-07 | Flat 06 Bathroom External | Leaded light, casement window. Painted frame. | | 4 Moderate | Moderate | | | | Side hung opening light. Masonry detail at head. Projected sill. | Single. | Replace with hardwood frame and rectangular leading |

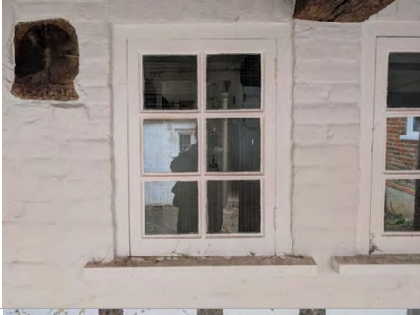
| Reference | Location | Style | Age | Condition | Significance | Internal | External | Detail | Special Features | Glazing Type | Proposed Works |
|---|---|---|---|---|---|---|---|---|---|---|---|
| WG-08 | Flat 06 Corridor Courtyard | Glazing bars, casement window. | | 4 Moderate. | Harmful | | | | Side hung opening light. Projected sill. | Single. | Replace with hardwood frame and rectangular leading |

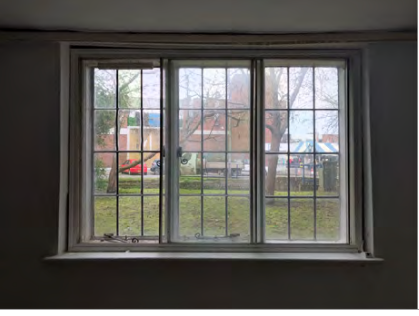
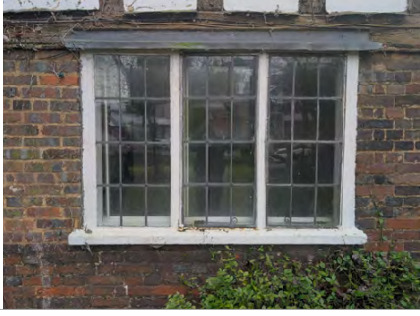
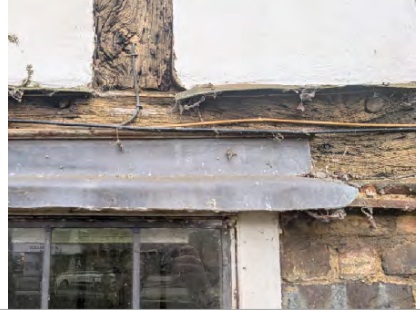
| Reference | Location | Style | Age | Condition | Significance | Internal | External | Detail | Special Features | Glazing Type | Proposed Works |
|---|---|---|---|---|---|---|---|---|---|---|---|
| WG-09 | Flat 06 Liv/Kit External | Three leaded vertical lights, casement window. Painted frame. | | 2 Poor. Worn lead flashing. Areas of frame in poor condition. | Considerable | | | | Two side hung opening lights. One fixed light. Original timber structure at head. Projected sill. | Single. Sliding secondary glaze panels internal. Green tinted panes. | Strip paint subject to timber condition. Remove partition wall. Add slimline secondary glazing. Code 5 Lead Works. |

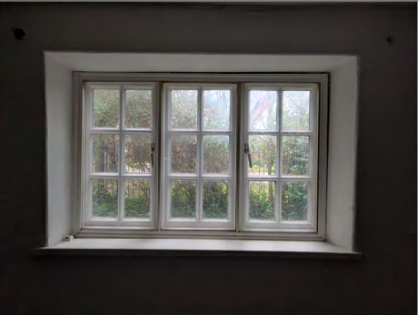
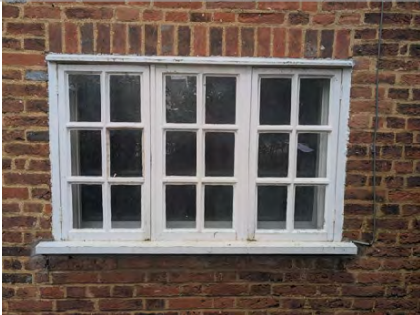
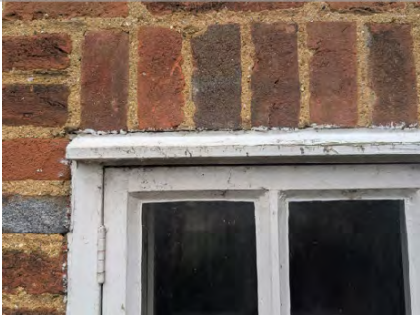
| Reference | Location | Style | Age | Condition | Significance | Internal | External | Detail | Special Features | Glazing Type | Proposed Works |
|---|---|---|---|---|---|---|---|---|---|---|---|
| WG-10 | Flat 05 Liv/Bed External | Three vertical lights with glazing bars, casement window. | | 4 Moderate. Areas of frame in poor condition. | Low | | | | Side hung casement windows. Two side hung opening lights. Fixed centre light. Projected sill. | Single. Side hung secondary glazing panels internal. | Replace with hardwood frame and rectangular leading |

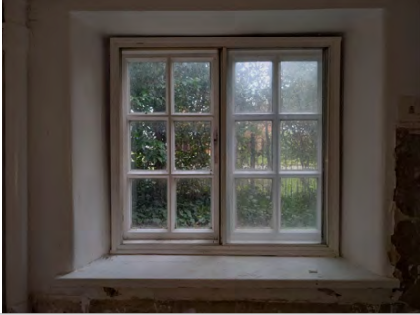
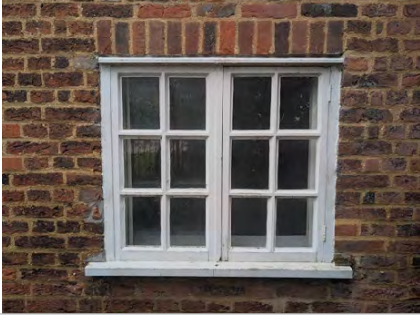
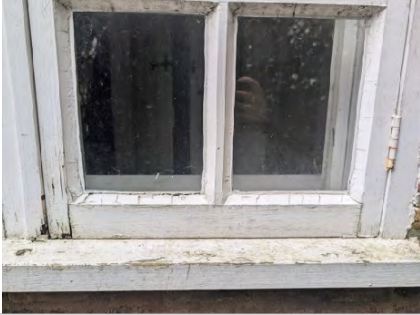
| Reference | Location | Style | Age | Condition | Significance | Internal | External | Detail | Special Features | Glazing Type | Proposed Works |
|---|---|---|---|---|---|---|---|---|---|---|---|
| WG-11 | Flat 05 Kitchen<br>External | Two vertical lights with glazing bars, casement window. Painted frame. | | 4 Moderate. Areas of frame in poor condition. | Low | | | | One side hung opening light, one fixed light. Projected sill. | Single. Side hung secondary glazing panels internal. | Replace with hardwood frame and rectangular leading |

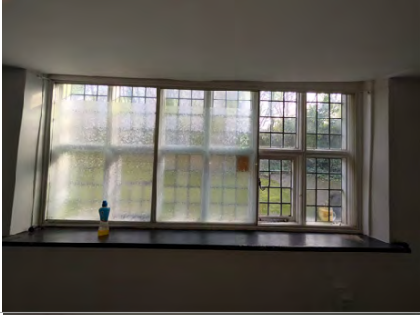
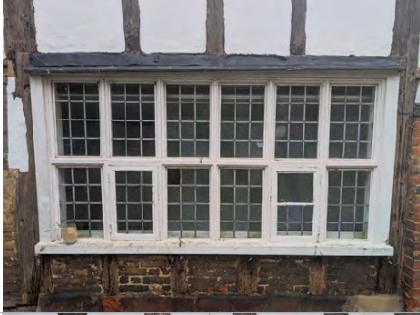
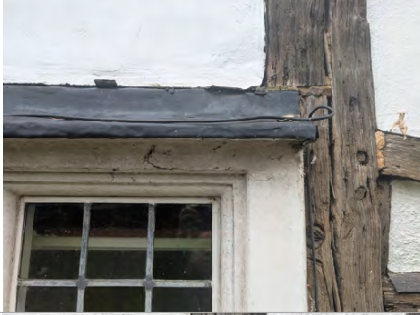
| Reference | Location | Style | Age | Condition | Significance | Internal | External | Detail | Special Features | Glazing Type | Proposed Works |
|---|---|---|---|---|---|---|---|---|---|---|---|
| WG-12 | Flat 04 Liv/Bed<br>External | Twelve leaded vertical lights across two rows, casement window. Painted frame. | | 2 Poor. Worn lead flashing. | Exceptional | | | | Multiple side hung opening lights. Projected sill. | Single. Sliding secondary glazing panels internal. Green tinted panes. | Strip paint subject to timber condition. Add slimline secondary glazing. Code 5 Lead Works. Timber repairs to rotting. Reinstate leading in pane with glazing bar. |

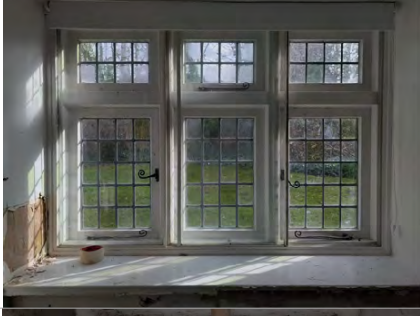
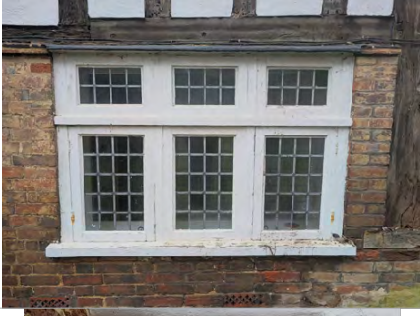
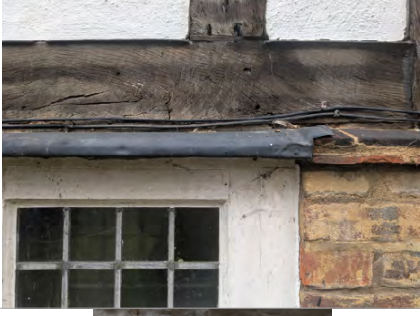
| Reference | Location | Style | Age | Condition | Significance | Internal | External | Detail | Special Features | Glazing Type | Proposed Works |
|---|---|---|---|---|---|---|---|---|---|---|---|
| WG-13 | Flat 04 Kitchen<br>External | Three leaded horizontal lights over three leaded vertical lights, casement window. Painted frame. | | 3 Poor. Worn lead flashing. Lintel works required as per structural survey. | Moderate | | | | Two side hung opening lights, fixed light in centre. Top hung light at top centre. Original timber structure at head. Projected sill. | Single. | Strip paint subject to timber condition. Add slimline secondary glazing. Code 5 Lead Works. Lintel works. |

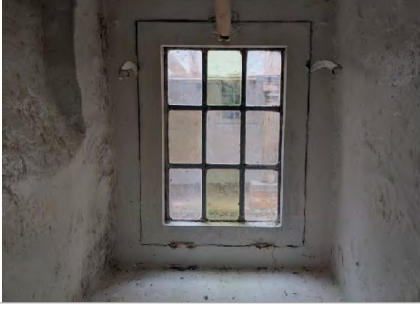
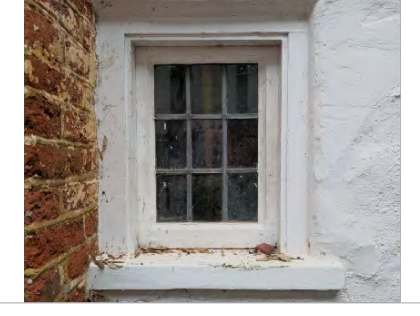
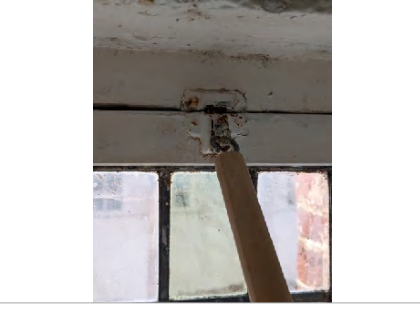
| Reference | Location | Style | Age | Condition | Significance | Internal | External | Detail | Special Features | Glazing Type | Proposed Works |
|---|---|---|---|---|---|---|---|---|---|---|---|
| WG-14 | Flat 04 Bathroom<br>Courtyard | Leaded light, casement window. Painted frame. | | 3 Moderate. | Considerable | | | | Pivot hinge. Opening accessed with timber reacher. Deep into window recess. | Single. | Clean and introduce secondary glazing. |

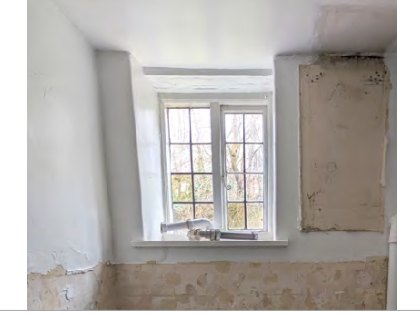
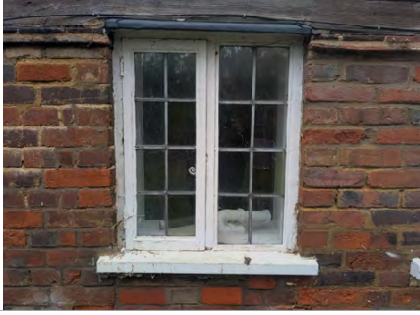
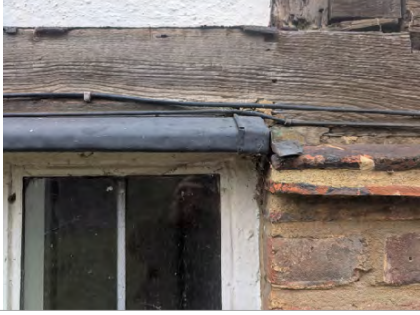
| Reference | Location | Style | Age | Condition | Significance | Internal | External | Detail | Special Features | Glazing Type | Proposed Works |
|---|---|---|---|---|---|---|---|---|---|---|---|
| WG-15 | Flat 03 Kitchen<br>External | Two vertical leaded lights, casement window. Painted frame. | | 3 Poor. Worn lead flashing. Areas of frame in poor condition. | Moderate | | | | One side hung opening light, one fixed light. Projected sill. Original timber structure at head. Projected sill. | Single. | Strip paint subject to timber condition. Add slimline secondary glazing. Code 5 Lead Works. Timber repairs to rotting. |

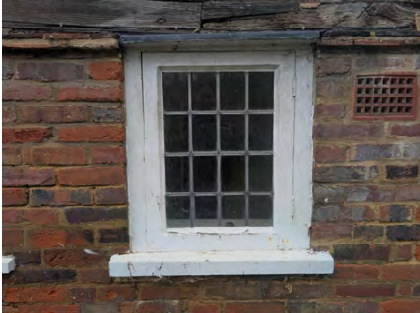
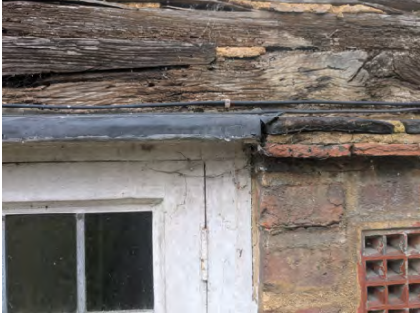
| Reference | Location | Style | Age | Condition | Significance | Internal | External | Detail | Special Features | Glazing Type | Proposed Works |
|---|---|---|---|---|---|---|---|---|---|---|---|
| WG-16 | Flat 03 Bathroom<br>External | Leaded light, casement window. Painted frame. | | 3 Moderate. Worn lead flashing. | Moderate | | | | Side hung opening light. Original timber structure at head. Projected sill. | Single. | Strip paint subject to timber condition. Add slimline secondary glazing. Code 5 Lead Works. |

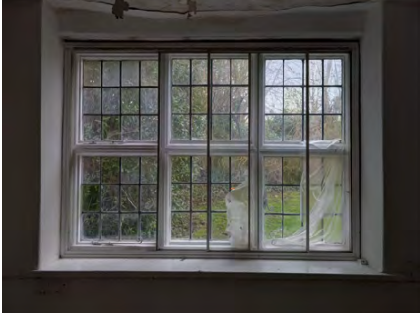
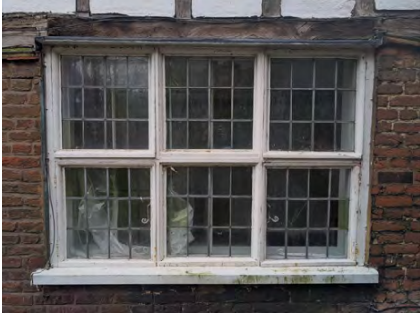
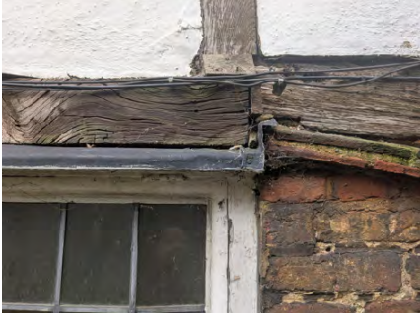
| Reference | Location | Style | Age | Condition | Significance | Internal | External | Detail | Special Features | Glazing Type | Proposed Works |
|---|---|---|---|---|---|---|---|---|---|---|---|
| WG-17 | Flat 03 Liv/Bed<br>External | Two rows of three leaded lights, casement window. Painted frame. | | 2 Poor. Worn lead flashing. Areas of frame in poor condition. Cement infill around edges. Lintel works required as per structural survey. | Considerable | | | | Two side hung opening lights, rest fixed. Projected sill. | Single. Sliding secondary glazing panels internal. Green tinted panes. | Strip paint subject to timber condition. Add slimline secondary glazing. Code 5 Lead Works. Timber repairs to rotting. Lintel works. |

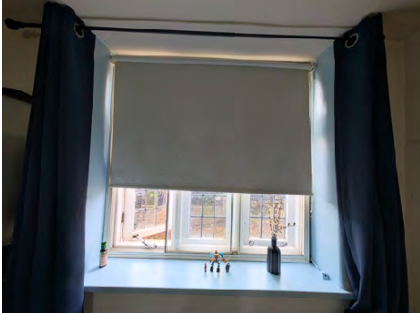
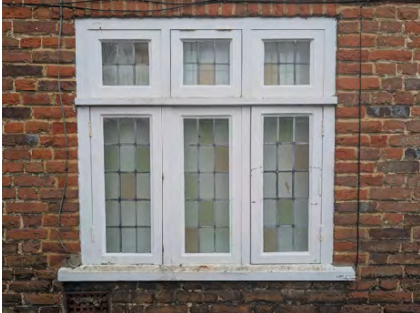
| Reference | Location | Style | Age | Condition | Significance | Internal | External | Detail | Special Features | Glazing Type | Proposed Works |
|---|---|---|---|---|---|---|---|---|---|---|---|
| WG-19 | Flat 02 Liv/Kit/Bed<br>External | Six leaded lights across two rows, casement window. Painted frame. | | 3 Moderate. | Considerable | | | | Two side hung and one top hung opening lights. | Single. Green and pink tinted panes. | Replace with hardwood frame and rectangular leading. |

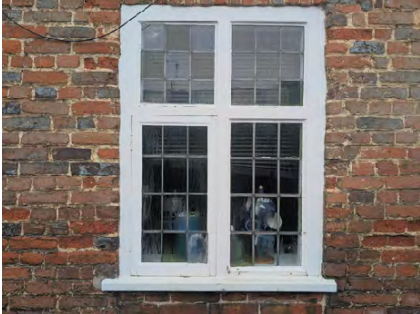
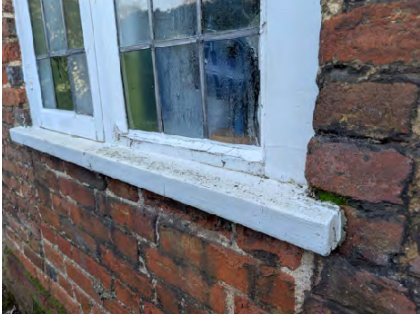
| Reference | Location | Style | Age | Condition | Significance | Internal | External | Detail | Special Features | Glazing Type | Proposed Works |
|---|---|---|---|---|---|---|---|---|---|---|---|
| WG-20 | Flat 02 Liv/Kit/Bed<br>External | Four leaded lights, casement window. Painted frame. | | 3 Moderate. | Considerable | | | | One side hung opening light, rest fixed. | Single. Green and orange tinted panes. | Strip paint subject to timber condition. Add slimline secondary glazing. |

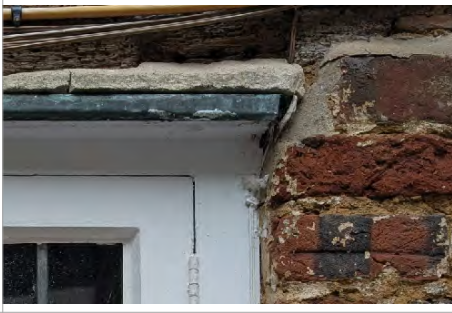
| Reference | Location | Style | Age | Condition | Significance | Internal | External | Detail | Special Features | Glazing Type | Proposed Works |
|---|---|---|---|---|---|---|---|---|---|---|---|
| WG-22 | Flat 02 Lobby<br>Courtyard | Leaded light,<br>casement window.<br>Painted frame. | | 3 Moderate. | Considerable | | | | Side hung opening.<br>Projected sill. | Single. | Strip paint subject<br>to timber condition.<br>Add slimline<br>secondary glazing.<br>Code 5 leadworks. |

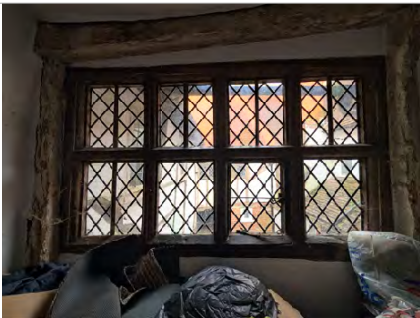
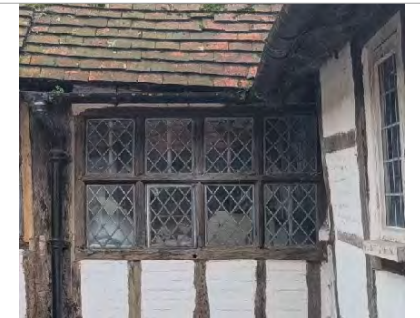
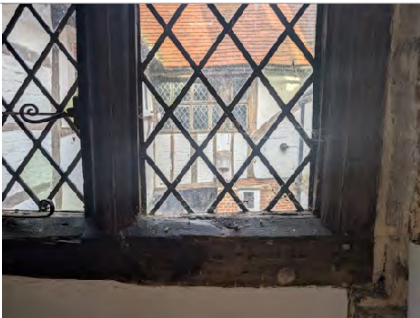
| Reference | Location | Style | Age | Condition | Significance | Internal | External | Detail | Special Features | Glazing Type | Proposed Works |
|---|---|---|---|---|---|---|---|---|---|---|---|
| WF-08 | Stairwell 03 Courtyard | Eight diamond leaded lights, casement window. Original hardwood frame and glass. | | 1 Good | Exceptional | | | | Multiple side hung opening lights. Original timber structure framing opening. | Single. | Sensitive cleaning. |

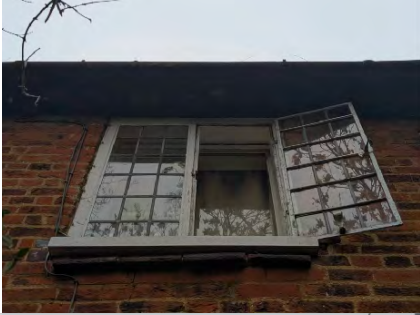
| Reference | Location | Style | Age | Condition | Significance | Internal | External | Detail | Special Features | Glazing Type | Proposed Works |
|---|---|---|---|---|---|---|---|---|---|---|---|
| WF-09 | Flat 11 Liv/Bed<br>External | Two leaded lights, casement window. Painted frame. | | 3 Moderate | Considerable | | | | Side hung opening light. Projected sill. | Single. | Strip paint subject to timber condition. Add slimline secondary glazing. |

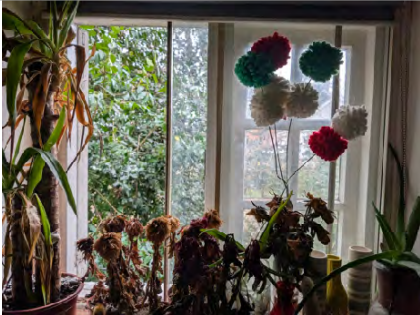
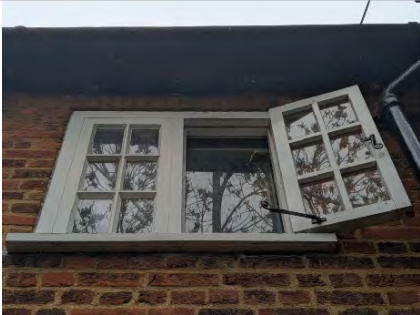
| Reference | Location | Style | Age | Condition | Significance | Internal | External | Detail | Special Features | Glazing Type | Proposed Works |
|---|---|---|---|---|---|---|---|---|---|---|---|
| WF-10 | Flat 11 Kitchen<br>External | Two vertical lights with glazing bars, casement window. Painted frame. | | 5 Poor | Low | | | | Side hung opening light. Projected sill. | Single. | Replace with hardwood frame and rectangular leading. |

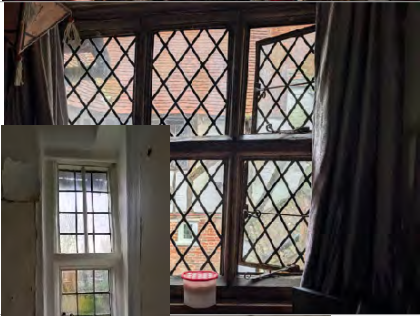
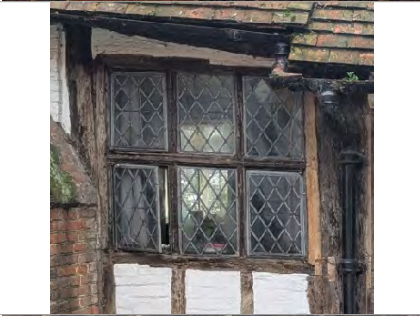
| Reference | Location | Style | Age | Condition | Significance | Internal | External | Detail | Special Features | Glazing Type | Proposed Works |
|---|---|---|---|---|---|---|---|---|---|---|---|
| WF-11 | Flat 11 Liv/Bed<br>Courtyard | Six diamond leaded lights, casement window. Original hardwood frame and glass with some repairs to frame. | | 1 Moderate | Exceptional | | | | Side hung casement openings. Original timber structure framing opening. | Single. | Sensitive cleaning. Introduction of secondary glazing. |

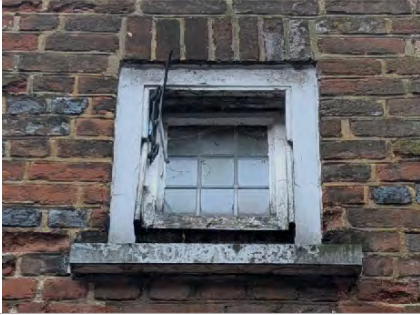
| Reference | Location | Style | Age | Condition | Significance | Internal | External | Detail | Special Features | Glazing Type | Proposed Works |
|---|---|---|---|---|---|---|---|---|---|---|---|
| WF-12 | Flat 11 Bathroom<br>Courtyard | Leaded light, pivot window. Painted frame. | | 4 Very poor | Considerable | | | | Horizontal pivot opening. Projected sill. | Single. Green and pink tinted panes. | Replace with hardwood frame and rectangular leading. |

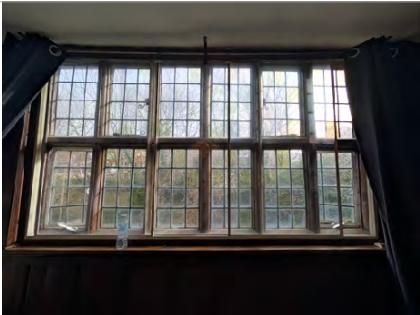
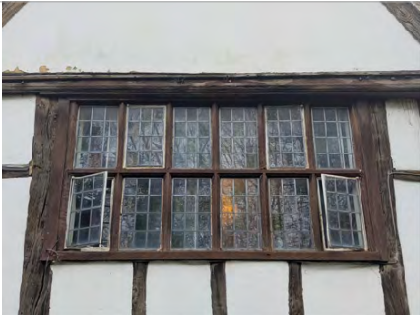
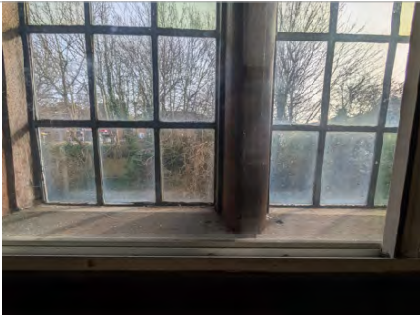
| Reference | Location | Style | Age | Condition | Significance | Internal | External | Detail | Special Features | Glazing Type | Proposed Works |
|---|---|---|---|---|---|---|---|---|---|---|---|
| WF-13 | Flat 10 Liv/Bed<br>External | Two rows of six leaded lights, casement window. Original hardwood frame. | | 2 Good | Exceptional | | | | Side hung casement openings. Original timber structure framing opening. | Single. Sliding secondary glazing panels internal. | Sensitive repairs and cleaning. Introduction of slimline secondary glazing to improve building performance. |

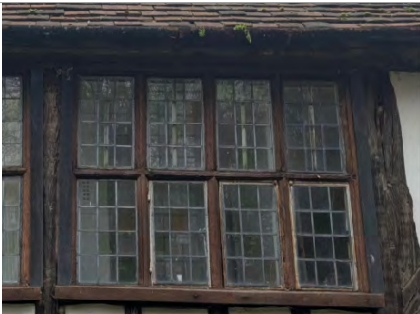
| Reference | Location | Style | Age | Condition | Significance | Internal | External | Detail | Special Features | Glazing Type | Proposed Works |
|---|---|---|---|---|---|---|---|---|---|---|---|
| WF-17 | Flat 09 Kitchen<br>External | Two rows of four leaded lights, casement window. Original hardwood frame with some repairs. | | 2 Moderate | Exceptional | | | | Side hung casement openings. Original timber structure framing opening with repairs. | Single. Sliding secondary glazing panels internal. | Sensitive repairs and cleaning. Introduction of slimline secondary glazing. Strip internal paint. |

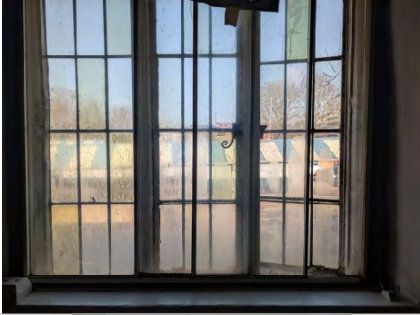
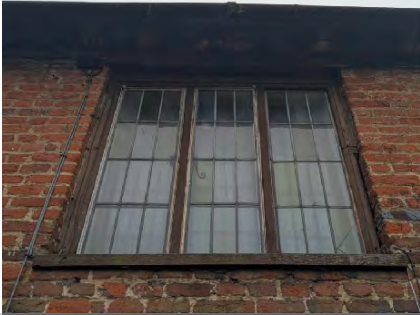
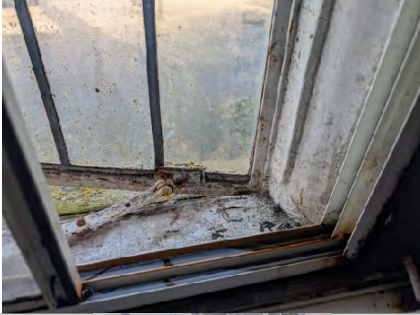
| Reference | Location | Style | Age | Condition | Significance | Internal | External | Detail | Special Features | Glazing Type | Proposed Works |
|---|---|---|---|---|---|---|---|---|---|---|---|
| WF-19 | Flat 08 Liv/Bed<br>External | Three vertical leaded lights, casement window. Original outer hardwood frames. | | 2 Poor | High | | | | Side hung casement openings. | Single. Green tinted panes. | Sensitive repairs. Introduction of slimline secondary glazing to improve building performance. |

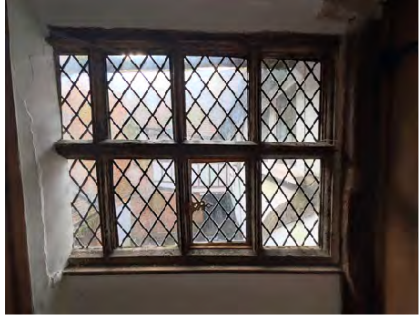
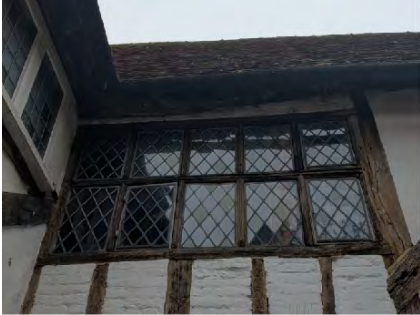
| Reference | Location | Style | Age | Condition | Significance | Internal | External | Detail | Special Features | Glazing Type | Proposed Works |
|---|---|---|---|---|---|---|---|---|---|---|---|
| WF-23 | Stairwell 01<br>Courtyard | Two rows of five vertical, diamond leaded lights, casement window. Original hardwood frame and glass. | | 1 Good | Exceptional | | | | Side hung openings. | Single. | Sensitive repairs and removal of partition wall. |

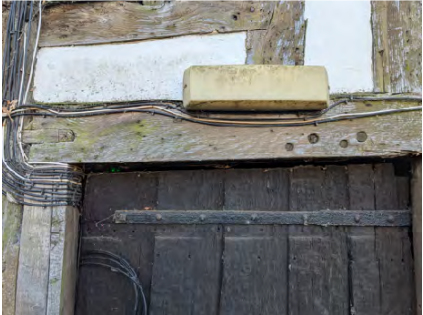
| Reference | Location | Style | Age | Condition | Significance | Internal | External | Detail | Special Features | Glazing Type | Proposed Works |
|---|---|---|---|---|---|---|---|---|---|---|---|
| DG-01 | First entrance door | | | 2 Moderate | Considerable | | | | | | Retain, remove fixtures. Add subtle bronze up down lighting features outside the door frame. |

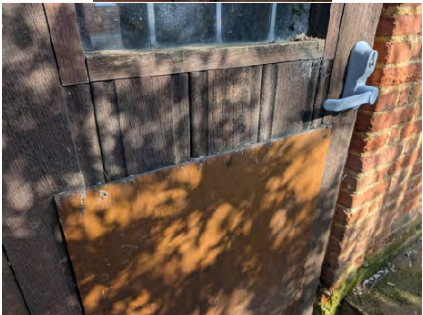
| Reference | Location | Style | Age | Condition | Significance | Internal | External | Detail | Special Features | Glazing Type | Proposed Works |
|---|---|---|---|---|---|---|---|---|---|---|---|
| DG-03 | Back entrance door | | | 5 Very poor | Low | | | | | | Replace |
