INITIAL STRUCTURAL REPORT:  
**The Biggin, Hitchin**

26<sup>th</sup> February 2026

On behalf of:

Michael Collins Associates  
99 Bancroft,  
Hitchin,  
Hertfordshire, SG5 1NQ

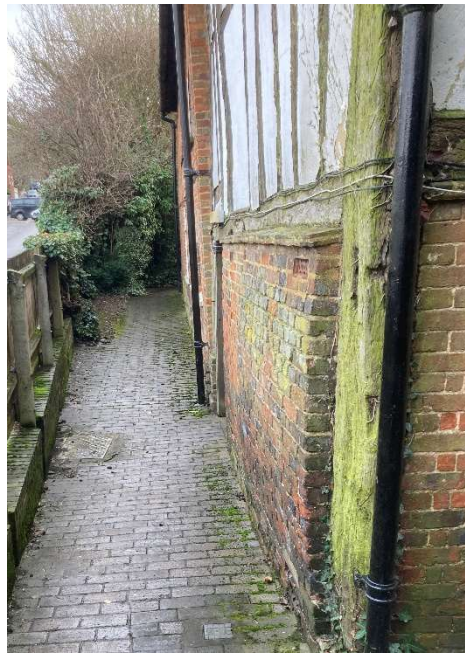
- 3.1. The north elevation comprised a largely red brick construction over the full two-storeys of its eastern end culminating in a gable. Approximately two-thirds of the way along the elevation from the eastern side the structure reverted to two storey timber framing and contained the accessway into the inner courtyard. Further west of this doorway, the timber construction continued at first floor, but had been replaced with brick at ground floor.

*View along the face of the north elevation*

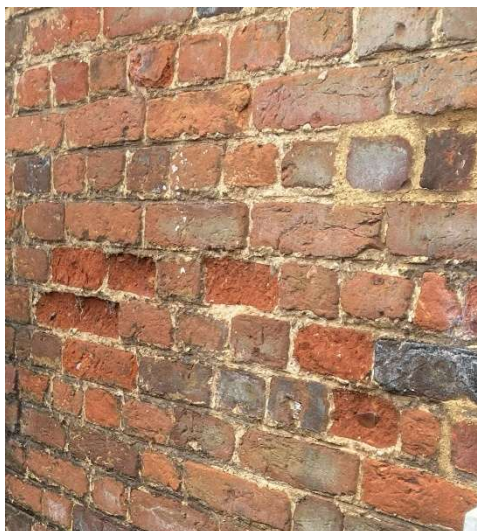
- 3.2. The brickwork was in a reasonable condition for its age, however, several bricks had become de-faced generally due to the natural softness of the hand-fired brick and harder surrounding mortars (the majority of the mortar present was a lime mortar, but there were areas of cementitious mortar). Lime mortars better protect the masonry against water induced erosion ( freeze-thaw action or salt crystallisation ) as they keep the masonry drier than cement based mortars, however the mortar still needs to be softer than the brick to provide greatest protection and it was probable that the lime mortar was too hard to suit all the variable hardnesses of brick in the façade. The cement mortars would certainly have held moisture in the brick and increased water induced erosion and damage.

*Brick face erosion and signs of 'Penny Roll' pointing*

- 3.4. All cement mortar (but also lime mortar in those joints around the defaced, softer bricks) should be raked back to remove the cement mortar (or taken back to 35mm from the masonry face in the case of existing lime mortar) and repointed in a softer, air lime mortar. This will protect the masonry from future erosion and in time, with repeated similar repairs, the entire façade will eventually have the correct mortar, which will preserve the bricks and keep the building envelope drier.

- 3.7. There was evidence of penny roll pointing in places and therefore, when the joints are still green, they should be incised with vertical and horizontal grooves to emulate the penny roll pointing.

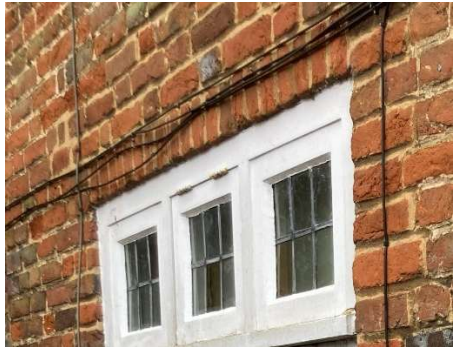
- 3.11. Window openings did not have lintols above them. In some locations a header course or rowlock course had been installed over the window openings providing some flat arching action, albeit probably still reliant on the timber window frame for ultimate support.

*Rowlock course forming a flat arch lintol*

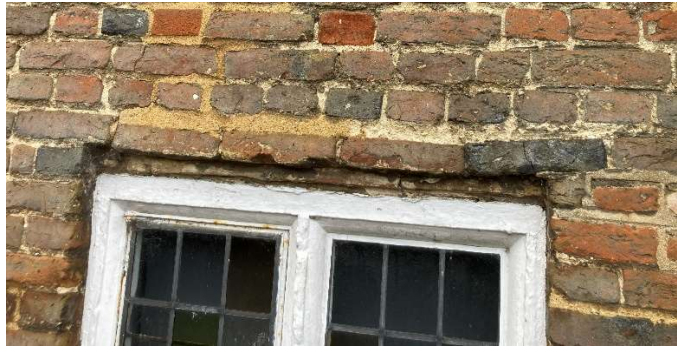
- 3.12. Other windows, however, merely had a continuation of stretchers above them, which provided almost no support for the masonry above and were entirely reliant on the timber window framing for support. In locations where this arrangement was observed, the masonry had dropped and the joints had been repointed, but were significantly wider than elsewhere to account for the movement.

*Continuation of stretcher course, dropped and supported by frame below*

- 4.12. Part of the timber repairs will be to rectify those previous repairs where new lengths of plate rely on window frames for support, or where articulation of the building envelope has arisen from discontinuity of the framing at window locations etc.

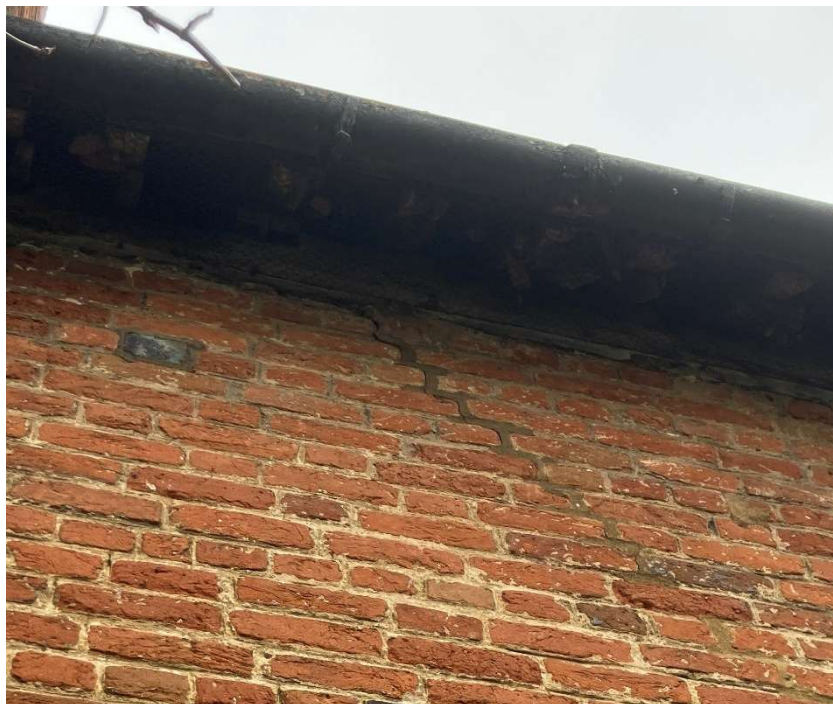
- 3.13. There was evidence of an historical crack at the eastern end of the façade at high level. This had been filled with a cement based mortar and further significant movement did not seem to have occurred, but there may be some slight opening of the joint at the higher level. Closer inspection is recommended from improved access both inside and outside to confirm that the crack is not progressive and the building has stabilised.

*Previously cracked and filled masonry – Further review required*

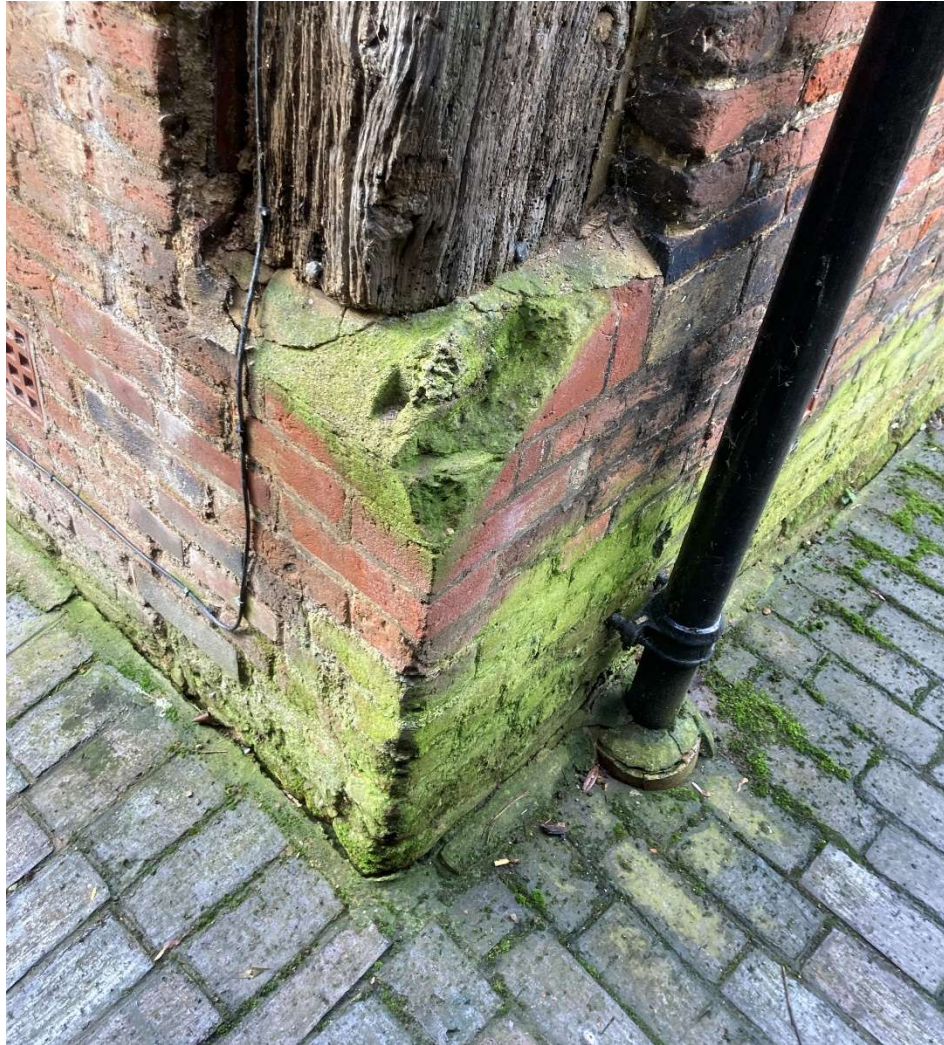
- 3.14. Cement mortar infilling around timbers had been used in many locations. On the north-east corner, the corner post had decayed at the base as a result of moisture trapped against the timber by the cement mortar infill. The base of the post was most affected as the end grain of the timber was more vulnerable to damp induced decay and gravity had concentrated moisture at the post base.

*North-east corner post: Note algae/ moss growth indicating consistent dampness in the lower wall*

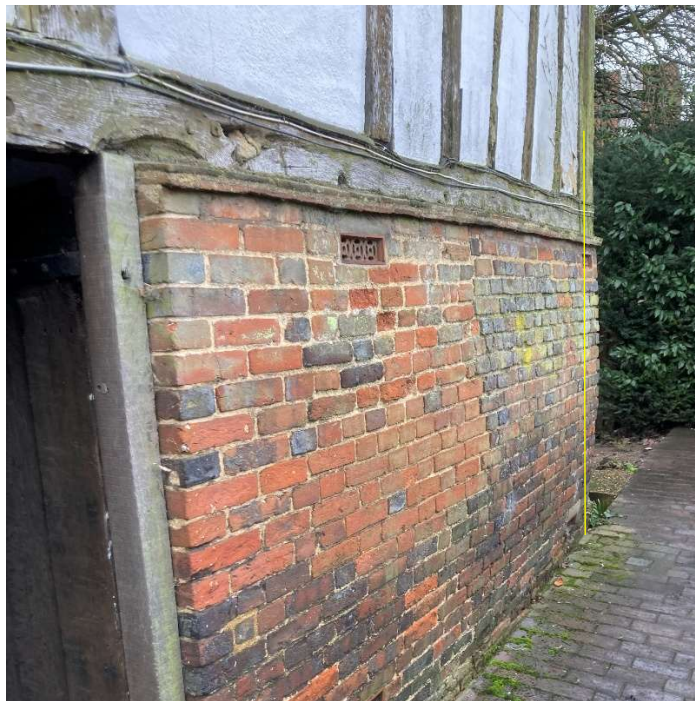
- 3.17. Cement mortar packing was also present beside the main timber post immediately to the east of the entranceway to the courtyard beyond, but the accessible elements of this post appeared sound at the time of survey and the same observations applied as to the north-western corner post.
- 3.18. There was a general bulge in the two-storey masonry at the eastern side of the elevation, but it was not severe and probably due to the facade being poorly tied into the first-floor structure behind.
- 3.19. There was a more significant bulge in the ground floor masonry west of the access door and the stability of this panel should be further reviewed.

*Bowing in the masonry west of the access into the courtyard*

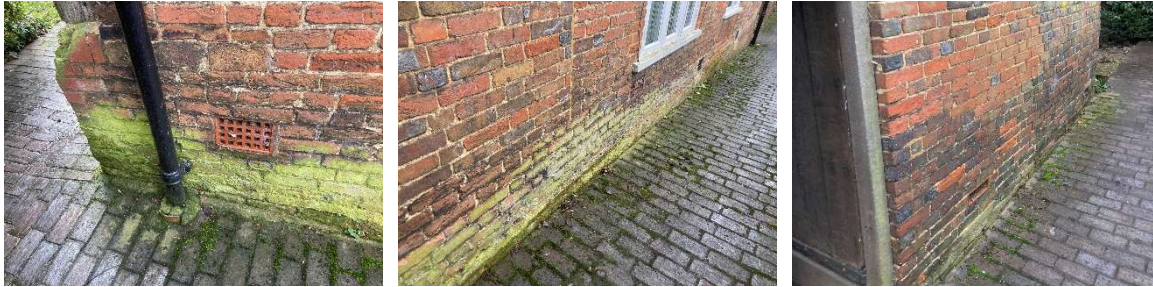
- 3.22. Lastly, ground treatment along the façade comprised a flooring brick path taken tight up against the building. The path would have drained well on initial installation through the joints, however, the joints between the bricks had become silted up and drainage would have slowed considerably. The path was holding moisture against the side of the building as could be seen by the moss and algal growth in the path adjacent to the building façade and in the base of the building.

*Excessive dampness causing moss and algae growth along the base of the wall*

- downpipes discharge into a system that takes water away from the base of the building structure.
- 4.3. Further to the control of moisture, hard standings around the building should be separated/ cut back from the base of the building and a French drain installed to keep the ground adjacent the structure dry.

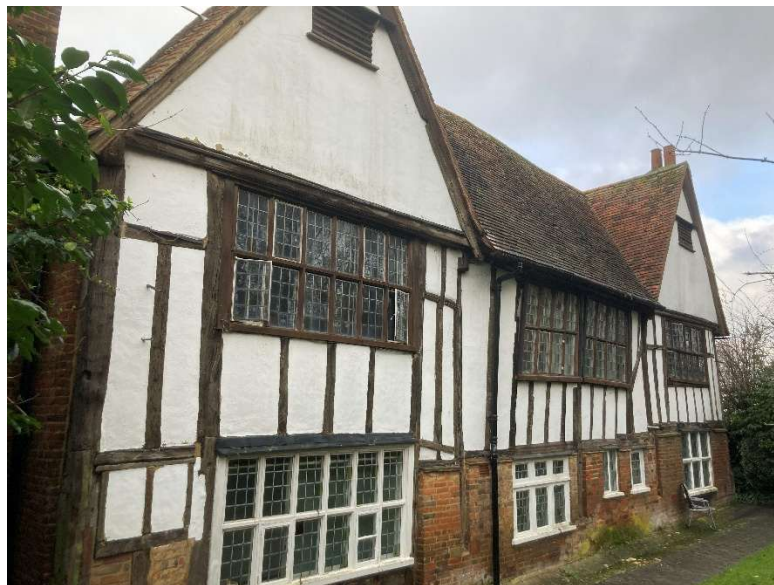
- 3.23. The east elevation comprised two gable ends on the north and south sides and a central roof eaves spanning between them.
- 3.24. The elevation was constructed from the traditional oak frame at first floor, with rendered panels between members. Brick elevations were present at ground floor, which was a later addition, and retained some of the exposed timber of the original frame embedded within it.

*Eastern Elevation*

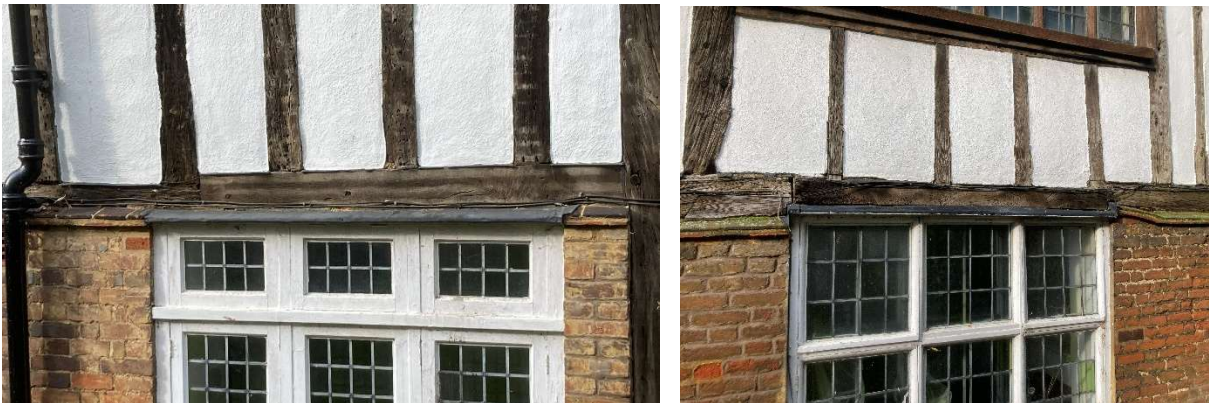
- 3.25. A skirt of old tile dressed the base of the wall at the southern end and a brick drainage channel had been constructed along the length of the elevation, tight up to the building.
- 3.26. New oak wall plate sections had been installed along the façade. One such replacement was present over both the central and northern primary windows at ground floor. The repaired wall plate stopped short of the southern reveal of the central window opening and the repair did not extend onto either reveal of the northern window opening. The jointing between the infill and original oak could not be fully assessed to determine if a moment transfer between oak sections was achieved, but it was likely that in both locations the wall panel above was bearing onto the window frame and loads were not carried by the oak frame.

*Oak repairs to the first floor plate stopping short of bearings*

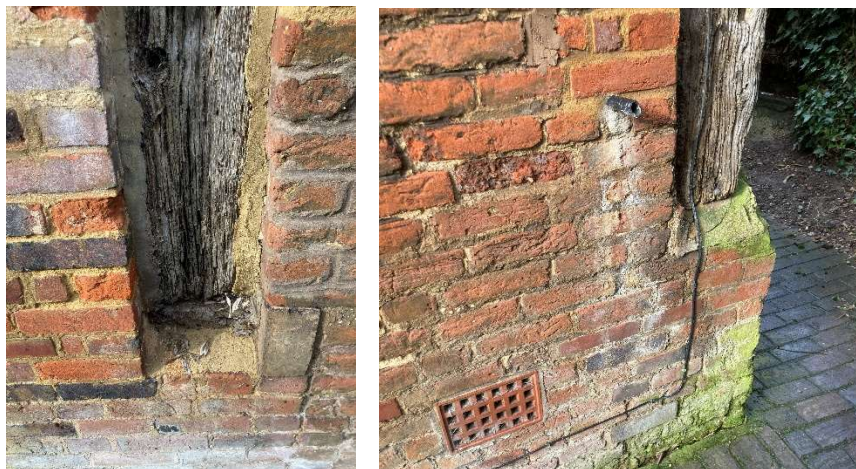
- 3.27. Timber posts had been cut back from the base due to historical decay and rested on the masonry. These posts had been flaunching with cement-based mortars and the base of the north-eastern corner post exhibited decay, as did the next adjacent principal post at the opposite side of the north gable.

*West and east corner posts of northern gable, eastern elevation*

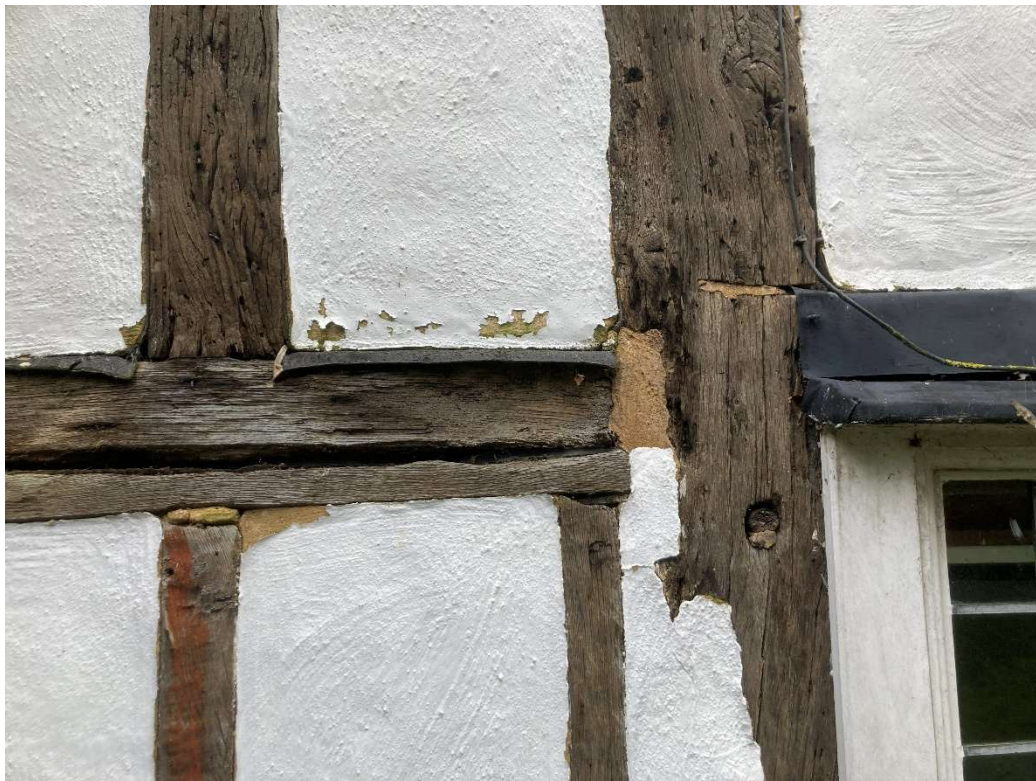
- 3.28. A standard detail had been to introduce a roofing felt flashing over the top of the first-floor wall plate throughout the elevation, dressed up the sides of the studs. This felt flashing was well intentioned, but incorrectly applied and held damp against the timbers.
- 3.29. Additionally, some of the rendered panels may have comprised lime render, but some panels were expected to consist of a cement based render and all panels were painted. The cement render panels would encourage decay in the surrounding timber, but the paint finish, which was not breathable as determined from the manner in which it was peeling in places, would have encouraged the retention of water in the timbers regardless of the presence of lime mortar.

*Roofing felt used to flash oak plate/ Peeling paint suggesting the paint finish is not breathable/ Render below the plate seems to have a cementitious base; above the plate the render may have a lime base.*

- 4.14. The roofing felt flashings should also be removed from around the timbers. The felt does not allow the timber to vent and release moisture and holds moisture against the timber: it was a poor detail that should be reversed.

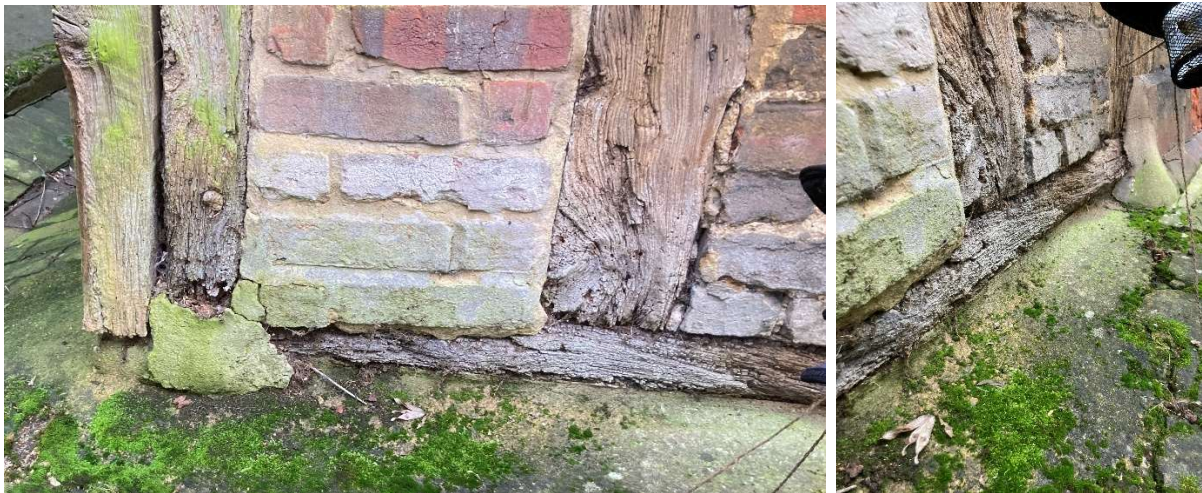
- 3.32. The sole plate was exposed at the very southern end of the elevation but disappeared behind the tiled skirt below the window and was not visible thereafter.
- 3.33. The short length of sole plate visible, the base of the short studs below the window at ground floor and the base of the south-east corner post had all decayed. The south-east corner post had been repaired previously with a second timber planted onto the face of it, but this secondary timber had also decayed at its base.

*Rot in the south-east corner post, stud bases and sole plate*

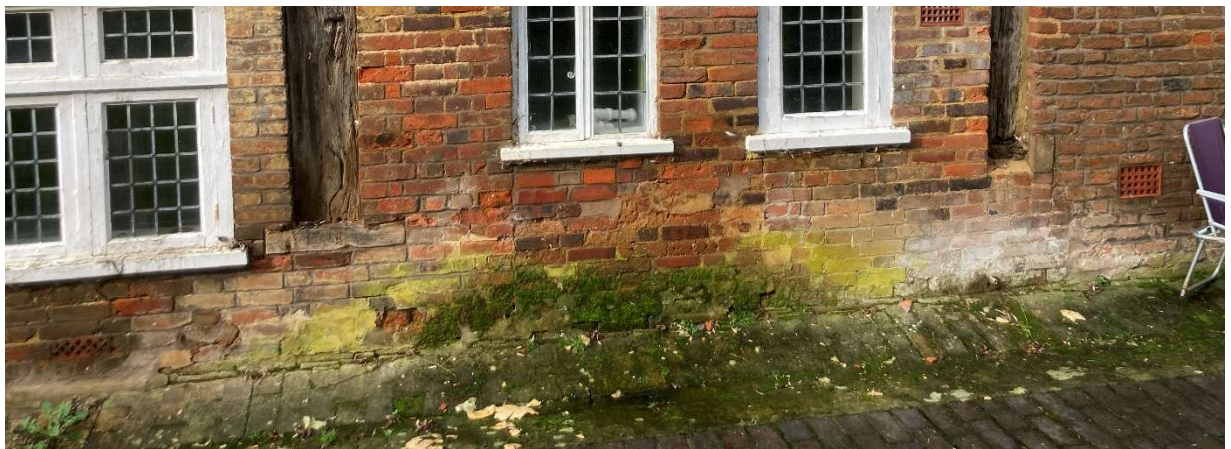
- 3.34. The base of the building was very wet throughout the length of the elevation due to the drainage channel and brickwork holding moisture against the building and the drain, combined with the tiled skirt and areas of cement-based pointing were all holding water in the timbers and causing decay.

*Excessive damp in the base of the eastern elevation and the drainage channel*

- 4.5. Where the building has a skirt of upstanding tiles (east elevation) or concrete (south and west elevations), the skirt should be removed and the base of the walls repaired using a lime mortar and replacement or reversed bricks. The newly installed French drain will take moisture away from the building and removal of the 'skirt' detailing will allow the low level masonry to ventilate and dry.

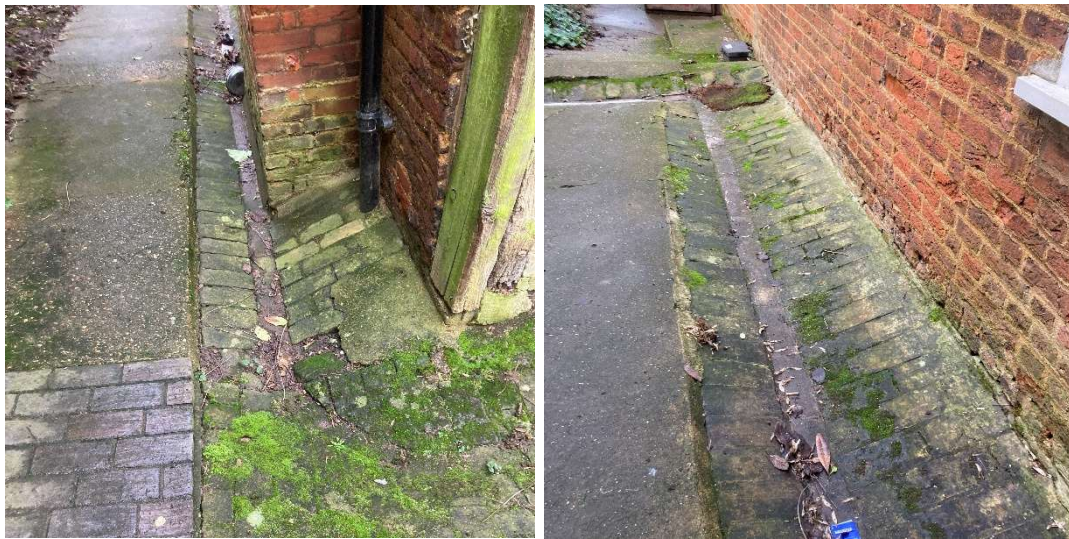
- 3.35. The eastern side of the south elevation comprised masonry, which had been repointed in what appeared to be a lime mortar.
- 3.36. The base of the wall was damp as a result of the continuation of the drainage channel from the eastern elevation, which deviated south approximately halfway along the elevation to dispose of any running water away from the building.
- 3.37. The condition of the drainage channel meant that much water would escape and stay in the vicinity of the wall thus causing the damp.

*Damp in the base of the south wall caused by the drainage channel*

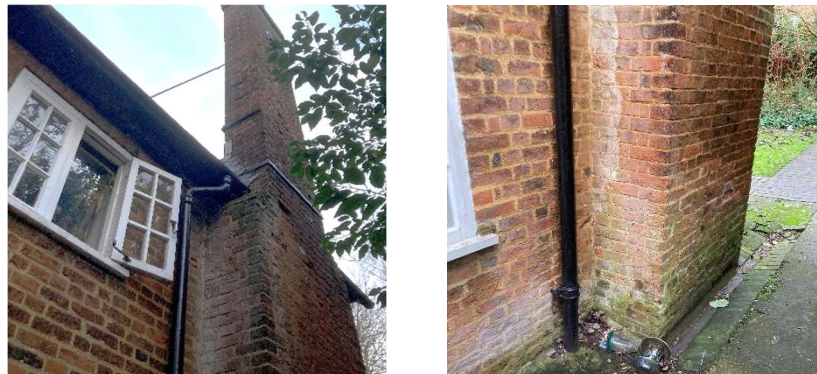
- 3.38. There was also efflorescence down the side of the chimneybreast at its junction with the main façade, and this was probably due to historical leakage of the gutter, which outfalls in this location. The downpipe and rainwater goods appeared sound at the time of survey, but required careful assessment and review once improved access is available.

*Efflorescence along side of chimney – probably due to historical failure of the gutter and downpipe*

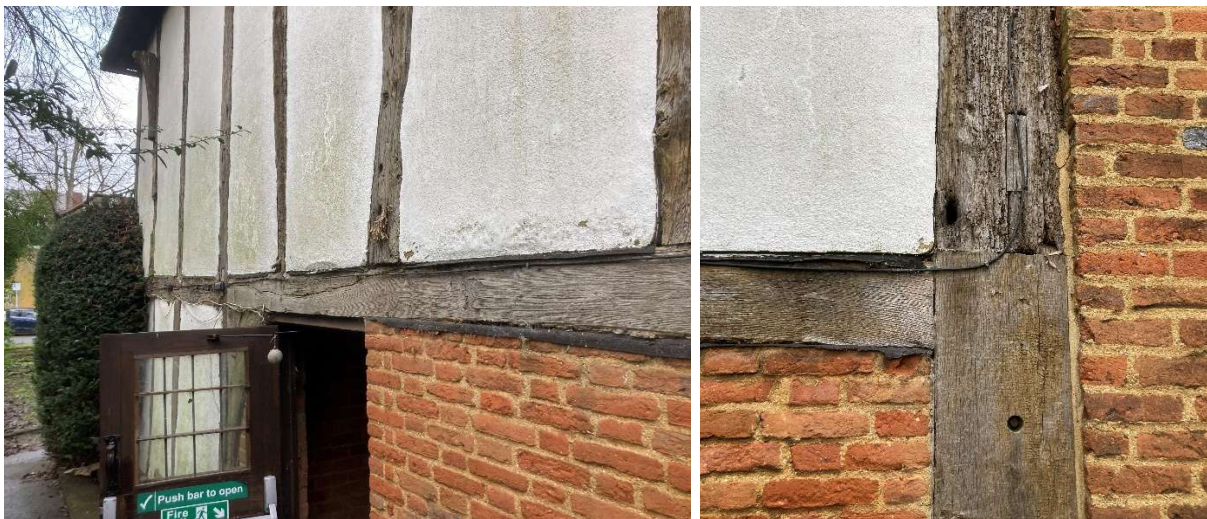
- 3.40. The base of the full height post mid-way along the elevation had been cut back (raised) probably due to previous decay, and now rested on a cement plinth. The post was either a replacement for the original post, or a facing fixed back to what remained of the original post, but the oak sounded hollow as high as could be accessed from the ground and so too did the first-floor plate that joined it and the base of the adjacent first floor stud.

- 3.41. This hollow sound indicated that the oak was hollow behind, either with the original timber having decayed still further and no longer integral to the facing, or the replacement timber itself had decayed.

*'Hollow' sounding replacement oak and decayed stud bases  
Note the roof felt flashing detail used both top and bottom here.*

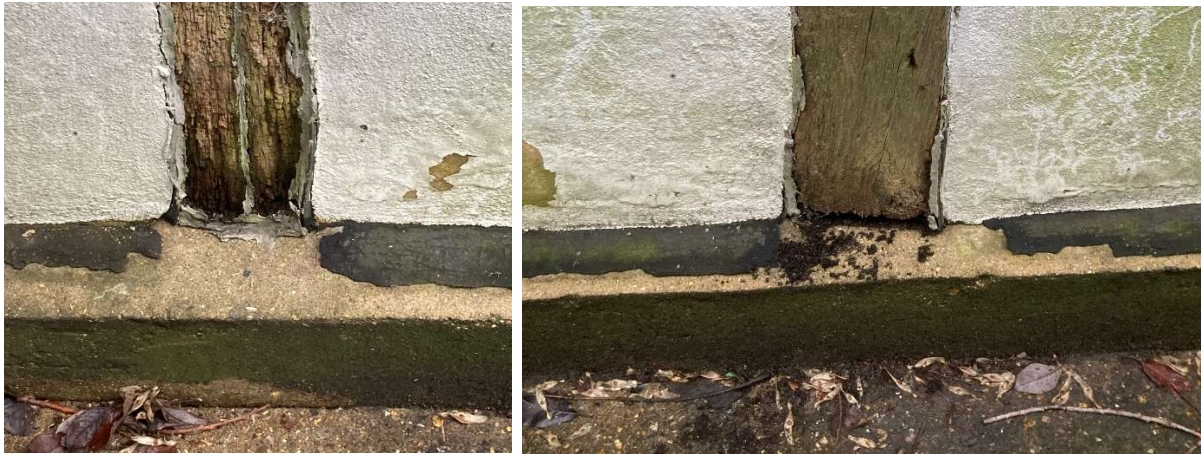
- 3.42. The base of the next two adjacent studs at their junction with the first floor plate were also decayed, as were sections of the plate.
- 3.43. A concrete plinth ran along the base of the western end of the wall and stud bases had decayed as a result.
- 3.44. The south-west corner of the building was inaccessible due to vegetation, but the timbers were likely to be decay in part through this area of the construction by nature of their position and dampness.

*Concrete plinth and decayed stud bases*

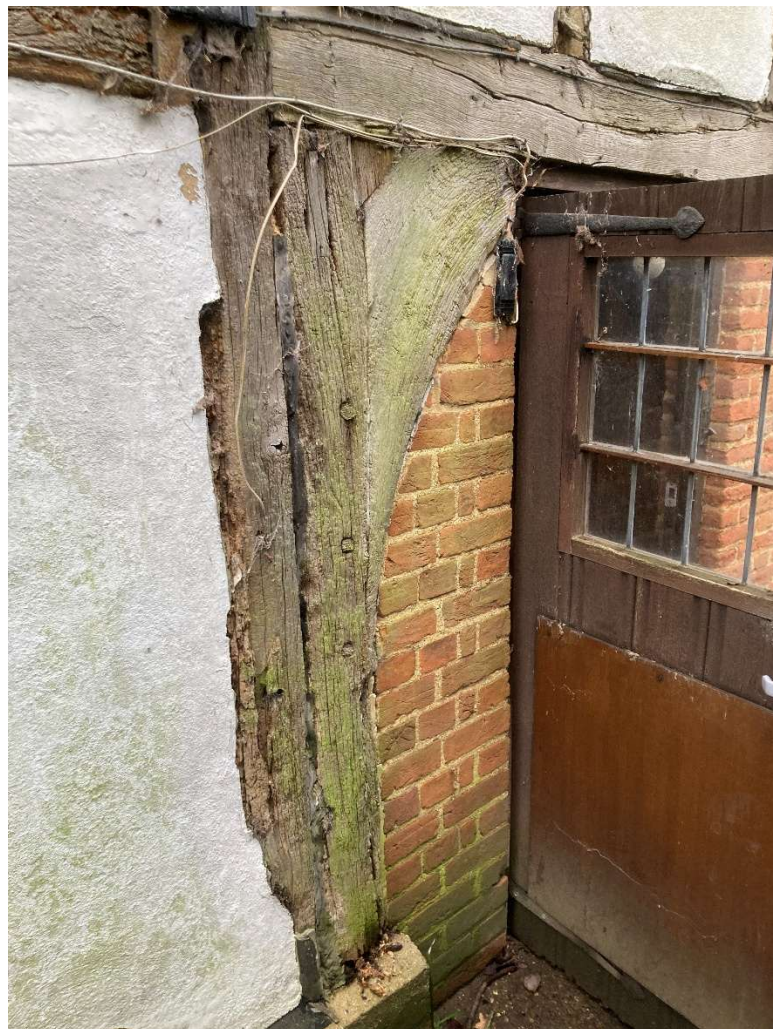
3.45. The original principal post and substantial haunch beside the rear access into the courtyard (now only present at ground floor) were heavily decayed, but were important historical details of the original construction.

*Original post and haunch, severely decayed*

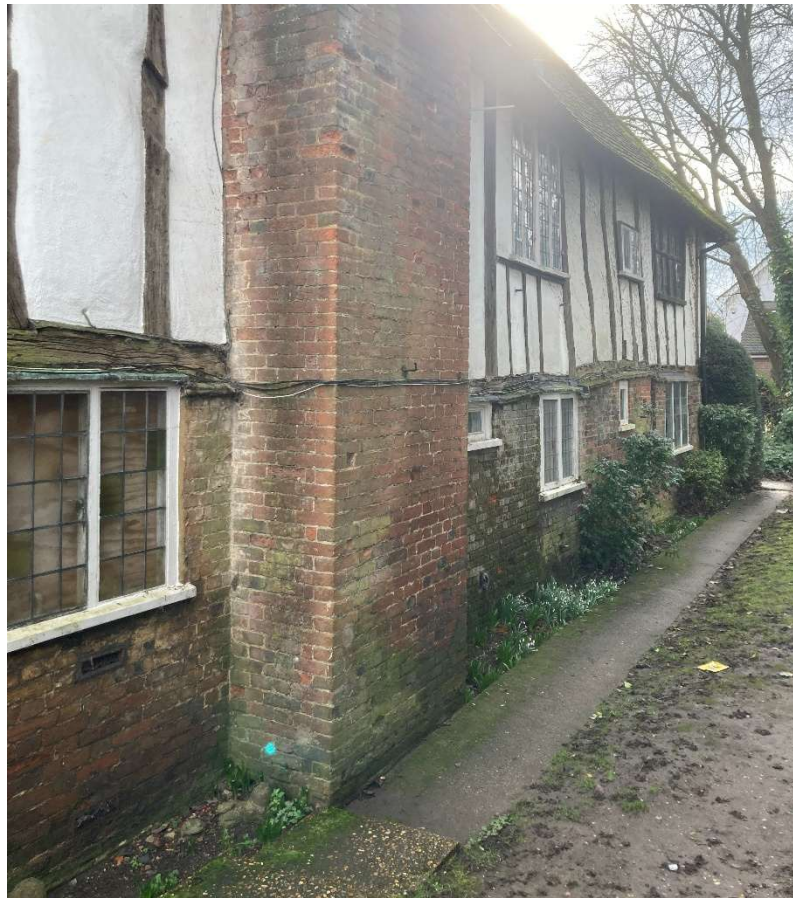
- 3.48. The west elevation consisted of brickwork at ground floor throughout, with the original timber frame and infilled rendered panels at first floor level; the only exception being the southernmost panel of render that extended down to a concrete skirt at ground level.

*General view of west elevation, looking south*

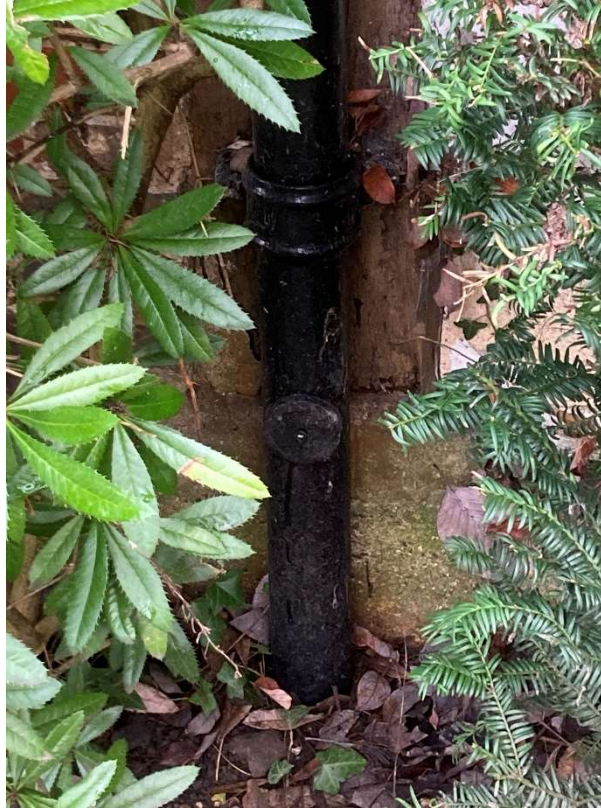
- 3.49. Full height posts at the southern end, each side of the full height rendered panel were partially obscured by vegetation, but the bases of these posts were decayed due to dampness held in the timber from the concrete skirt, the impermeable paint finish and, possibly, cement based render.

*Stud base behind downpipe, partially concealed.  
Rot in the base of the stud above the concrete skirt.*

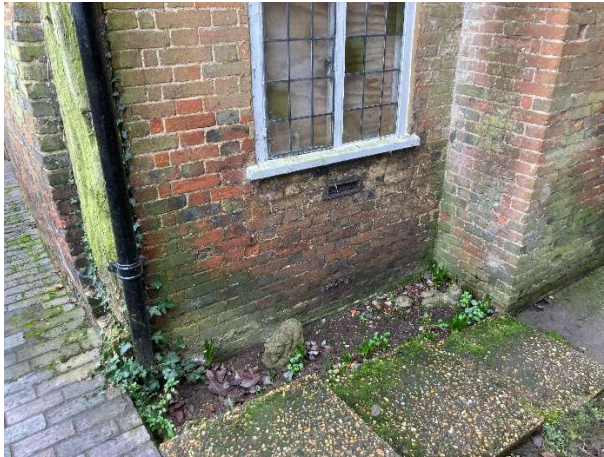
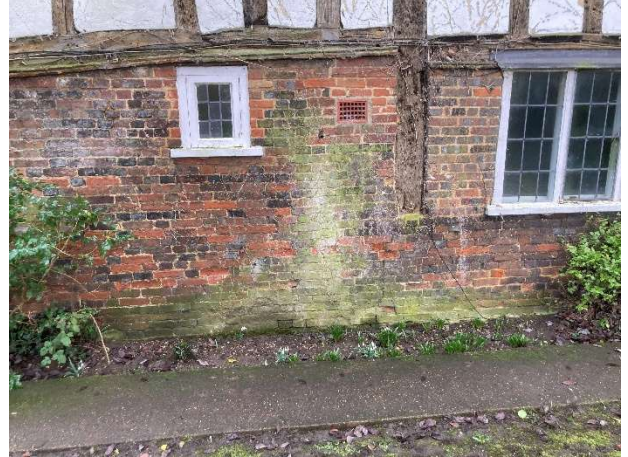
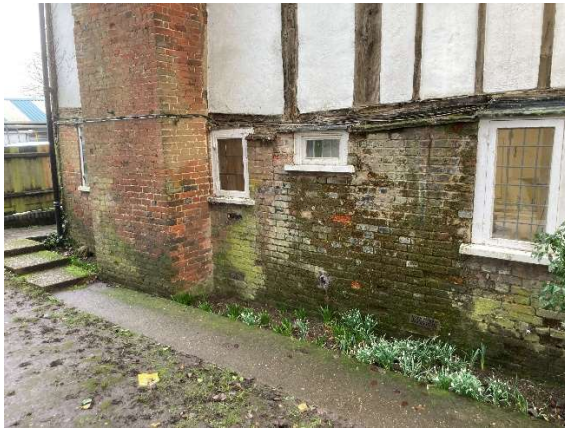
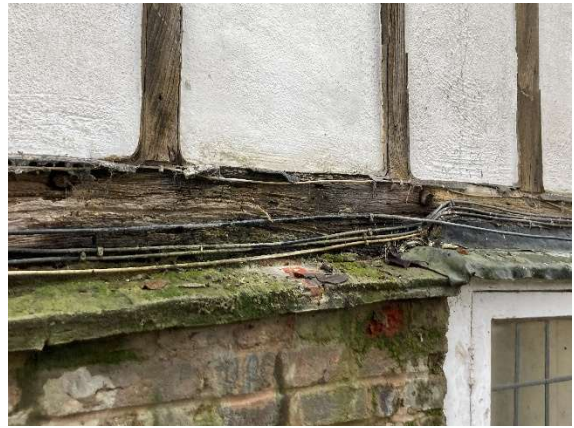
- 3.50. The west elevation was very damp. The hard standings did not abut the base of the wall along the elevation, instead, a flowerbed separated the walkway from the wall of the building. The flower bed would not drain quickly and would hold some moisture against the building, but did present an improvement over the hard standings and drainage channels present on the other elevations.
- 3.51. The same defective details like the roofing felt flashing over the first-floor wall plate and areas of cement pointing etc. were present in the façade, but the additional dampness was likely the result of the orientation of the wall, facing west and receiving the brunt of the weather. The south elevation, which was also quite wet would have received greater weather extremes as well, but was partially protected from the hedge line set circa 1.5m from the building.

*Saturated wall base along the western elevation, Downpipe discharge unknown, roofing felt flashings over first-floor plate, probable cement based render and impermeable paints*

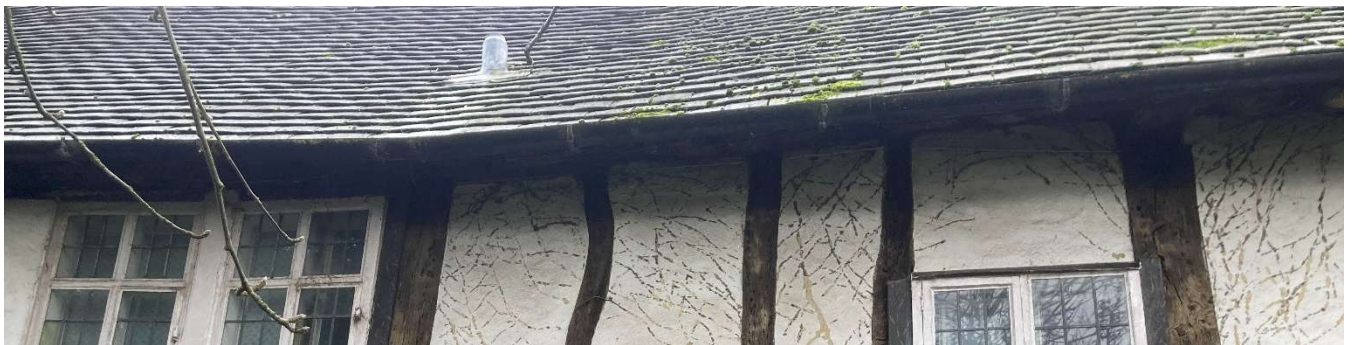
- 3.52. It was also possible that the downpipes discharged into the ground rather than discharging into a sewer run, or extending further from the building to some form of soakaway or disposal system and some of the rainwater goods may have been leaking: the gutter was poorly maintained and poorly aligned in places.

*Possible gutter deformity creating leaks*

- 4.2. The roof finishes and roof structure appeared to be relatively sound, so a complete review of the rainwater goods (gutters, outlets, hoppers and downpipes) should be undertaken with enhancement and repairs introduced to ensure:

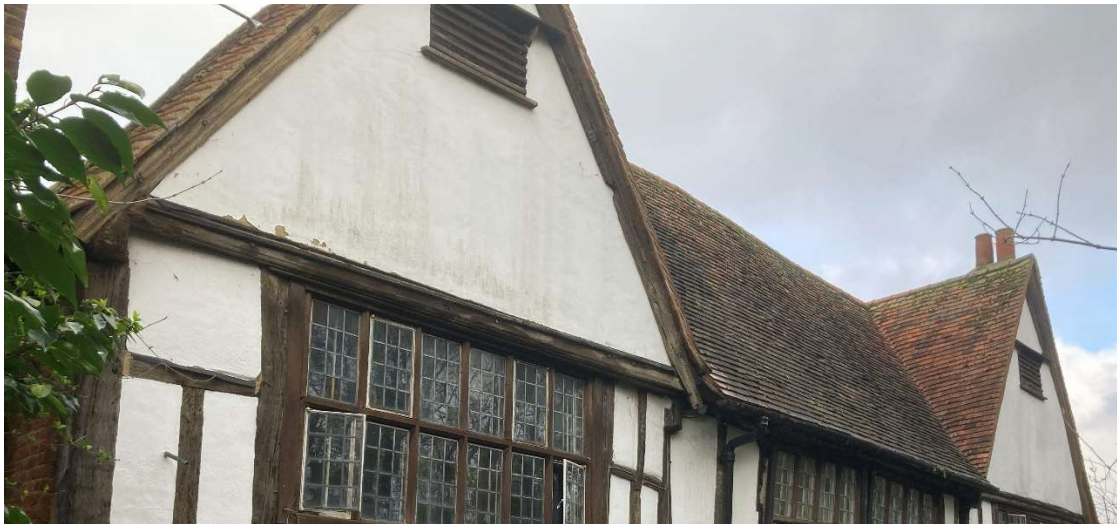
- 3.57. Two louvred openings through the eastern gables would have significantly benefitted the roof void by allowing air circulation and additional ventilation by other means seemed to have kept the roof structure in a healthy structural condition.

*Louvred panels in east facing gables help to ventilate the roof space*

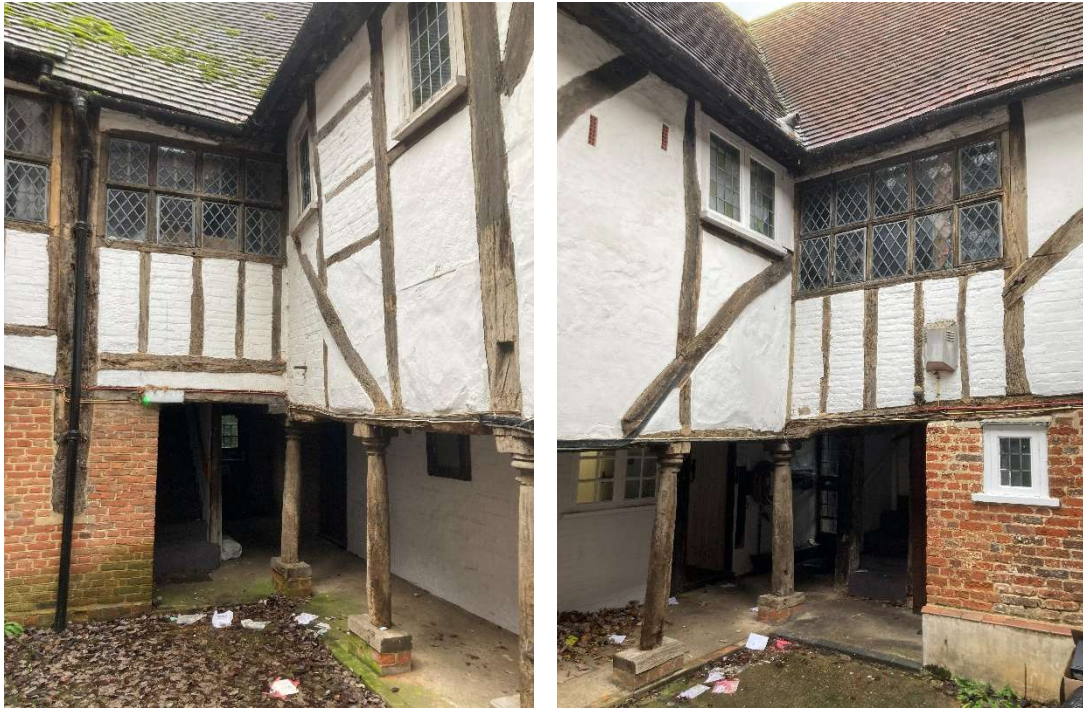
*South and north sides of the cloister respectively*

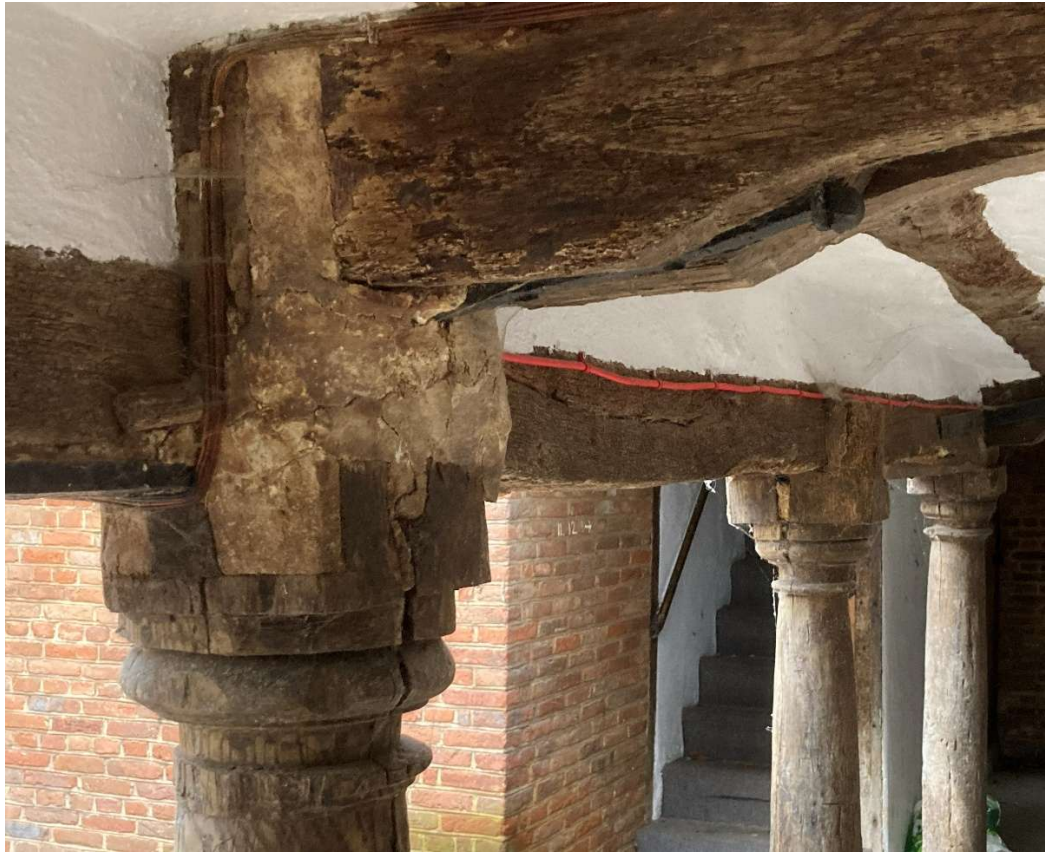
- 3.64. The timber columns of the colonnade forming the eastern side of the cloister were in relatively good condition and had been repaired and stabilised with replaced oak bearing plates and timber filler sculpted into the head sections in places.

- 3.65. While the repairs were not the most elegant, particularly the use of the timber filler, they did appear structurally sound and were not too visually intrusive.

*Timber filler to pack out the column heads*

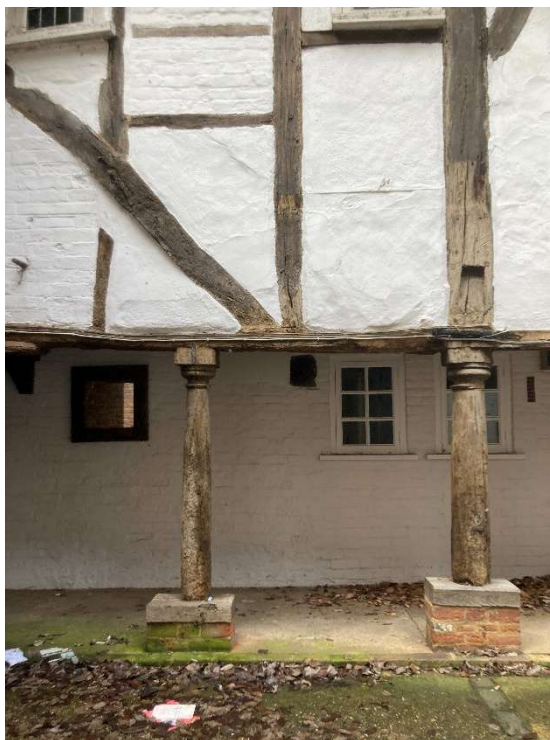
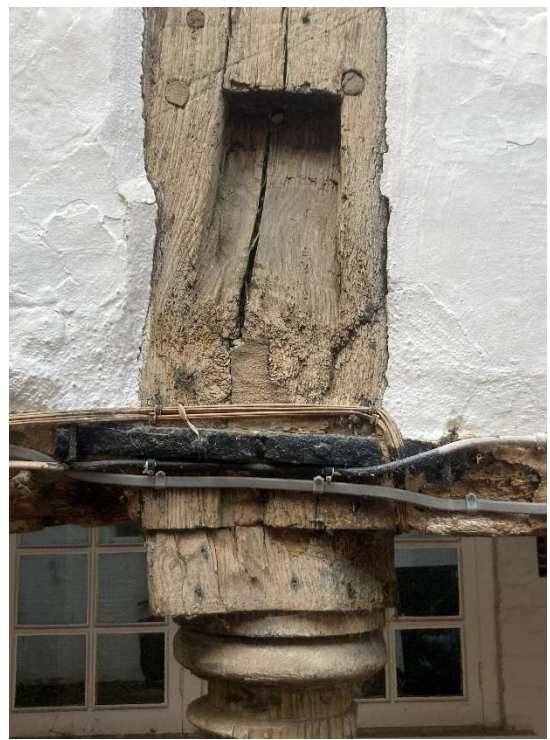
- 3.66. One interesting feature was a raking cut to form a pocket in the side of the central post above the cloister. This was almost certainly introduced to provide a 'jacking' point, such that a robust and slightly overlong timber strut could be located into the pocket at an angle to the ground. As the base of the strut was driven sideways, towards the pocket, the structure above would be lifted, taking load off the ground floor elements for repair: an early form of Acrow Prop.

*Pocket to provide means of temporary propping for repairs.*

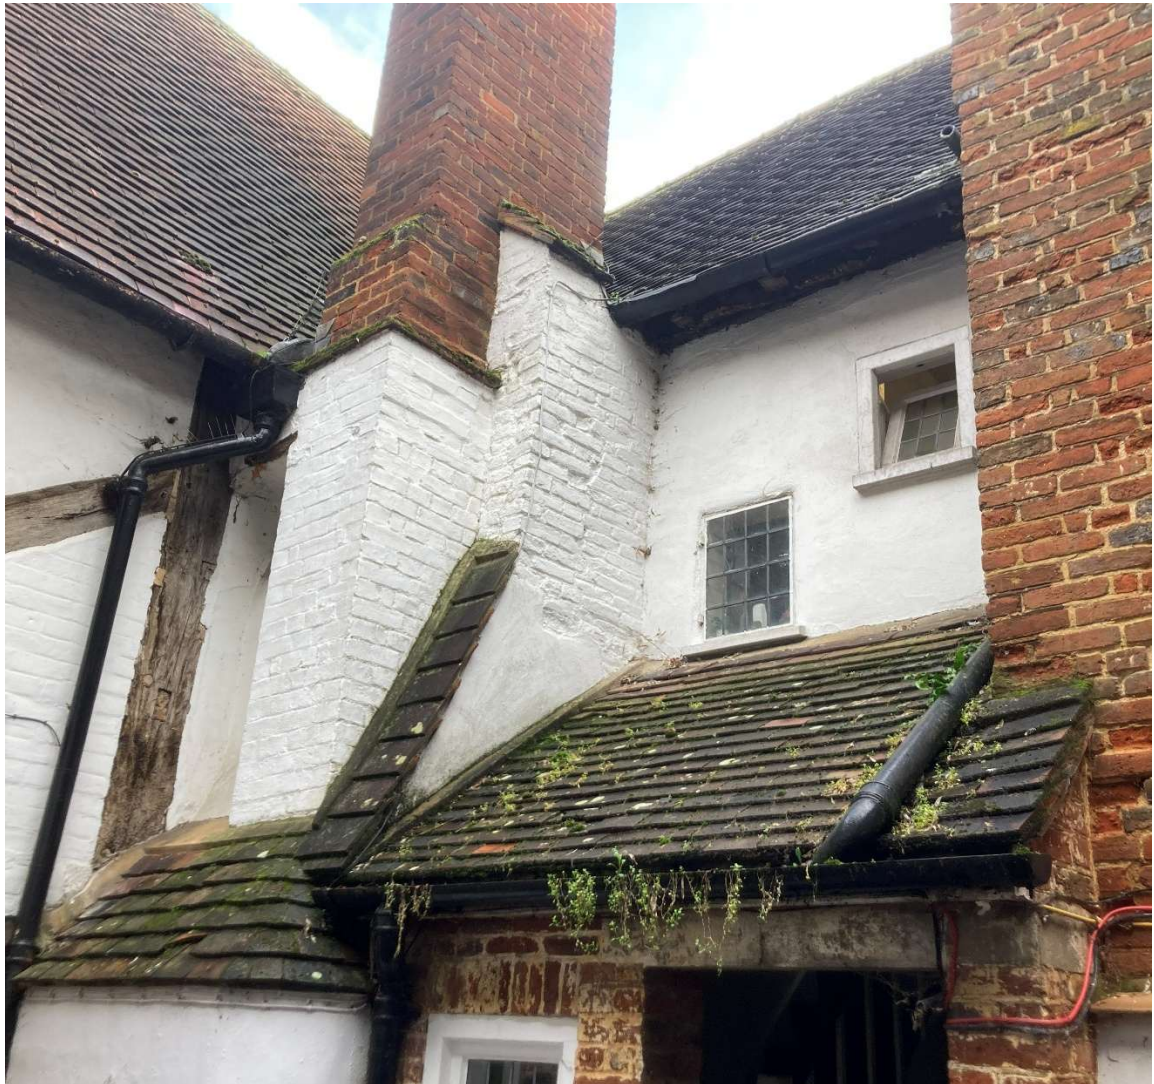
- 3.67. Generally the courtyard was in a relatively good structural condition, but it was very damp, particularly at high level on the south-west facing corner that received the worst of the weather.

*South-west facing corner with damp and vegetation on tiled slopes*

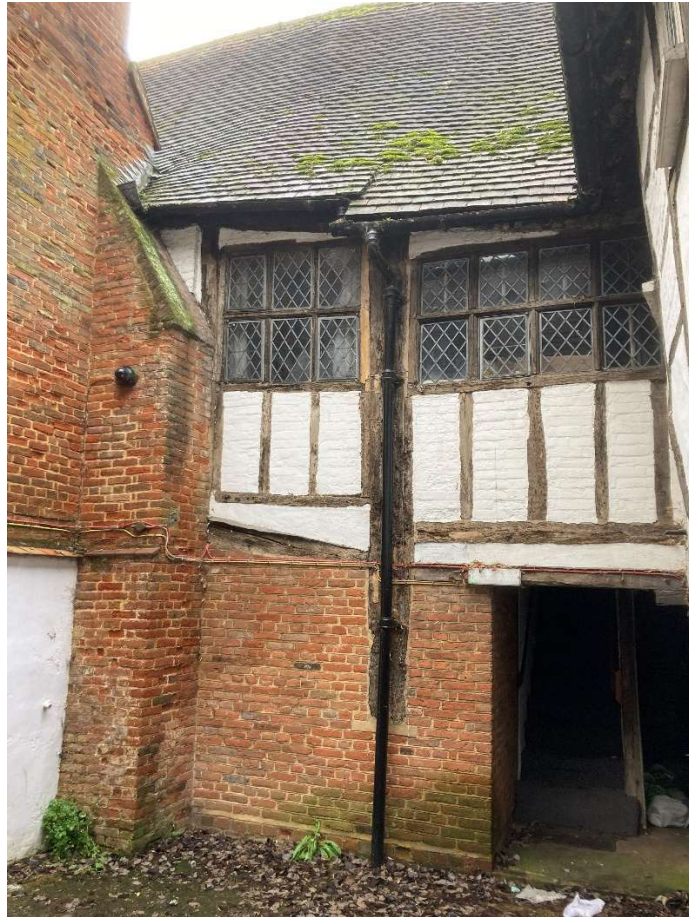
- 3.68. Extensive damp could also be seen at the base of the north facing elevation behind the down pipe at low-level and at high-level on the tiled shoulder of the chimney breast: the former probably due to poor disposal of rainwater from the base of the downpipe or a faulty downpipe that leaked; the latter due to discharge from the adjacent roof by-passing the upstanding lead deflector that was attempting to redirect the flow into the gutter.

*Damp in the north facing elevation within the courtyard*

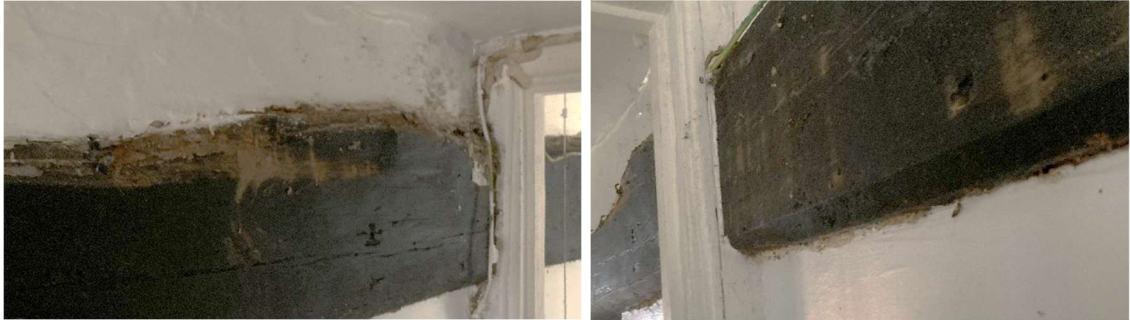
- 3.73. Various partitions in the flats that were accessed were of a modern construction and were not load bearing.
- 3.74. The internal timber structure generally appeared to be in good condition from the limited members observed, but in Flat 6, the beam adjacent the main chimneybreast did seem to have decay in both its top and bottom.

*Slight decay in the top and bottom of a principal beam in Flat 6*

- 3.75. The decayed timber in Flat 6 was a substantial member and the decay unlikely to have significantly affected its strength, but it did represent the importance of assessing all timbers when possible to determine their condition.
- 3.76. Decay only ever occurs in the presence of moisture and this beam must have experienced high moisture level at the top and bottom for rot to begin. The cause of this moisture may have been a defect in the chimneybreast or from internal condensation over a long period: the room in which the damp manifested had been a shower room I believe.
