| | <div>STRUCTURAL INSPECTION RECORD</div> <div>FIRE DAMAGED UNITS at BIRDS HILL, LETCHWORTH GARDEN CITY</div> | | | | | | REFERENCE: |
| | | | | | | | 7040 – IR-01 |
| PROJECT | BIRDS HILL, LETCHWORTH GARDEN CITY, SG6 1JE | | | | | | |
| BRIEF | KSA carried out a non-intrusive structural inspection on 13 <sup>th</sup> May 2026 on behalf of Greenchurch Developments Limited. | | | | | | |

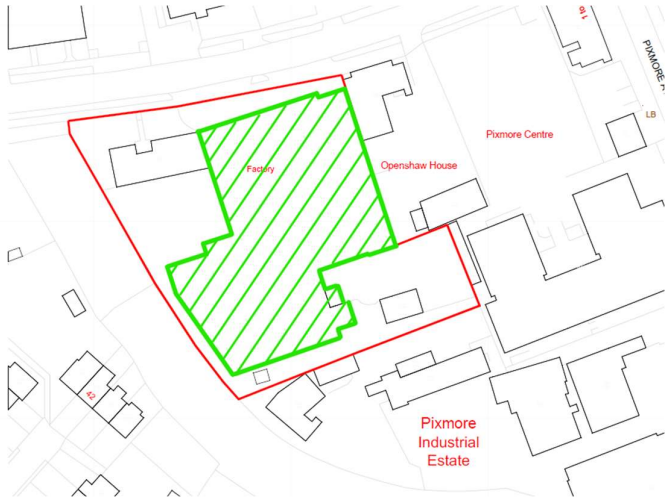
| | The green hatched area denotes extent covered by this report. | | | | | | |
