Our Ref: 24403/JL/PL

Date: 25 October 2024

**Re: Barn Conversion, Titmore Green Farm, Stevenage SG4 7JT**

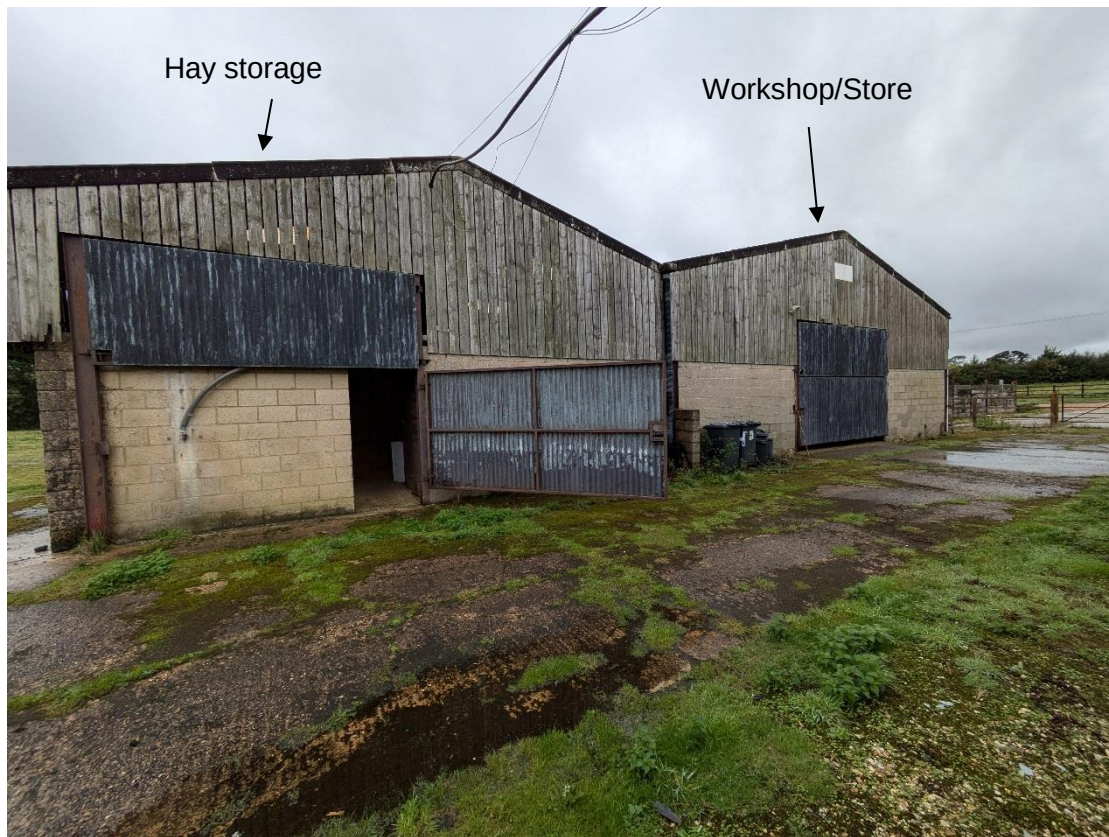
The left hand side barn is currently used for hay storage, the right hand side is used for machine storage and a workshop area. Refer to Photograph 1.

**Photograph 1** View on front of barns.

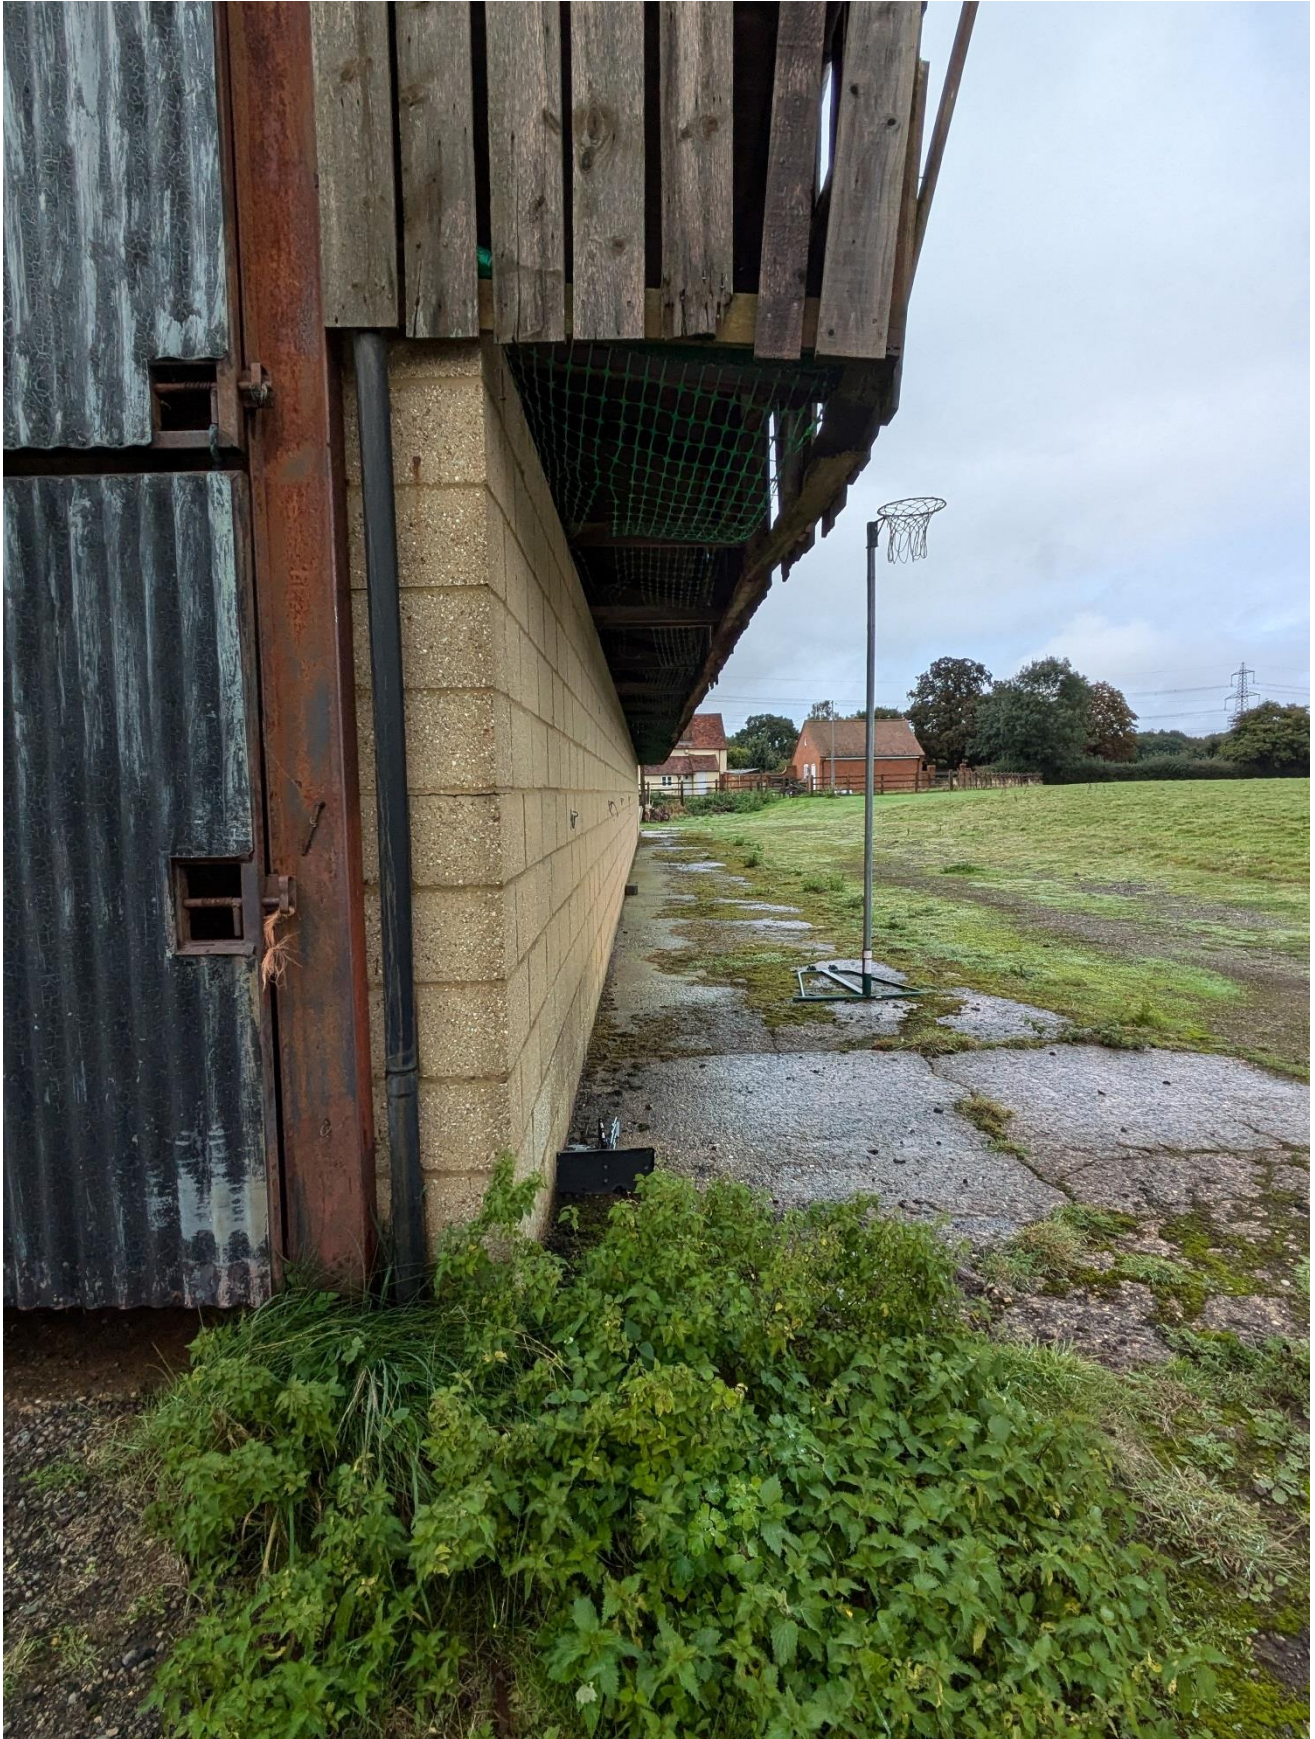
To the left hand side elevation additional steel framing has been provided to form an overhang. Refer to Photograph 2.

**Photograph 2** View of overhang, as viewed from rear.

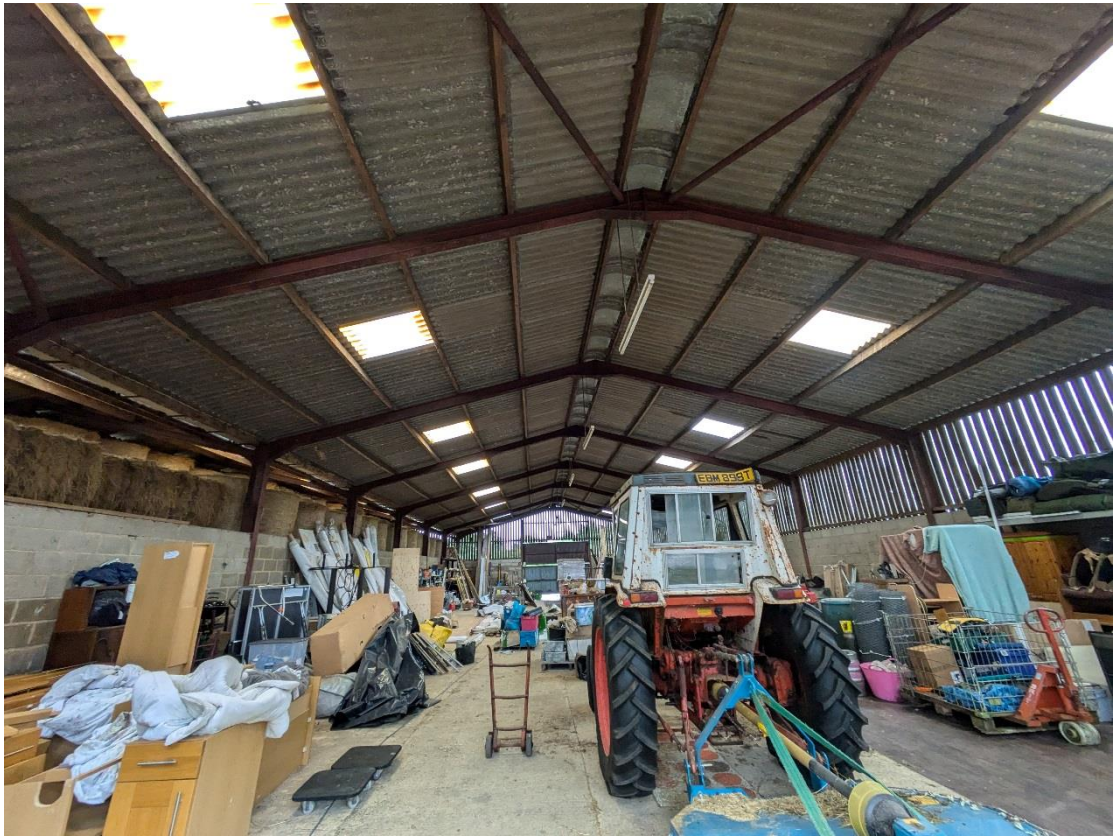
The steel portal frames support timber purlins which are supporting the profiled sheet, roof, refer to Photograph 3. As can be seen in the photograph the end bays of the structure have CHS cross bracing to the roof. Vertical bracing can also be noted to the end of the bay.

**Photograph 3** Internal view of workshop/storage barn.

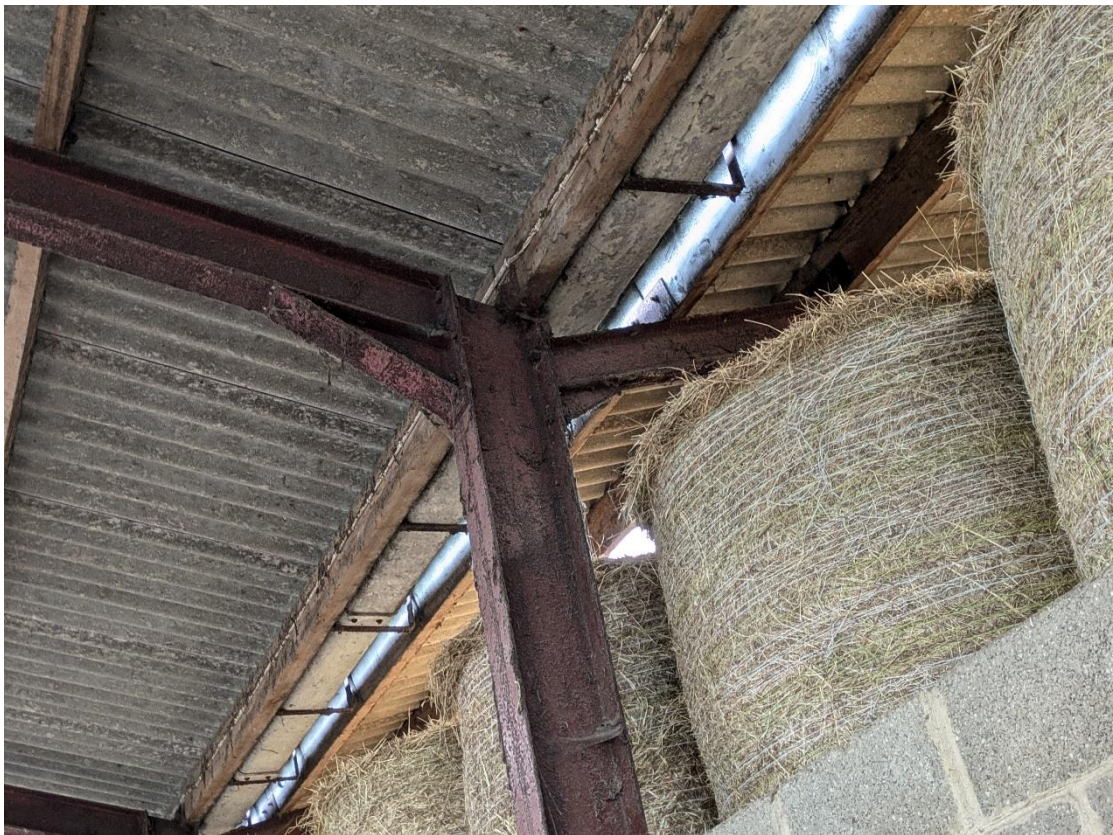
Photograph 4 shows the central post of the double portal. Haunches are evident to both portals and at the ridge.

**Photograph 4** Central post of double portal.

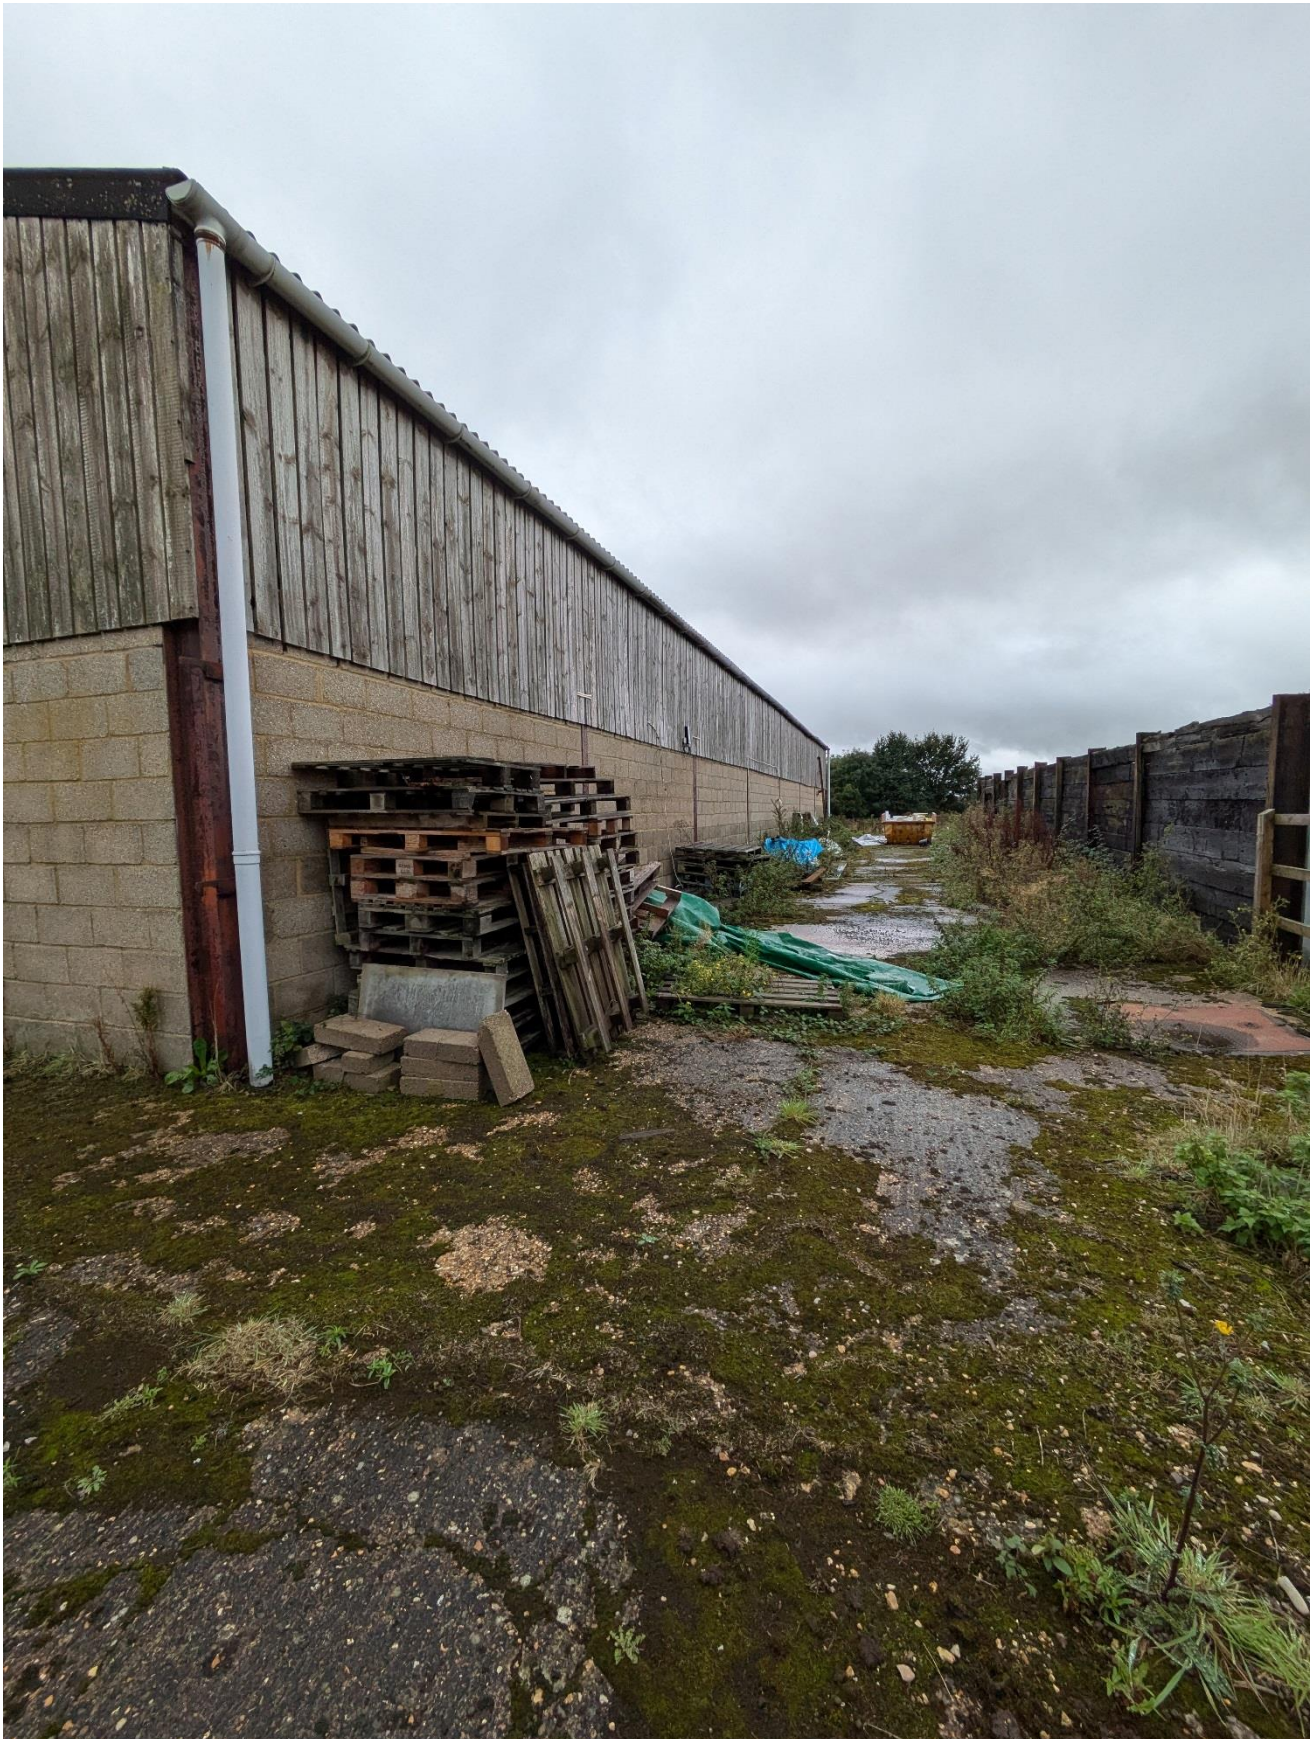
Photograph 5 shows a view of the right hand side elevation.

**Photograph 5** View along right hand side elevation.

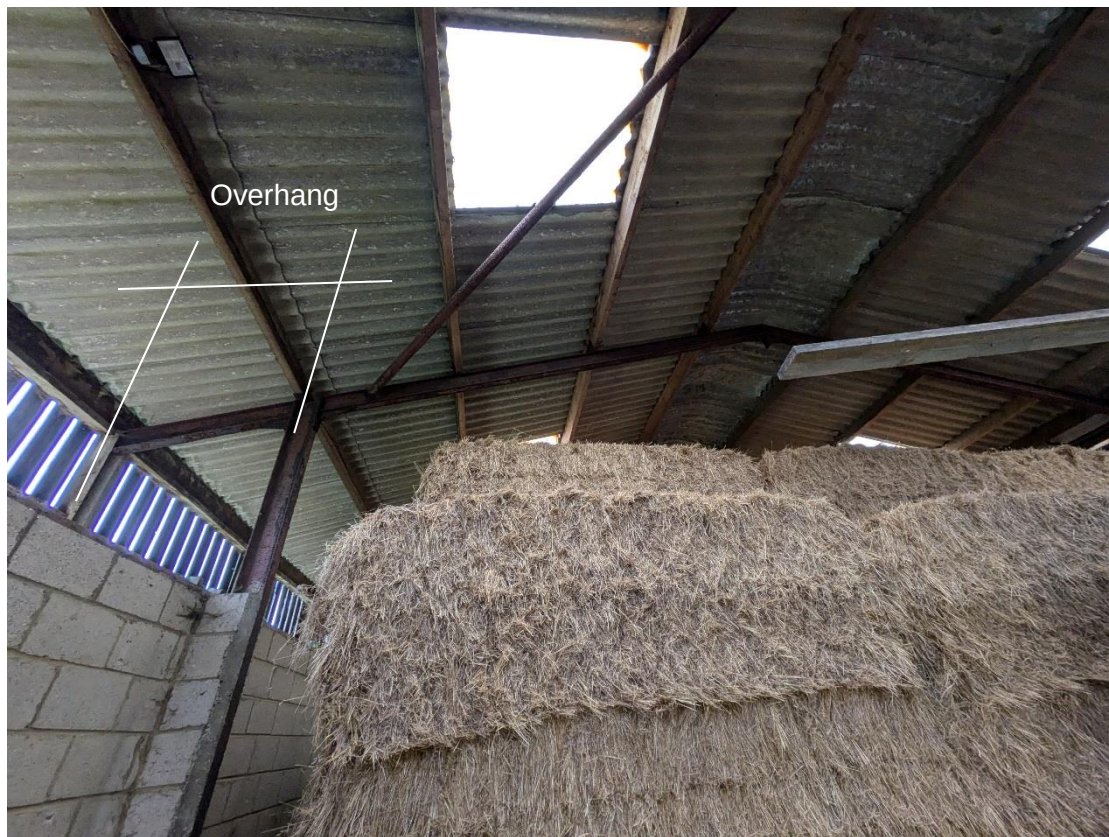
**Photograph 6** Internal view on overhang steel framing.

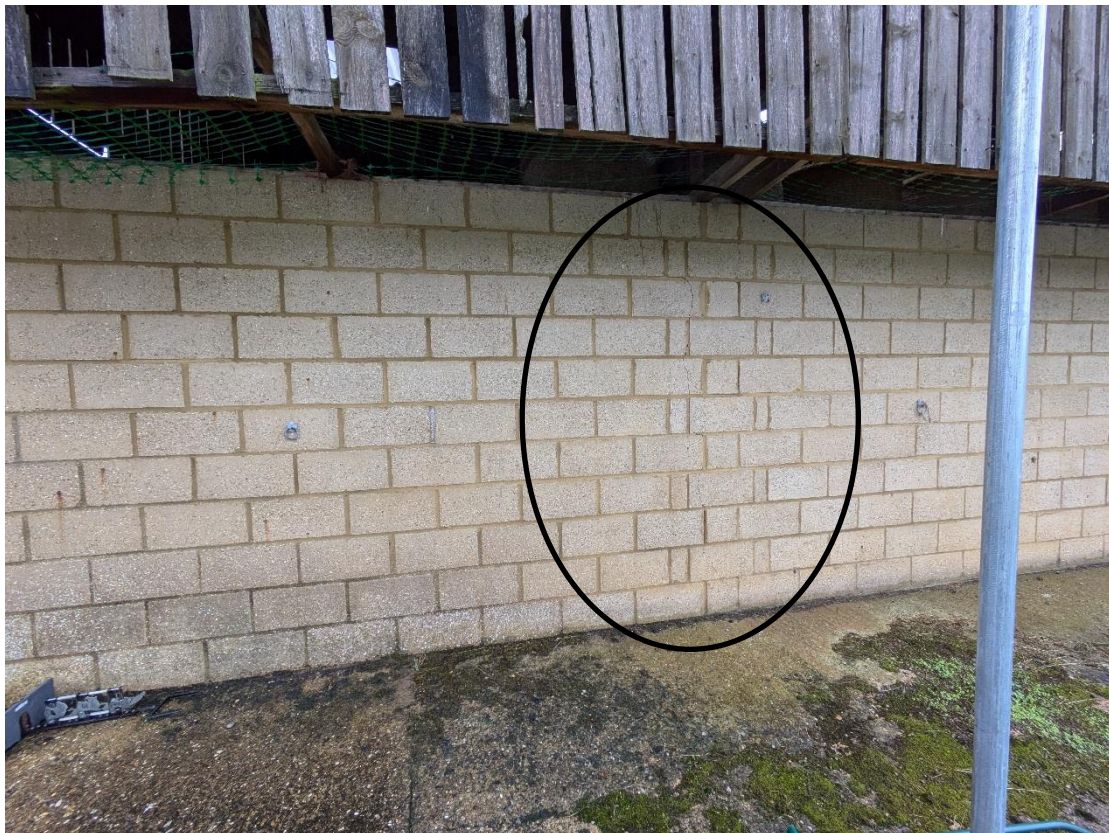
Photograph 6 indicates the steel frame extension forming the overhang. To the left hand side elevation vertical hairline shrinkage cracks were noted to the blockwork at approximately 6m centres, refer to Photograph 7.

The blockwork wall is over 30m long with no movement joints to allow for thermal movement. In blockwork these are usually required every 6m.

**Photograph 7** Left hand side elevation – typical vertical hairline crack.

The cracking to the blockwork on the left hand elevation can be retained by retro-fitting vertical expansion joints.

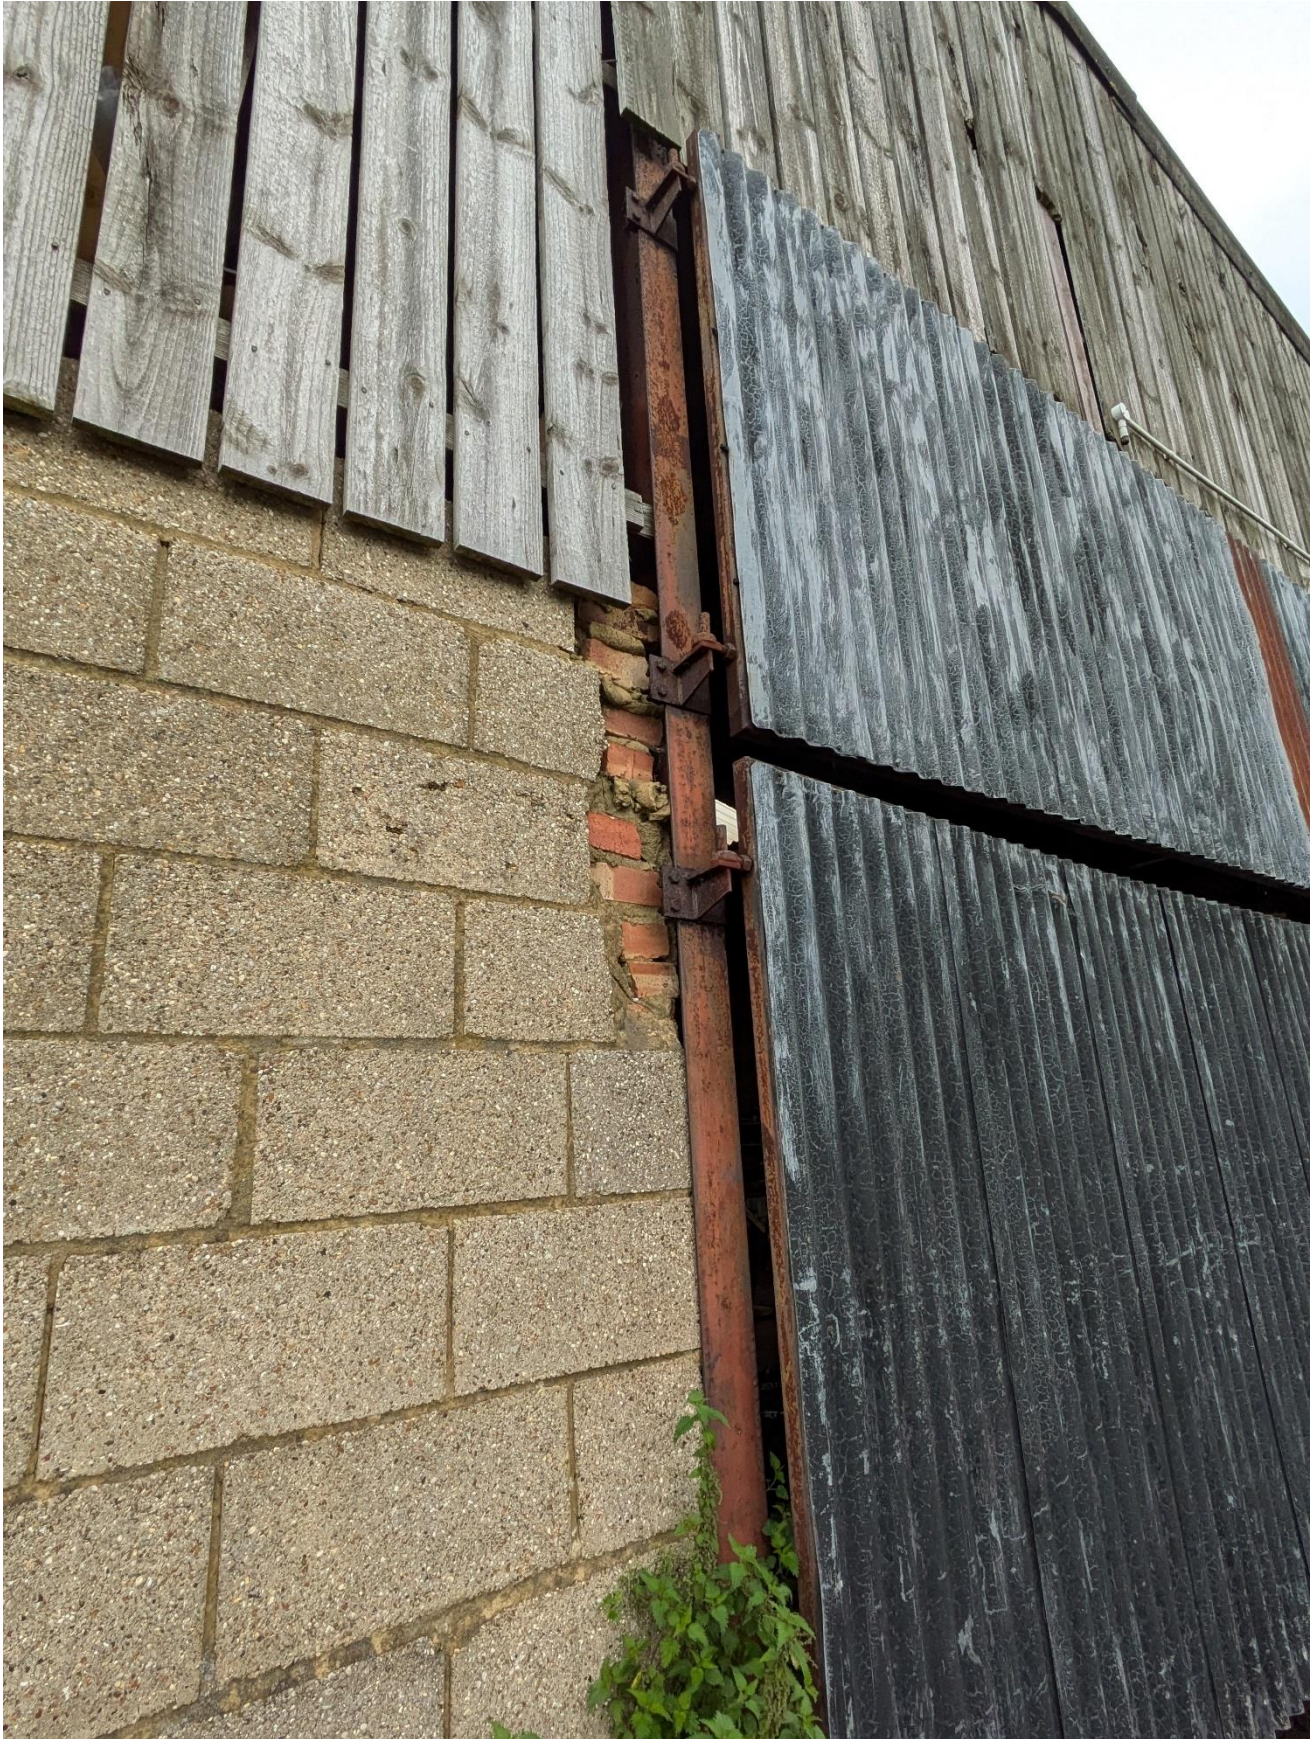
To the front and rear elevations, around doors, some loss of masonry was noted, refer to Photograph 8. This is localised and not in structural walls.

**Photograph 8** Typical views on loss of mortar at doors.

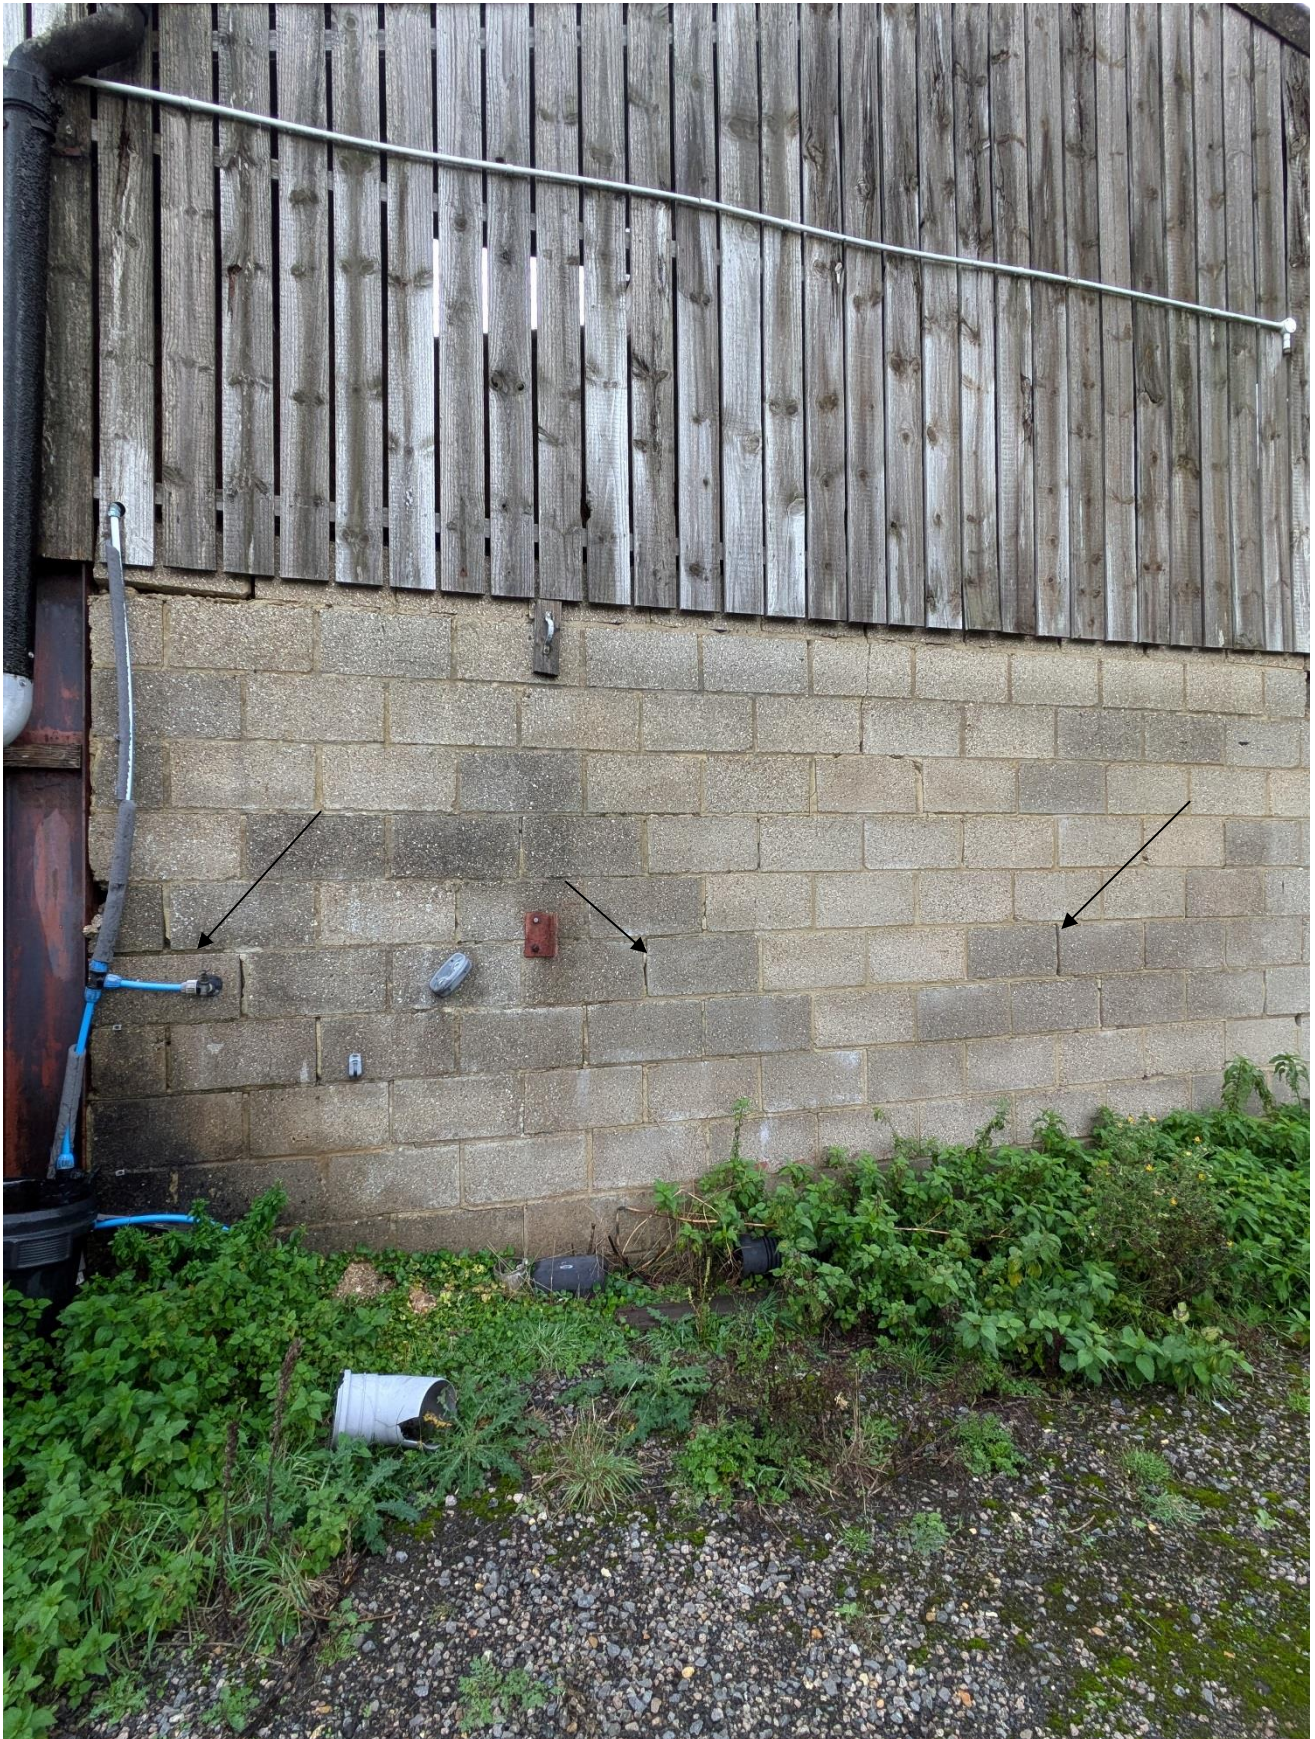
To the rear elevation diagonal hairline cracking was noted to the blockwork as shown in Photograph 9. The adjacent bay to the left has similar cracking. Between these bays there is a water butt, which is leaking.

**Photograph 9** Rear elevation – cracking in bay to right hand side of water butt.
