Tree Condition Survey

9 Hitchin Road

Letchworth Garden City

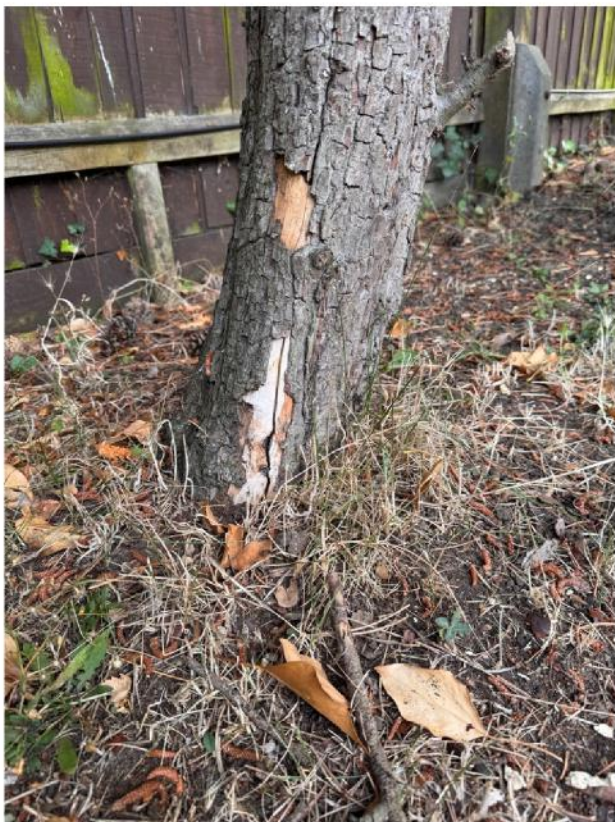
T3 Hawthorne

| Ident no.<br>on plan | Tree location | Species with<br>dimensions | Condition<br>and observations | Preliminary<br>management<br>recommendations | Reason | Priority and<br>Timescale |
|---|---|---|---|---|---|---|
| T3 | Driveway | Hawthorn | Physiologically – Mature tree. Poor condition. Declining, basal cracks. Physiologically – poor condition, low vigour. Deadwood present | Reduce height to leave at 2m above ground level | Safety | 1 year |

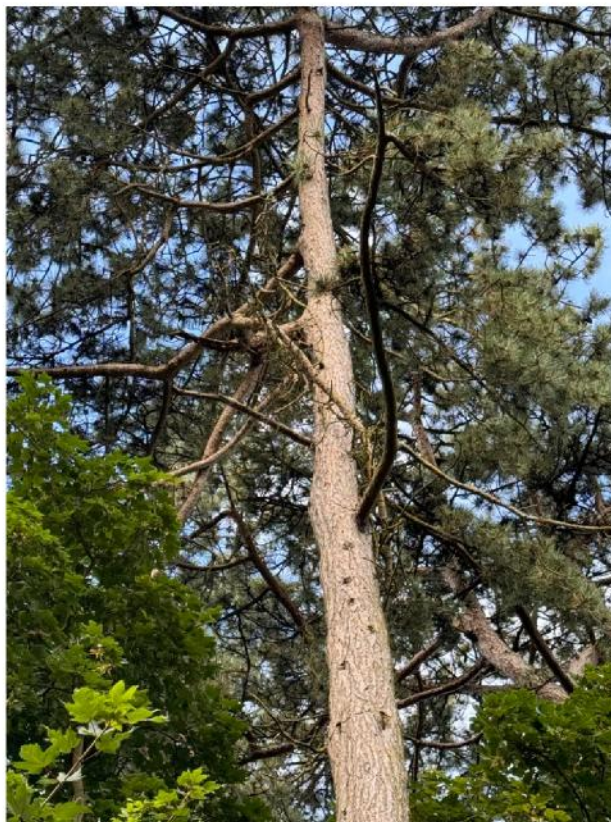
T6 Corsican pine

| Ident no.<br>on plan | Tree location | Species with<br>dimensions | Condition<br>and observations | Preliminary<br>management<br>recommendations | Reason | Priority and<br>Timescale |
|---|---|---|---|---|---|---|
| T6 | Corner of garage | Corsican pine | Structural – Early mature tree. Fair condition. Physiologically – Good condition. Broken limb partially hanging on South-eastern side. | Remove broken limb | Safety | 6 months |

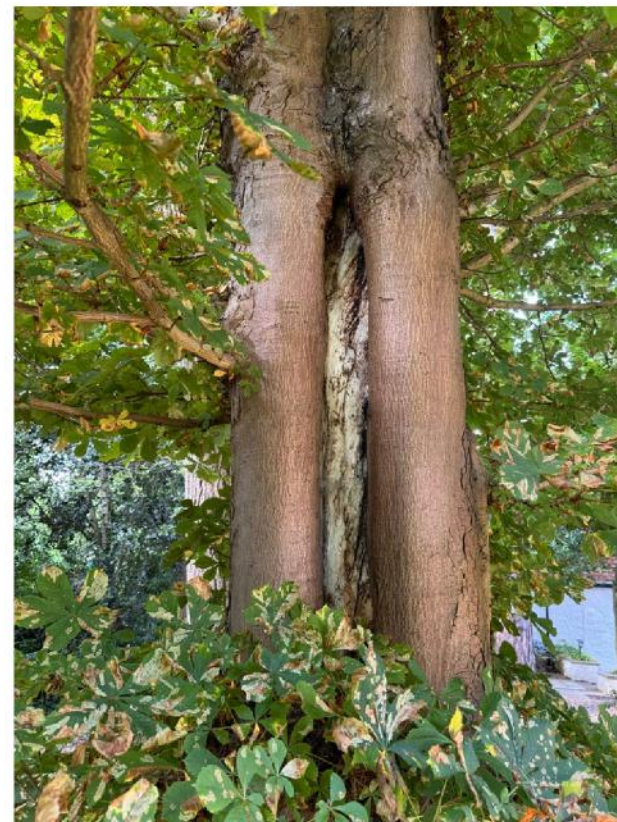
T12 Horse chestnut

| T12 | Side of garage | Multi stem Horse chestnut | Structural – Fair condition. Large, occluded wound on east stem. Physiologically – Fair condition. Cameraria present (Horse chestnut leaf minor). | No works necessary, reinspect | Duty of care | 2 years |
